Re: Property-Specific Remedial Action Report  
Newhall Street Neighborhood  
1061 Winchester Avenue, Block C  
Hamden, Connecticut 06517

**PROPERTY-SPECIFIC REMEDIAL ACTION REPORT  
1061 WINCHESTER AVENUE**

**NON PUBLIC PROPERTIES  
NEWHALL STREET NEIGHBORHOOD  
HAMDEN, CONNECTICUT**

AMEC Project Number: 6107120004/105

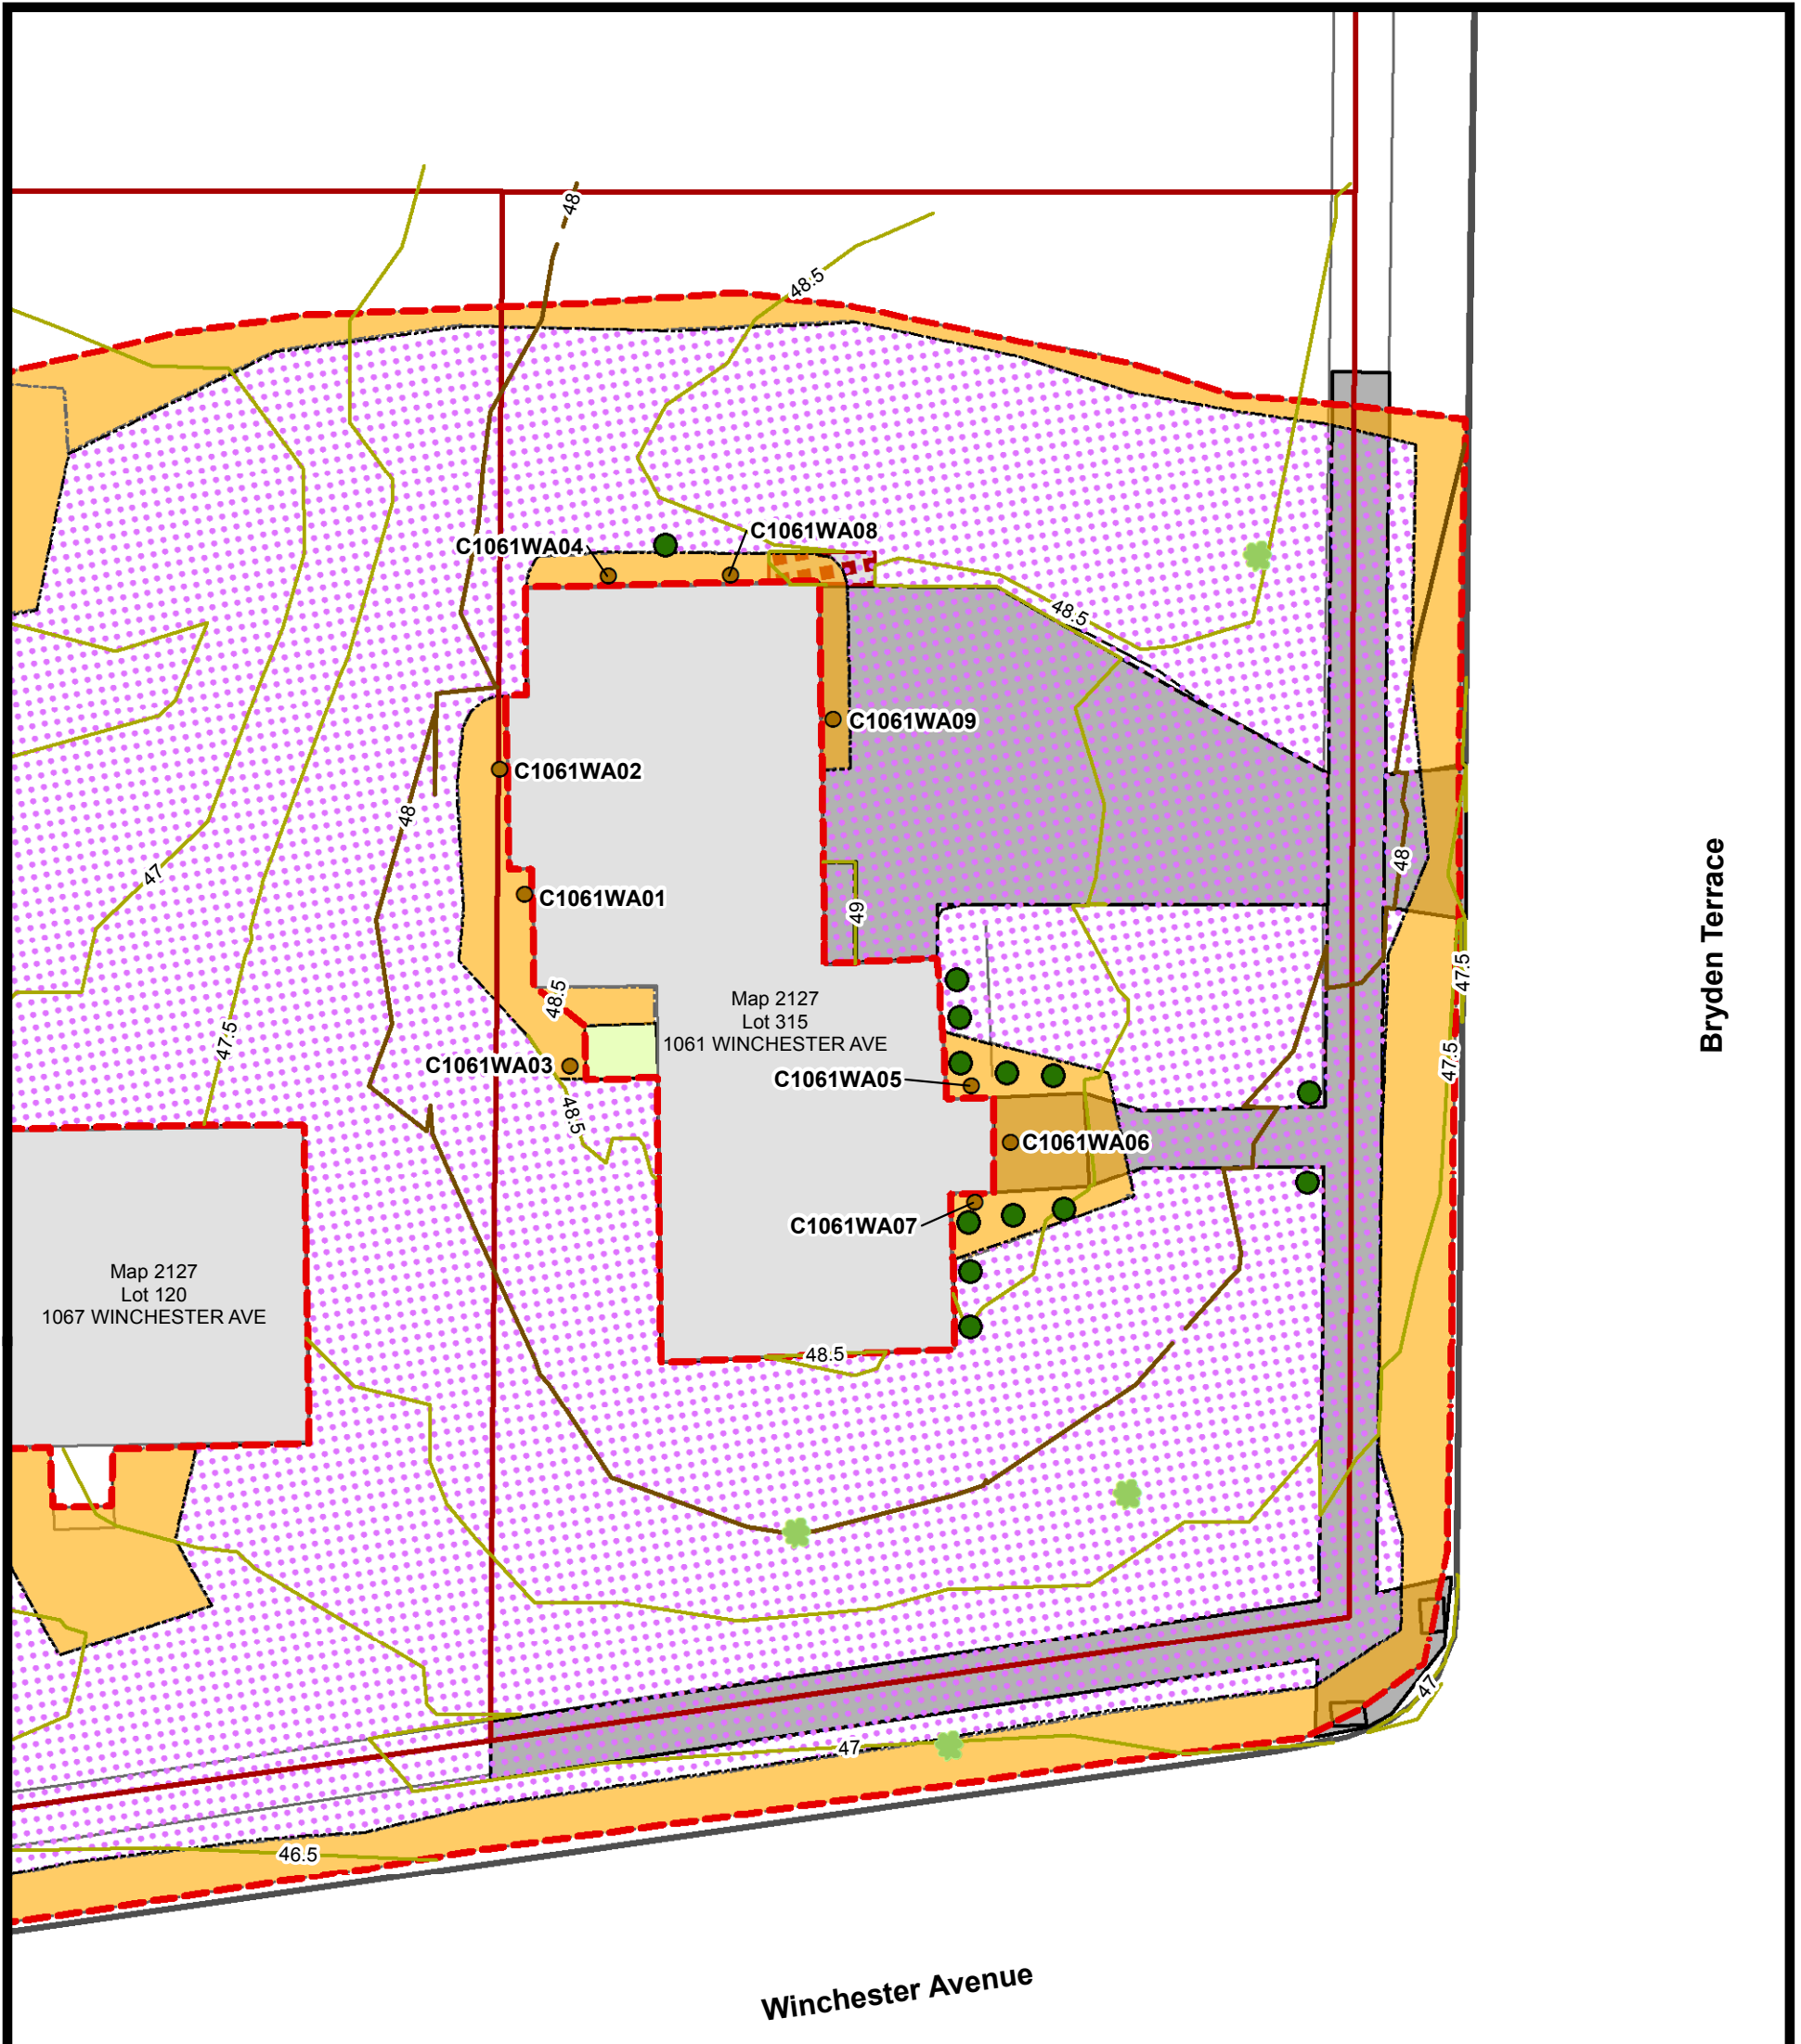
- Across the property, fill material was encountered at depths greater than 4 feet below ground surface (bgs). This fill material was left in place, covered by an orange geotextile fabric, and backfilled with clean soil in accordance with the Final Design - Generic RAP. Figure 2-1 shows the approximate area of geotextile fabric identifying the presence of fill at a depth greater than 4 feet bgs.

- In some locations, it was necessary to leave fill material in place at depths less than 4 feet bgs in order to avoid jeopardizing the integrity of a structure. This fill material was left in place, covered by an orange geotextile fabric and/or concrete, and backfilled with clean soil in accordance with the Final Design - Generic RAP. Figure 2-1 shows the approximate area of geotextile fabric/concrete identifying the presence of fill at a depth less than 4 feet bgs.

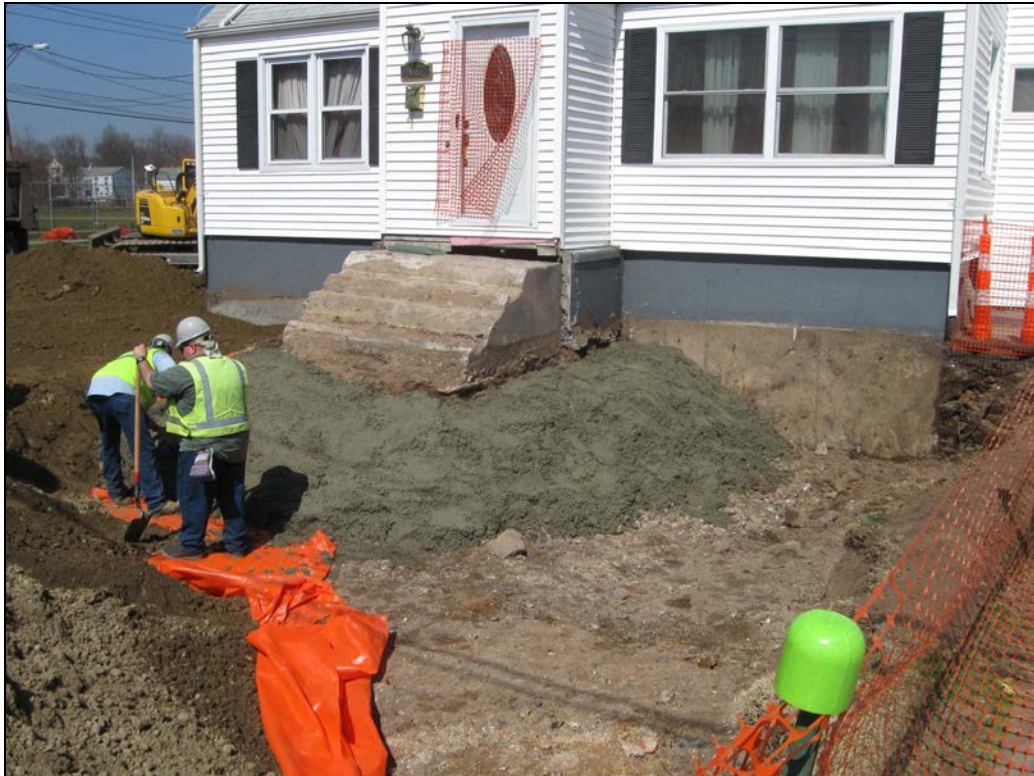
**View looking north at excavation of front yard with concrete along the front stairs.**

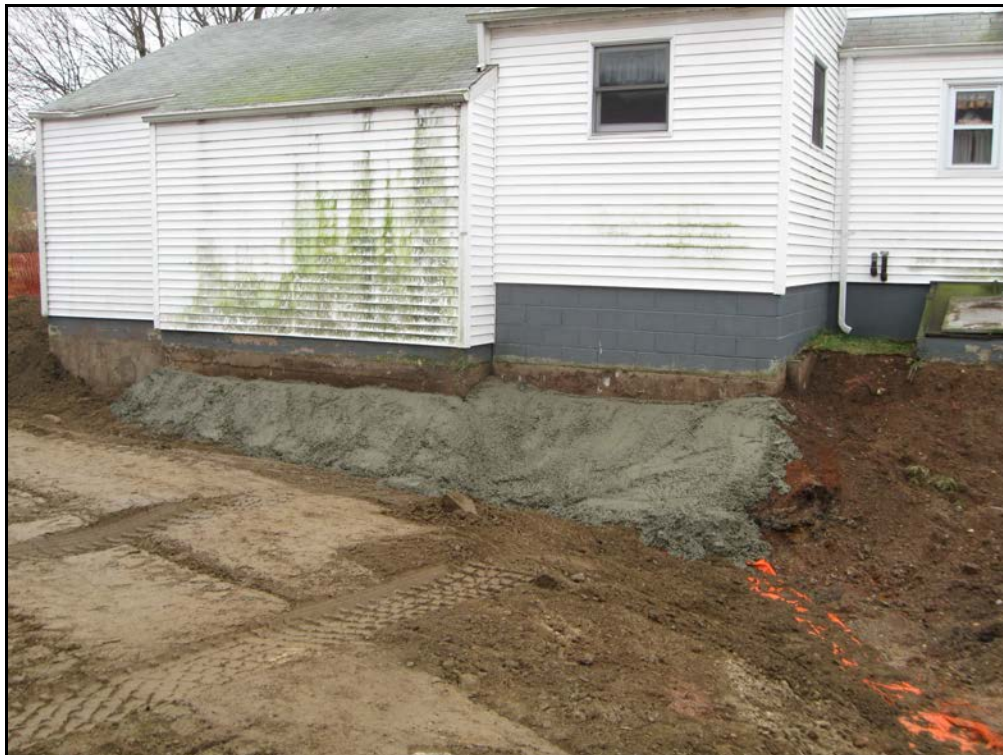
**View looking south at partially backfilled back yard showing marker barrier over fill material left in place.**

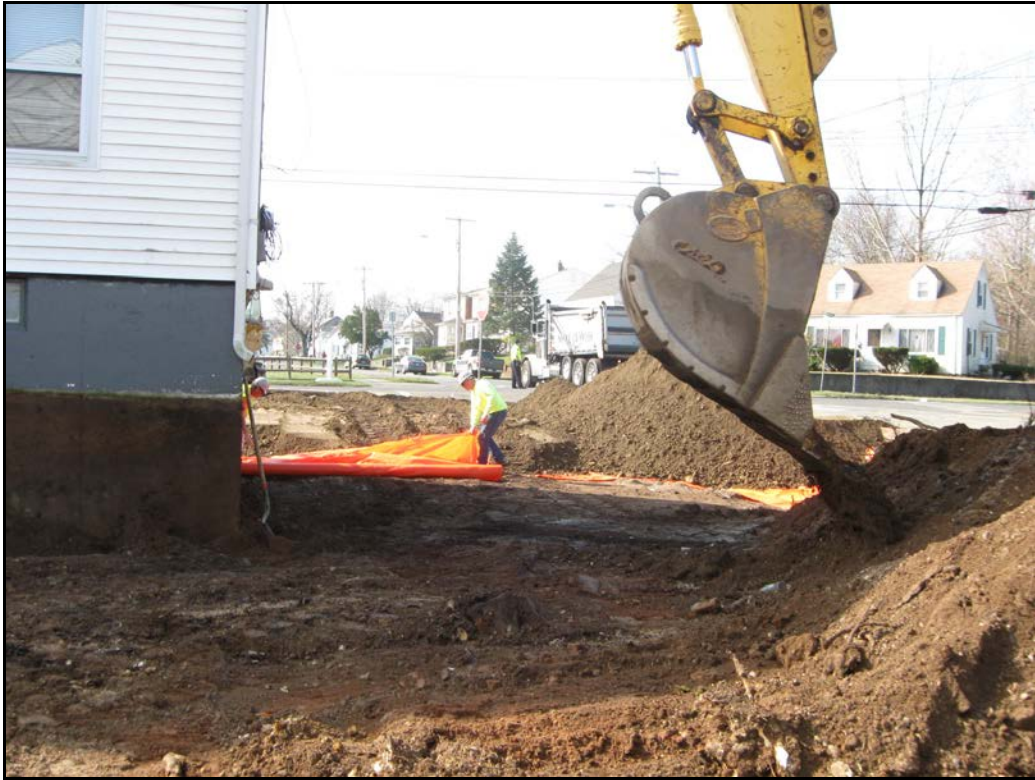
**View looking south at marker barrier being installed in the excavated side yard.**

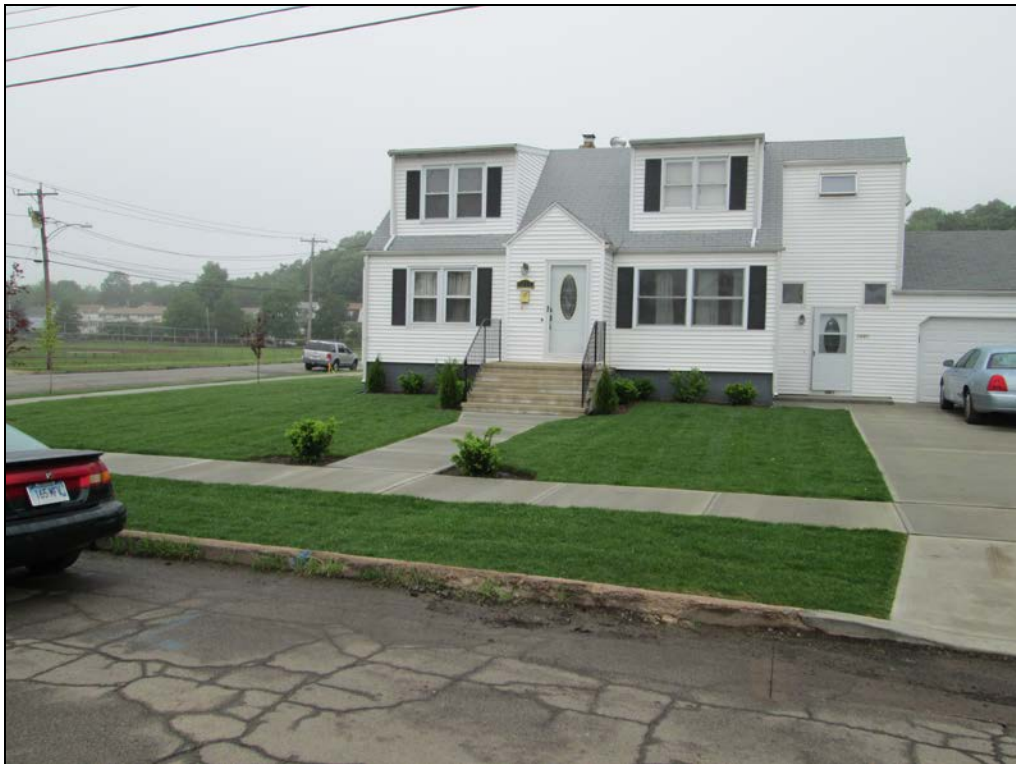
**View looking north at restored front yard.**

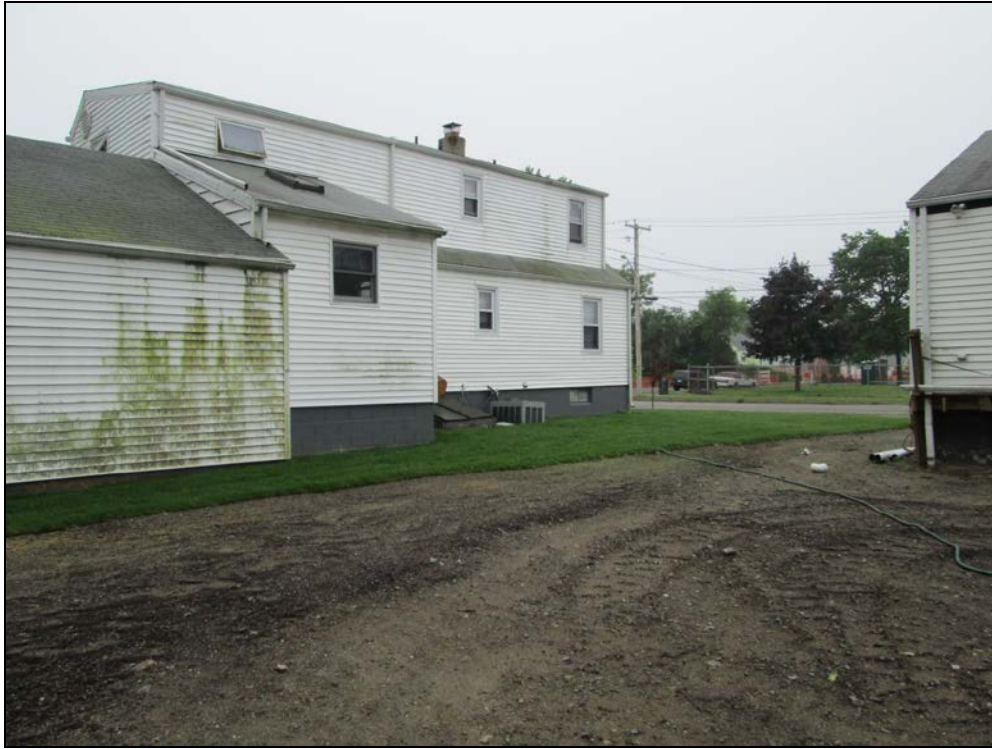
**View looking southwest at restored grass in back yard.**

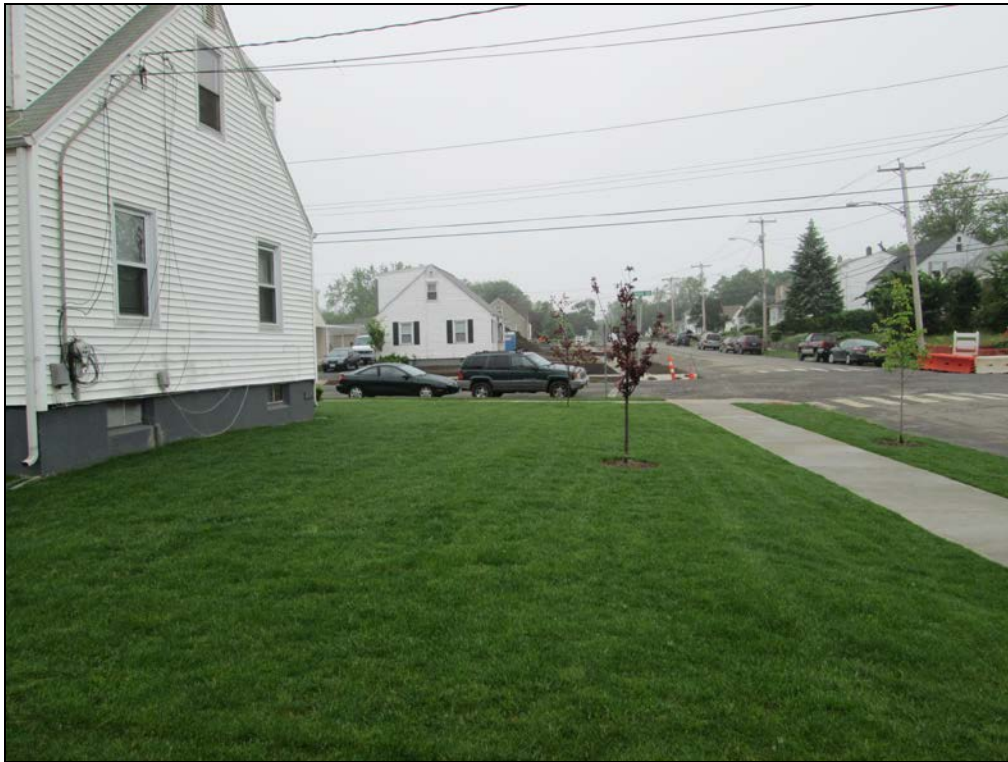
**View looking south at restored side yard.**
