Re: Property-Specific Remedial Action Report
Newhall Street Neighborhood
115 Marlboro Street, Block K
Hamden, Connecticut 06517

**PROPERTY-SPECIFIC REMEDIAL ACTION REPORT
115 MARLBORO STREET**

**NON-PUBLIC PROPERTIES
NEWHALL STREET NEIGHBORHOOD
HAMDEN, CONNECTICUT**

AMEC Project Number: 6107110004/95

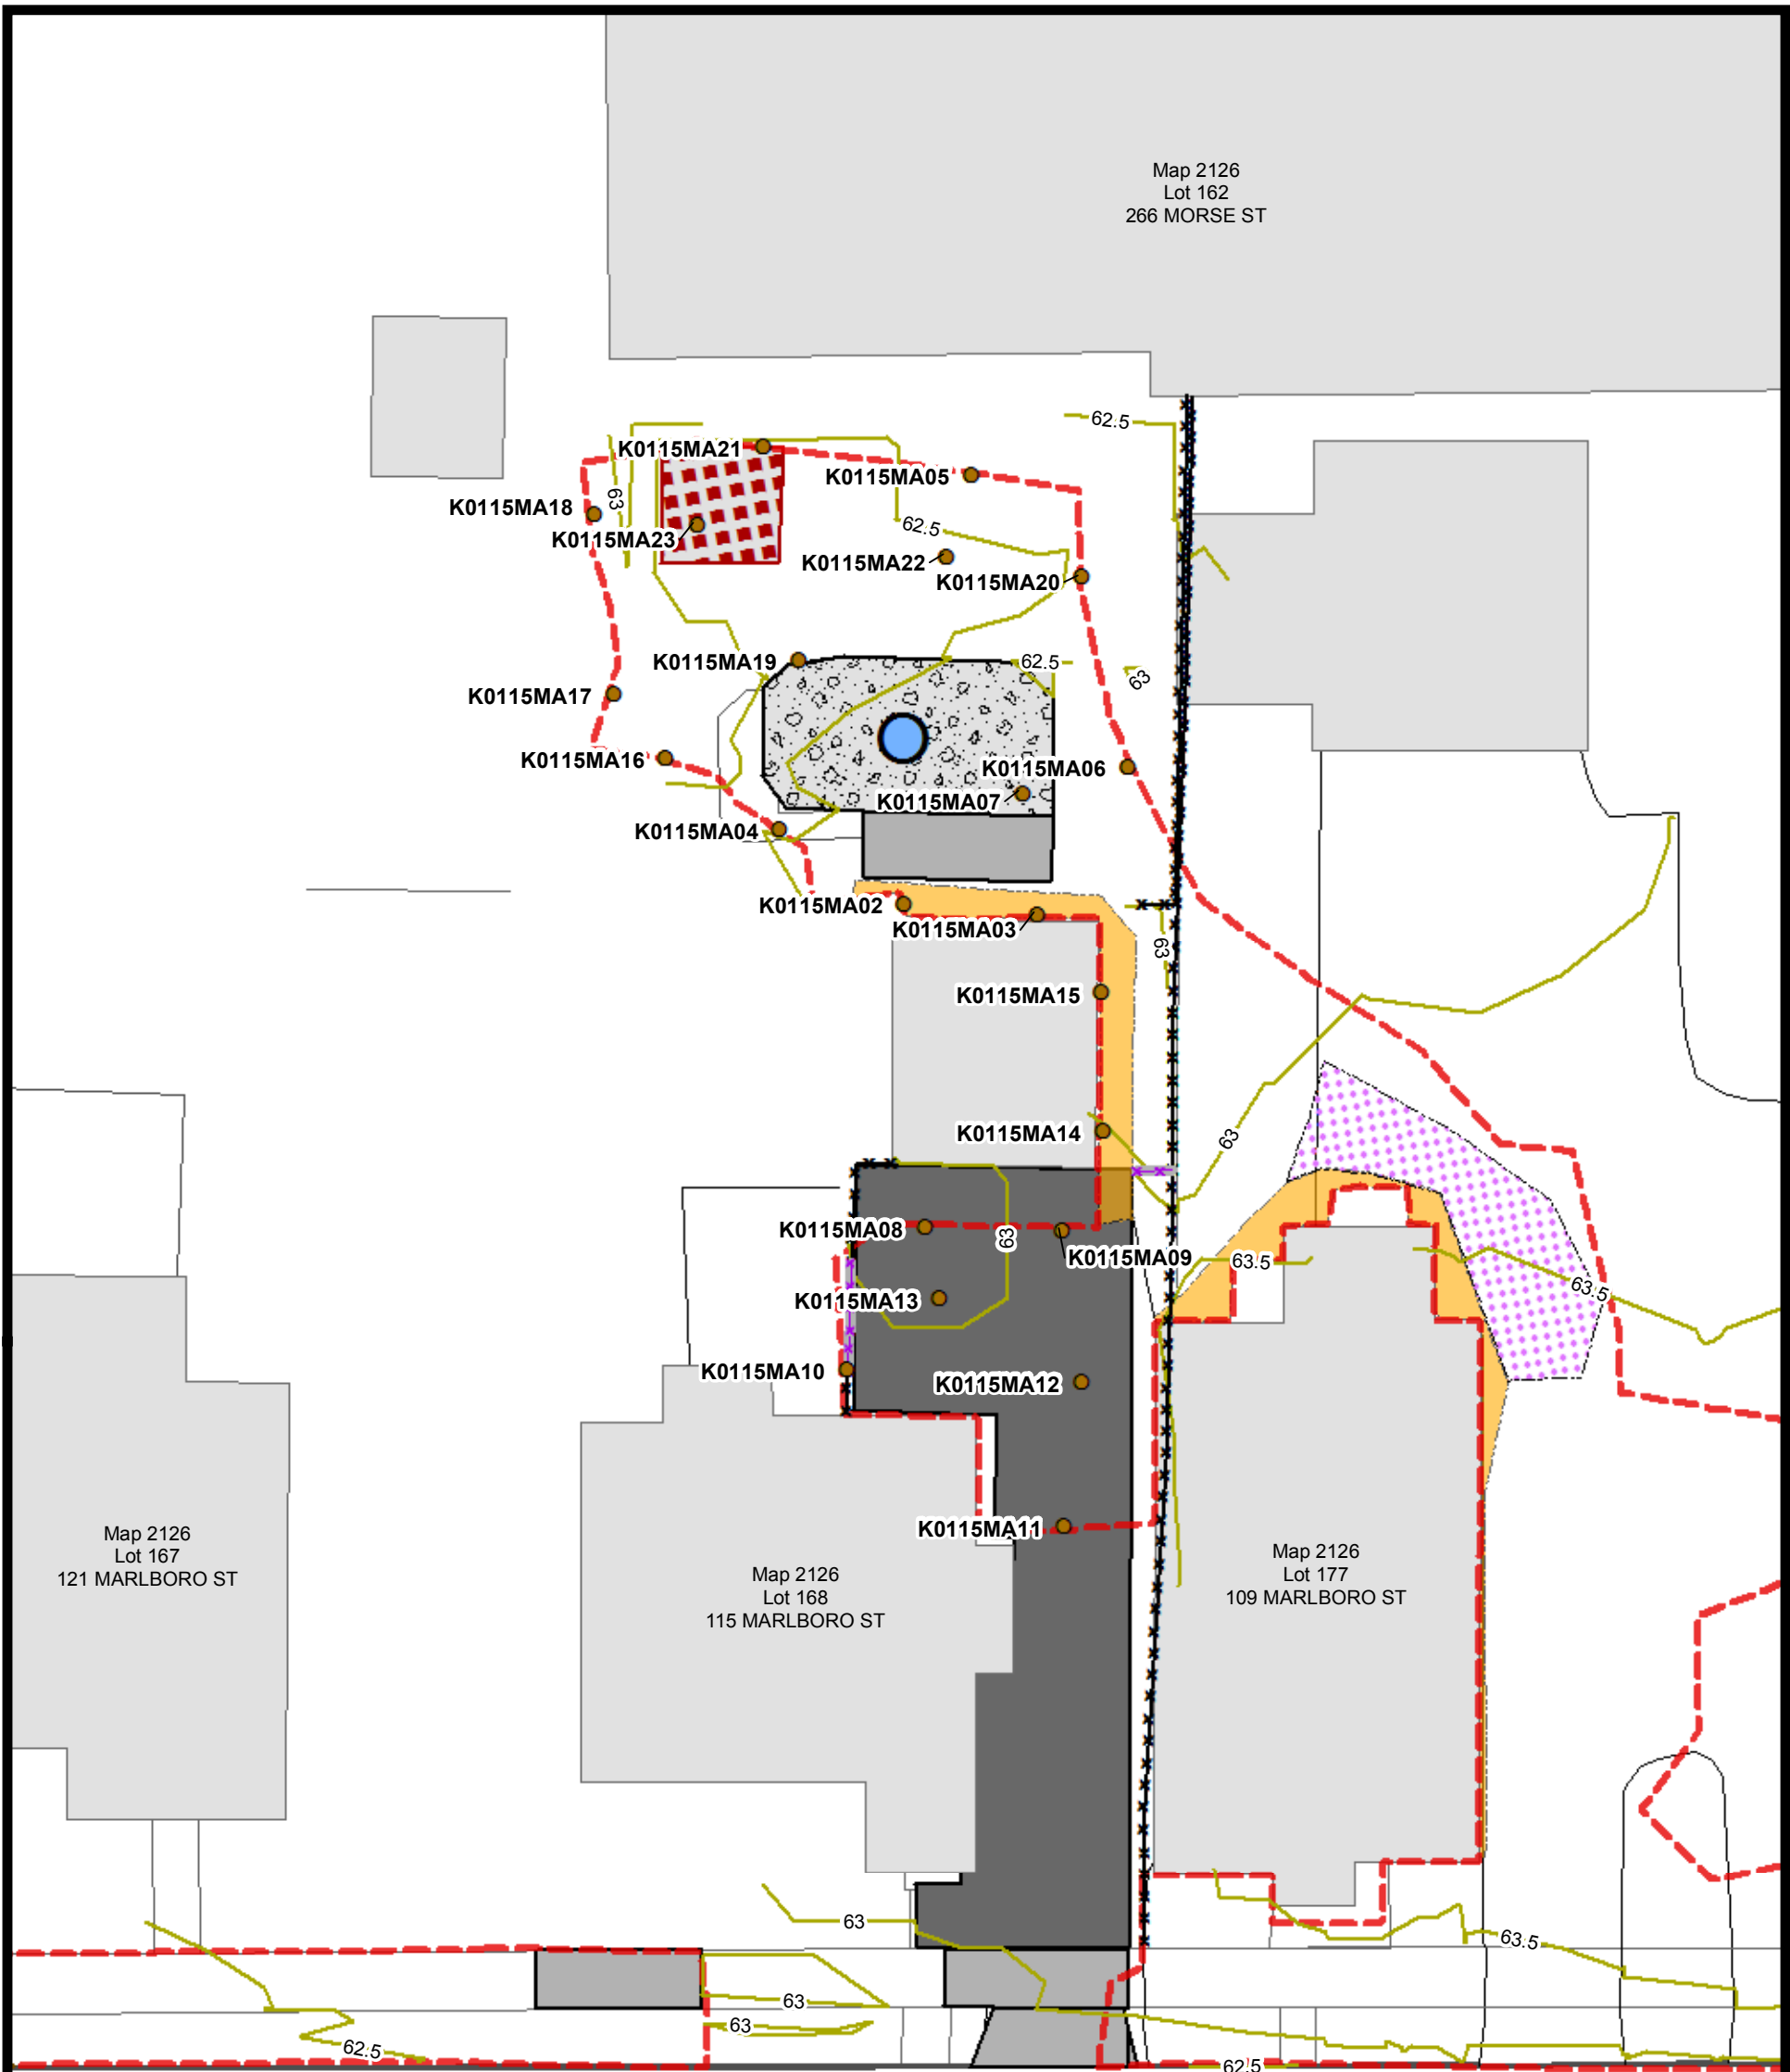
Figure 2-1 Post-Construction Conditions

During the 2011 construction season, Olin completed the excavation, backfill, and restoration of the property in accordance with the Final Design - Generic RAP and the Property-Specific RAP. Figure 2-1 shows the areas where excavation occurred on the property and the locations of excavation confirmation samples. Excavation confirmation samples were collected in accordance with Section 3.2.3 - Confirmatory Sampling of the Final Design - Generic RAP, including adherence to the sampling frequency requirements. X-ray fluorescence (XRF) excavation confirmation sampling results are presented in Table 2-1.

As indicated in Table 2-1, most confirmation sampling results indicate total lead concentrations less than the criteria of 400 milligrams per kilogram (mg/kg) approved by DEEP in the Final Design - Generic RAP. Several samples collected from the perimeter of the excavated area indicated total lead concentrations that exceeded 400 mg/kg. Additional soil could not be removed from these locations around the perimeter of the house, because continued excavation could jeopardize the integrity of the structure.

- In some locations, it was necessary to leave fill material in place at depths less than 4 feet bgs in order to avoid jeopardizing the integrity of a structure. This fill material was left in place, covered by a marker barrier (an orange geotextile fabric and/or shotcrete), and backfilled with clean soil in accordance with the Final Design - Generic RAP. Figure 2-1 shows the approximate area of geotextile fabric/shotcrete identifying the presence of fill at a depth less than 4 feet bgs.

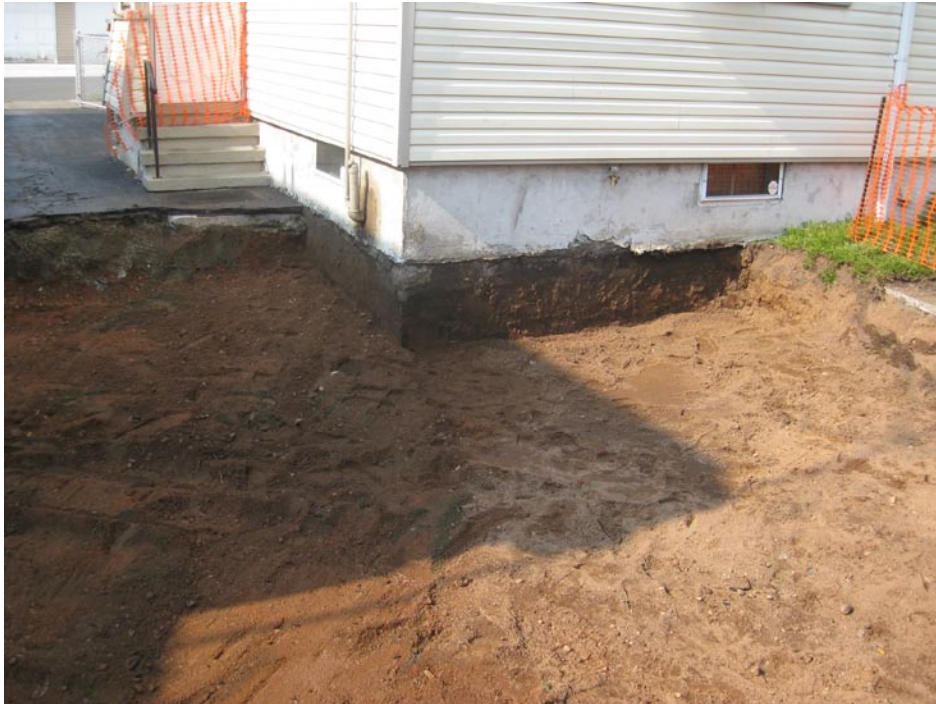
View looking Southwest at excavation behind house and in driveway

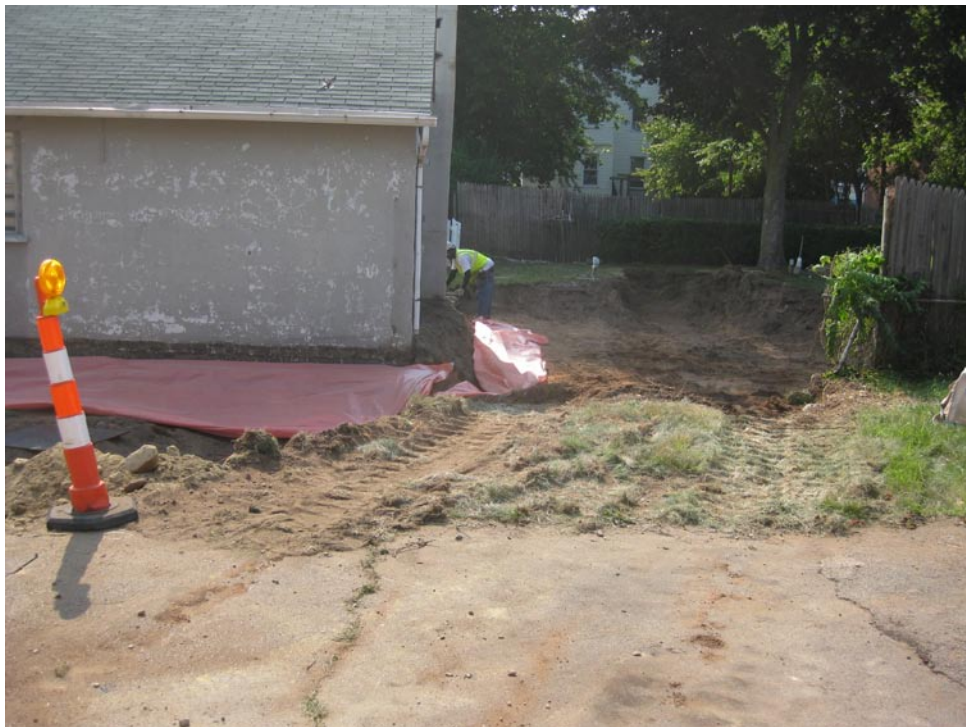
View looking East at excavation of back yard

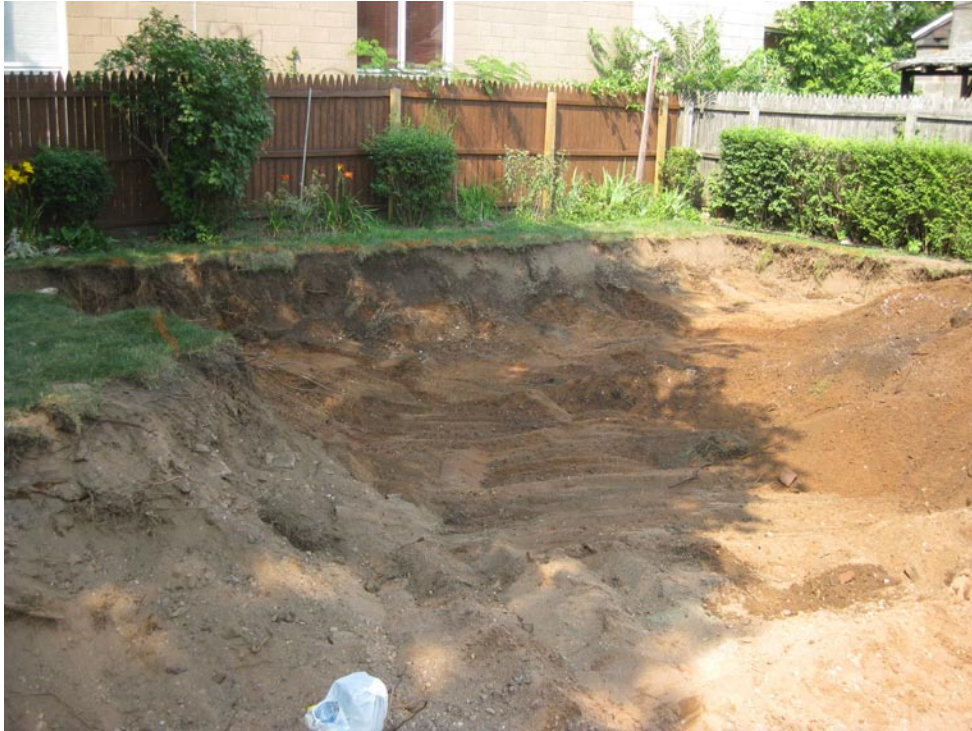
View looking Northwest at excavation area in back yard

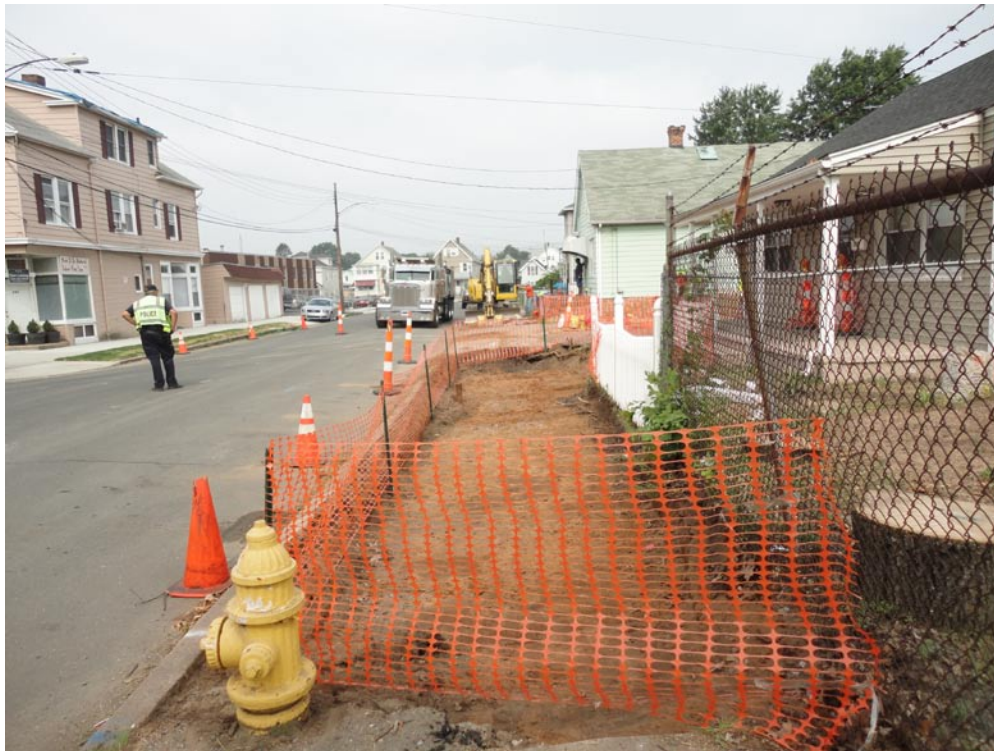
View looking West at excavation area in front yard

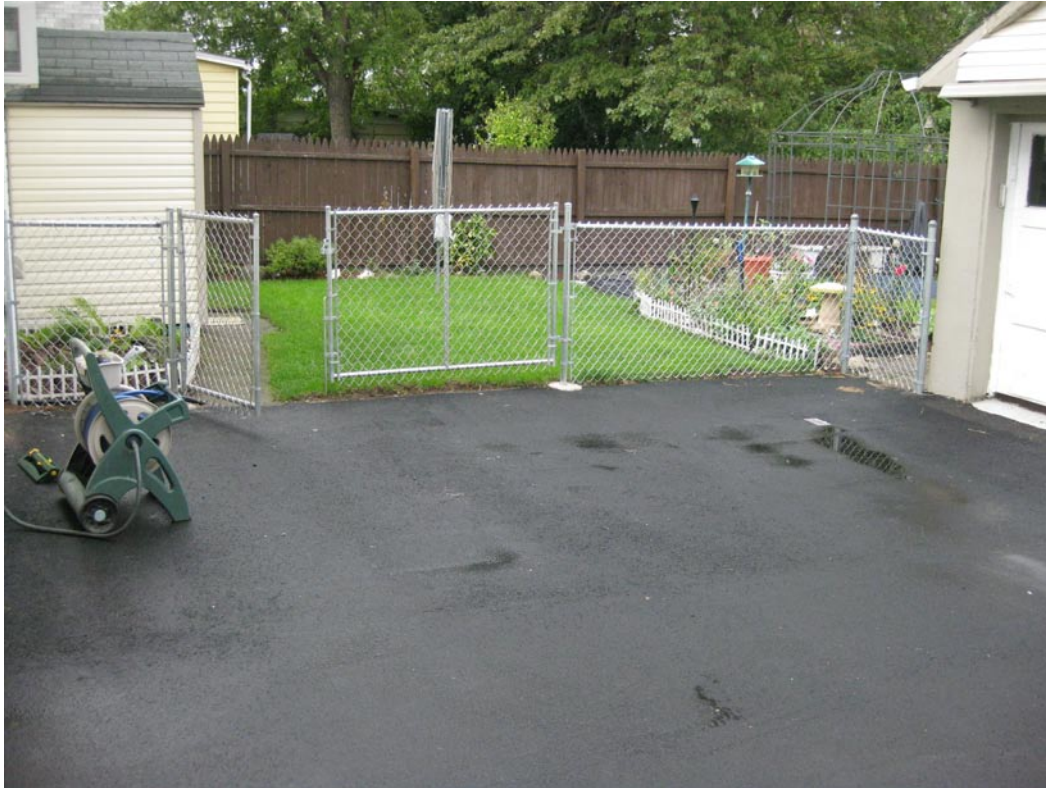
View looking West at restored driveway and landscape areas

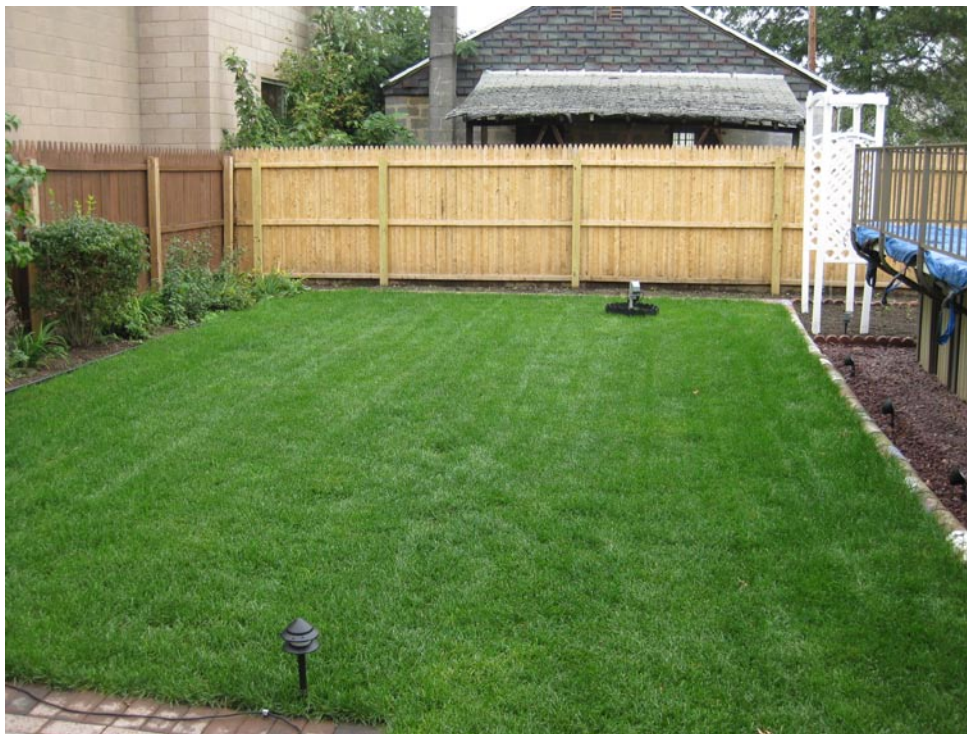
View looking East at partially restored lawn and fencing

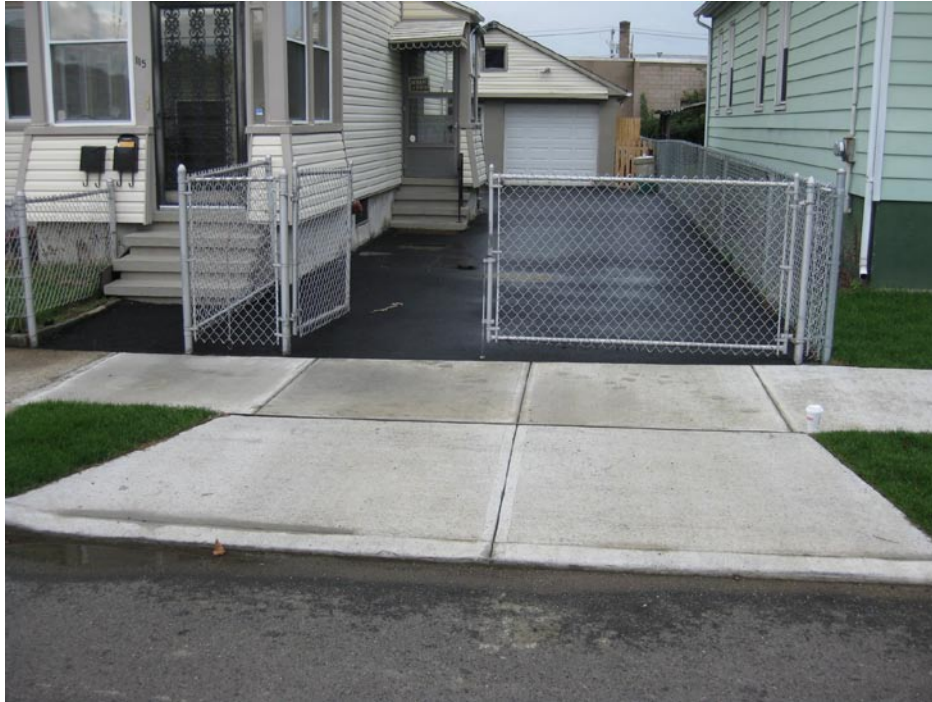
View looking North at restored driveway and sidewalk
