Re: Property-Specific Remedial Action Report
Newhall Street Neighborhood
127 Morse Street, Block F
Hamden, Connecticut 06517

**PROPERTY-SPECIFIC REMEDIAL ACTION REPORT
127 MORSE STREET**

**NON-PUBLIC PROPERTIES
NEWHALL STREET NEIGHBORHOOD
HAMDEN, CONNECTICUT**

October 5, 2012

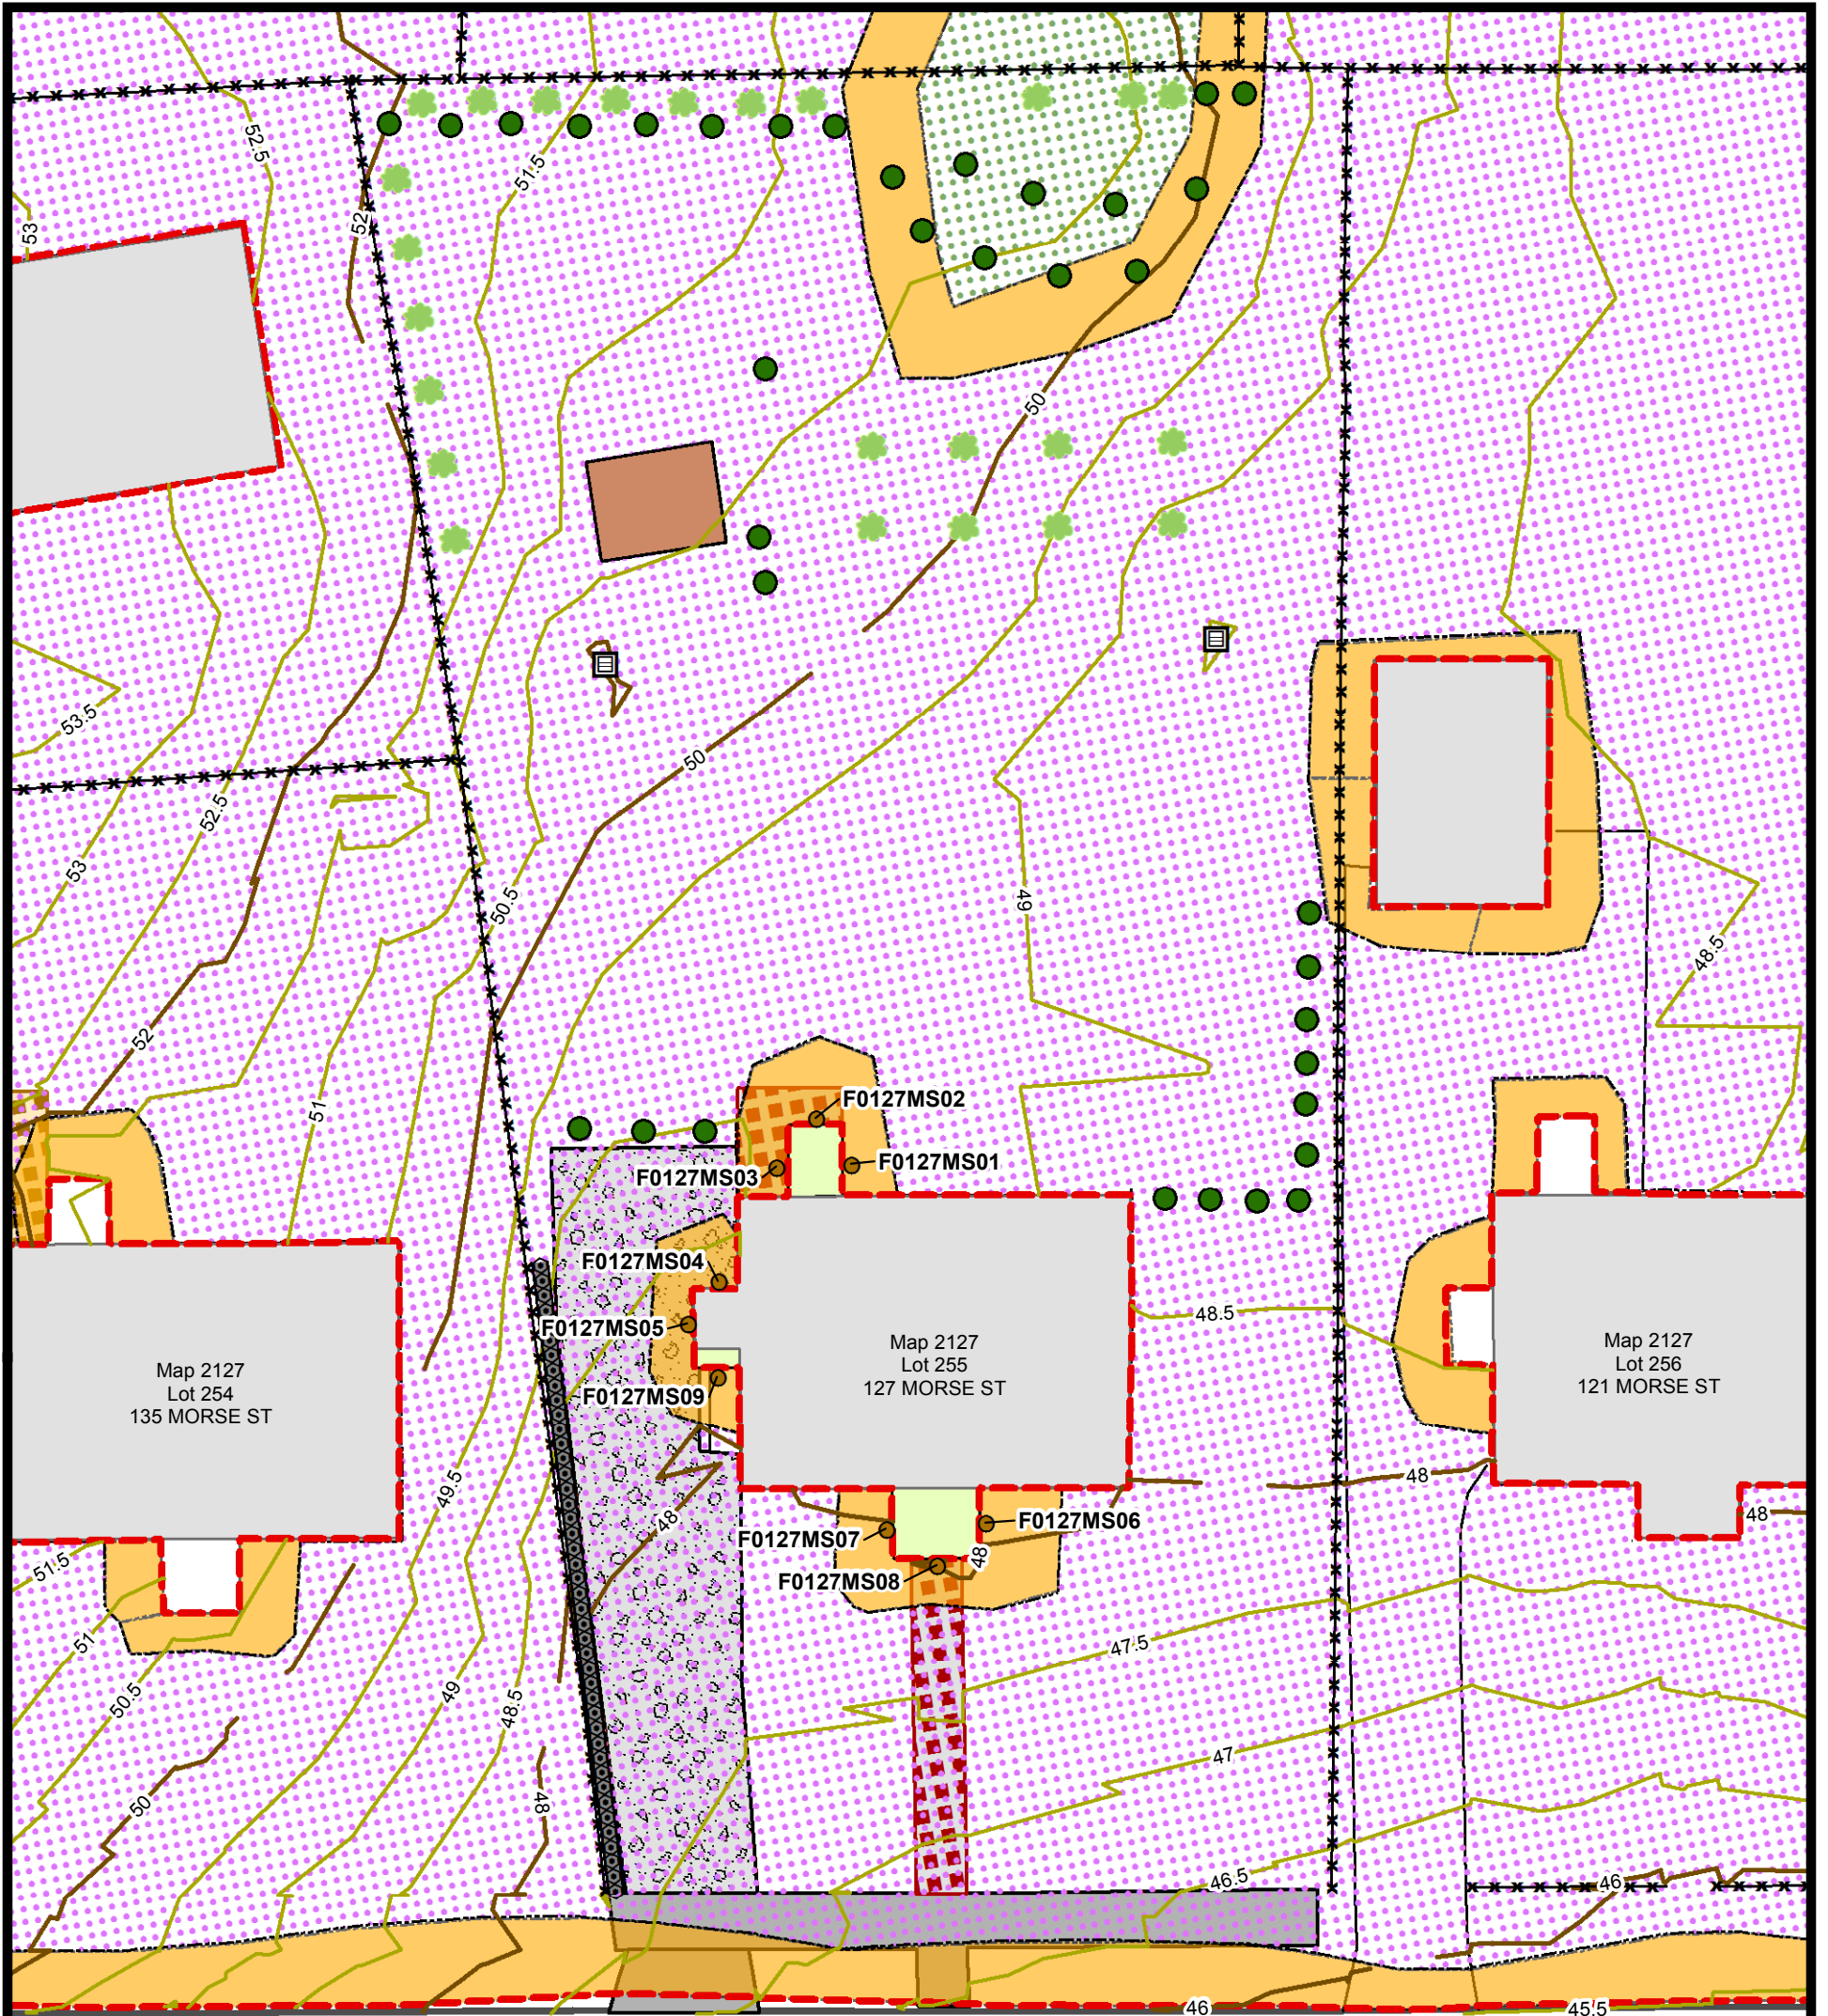
During the 2012 construction season, Olin completed the excavation, backfill, and restoration of the property in accordance with the Final Design - Generic RAP and the Property-Specific RAP. Figure 2-1 shows the areas where excavation occurred on the property and the locations of excavation confirmation samples. Excavation confirmation samples were collected in accordance with Section 3.2.3 - Confirmatory Sampling of the Final Design - Generic RAP, including adherence to the sampling frequency requirements. X-ray fluorescence (XRF) excavation confirmation sampling results are presented in Table 2-1.

As indicated in Table 2-1, some samples collected from the perimeter of the excavated area indicated total lead concentrations that exceeded 400 mg/kg. Additional soil could not be removed from these locations, because continued excavation could jeopardize the integrity of a structure or undermine a feature that was to be left in place.

- Throughout the entire property fill material was present at depths greater than 4 feet below ground surface (bgs). This fill material was left in place, covered by an orange geotextile fabric, and backfilled with clean soil in accordance with the Final Design - Generic RAP. Figure 2-1 shows the approximate area of geotextile fabric identifying the presence of fill at a depth greater than 4 feet bgs.

- In some locations, it was necessary to leave fill material in place at depths less than 4 feet bgs in order to avoid jeopardizing the integrity of a structure. This fill material was left in place, covered by an orange geotextile fabric and/or concrete, and backfilled with clean soil in accordance with the Final Design - Generic RAP. Figure 2-1 shows the approximate area of geotextile fabric/concrete identifying the presence of fill at a depth less than 4 feet bgs.

- The property owner requested that a tree within the expected excavation area be retained. After confirming that the tree met the established criteria in the Tree Sampling Plan which was approved by the DEEP in November 2009, the tree was retained. In accordance with the Tree Sampling Plan, the top six inches of soil were removed, and the remaining fill material within the drip line was left in place. Orange geotextile fabric was placed around the perimeter of the remaining fill. The location of this tree is shown on Figure 2-1.

- As part of efforts to improve drainage following excavation and backfill activities, two drywells were installed in low-lying portions of the yard. The approximate location of this feature is shown on Figure 2-1.

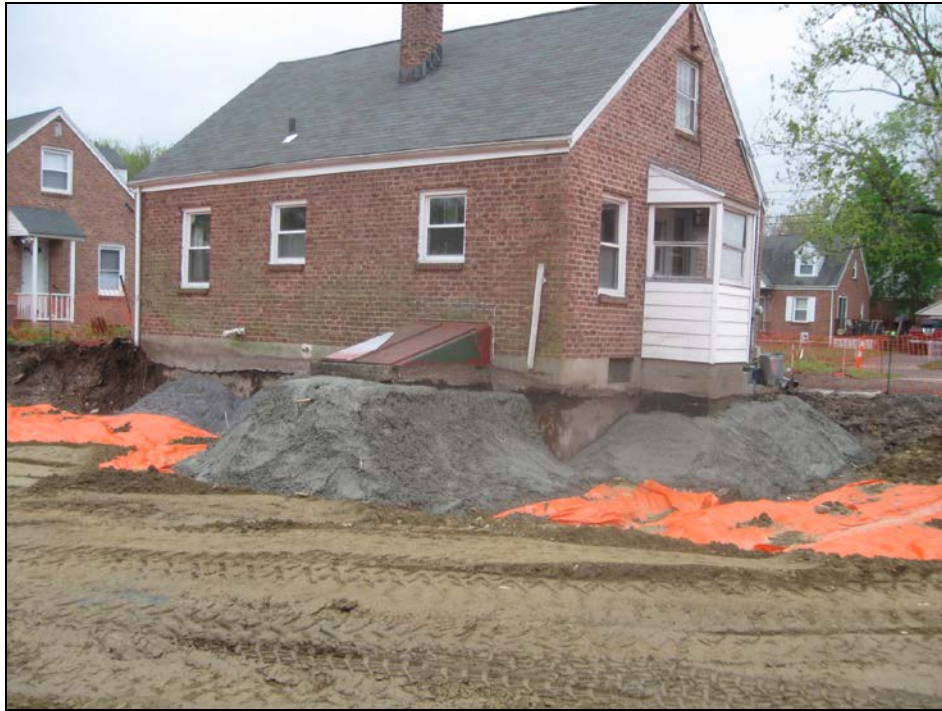
View facing southeast at partially backfilled back yard.

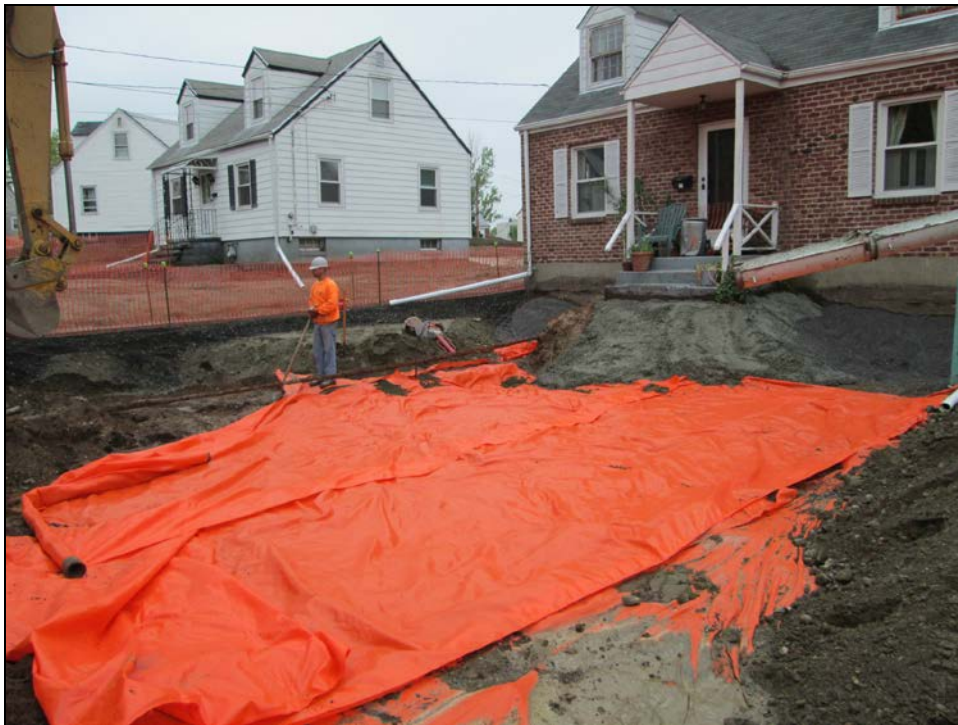
View looking northwest at marker barrier being installed in front yard.

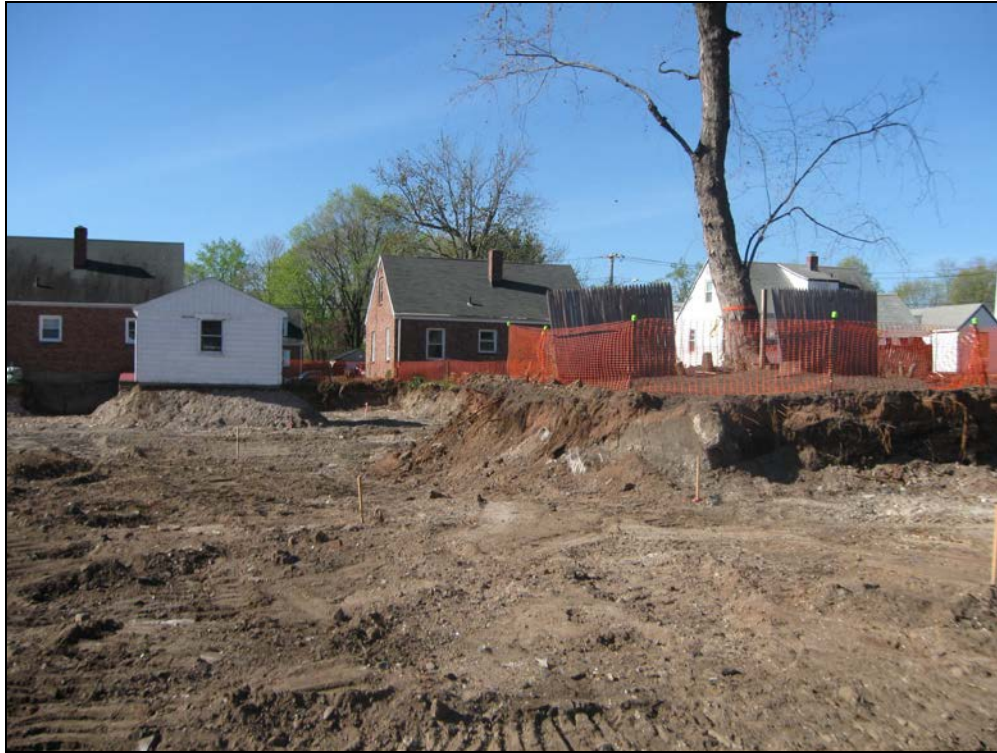
View looking south at excavation around a tree that was retained in accordance with the Tree Sampling Plan.

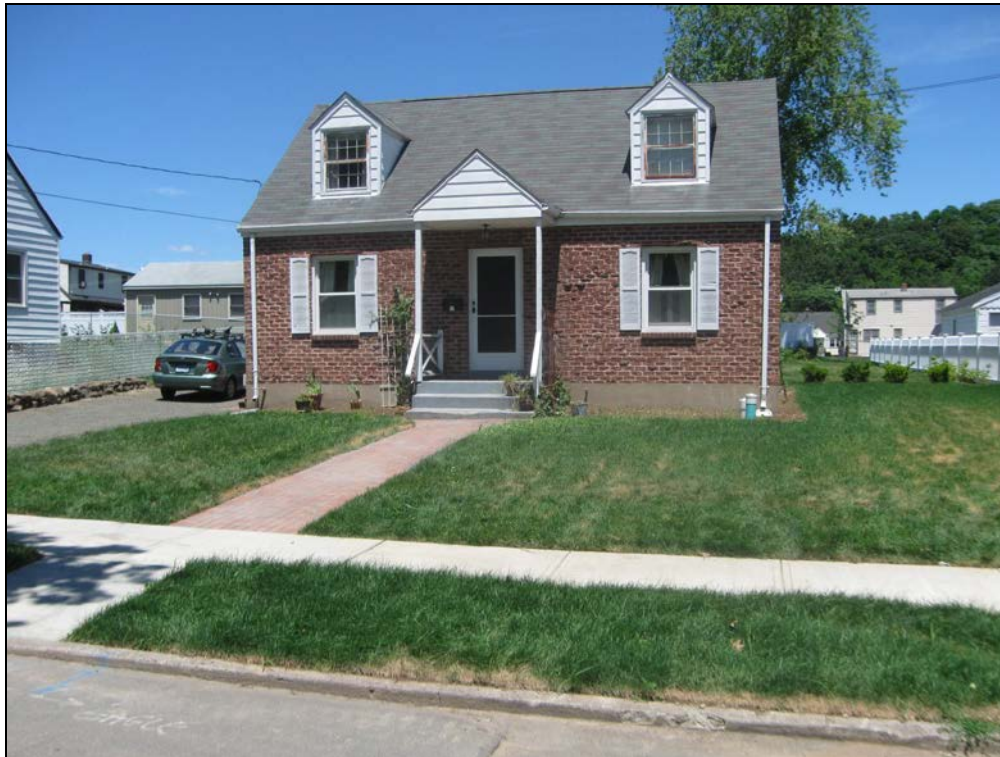
View looking north at restored front yard.

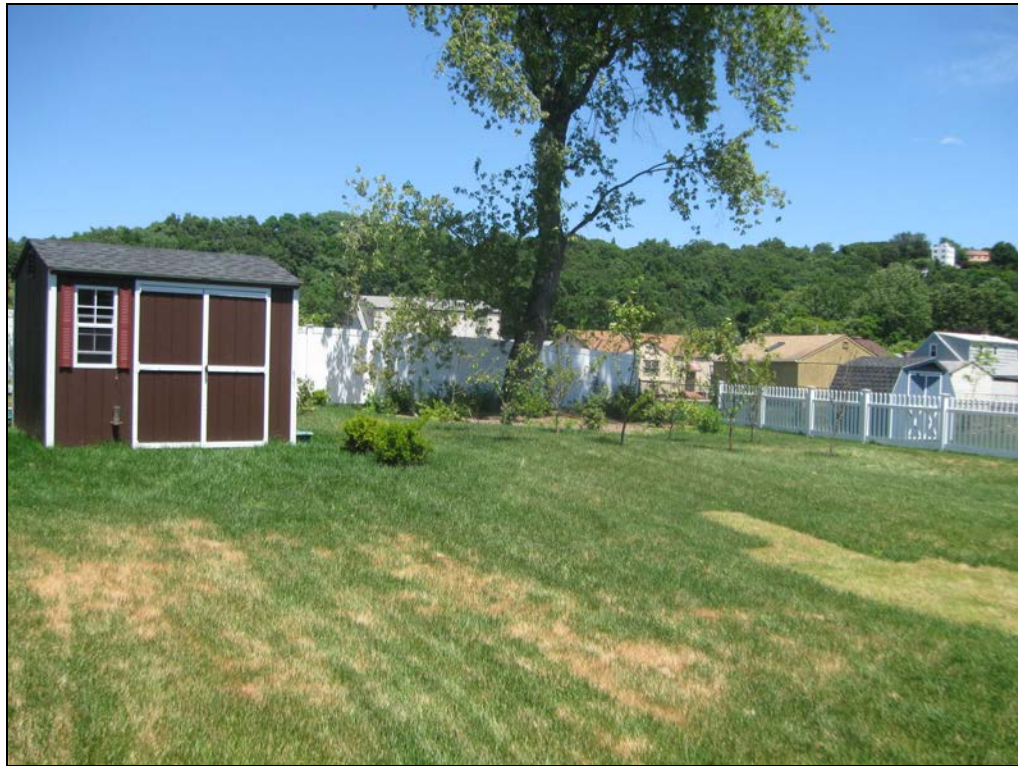
View looking north at restored back yard.

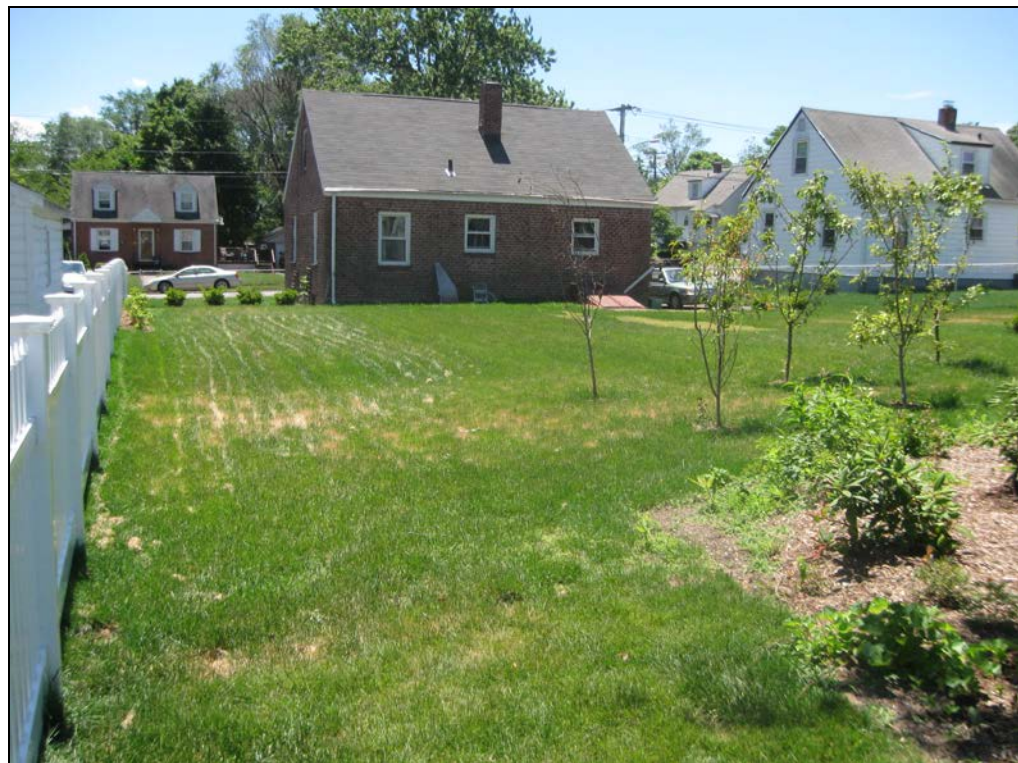
View looking south at restored back yard.
