Re: Property-Specific Remedial Action Report  
Newhall Street Neighborhood  
142 Bryden Terrace, Block F  
Hamden, Connecticut 06517

**PROPERTY-SPECIFIC REMEDIAL ACTION REPORT  
142 BRYDEN TERRACE**

**NON-PUBLIC PROPERTIES  
NEWHALL STREET NEIGHBORHOOD  
HAMDEN, CONNECTICUT**

**AMEC Project Number: 6107120004.115**

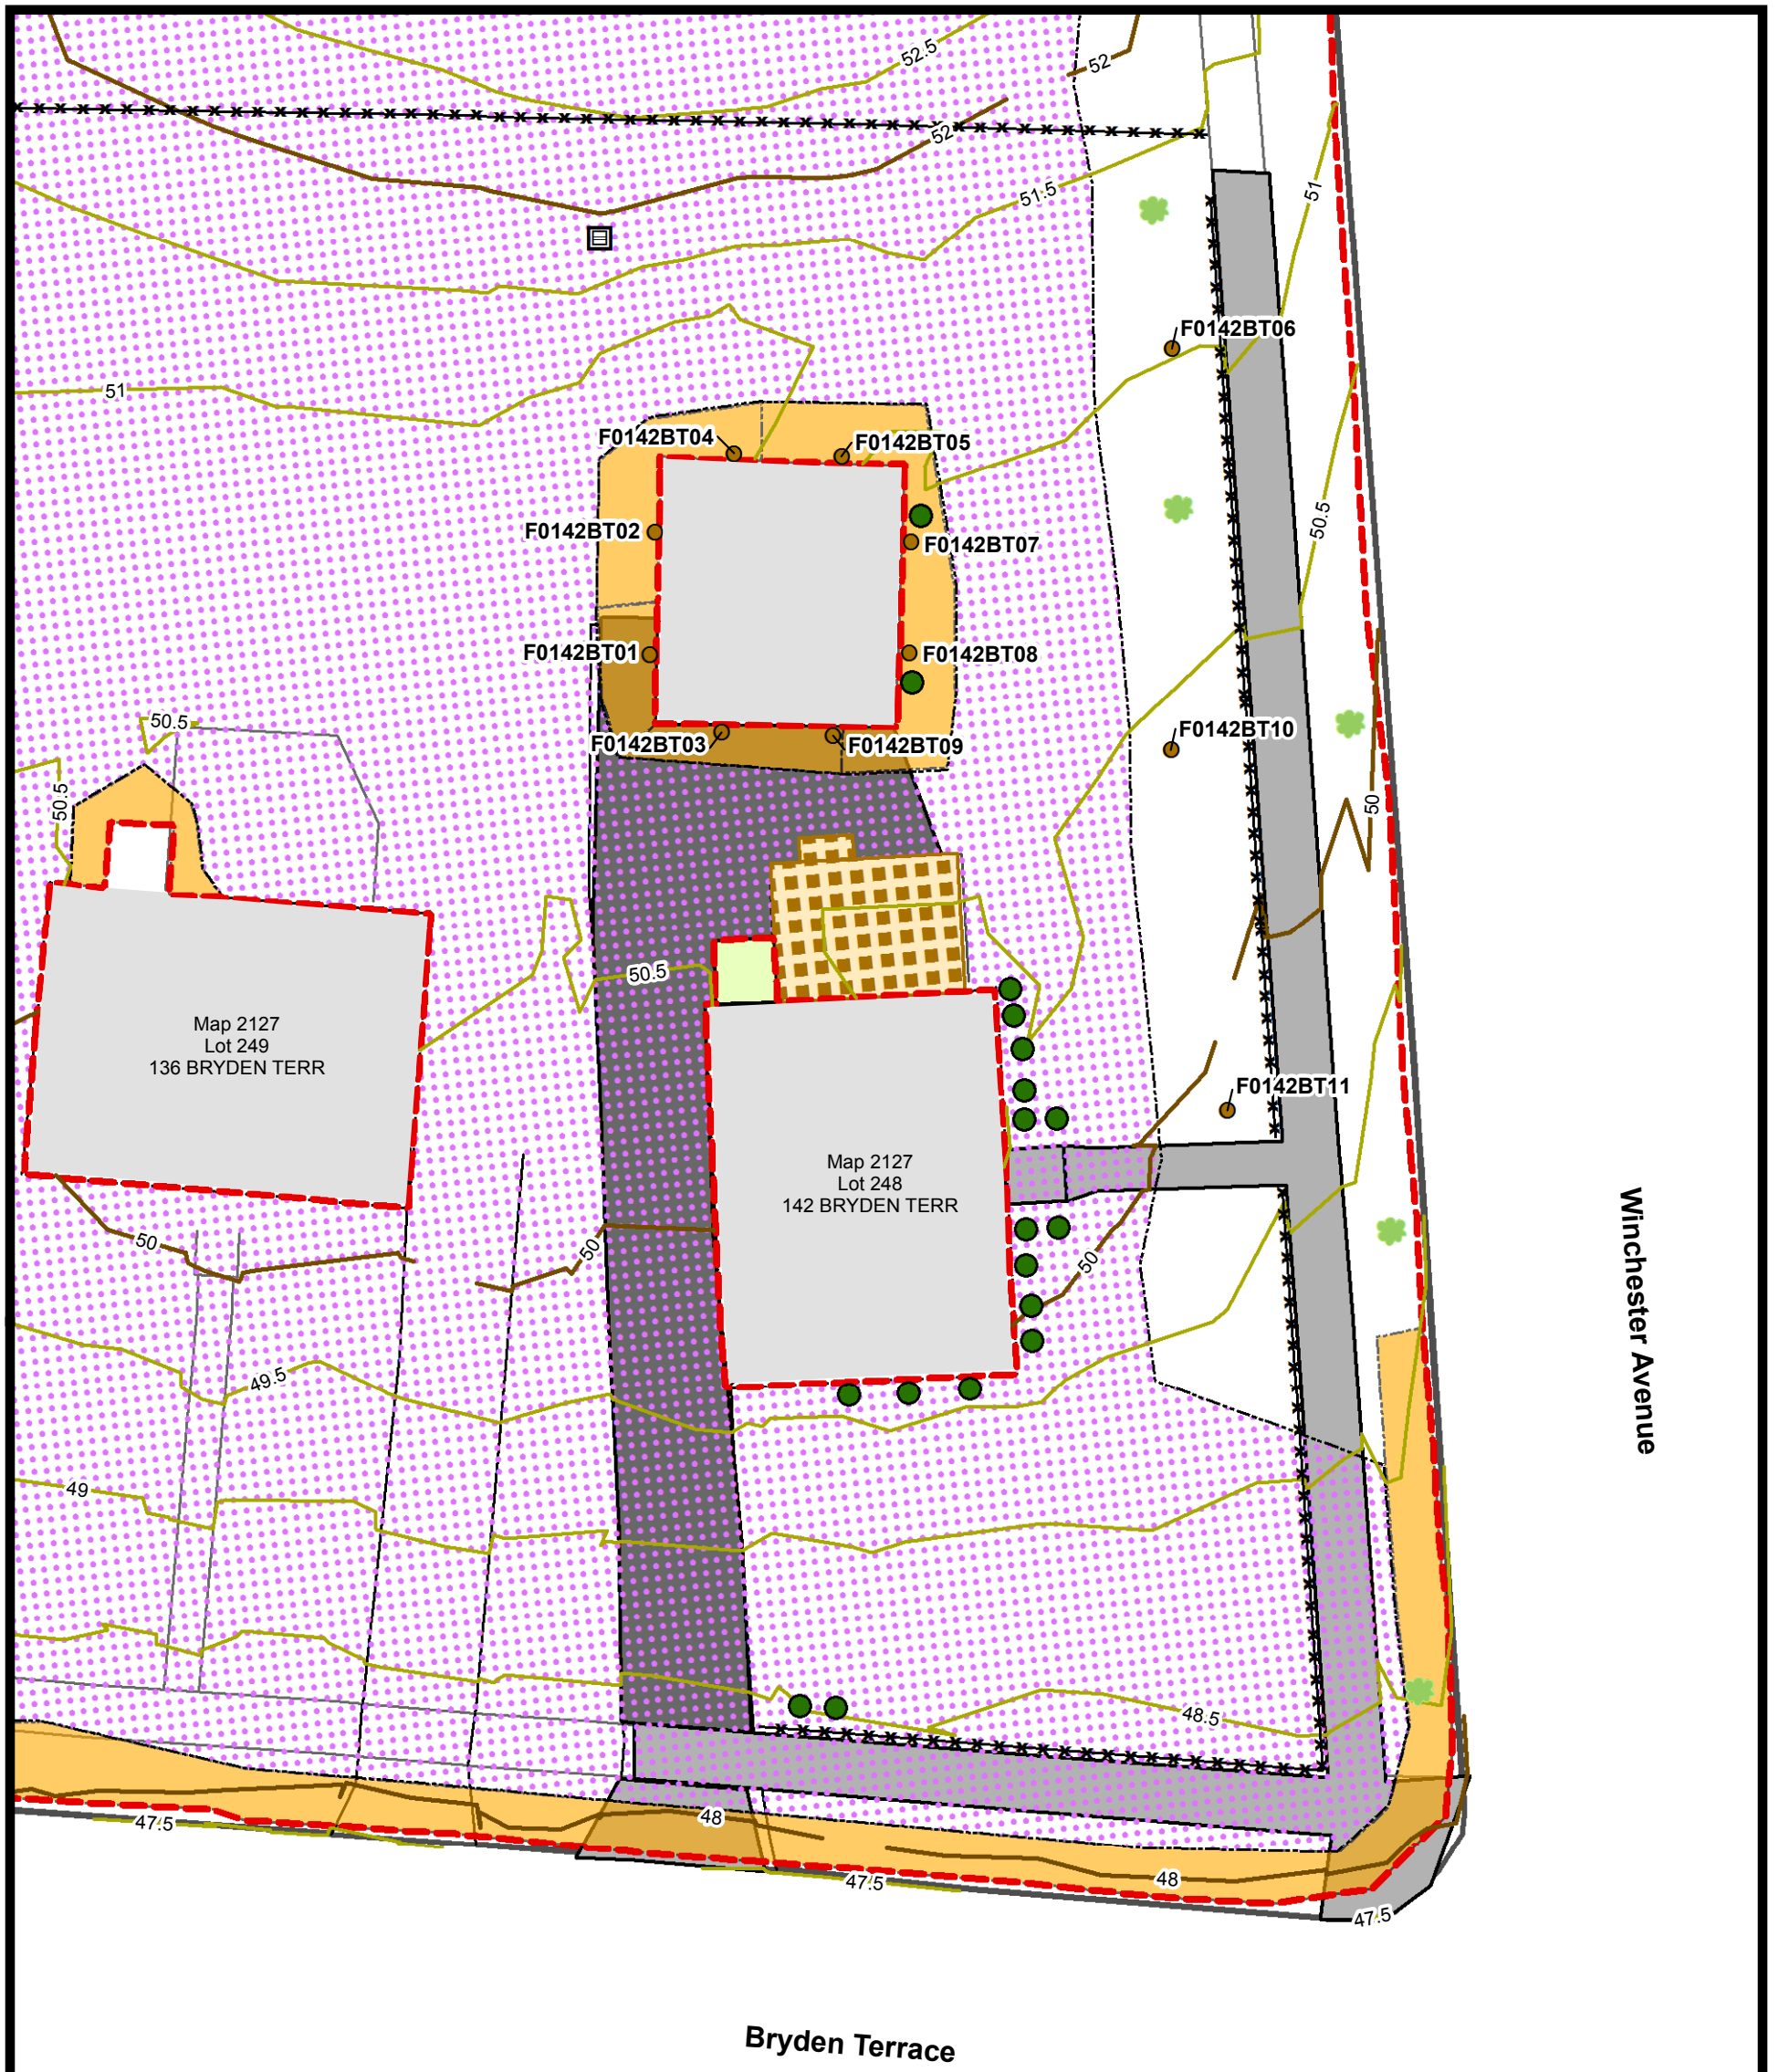
During the 2012 construction season, Olin completed the excavation, backfill, and restoration of the property in accordance with the Final Design - Generic RAP and the Property-Specific RAP. Figure 2-1 shows the areas where excavation occurred on the property and the locations of excavation confirmation samples. Excavation confirmation samples were collected in accordance with Section 3.2.3 - Confirmatory Sampling of the Final Design - Generic RAP, including adherence to the sampling frequency requirements. X-ray fluorescence (XRF) excavation confirmation sampling results are presented in Table 2-1.

As indicated in Table 2-1, some of the samples collected from the perimeter of the excavated area indicated total lead concentrations that exceeded 400 mg/kg. Additional soil could not be removed from these locations, because continued excavation could jeopardize the integrity of a structure or undermine a feature that was to be left in place.

- In certain locations on the property, fill material was present at depths greater than 4 feet below ground surface (bgs). This fill material was left in place, covered by an orange geotextile fabric, and backfilled with clean soil in accordance with the Final Design - Generic RAP. Figure 2-1 shows the approximate area of geotextile fabric identifying the presence of fill at a depth greater than 4 feet bgs.

- In some locations, it was necessary to leave fill material in place at depths less than 4 feet bgs in order to avoid jeopardizing the integrity of a structure. This fill material was left in place, covered by an orange geotextile fabric and/or concrete, and backfilled with clean soil in accordance with the Final Design - Generic RAP. Figure 2-1 shows the approximate area of geotextile fabric/concrete identifying the presence of fill at a depth less than 4 feet bgs.

- As part of efforts to improve drainage following excavation and backfill activities, a drywell was installed in a low-lying portion of the yard. The approximate location of this feature is shown on Figure 2-1.

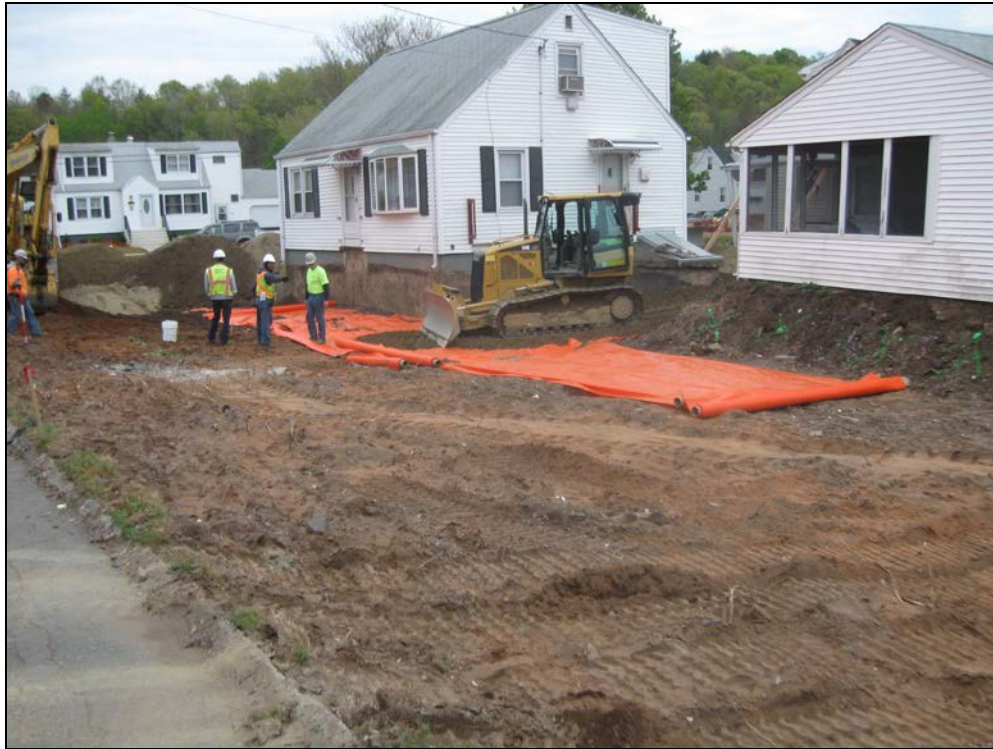
**View facing northeast at excavated front yard.**

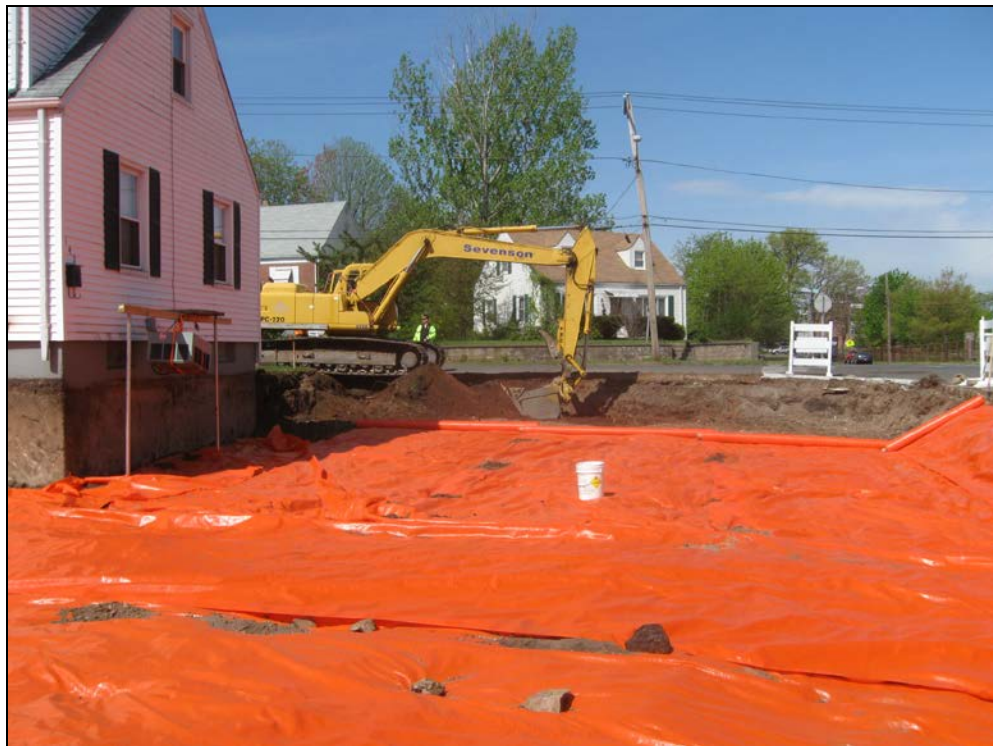
**View looking west at excavated side yard.**

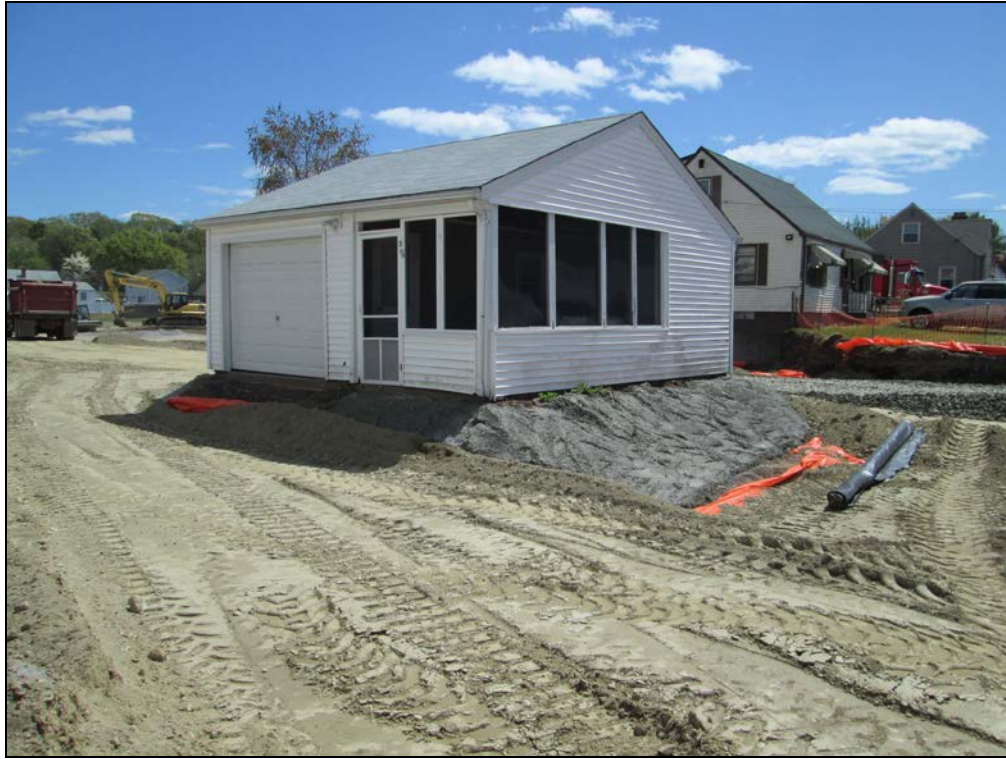
**View looking southeast at the partially backfilled area around the garage.**

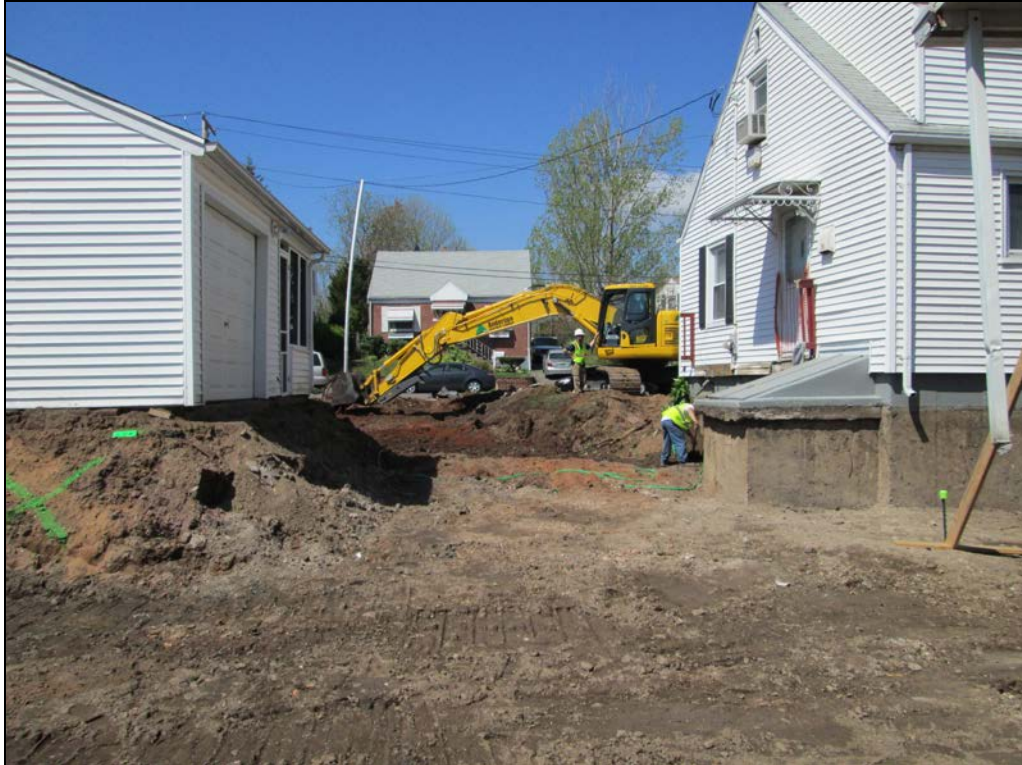
**View looking west at excavated back yard.**

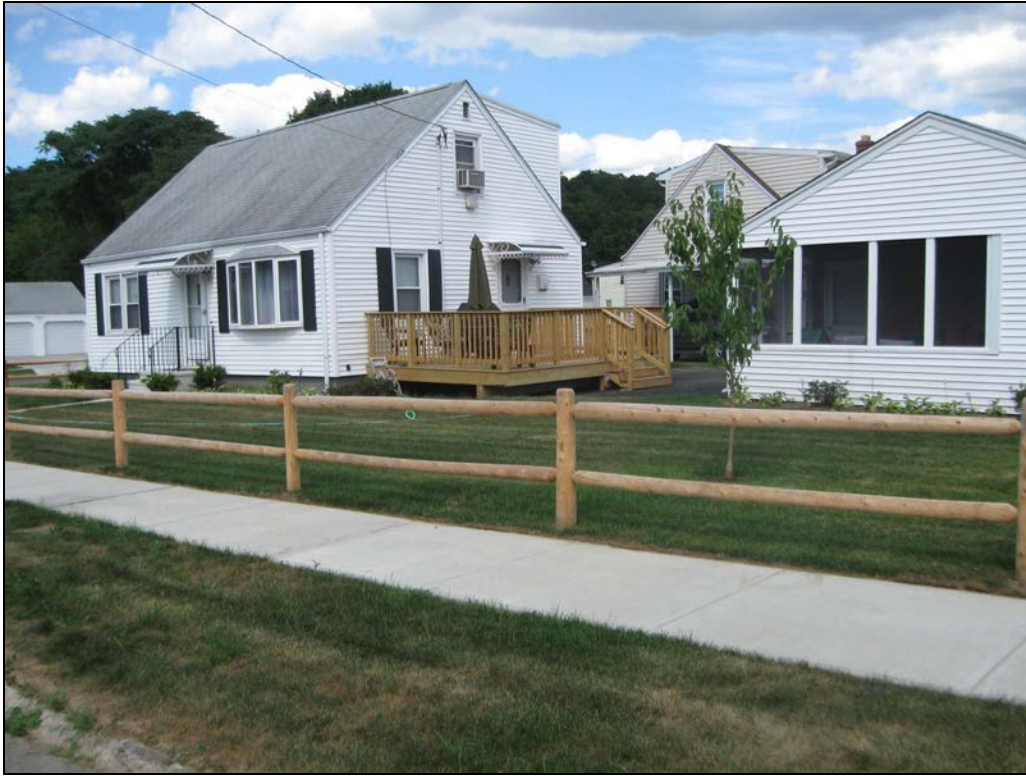
**View looking northeast at restored front yard.**

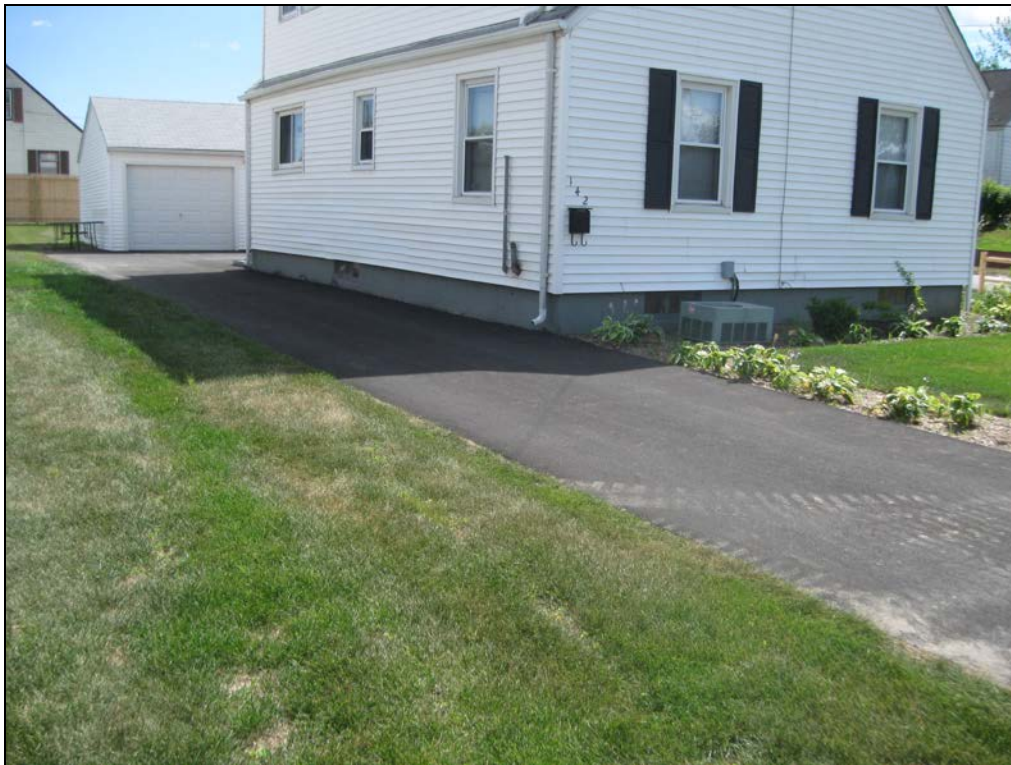
**View looking south at restored back and side yard.**

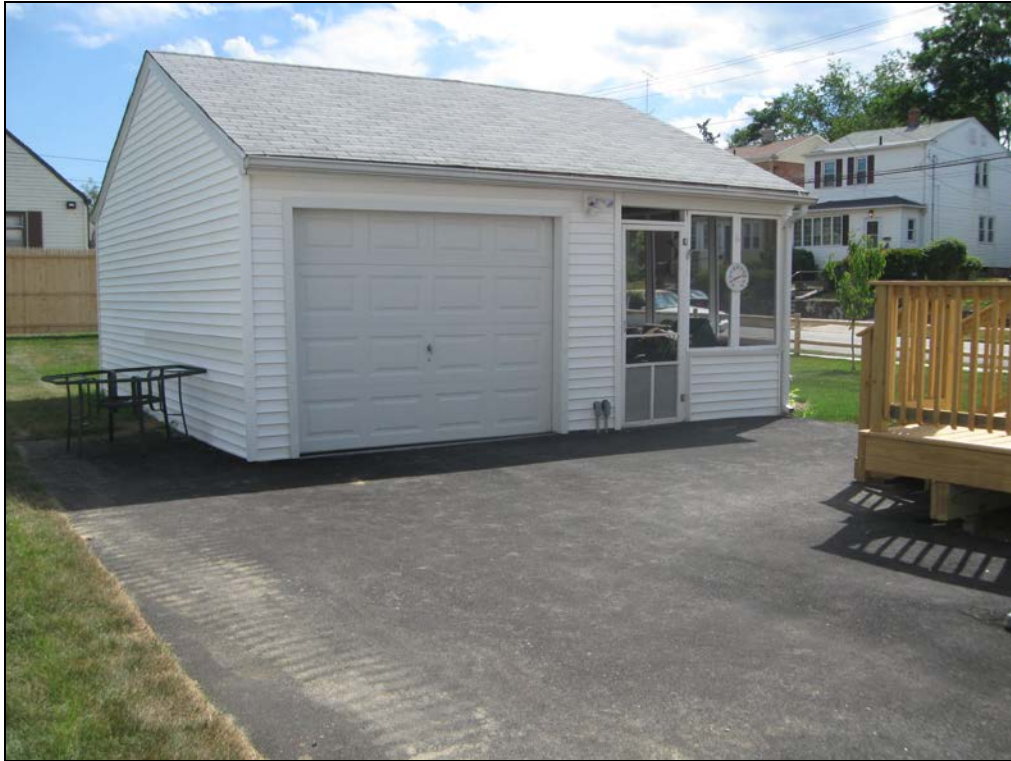
**View looking southwest at restored driveway.**
