Re: Property-Specific Remedial Action Report  
Newhall Street Neighborhood  
16 Marlboro Street, Block Q  
Hamden, Connecticut 06517

**PROPERTY-SPECIFIC REMEDIAL ACTION REPORT  
16 MARLBORO STREET**

**NON-PUBLIC PROPERTIES  
NEWHALL STREET NEIGHBORHOOD  
HAMDEN, CONNECTICUT**

**January 11, 2013**

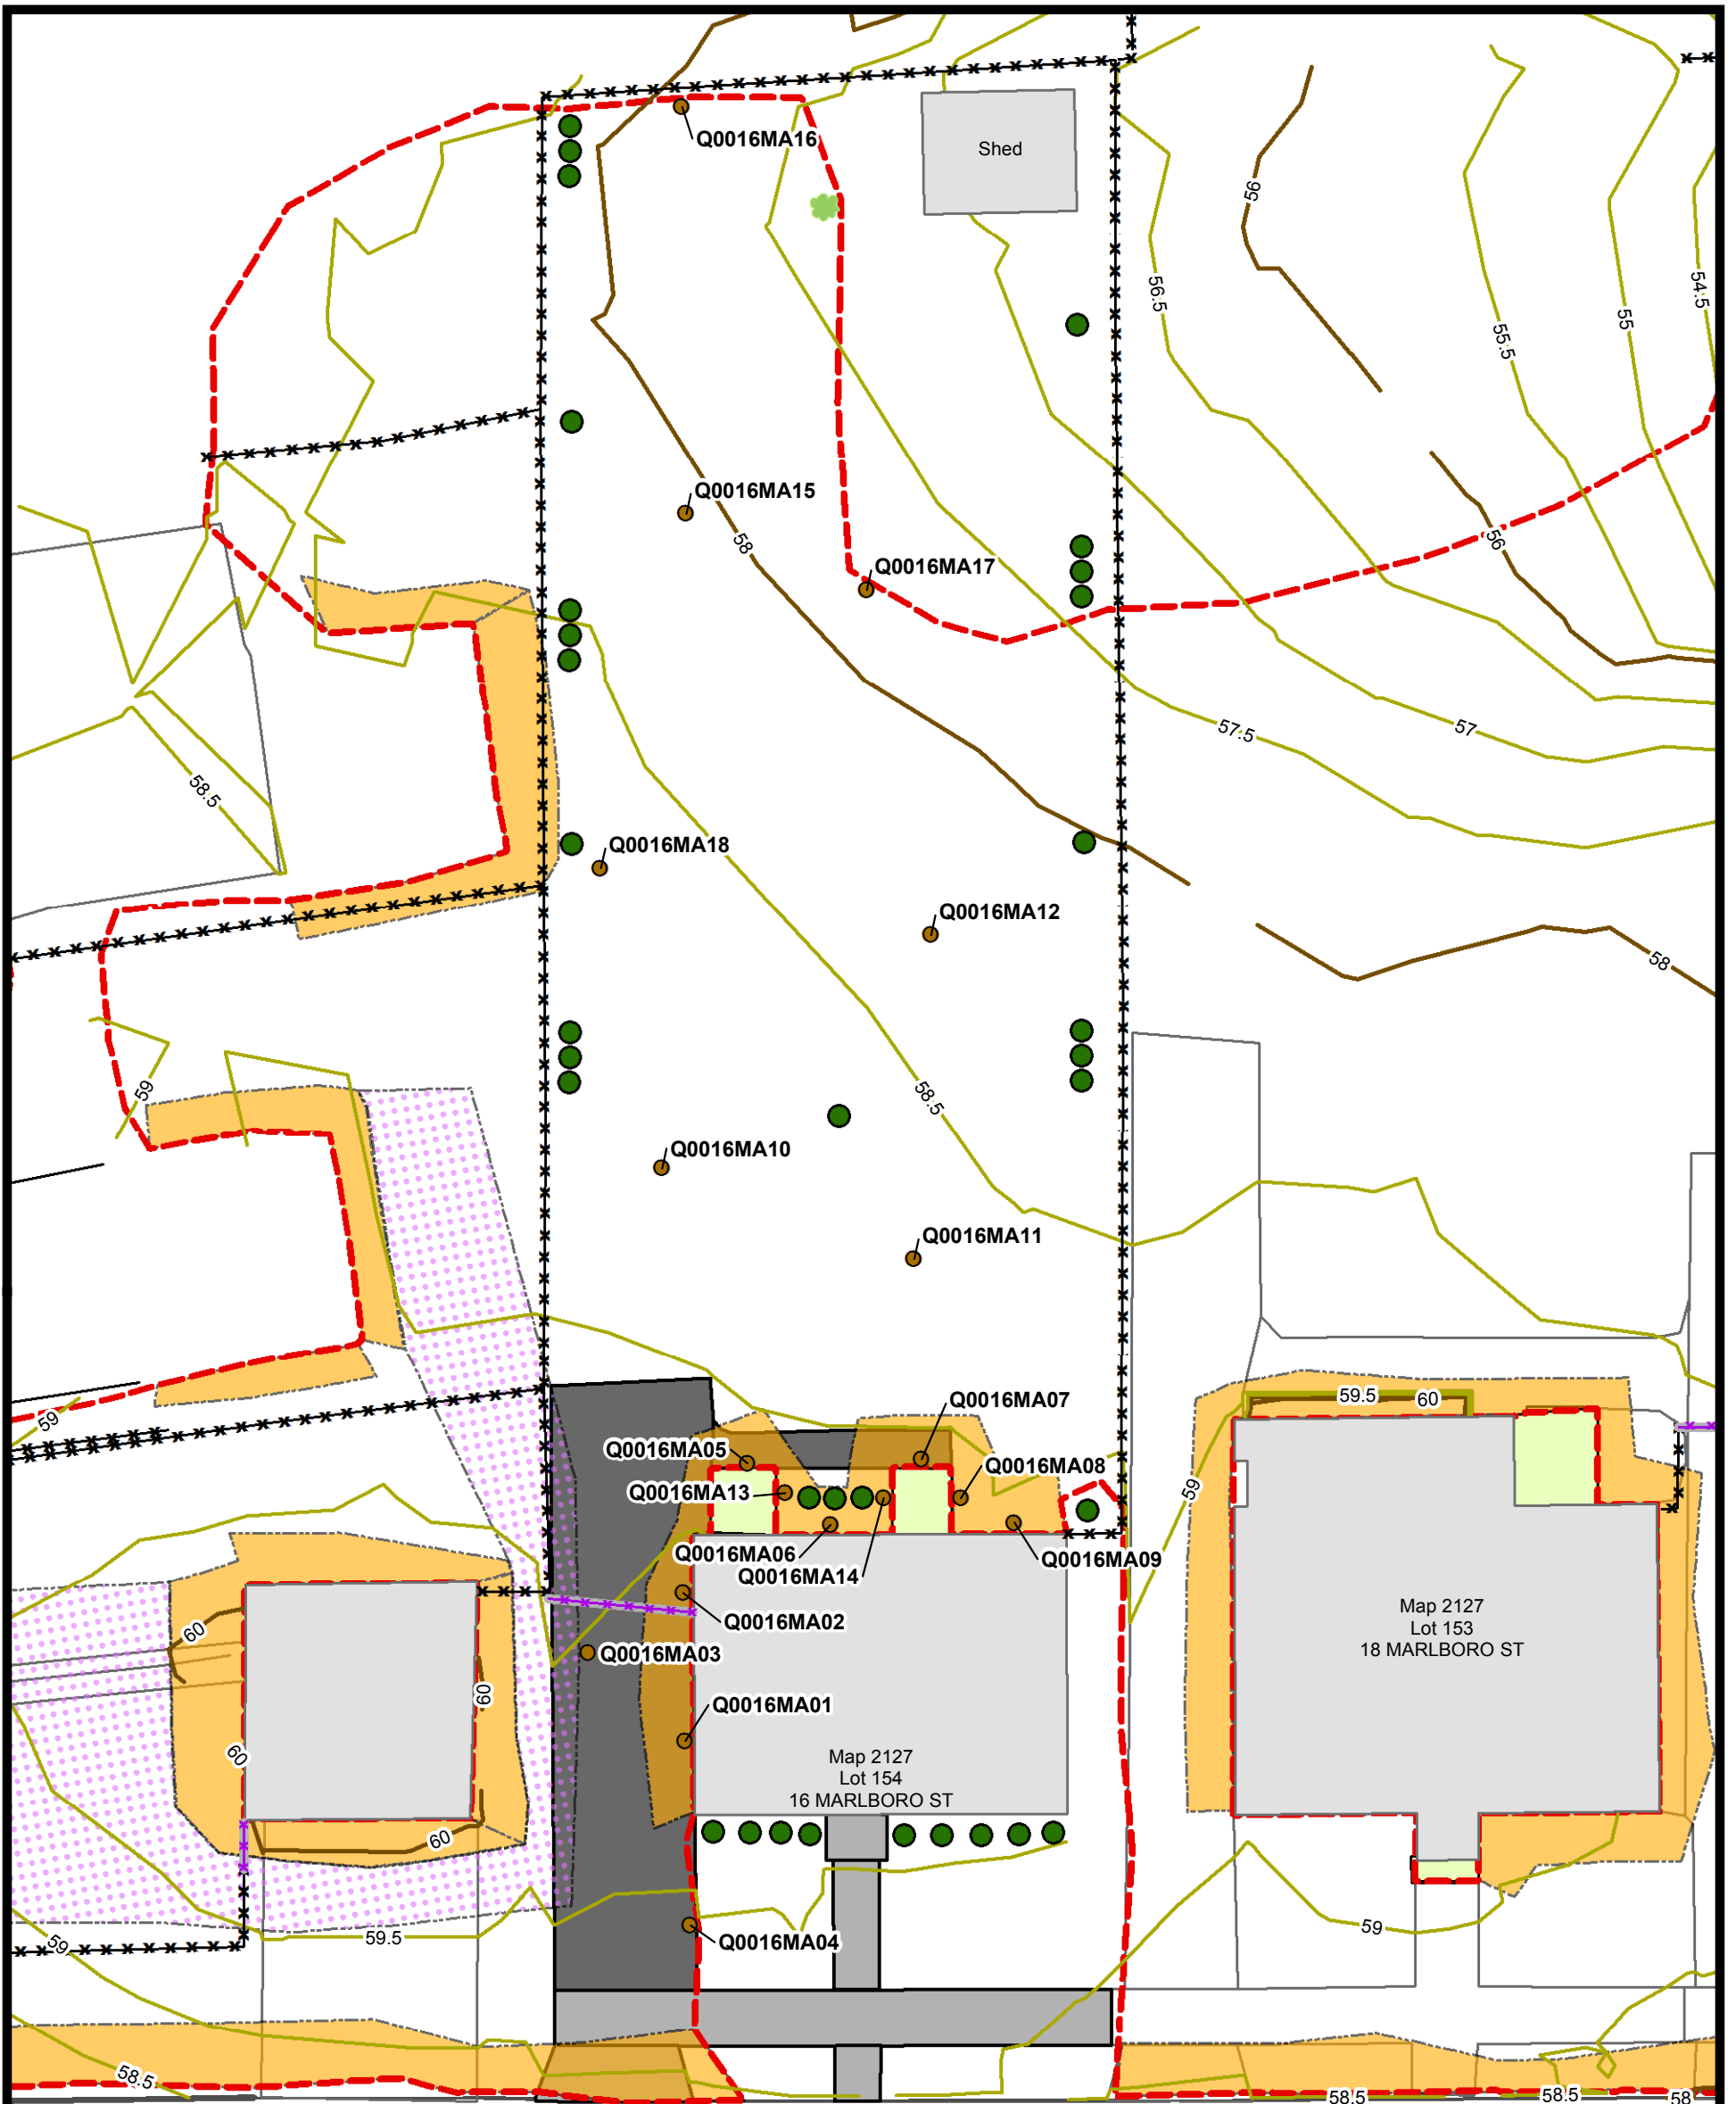
During the 2012 construction season, Olin completed the excavation, backfill, and restoration of the property in accordance with the Final Design - Generic RAP. Figure 2-1 shows the areas where excavation occurred on the property and the locations of excavation confirmation samples. Excavation confirmation samples were collected in accordance with Section 3.2.3 - Confirmatory Sampling of the Final Design - Generic RAP, including adherence to the sampling frequency requirements. X-ray fluorescence (XRF) excavation confirmation sampling results are presented in Table 2-1.

- In some locations on the property, fill material was present at depths greater than 4 feet below ground surface (bgs). This fill material was left in place, covered by an orange geotextile fabric, and backfilled with clean soil in accordance with the Final Design - Generic RAP. Figure 2-1 shows the approximate area of geotextile fabric identifying the presence of fill at a depth greater than 4 feet bgs.

- In some locations it was necessary to leave fill material in place at depths less than 4 feet bgs in order to avoid jeopardizing the integrity of a structure or feature that was to be left in place. This fill material was left in place, covered by an orange geotextile fabric and/or concrete, and backfilled with clean soil in accordance with the Final Design - Generic RAP. Figure 2-1 shows the approximate area of geotextile fabric/concrete identifying the presence of fill at a depth less than 4 feet bgs.

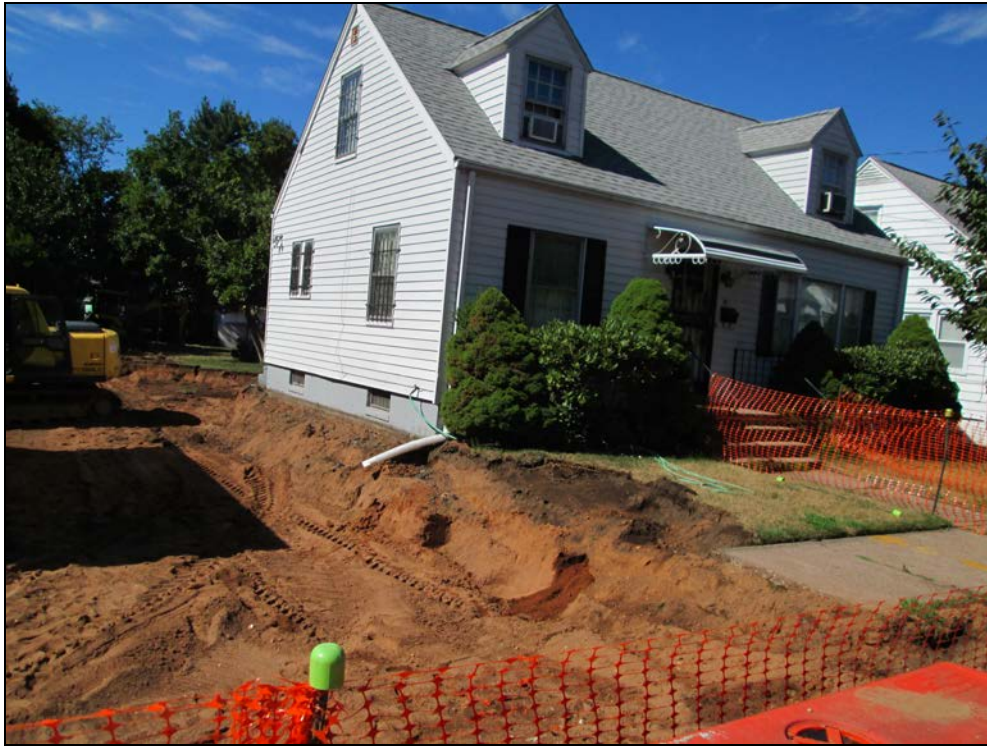
**View looking southwest at excavated driveway area.**

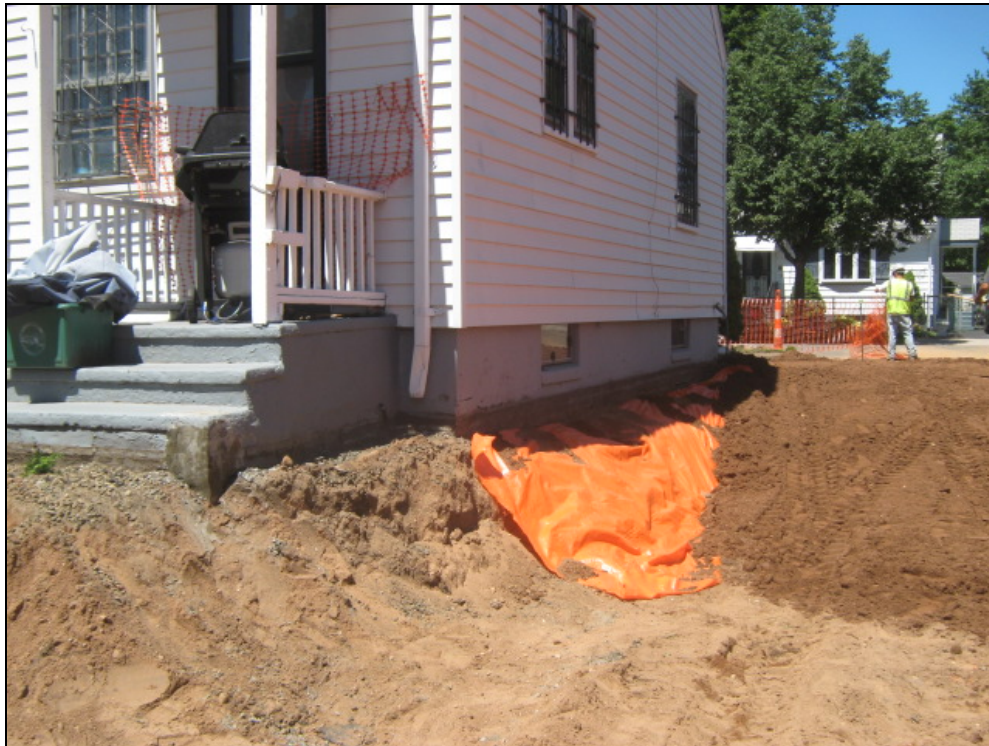
**View looking northwest at excavated side yard following placement of marker barrier.**

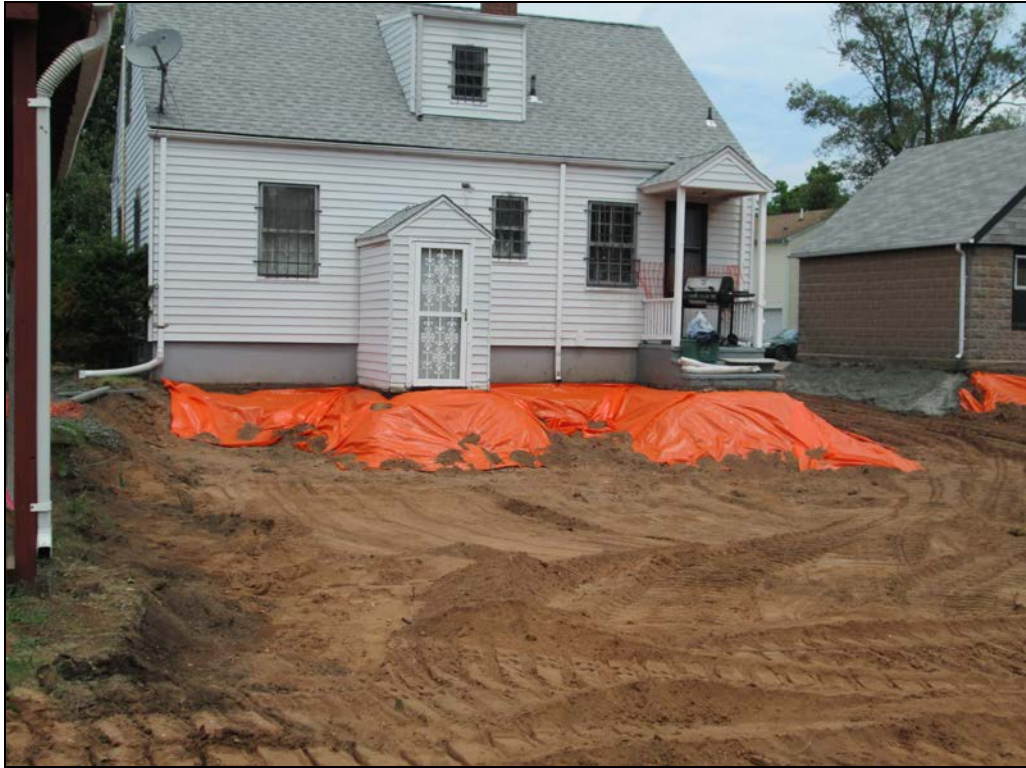
**View looking north at excavated back yard.**

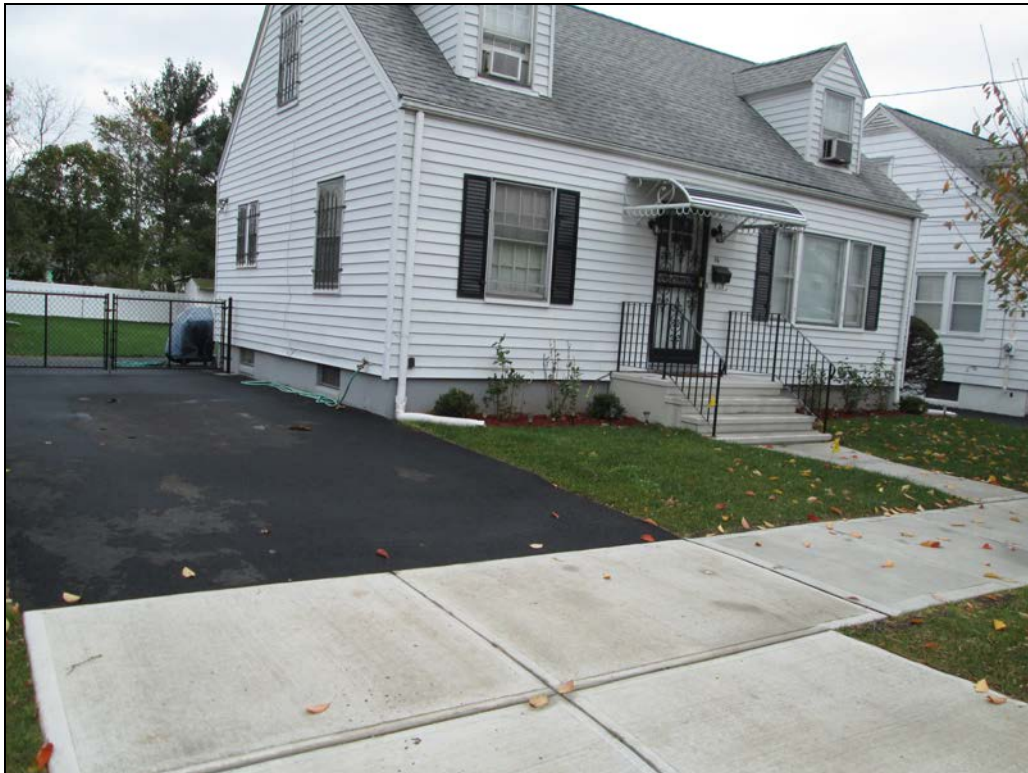
**View looking southwest at restored front yard.**

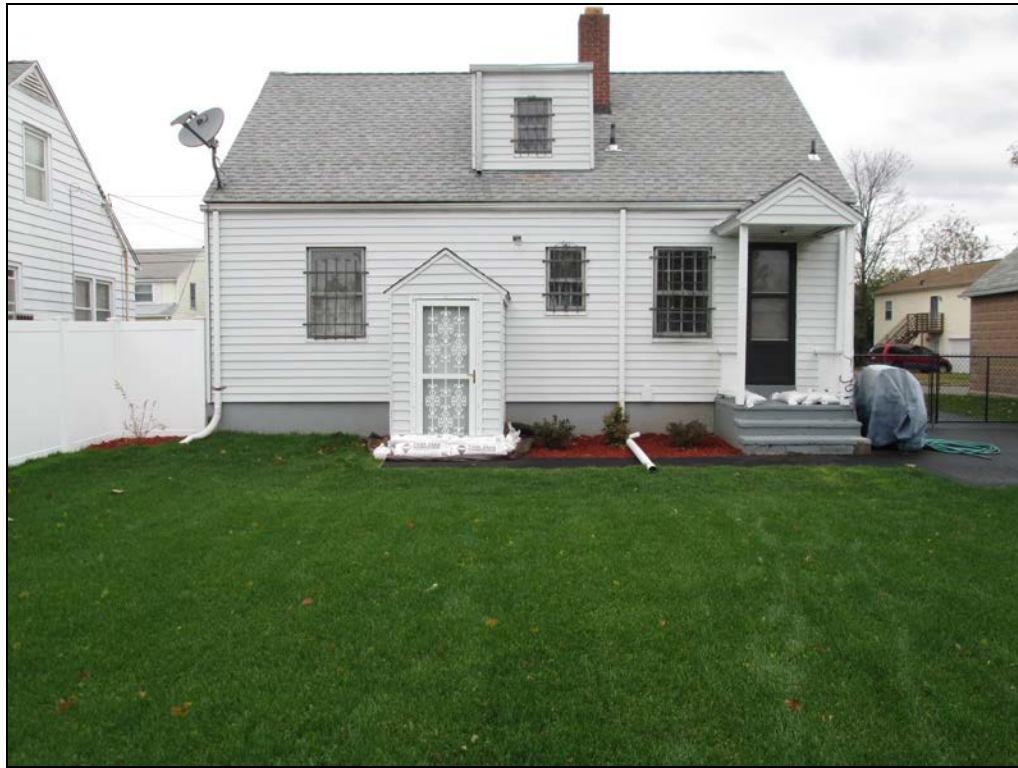
**View looking north at restored back yard.**

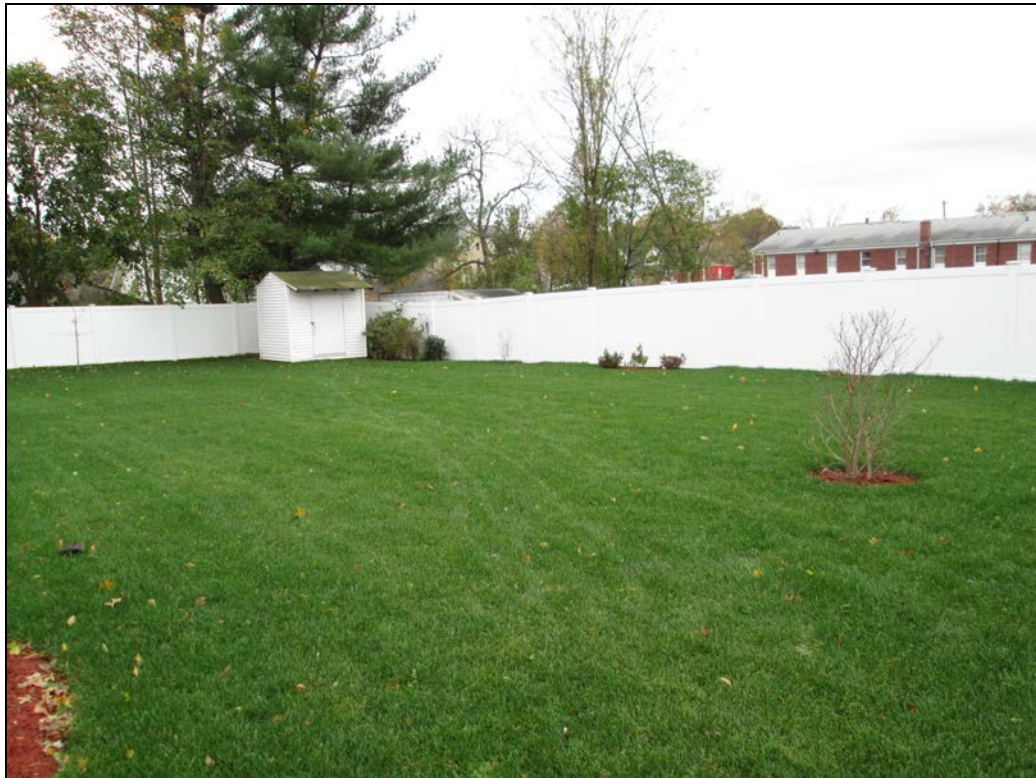
**View looking south at restored back yard.**
