Re: Property-Specific Remedial Action Report  
Newhall Street Neighborhood  
17 Marlboro Street, Block P  
Hamden, Connecticut 06517

**PROPERTY-SPECIFIC REMEDIAL ACTION REPORT  
17 MARLBORO STREET**

**NON-PUBLIC PROPERTIES  
NEWHALL STREET NEIGHBORHOOD  
HAMDEN, CONNECTICUT**

**December 12, 2012**

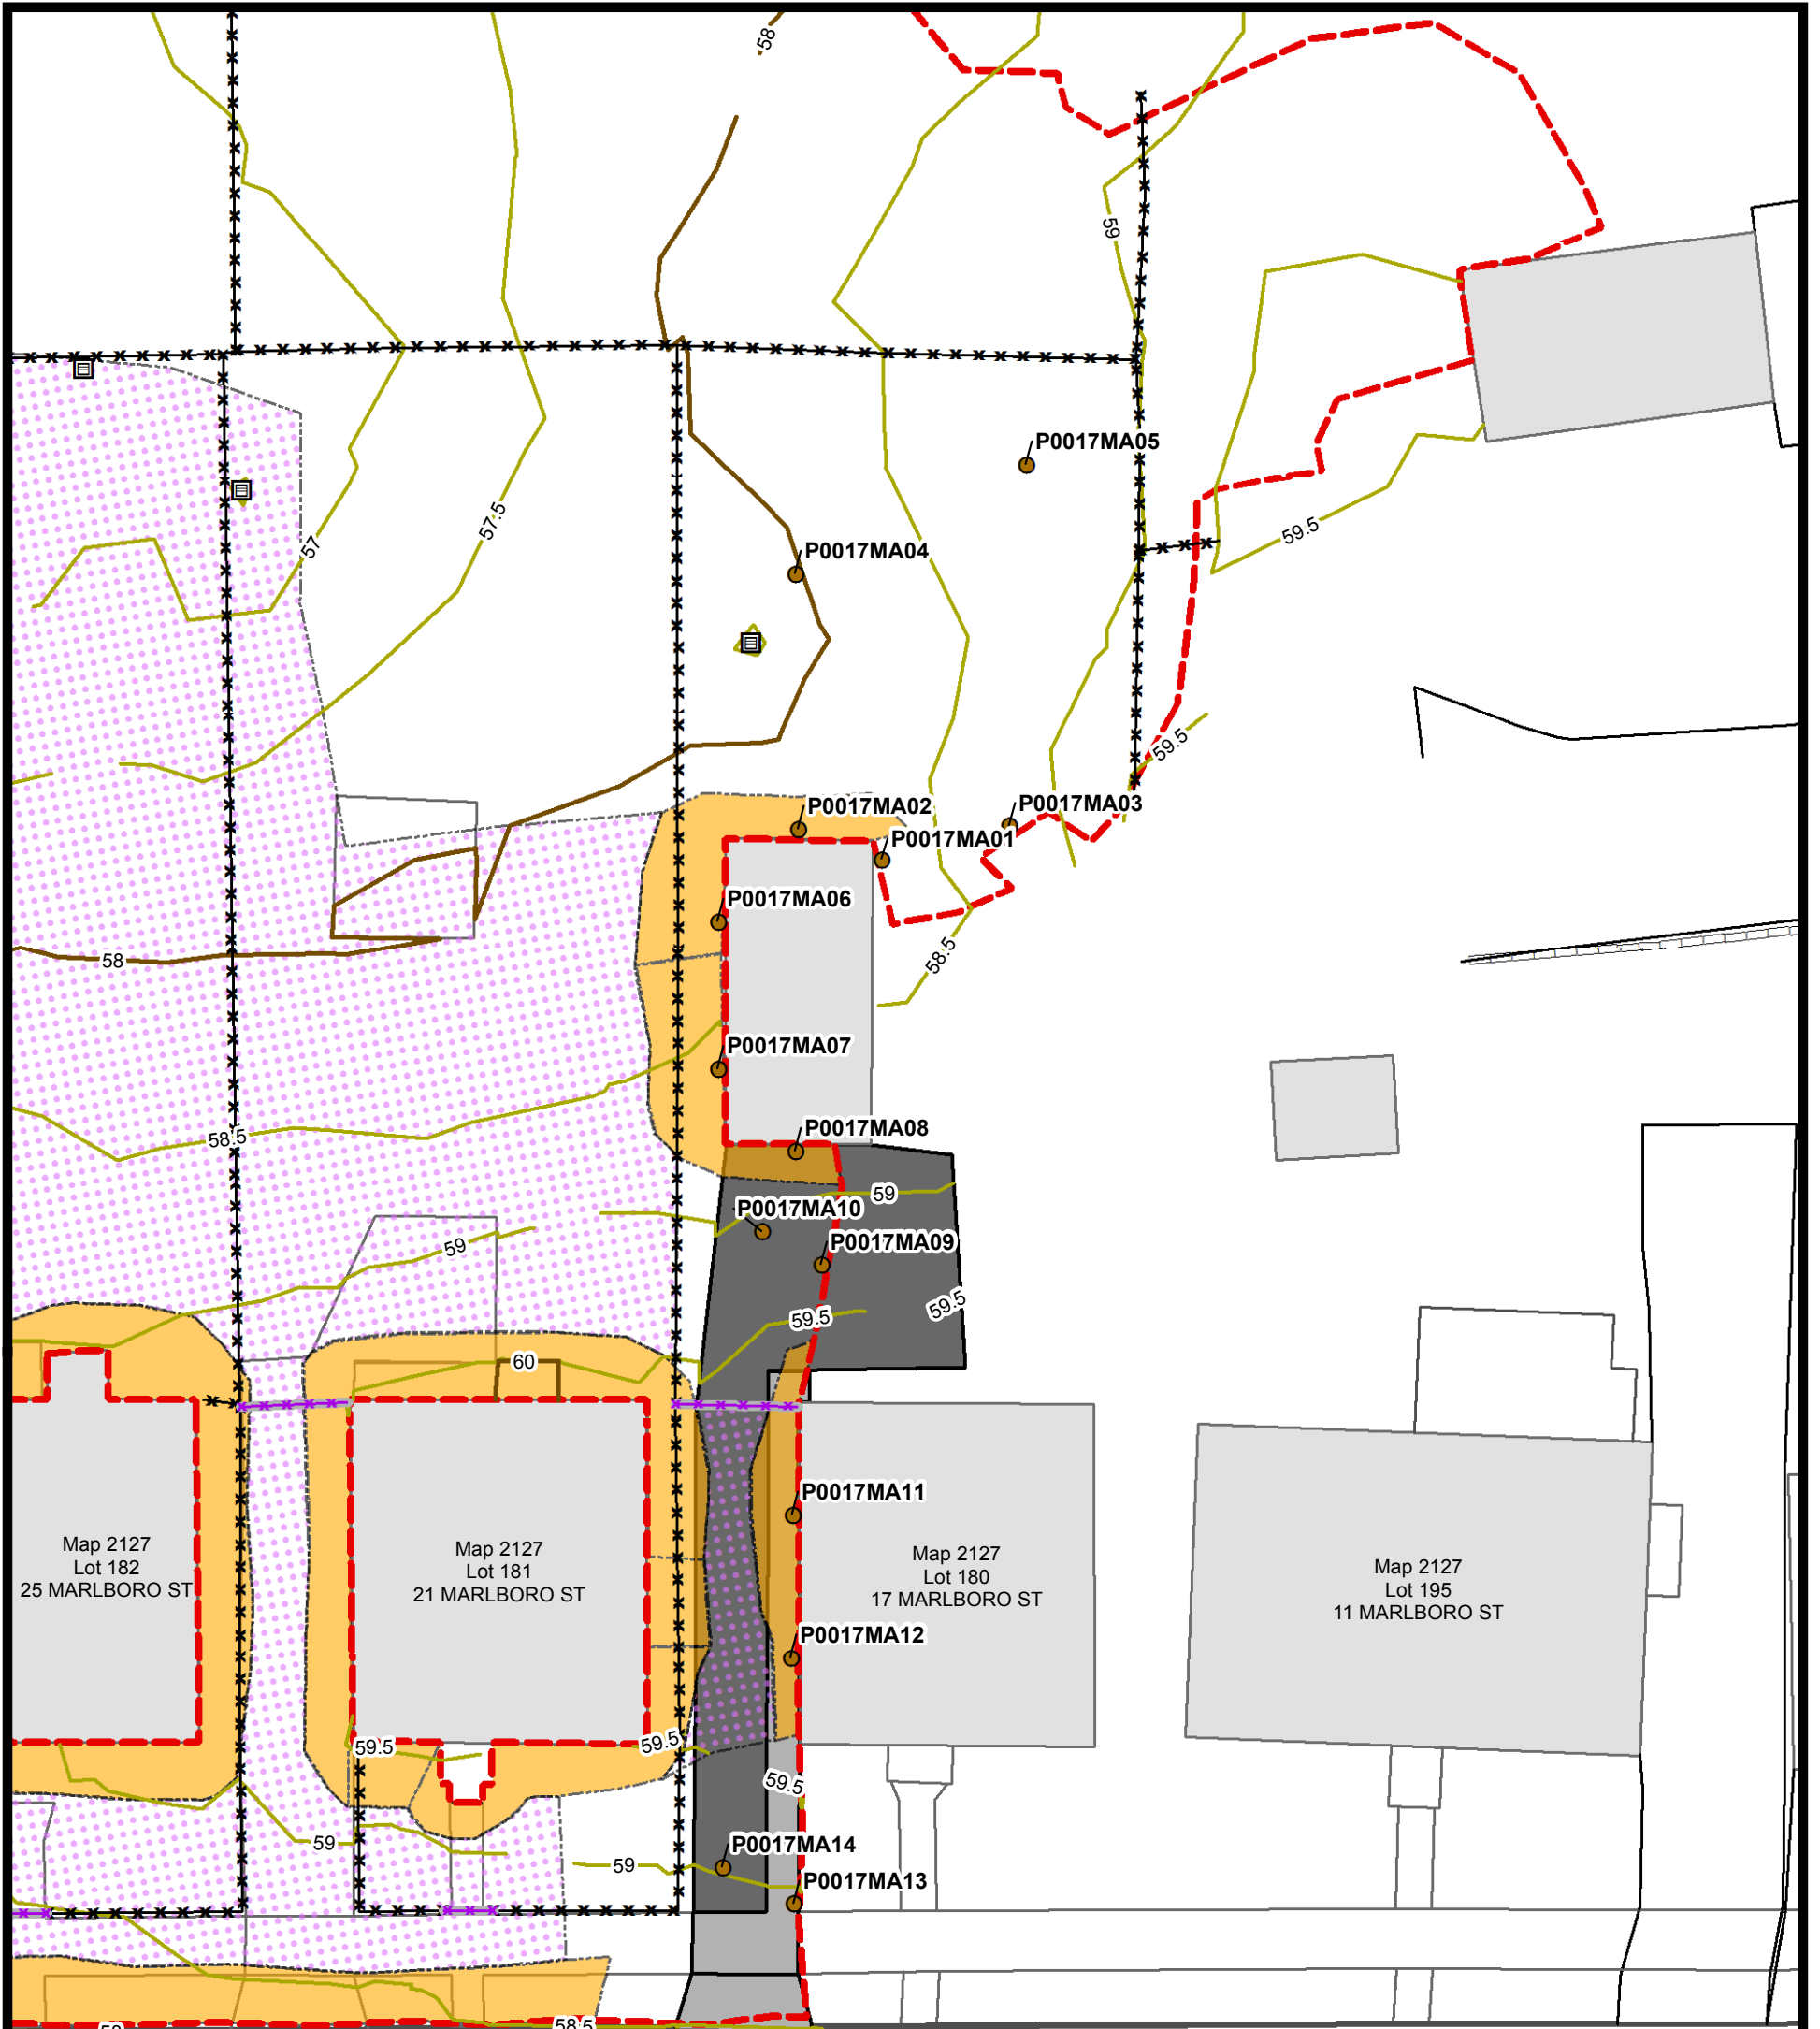
Figure 2-1 Post-Construction Conditions

As indicated in Table 2-1, most confirmation sampling results indicate total lead concentrations less than the criteria of 400 mg/kg approved by DEEP in the Final Design - Generic RAP. One sample collected from the perimeter of the excavated area indicated total lead concentrations that exceeded 400 mg/kg. Additional soil could not be removed from this location, because continued excavation could jeopardize the integrity of the structure.

- In some locations on the property, fill material was present at depths greater than 4 feet below ground surface (bgs). This fill material was left in place, covered by an orange geotextile fabric, and backfilled with clean soil in accordance with the Final Design - Generic RAP. Figure 2-1 shows the approximate area of geotextile fabric identifying the presence of fill at a depth greater than 4 feet bgs.

- In some locations, it was necessary to leave fill material in place at depths less than 4 feet bgs in order to avoid jeopardizing the integrity of a structure. This fill material was left in place, covered by an orange geotextile fabric and/or concrete, and backfilled with clean soil in accordance with the Final Design - Generic RAP. Figure 2-1 shows the approximate area of geotextile fabric/concrete identifying the presence of fill at a depth less than 4 feet bgs.

- As part of efforts to improve drainage following excavation and backfill activities, a drywell was installed in a low-lying portion of the yard. The location of this feature is shown on Figure 2-1.

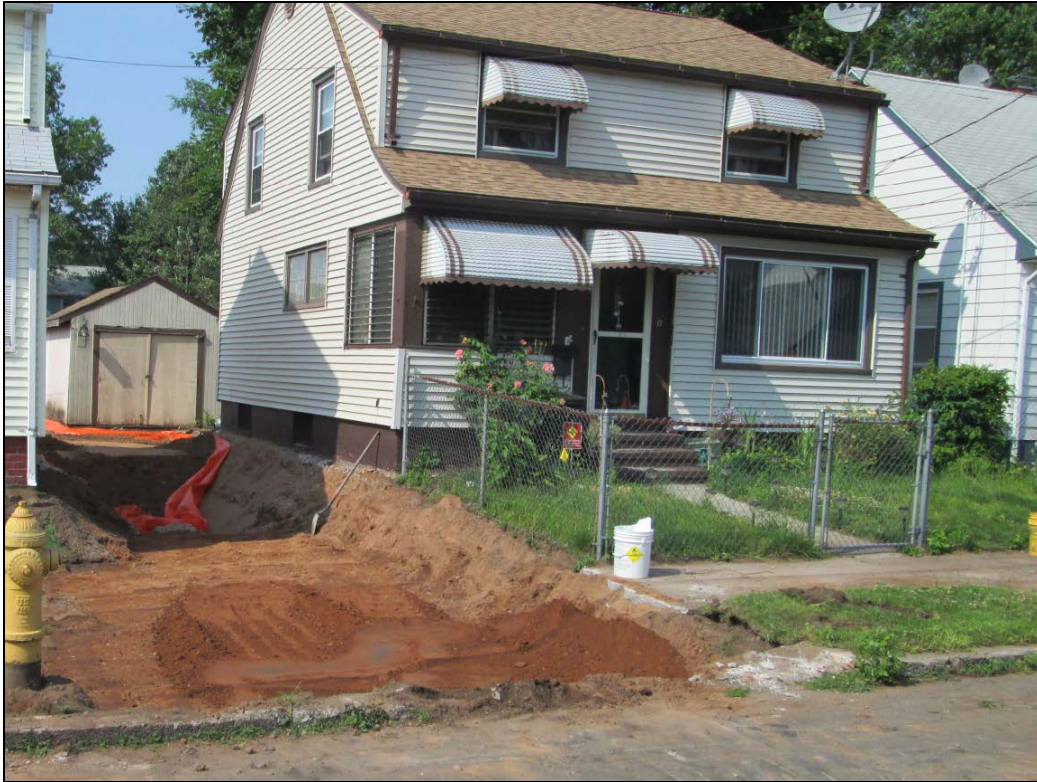
**View looking north at excavation in driveway area.**

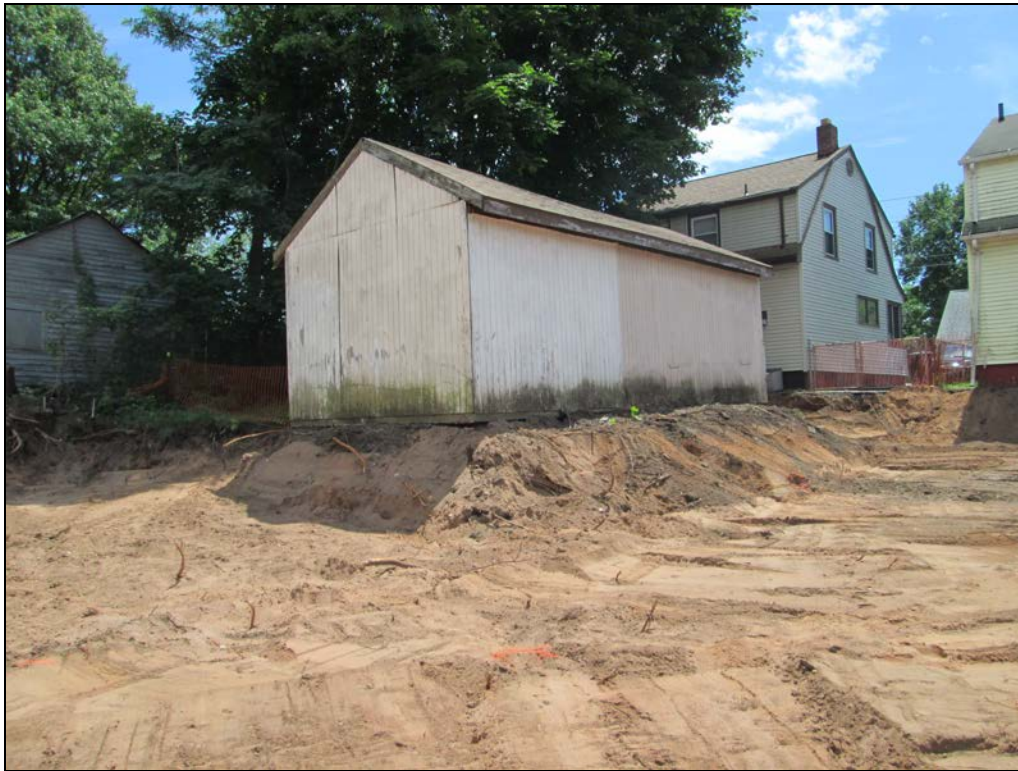
**View looking southeast at excavated back yard.**

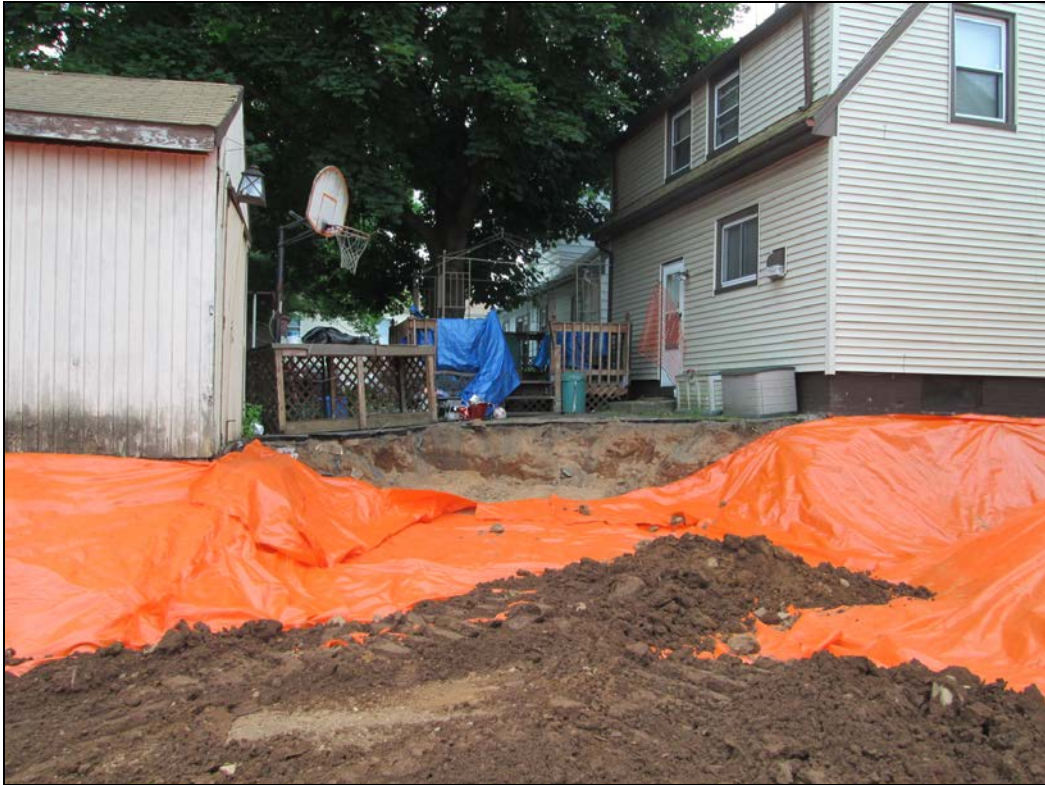
**View looking east at excavated back yard with marker barrier over remaining fill.**

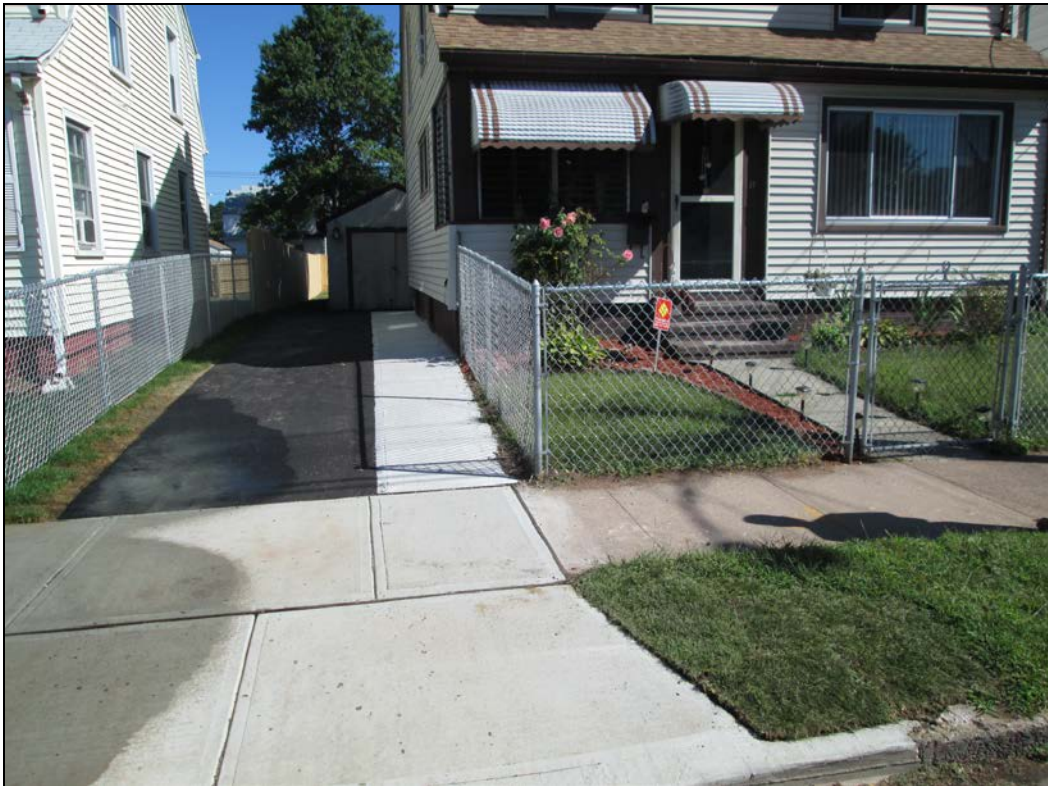
**View looking north at restored front yard.**

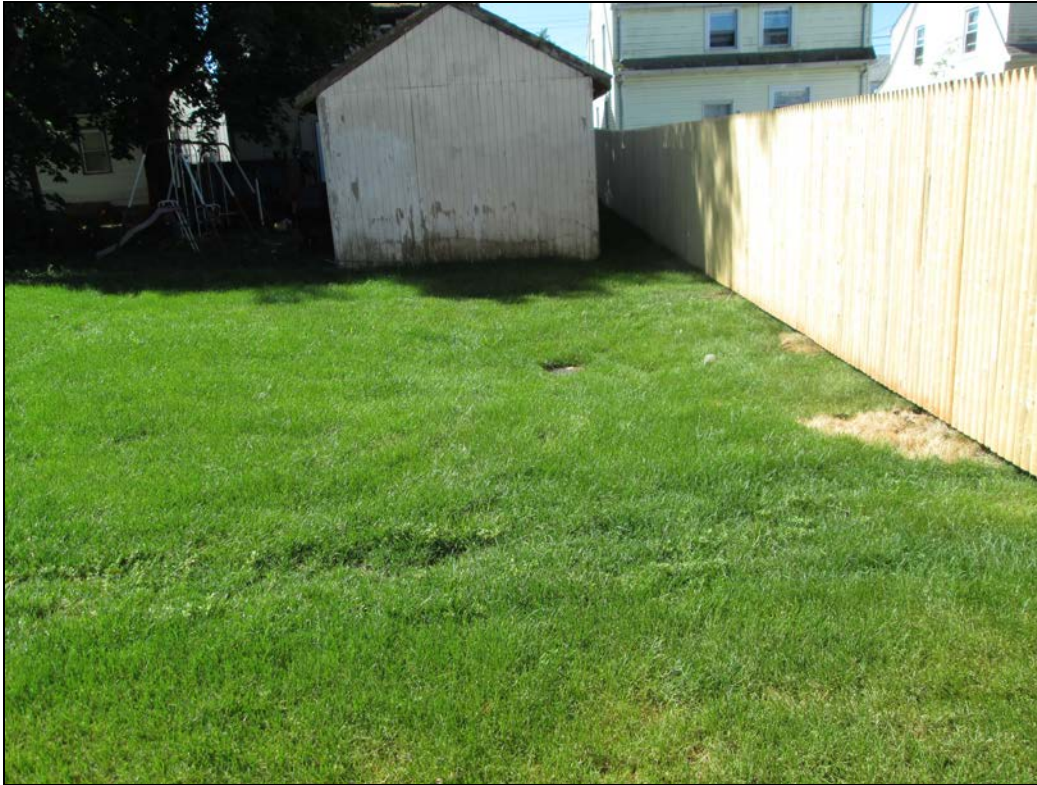
**View looking south at restored back yard.**

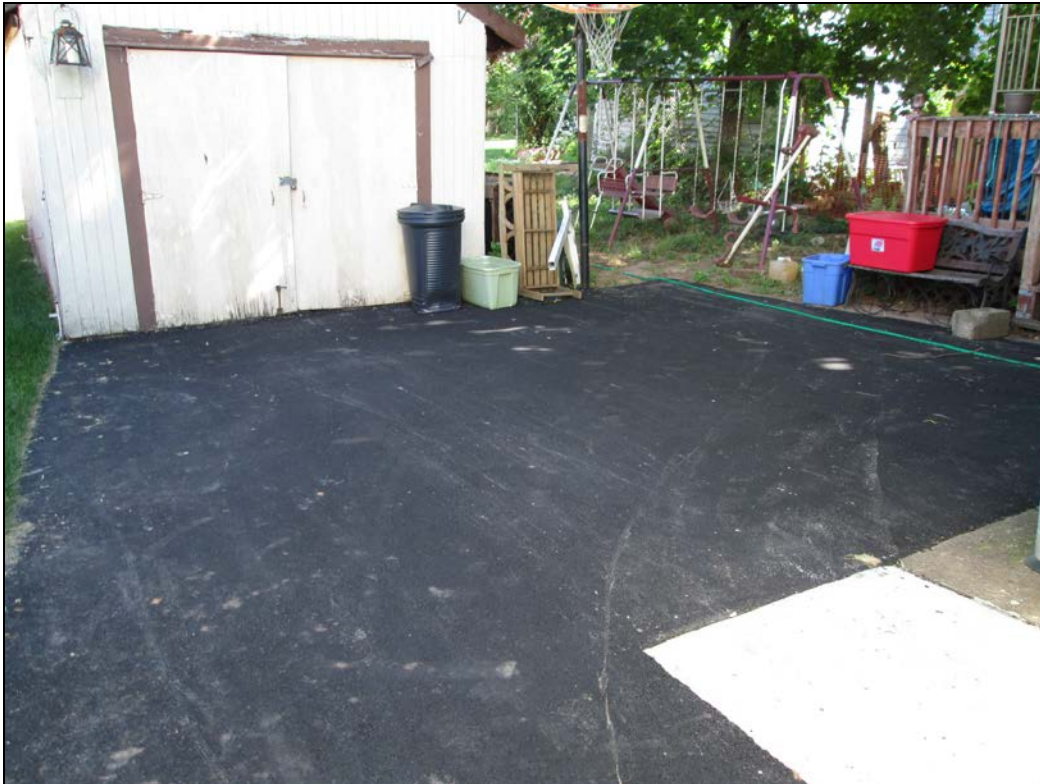
**View looking north at restored parking area.**
