Re: Property-Specific Remedial Action Report
Newhall Street Neighborhood
180 Morse Street, Block P
Hamden, Connecticut 06517

**PROPERTY-SPECIFIC REMEDIAL ACTION REPORT
180 MORSE STREET**

**NON-PUBLIC PROPERTIES
NEWHALL STREET NEIGHBORHOOD
HAMDEN, CONNECTICUT**

December 12, 2012

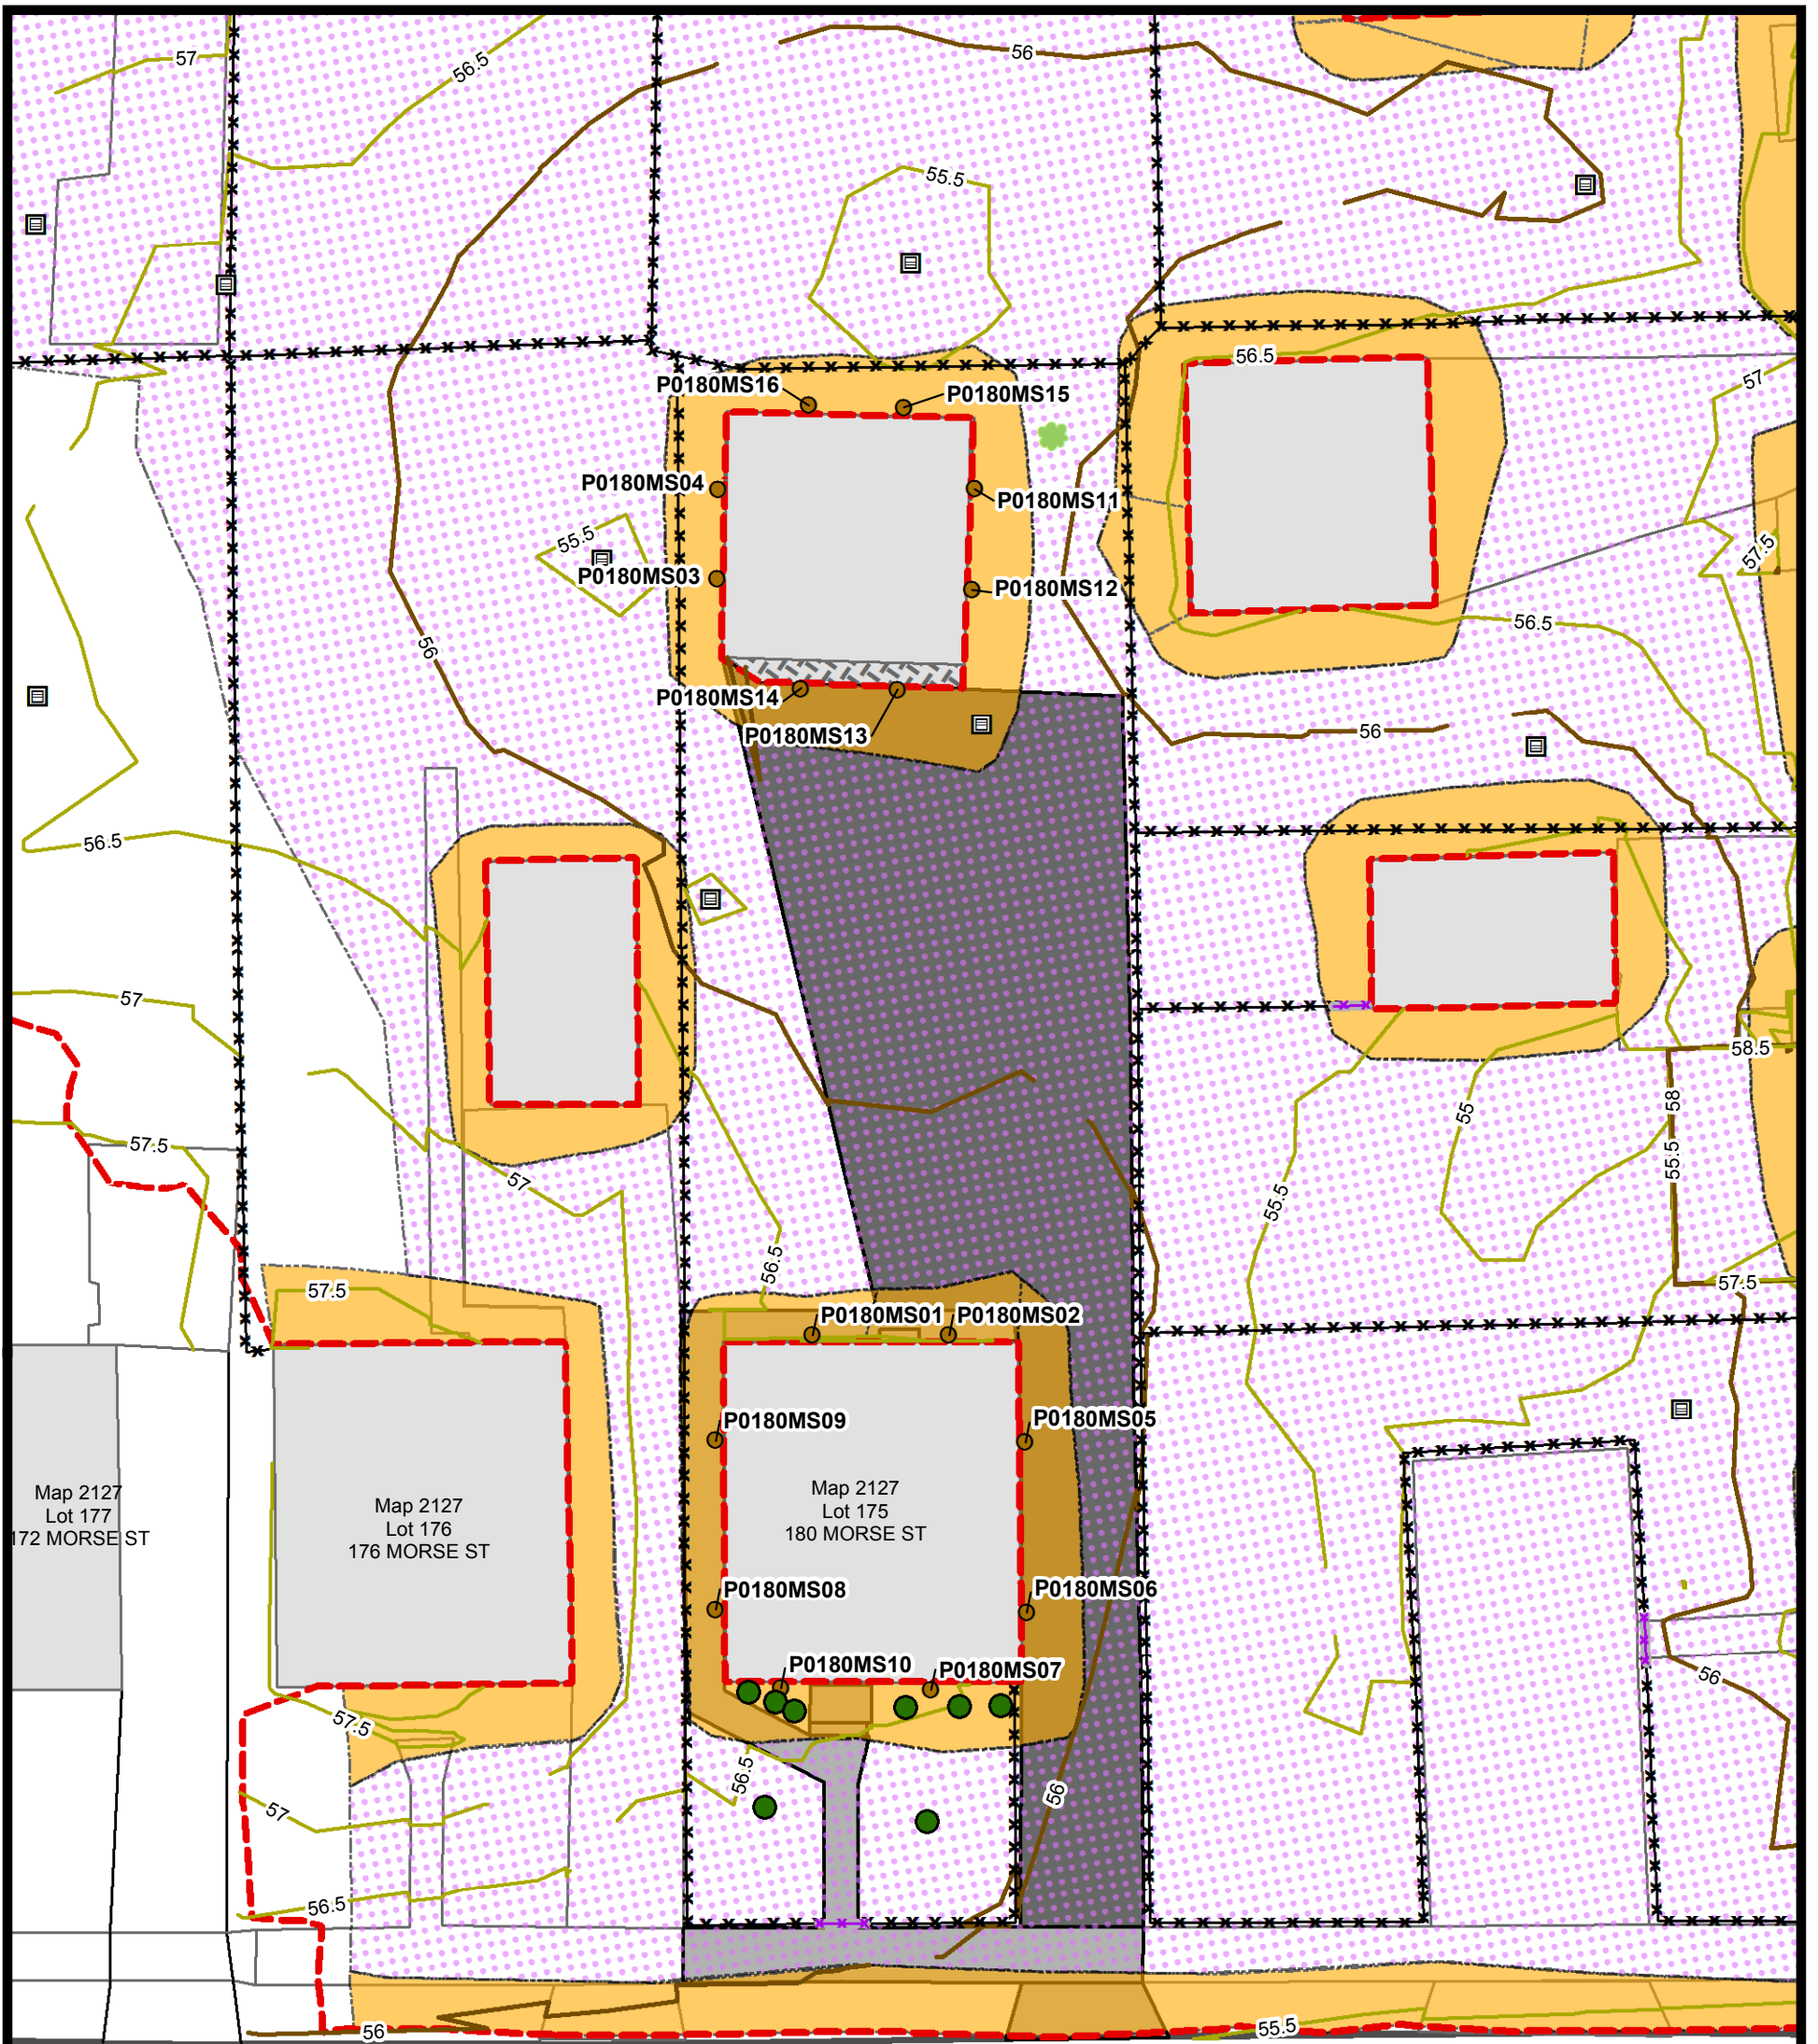
- In some locations, fill material was present at depths greater than 4 feet below ground surface (bgs). This fill material was left in place, covered by an orange geotextile fabric, and backfilled with clean soil in accordance with the Final Design - Generic RAP. Figure 2-1 shows the approximate area of geotextile fabric identifying the presence of fill at a depth greater than 4 feet bgs.

- In some locations, it was necessary to leave fill material in place at depths less than 4 feet bgs in order to avoid jeopardizing the integrity of a structure. This fill material was left in place, covered by an orange geotextile fabric and/or concrete, and backfilled with clean soil in accordance with the Final Design - Generic RAP. Figure 2-1 shows the approximate area of geotextile fabric/concrete identifying the presence of fill at a depth less than 4 feet bgs.

- As part of efforts to improve drainage following excavation and backfill activities, a drywell was installed in a low-lying portion of the yard. The location of this feature is shown on Figure 2-1.

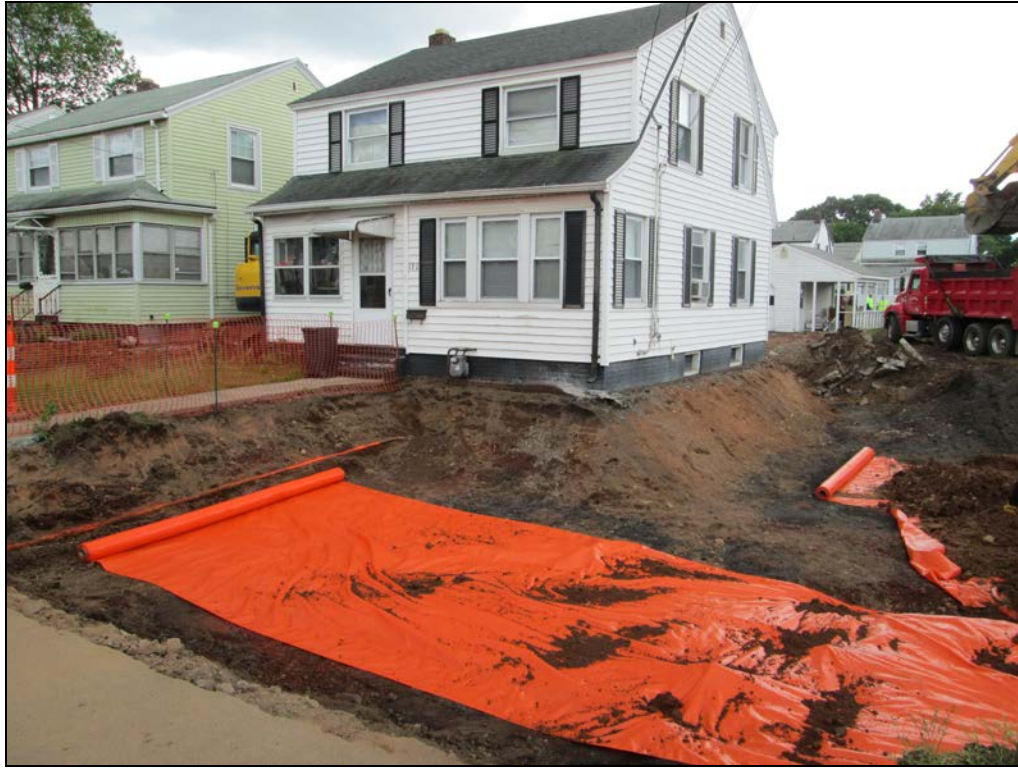
View looking southeast at excavated front and side yard during placement of marker barrier.

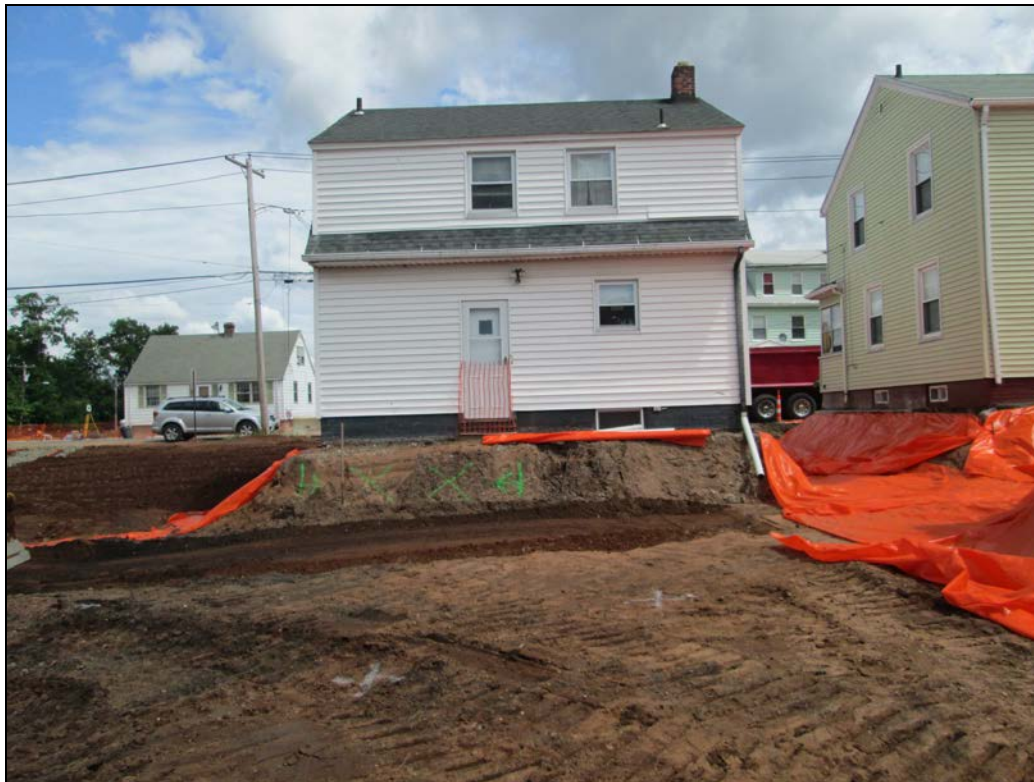
View looking north at excavated back yard.

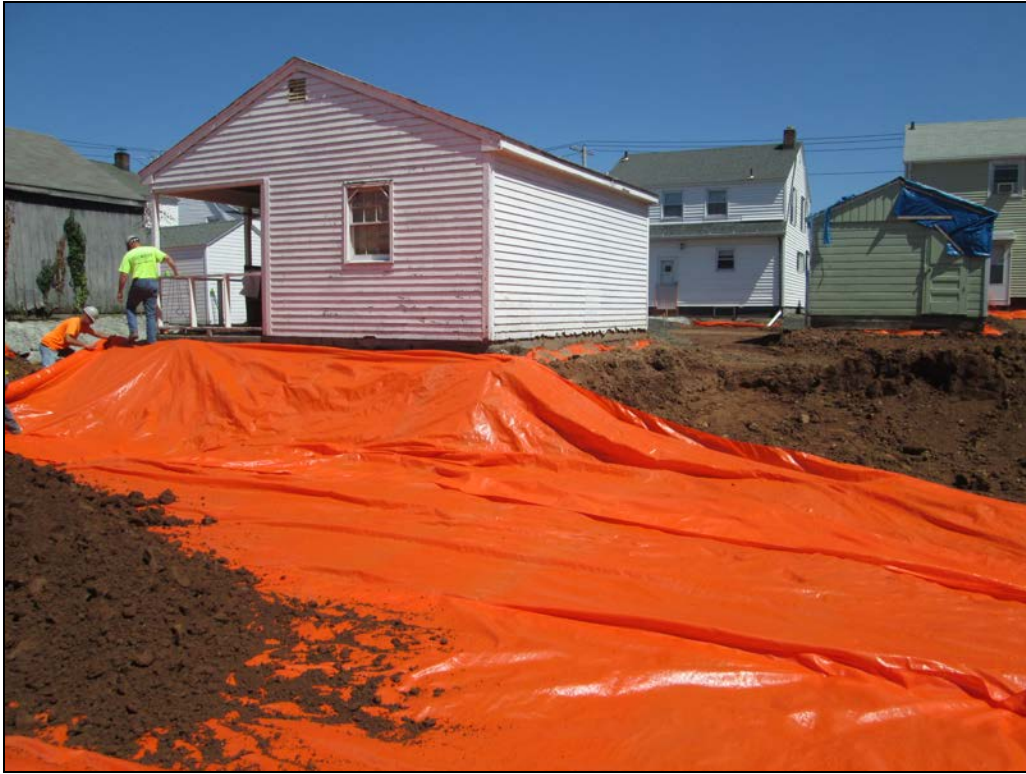
View looking north at marker barrier being installed in back yard.

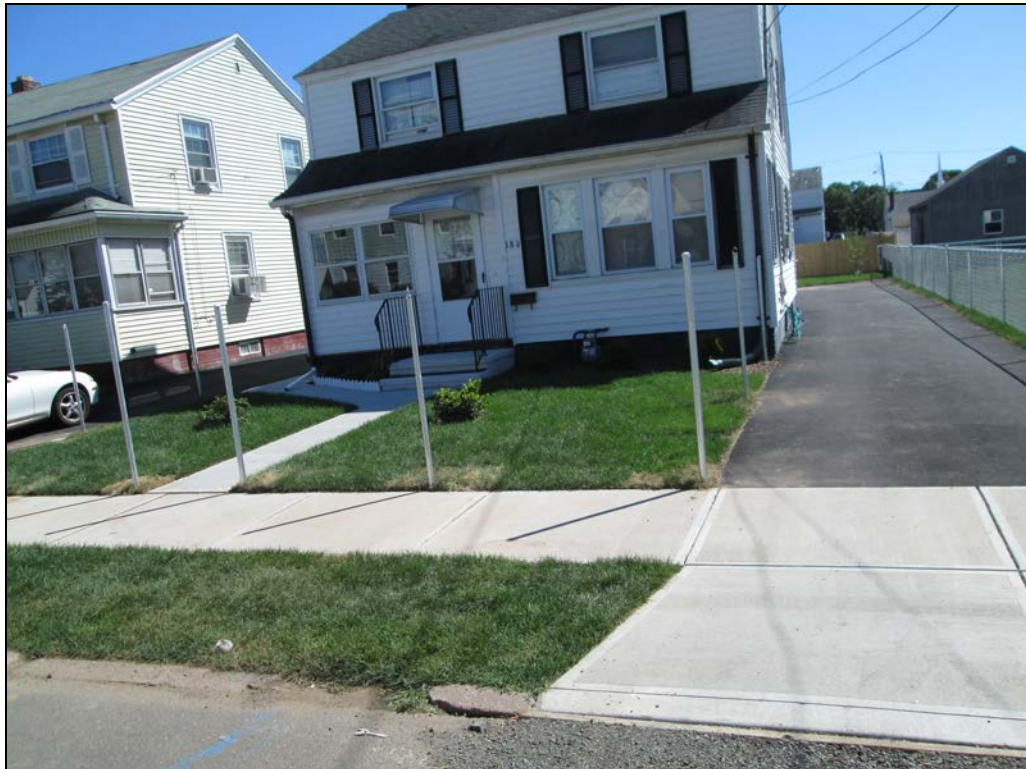
View looking south at partially restored front yard.

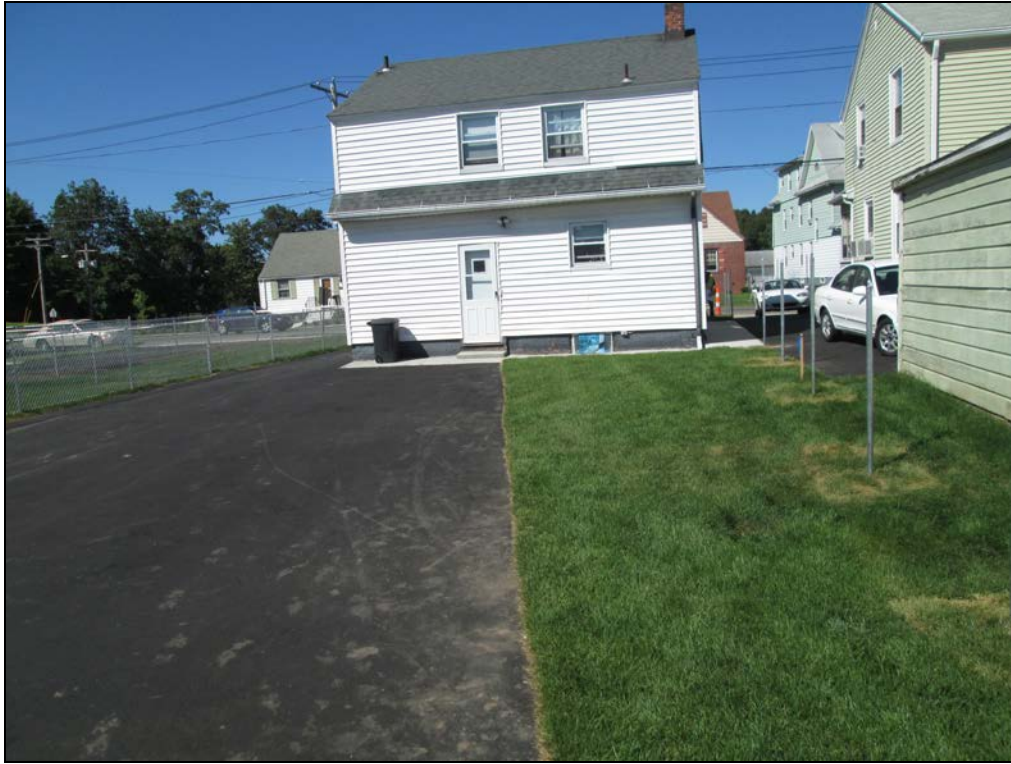
View looking north at restored back yard.

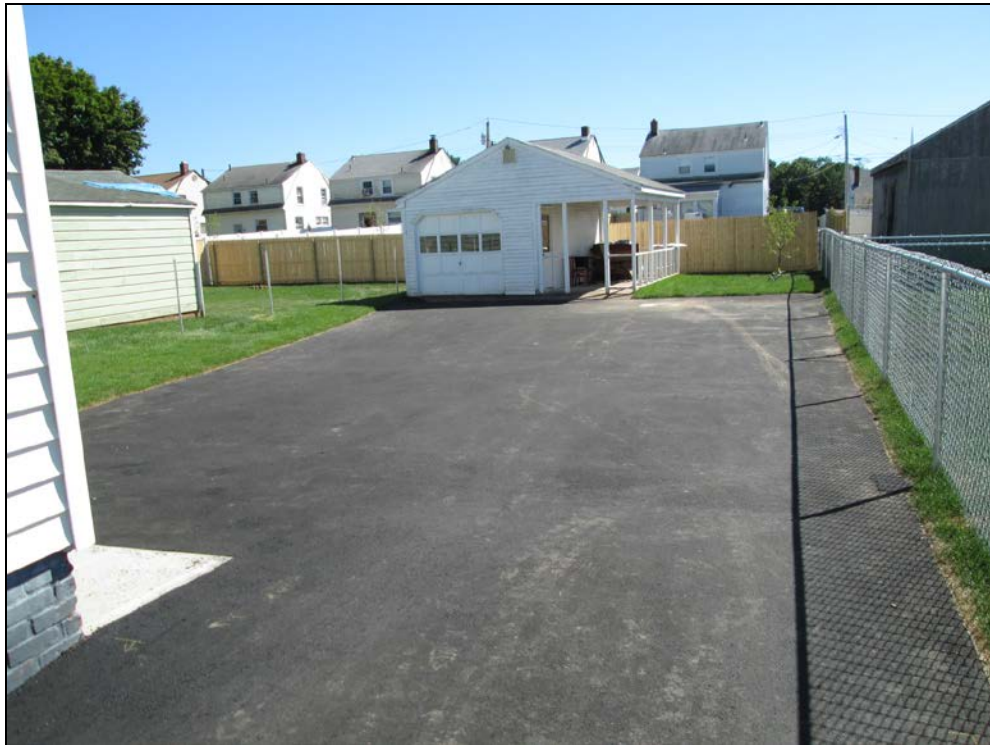
View looking south at restored driveway.
