Re: Property-Specific Remedial Action Report
Newhall Street Neighborhood
20 Harris Street, Block T
Hamden, Connecticut 06517

**PROPERTY-SPECIFIC REMEDIAL ACTION REPORT
20 HARRIS STREET**

**NON-PUBLIC PROPERTIES
NEWHALL STREET NEIGHBORHOOD
HAMDEN, CONNECTICUT**

December 21, 2012

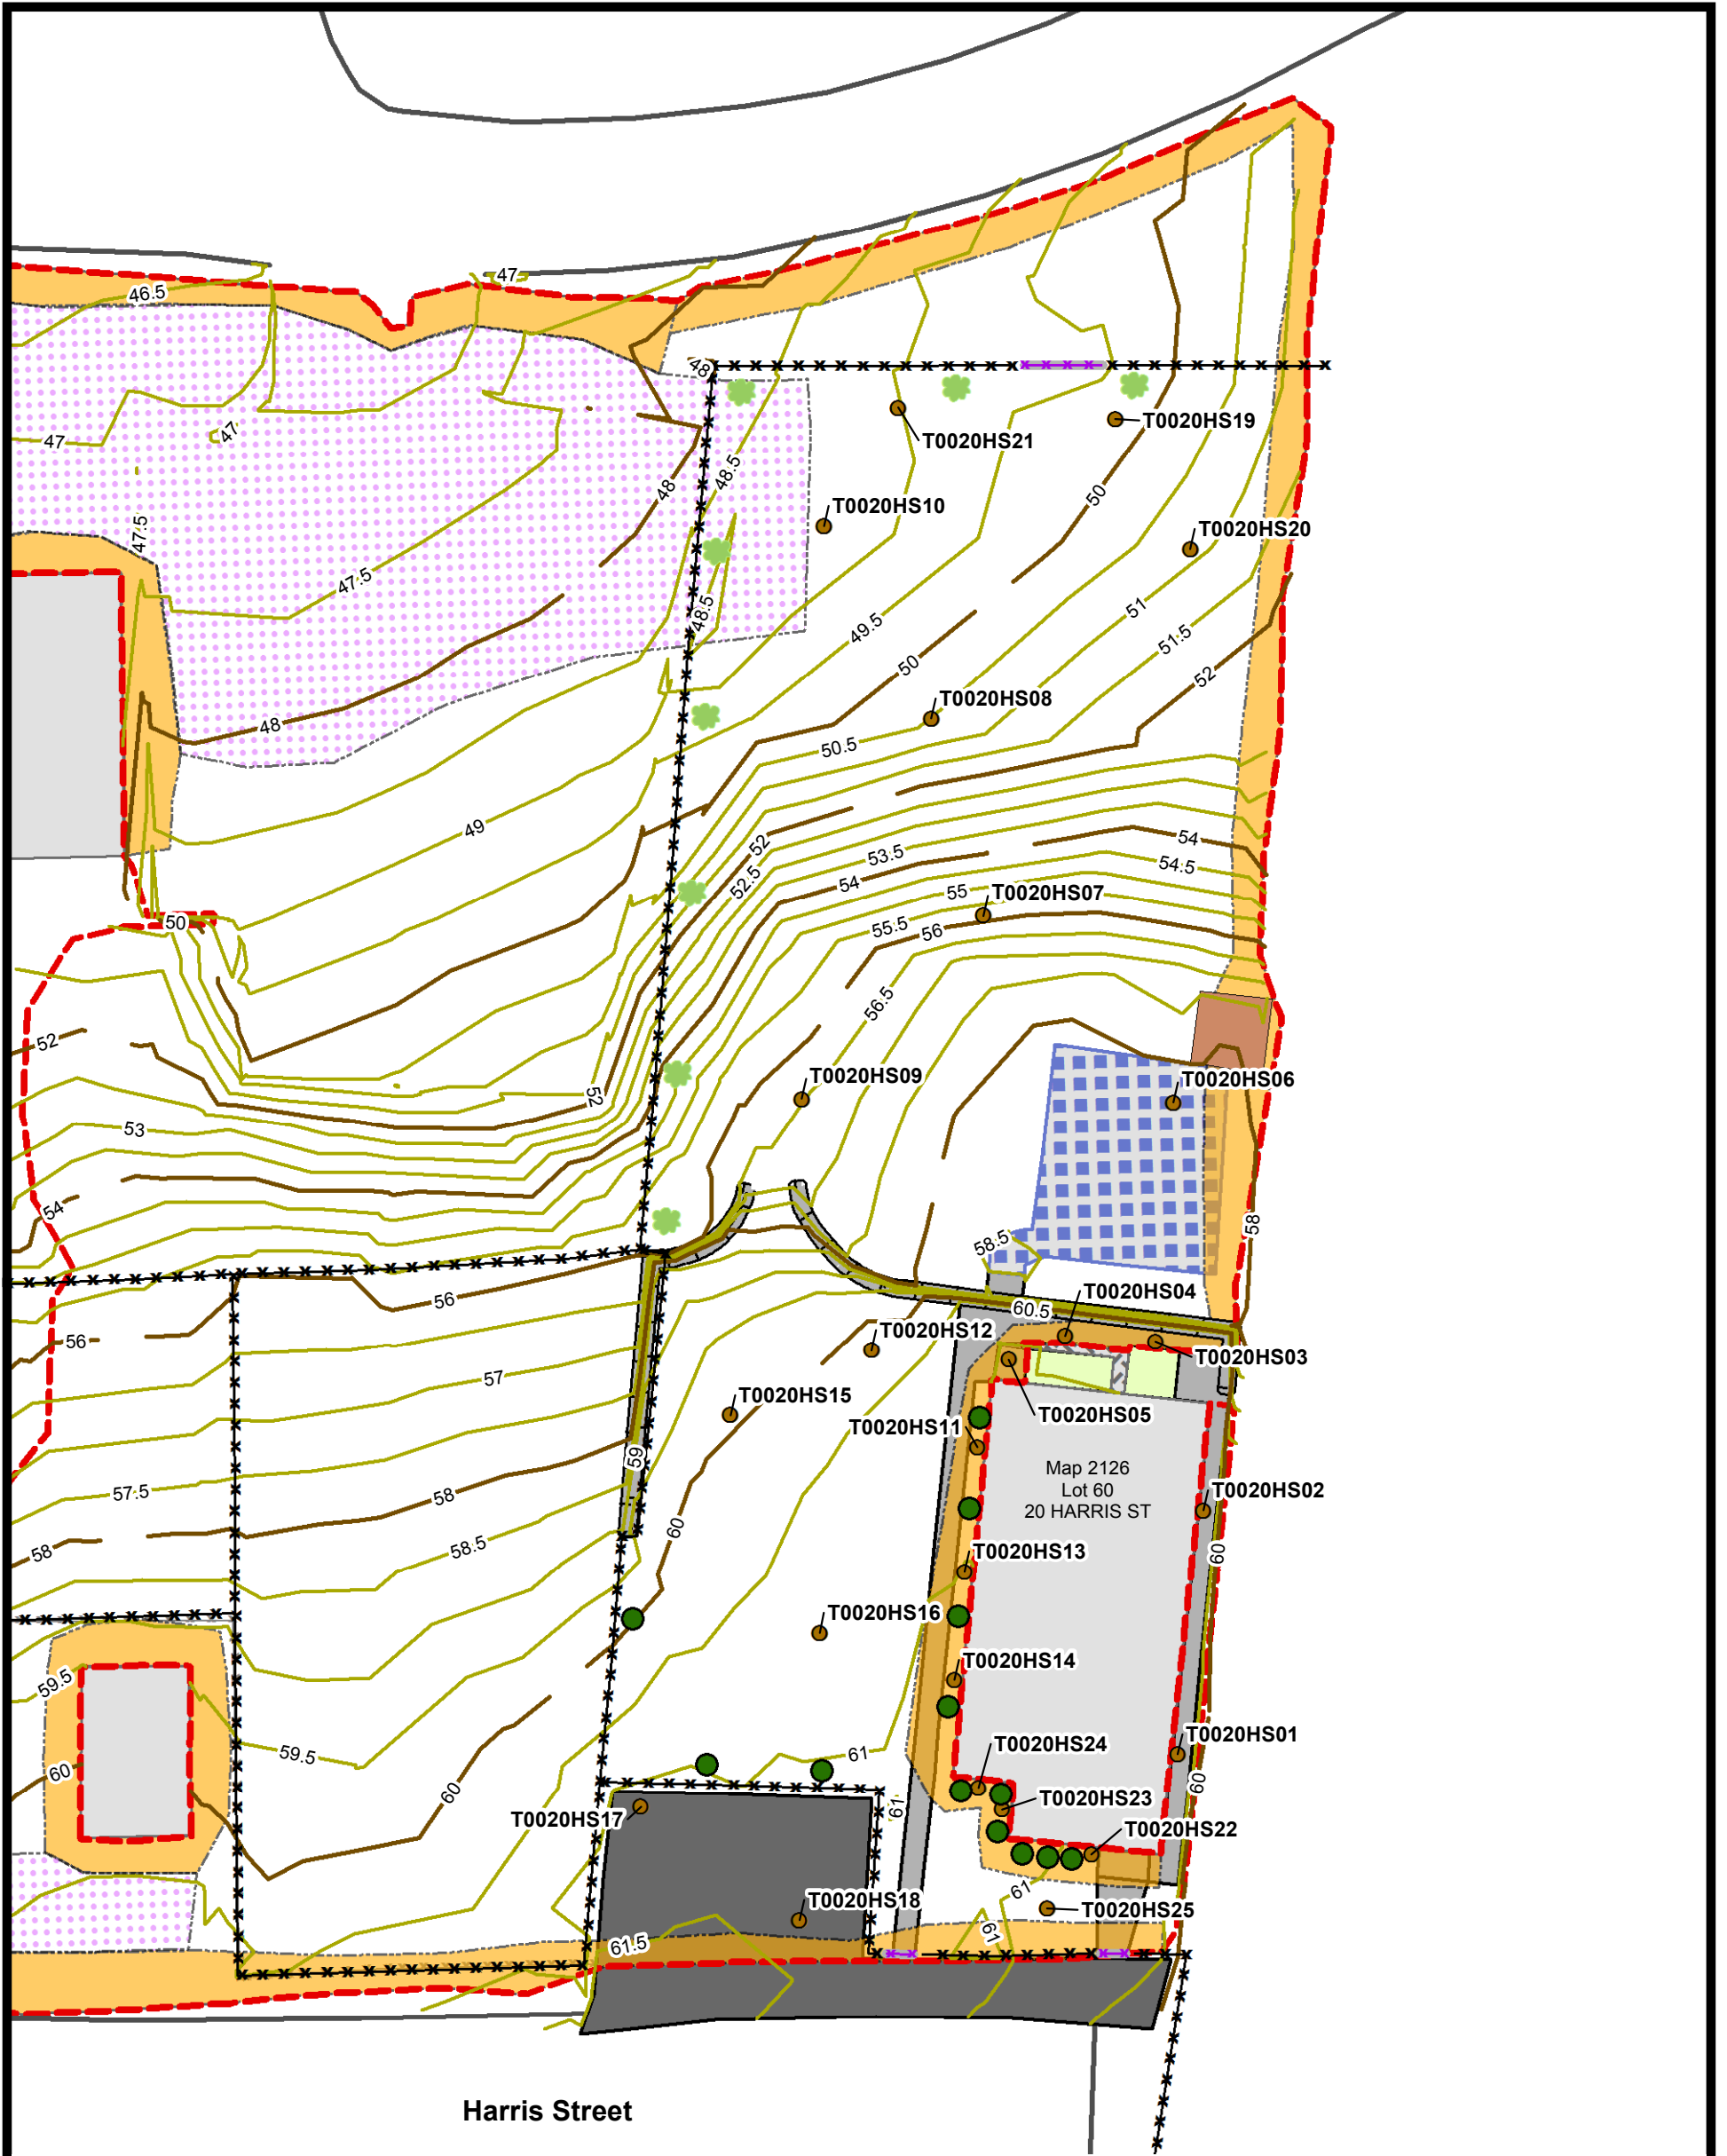
During the 2012 construction season, Olin completed the excavation, backfill, and restoration of the property in accordance with the Final Design - Generic RAP and the Property-Specific RAP. Figure 2-1 shows the areas where excavation occurred on the property and the locations of excavation confirmation samples. Excavation confirmation samples were collected in accordance with Section 3.2.3 - Confirmatory Sampling of the Final Design - Generic RAP, including adherence to the sampling frequency requirements. X-ray fluorescence (XRF) excavation confirmation sampling results are presented in Table 2-1.

- In some locations on the property, fill material was present at depths greater than 4 feet below ground surface (bgs). This fill material was left in place, covered by an orange geotextile fabric, and backfilled with clean soil in accordance with the Final Design - Generic RAP. Figure 2-1 shows the approximate area of geotextile fabric identifying the presence of fill at a depth greater than 4 feet bgs.

- In some locations, it was necessary to leave fill material in place at depths less than 4 feet bgs in order to avoid jeopardizing the integrity of a structure or a feature that was to be left in place. This fill material was left in place, covered by an orange geotextile fabric and/or concrete, and backfilled with clean soil in accordance with the Final Design - Generic RAP. Figure 2-1 shows the approximate area of geotextile fabric/concrete identifying the presence of fill at a depth less than 4 feet bgs.

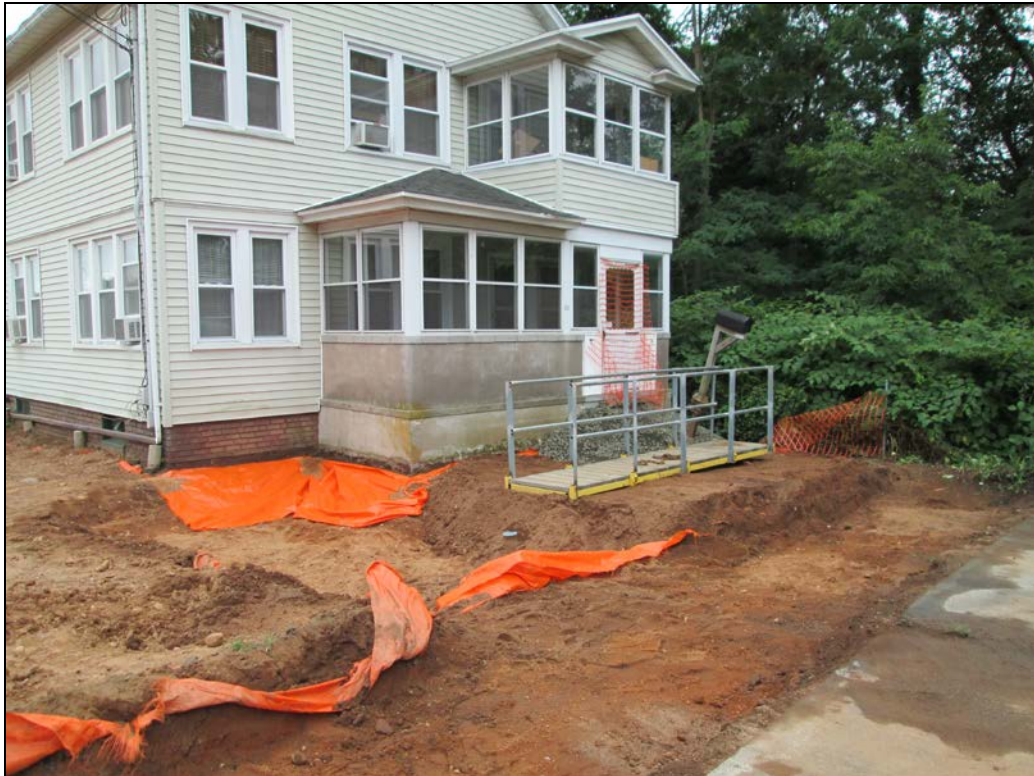
View looking southwest at partially backfilled front yard.

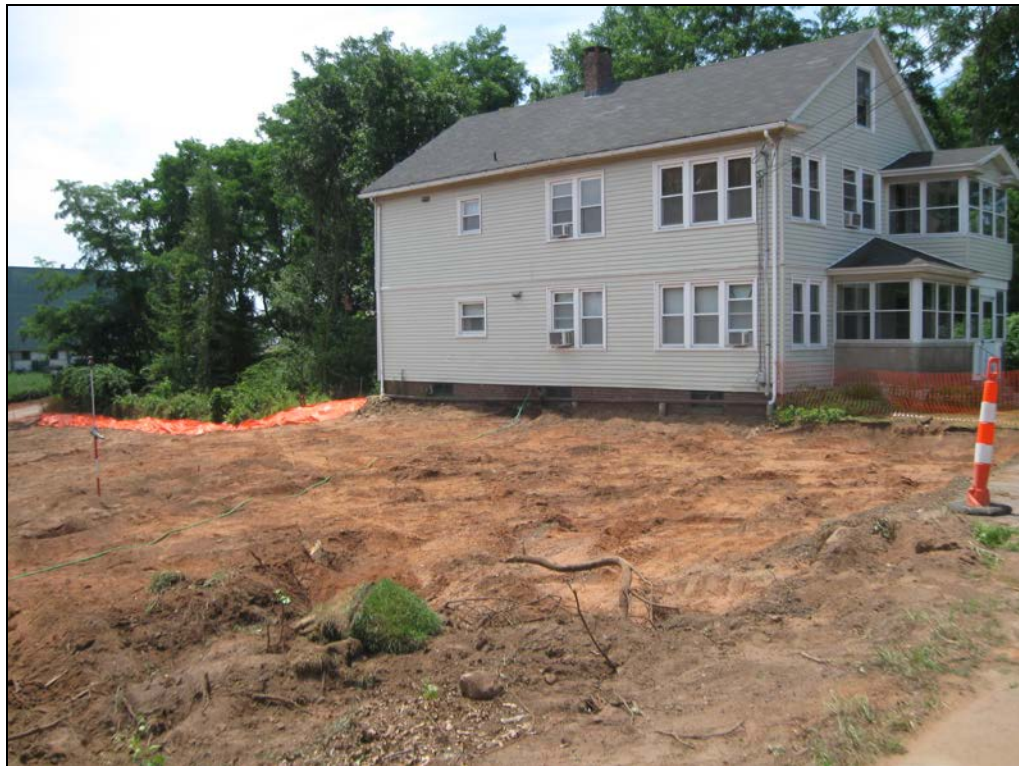
View looking southwest at excavated side yard.

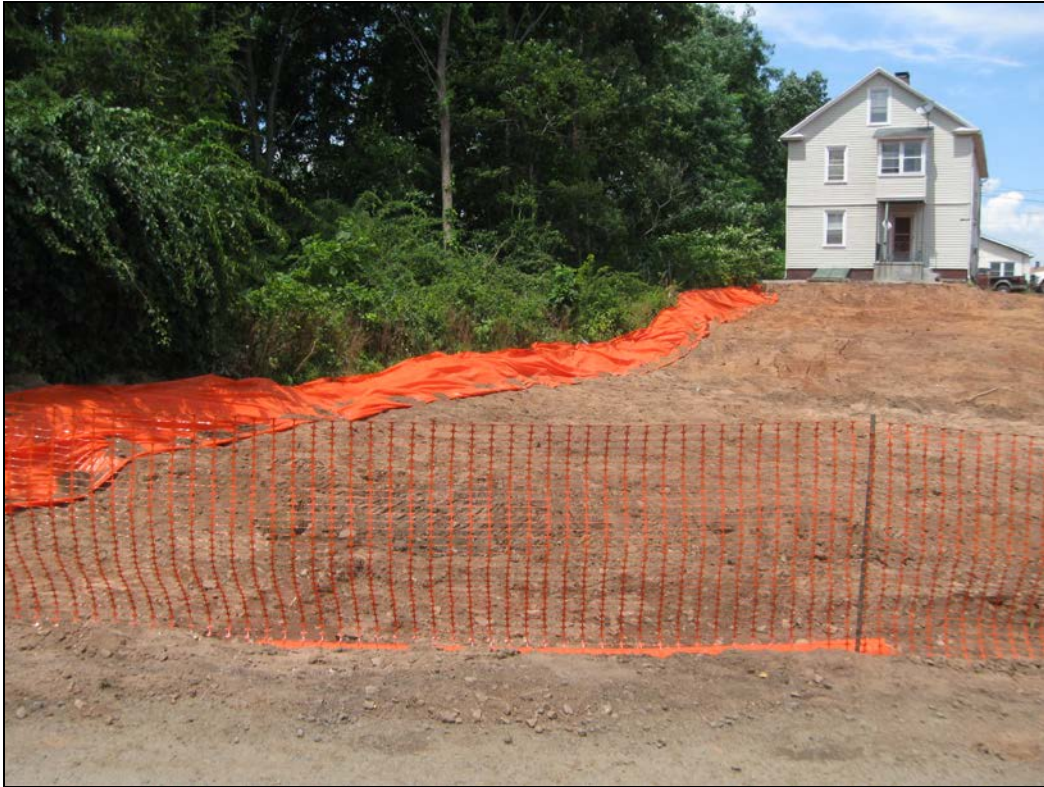
View looking north at excavated back yard.

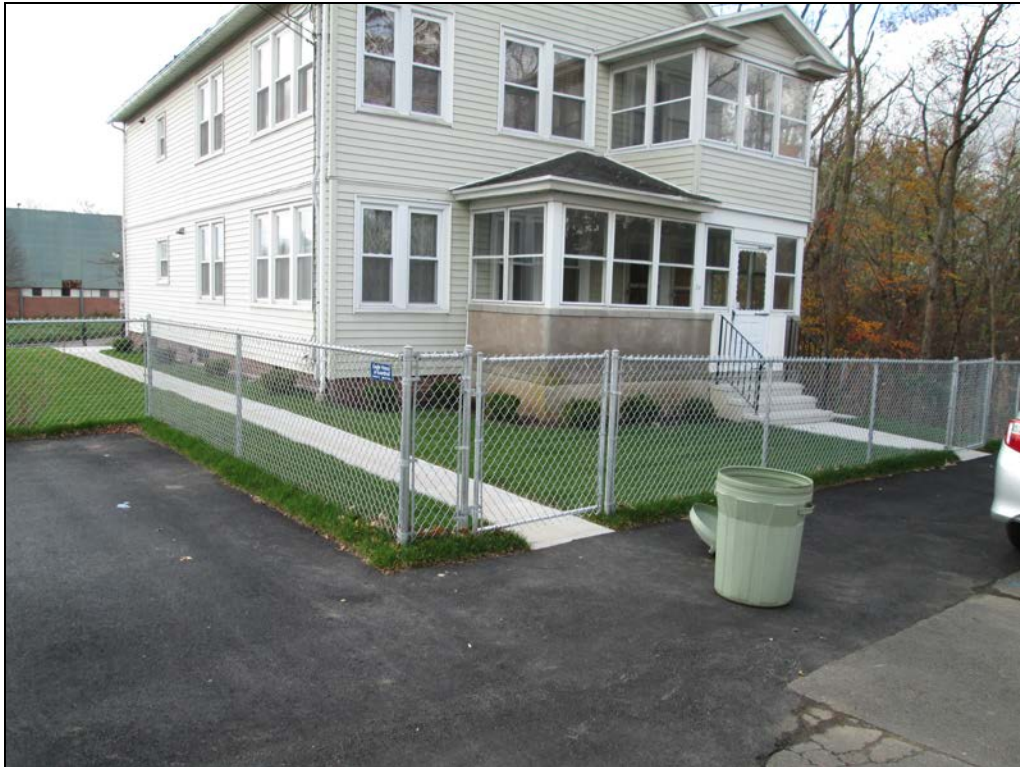
View looking south at restored front yard

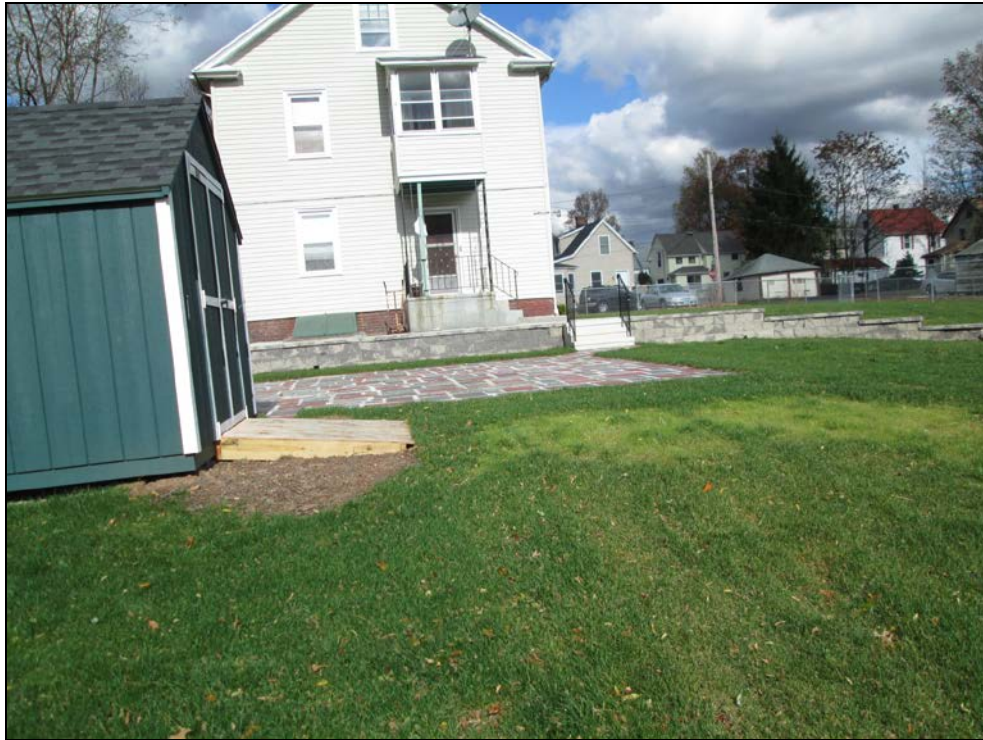
View facing north at restored back yard.

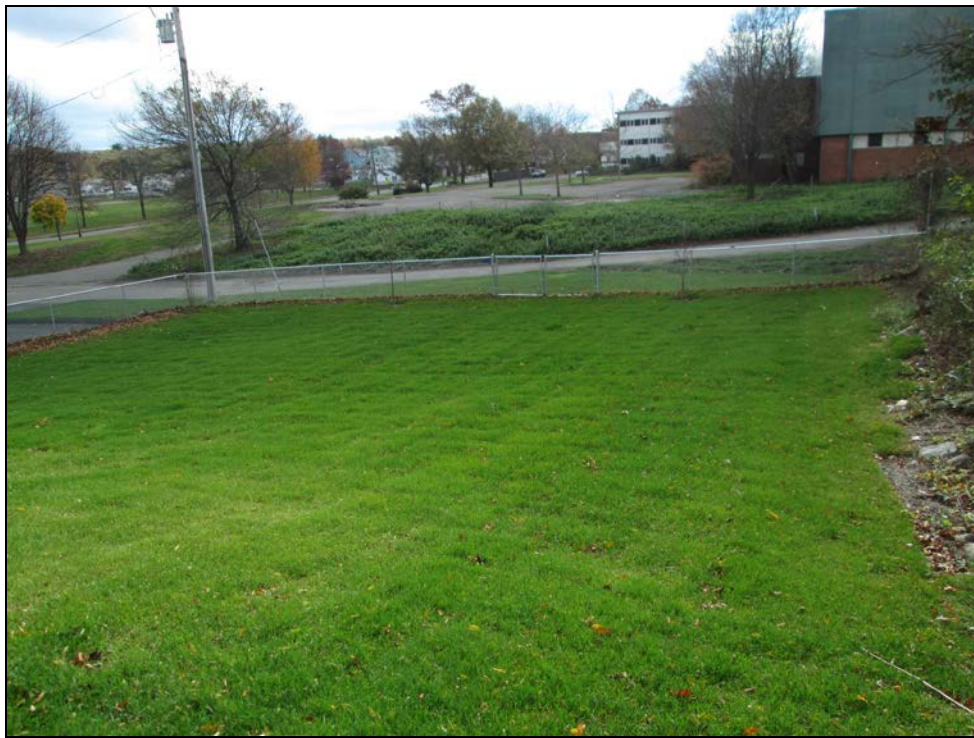
View facing south at restored back yard.
