Re: Property-Specific Remedial Action Report  
Newhall Street Neighborhood  
214 Morse Street, Block K  
Hamden, Connecticut 06517

**PROPERTY-SPECIFIC REMEDIAL ACTION REPORT  
214 MORSE STREET**

**NON-PUBLIC PROPERTIES  
NEWHALL STREET NEIGHBORHOOD  
HAMDEN, CONNECTICUT**

**November 30, 2011**

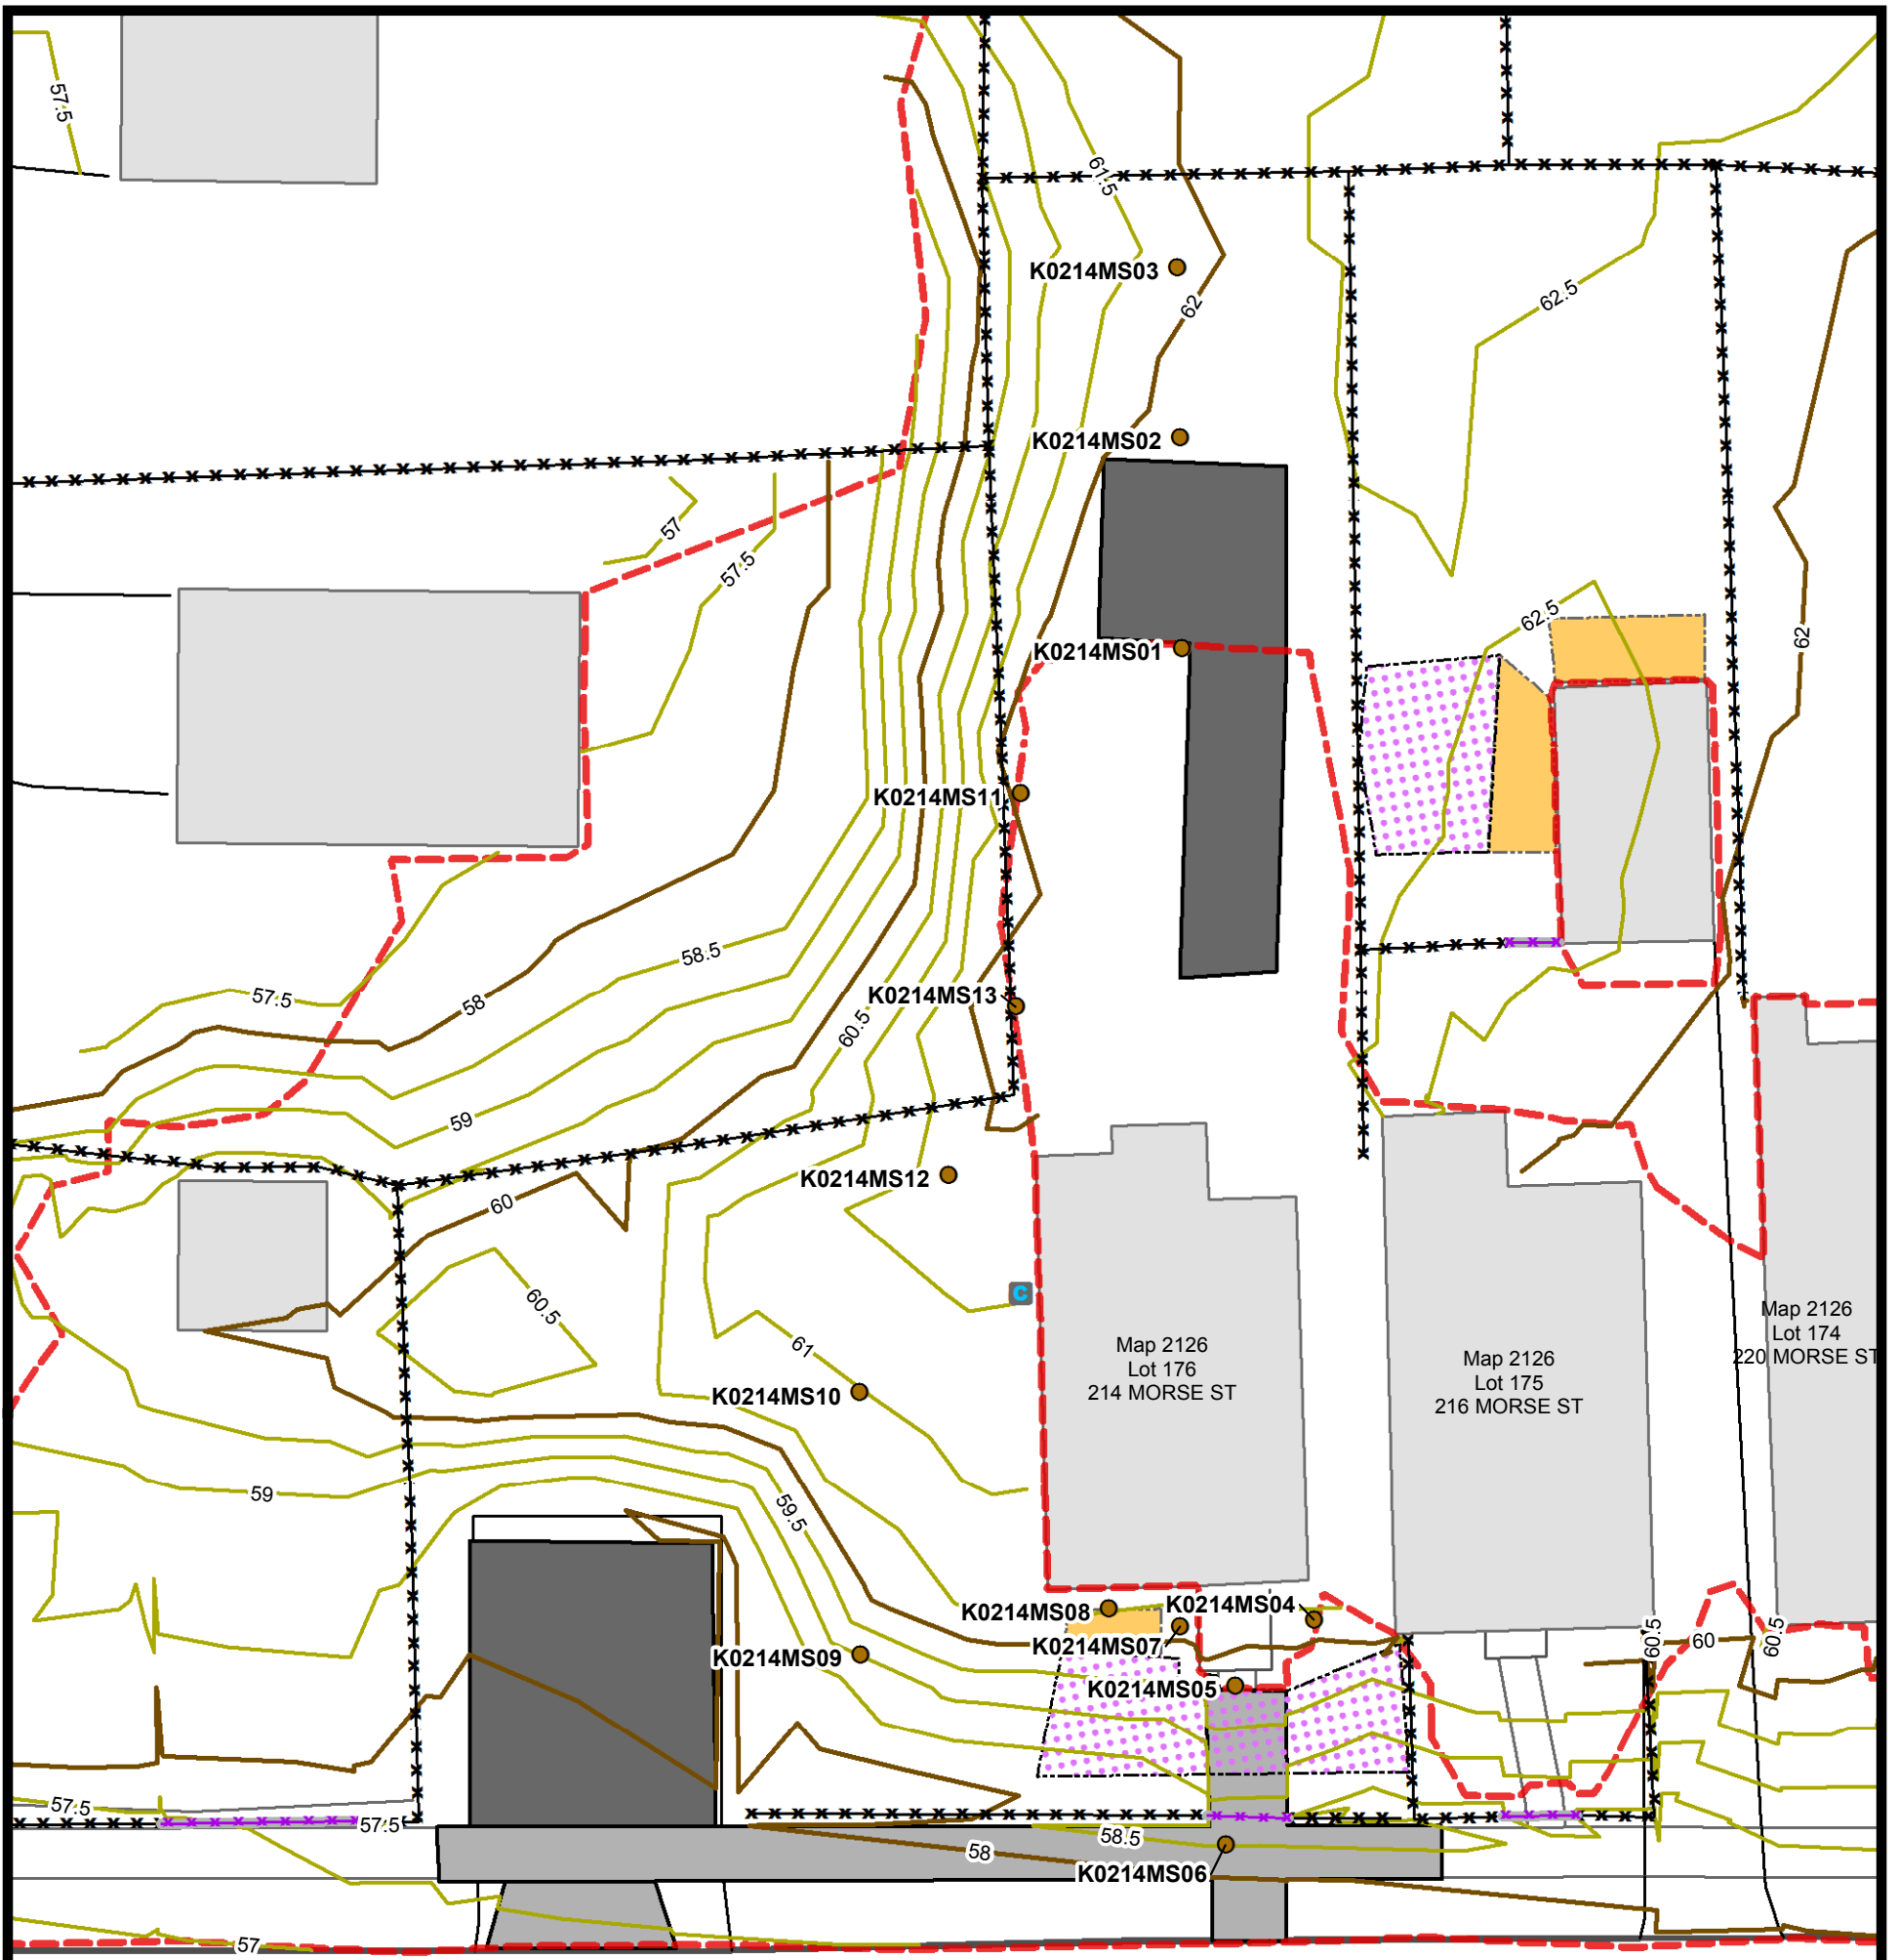
Figure 2-1 Post-Construction Conditions

During the 2011 construction season, Olin completed the excavation, backfill, and restoration of the property in accordance with the Final Design - Generic RAP. Figure 2-1 shows the areas where excavation occurred on the property and the locations of excavation confirmation samples. Excavation confirmation samples were collected in accordance with Section 3.2.3 - Confirmatory Sampling of the Final Design - Generic RAP, including adherence to the sampling frequency requirements. X-ray fluorescence (XRF) excavation confirmation sampling results are presented in Table 2-1.

As indicated in Table 2-1, most confirmation sampling results indicate total lead concentrations less than the criteria of 400 milligrams per kilogram (mg/kg) approved by DEEP in the Final Design - Generic RAP. Several samples collected from the perimeter of the excavated area indicated total lead concentrations that exceeded 400 mg/kg. Additional soil could not be removed from these locations around the perimeter of the house, because continued excavation could jeopardize the integrity of the structure.

- In some locations, fill material was encountered at greater than 4 feet in depth below ground surface (bgs). This fill material was left in place, covered by an orange geotextile fabric, and backfilled with clean soil in accordance with the Final Design - Generic RAP. Figure 2-1 shows the approximate area of geotextile fabric identifying the presence of fill at a depth greater than 4 feet bgs.
- In some locations, it was necessary to leave fill material in place at depths less than 4 feet bgs in order to avoid jeopardizing the integrity of a structure. This fill material was left in place, covered by a marker barrier (an orange geotextile fabric and/or shotcrete), and backfilled with clean soil in accordance with the Final Design - Generic RAP. Figure 2-1 shows the approximate area of geotextile fabric/shotcrete identifying the presence of fill at a depth less than 4 feet bgs.

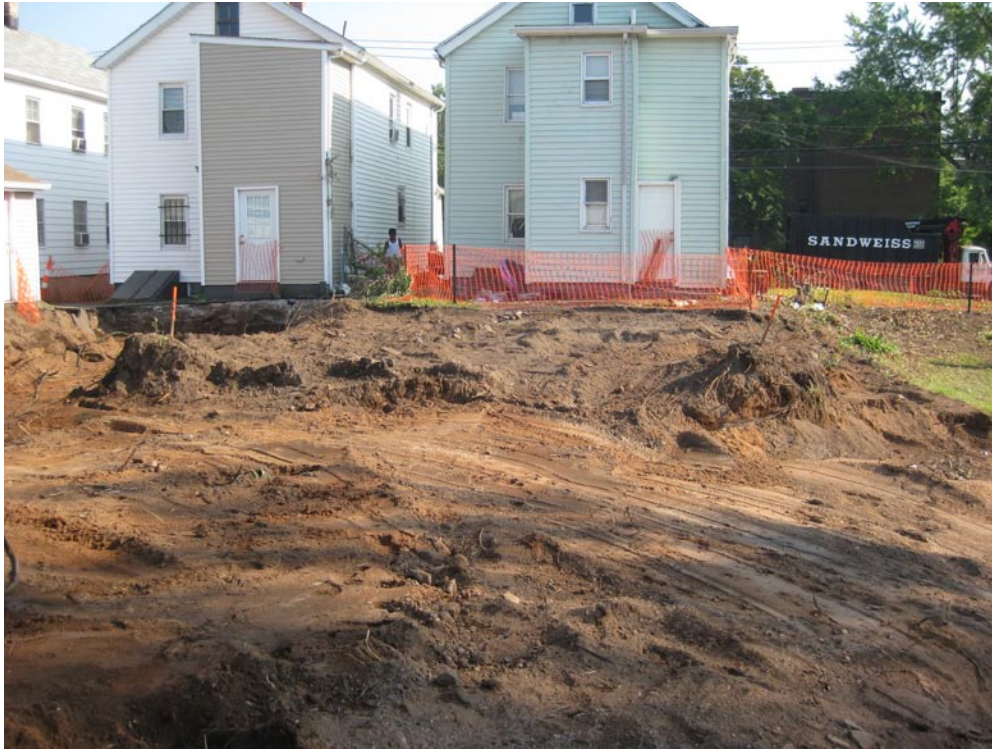
**View looking North at excavated backyard**

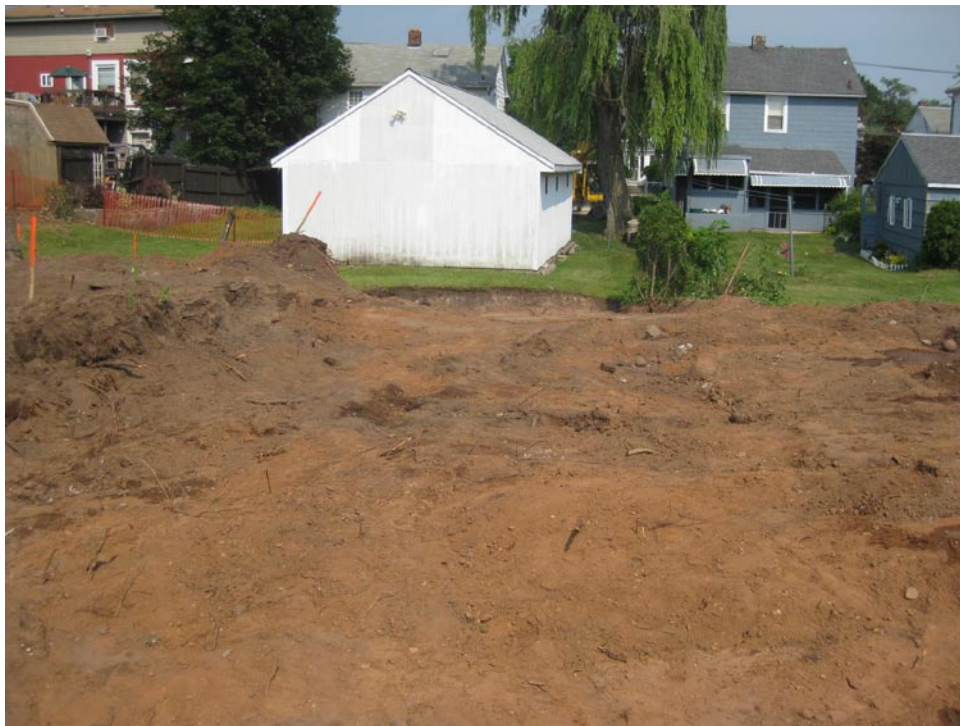
**View looking East at excavation of side yard**

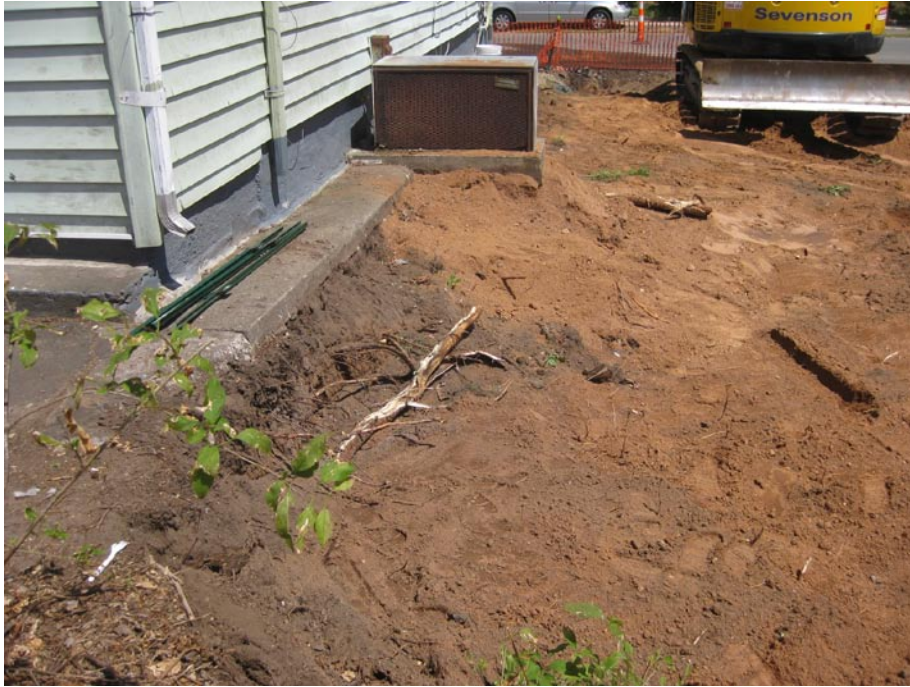
**View looking North at excavation area along side of house**

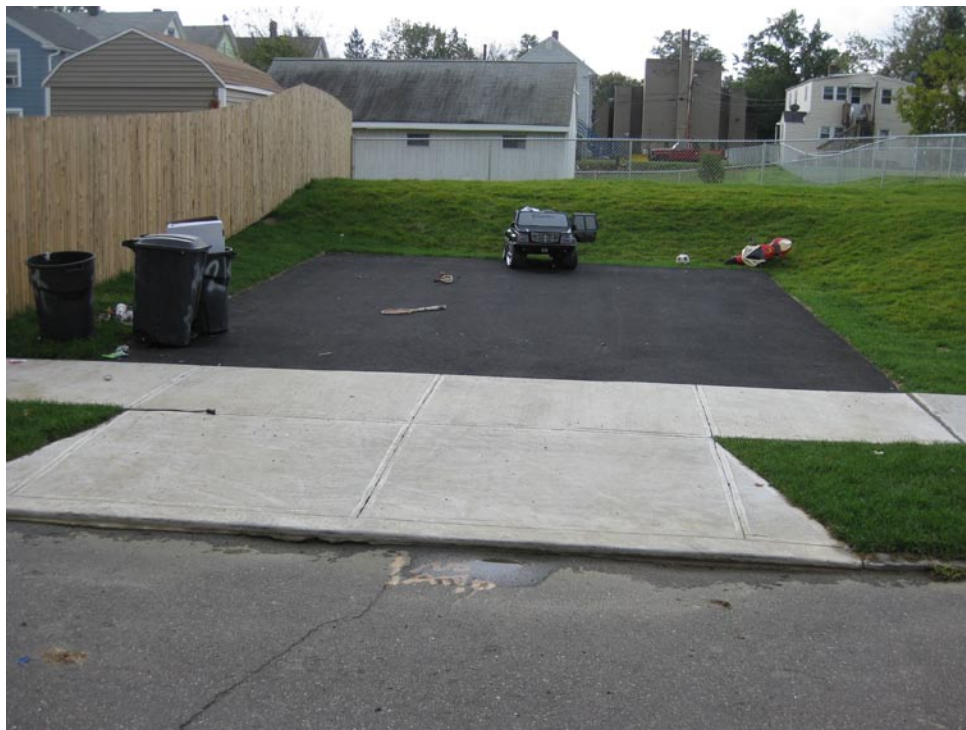
**View looking South at restored driveway and side yard**

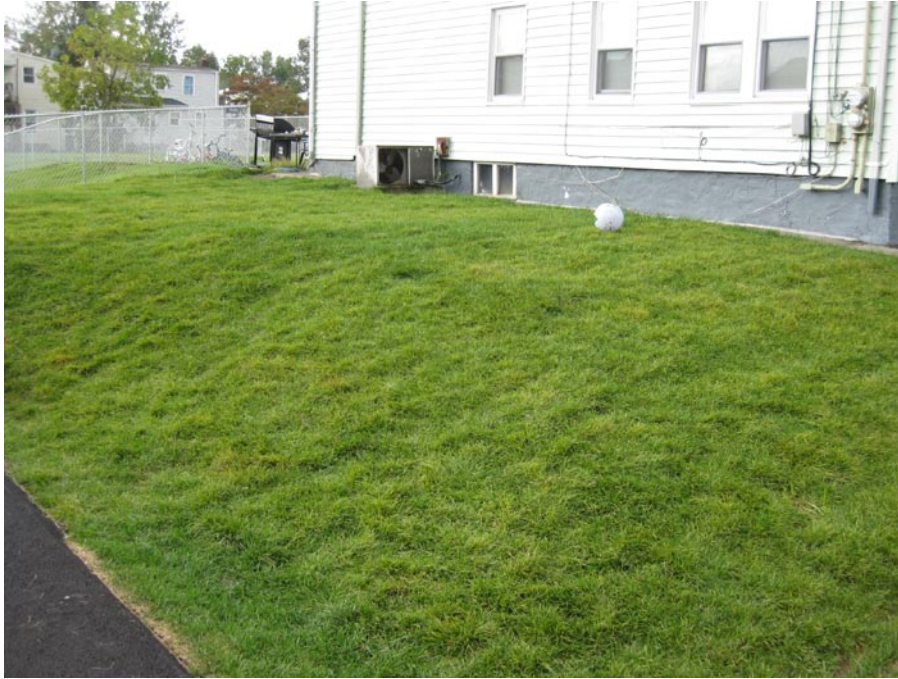
**View looking Southwest at restored yard at side of house**

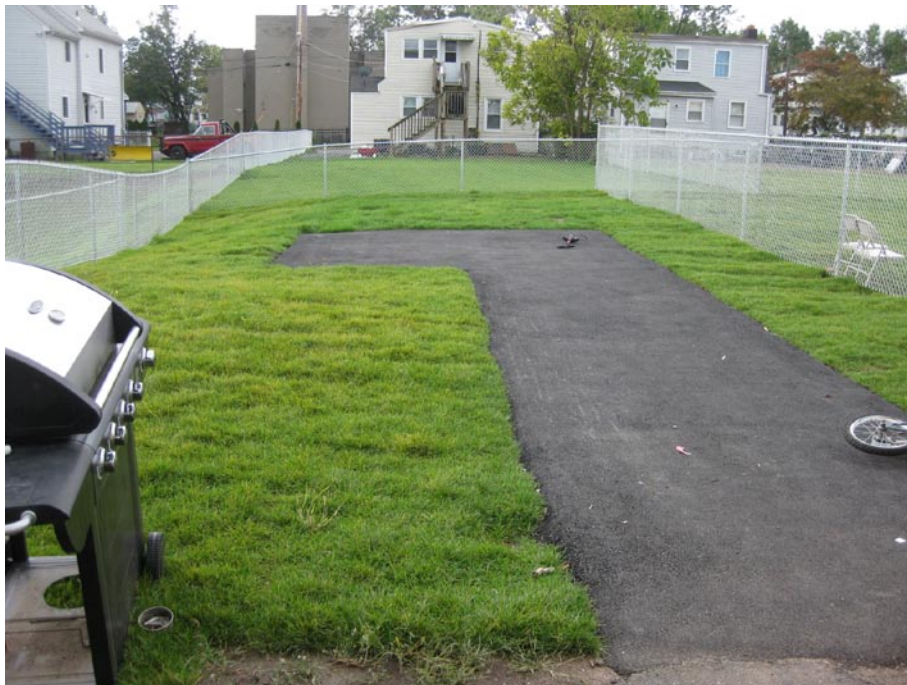
**View looking North at partially restored back yard**
