Re: Property-Specific Remedial Action Report
Newhall Street Neighborhood
21 Marlboro Street, Block P
Hamden, Connecticut 06517

**PROPERTY-SPECIFIC REMEDIAL ACTION REPORT
21 MARLBORO STREET**

**NON-PUBLIC PROPERTIES
NEWHALL STREET NEIGHBORHOOD
HAMDEN, CONNECTICUT**

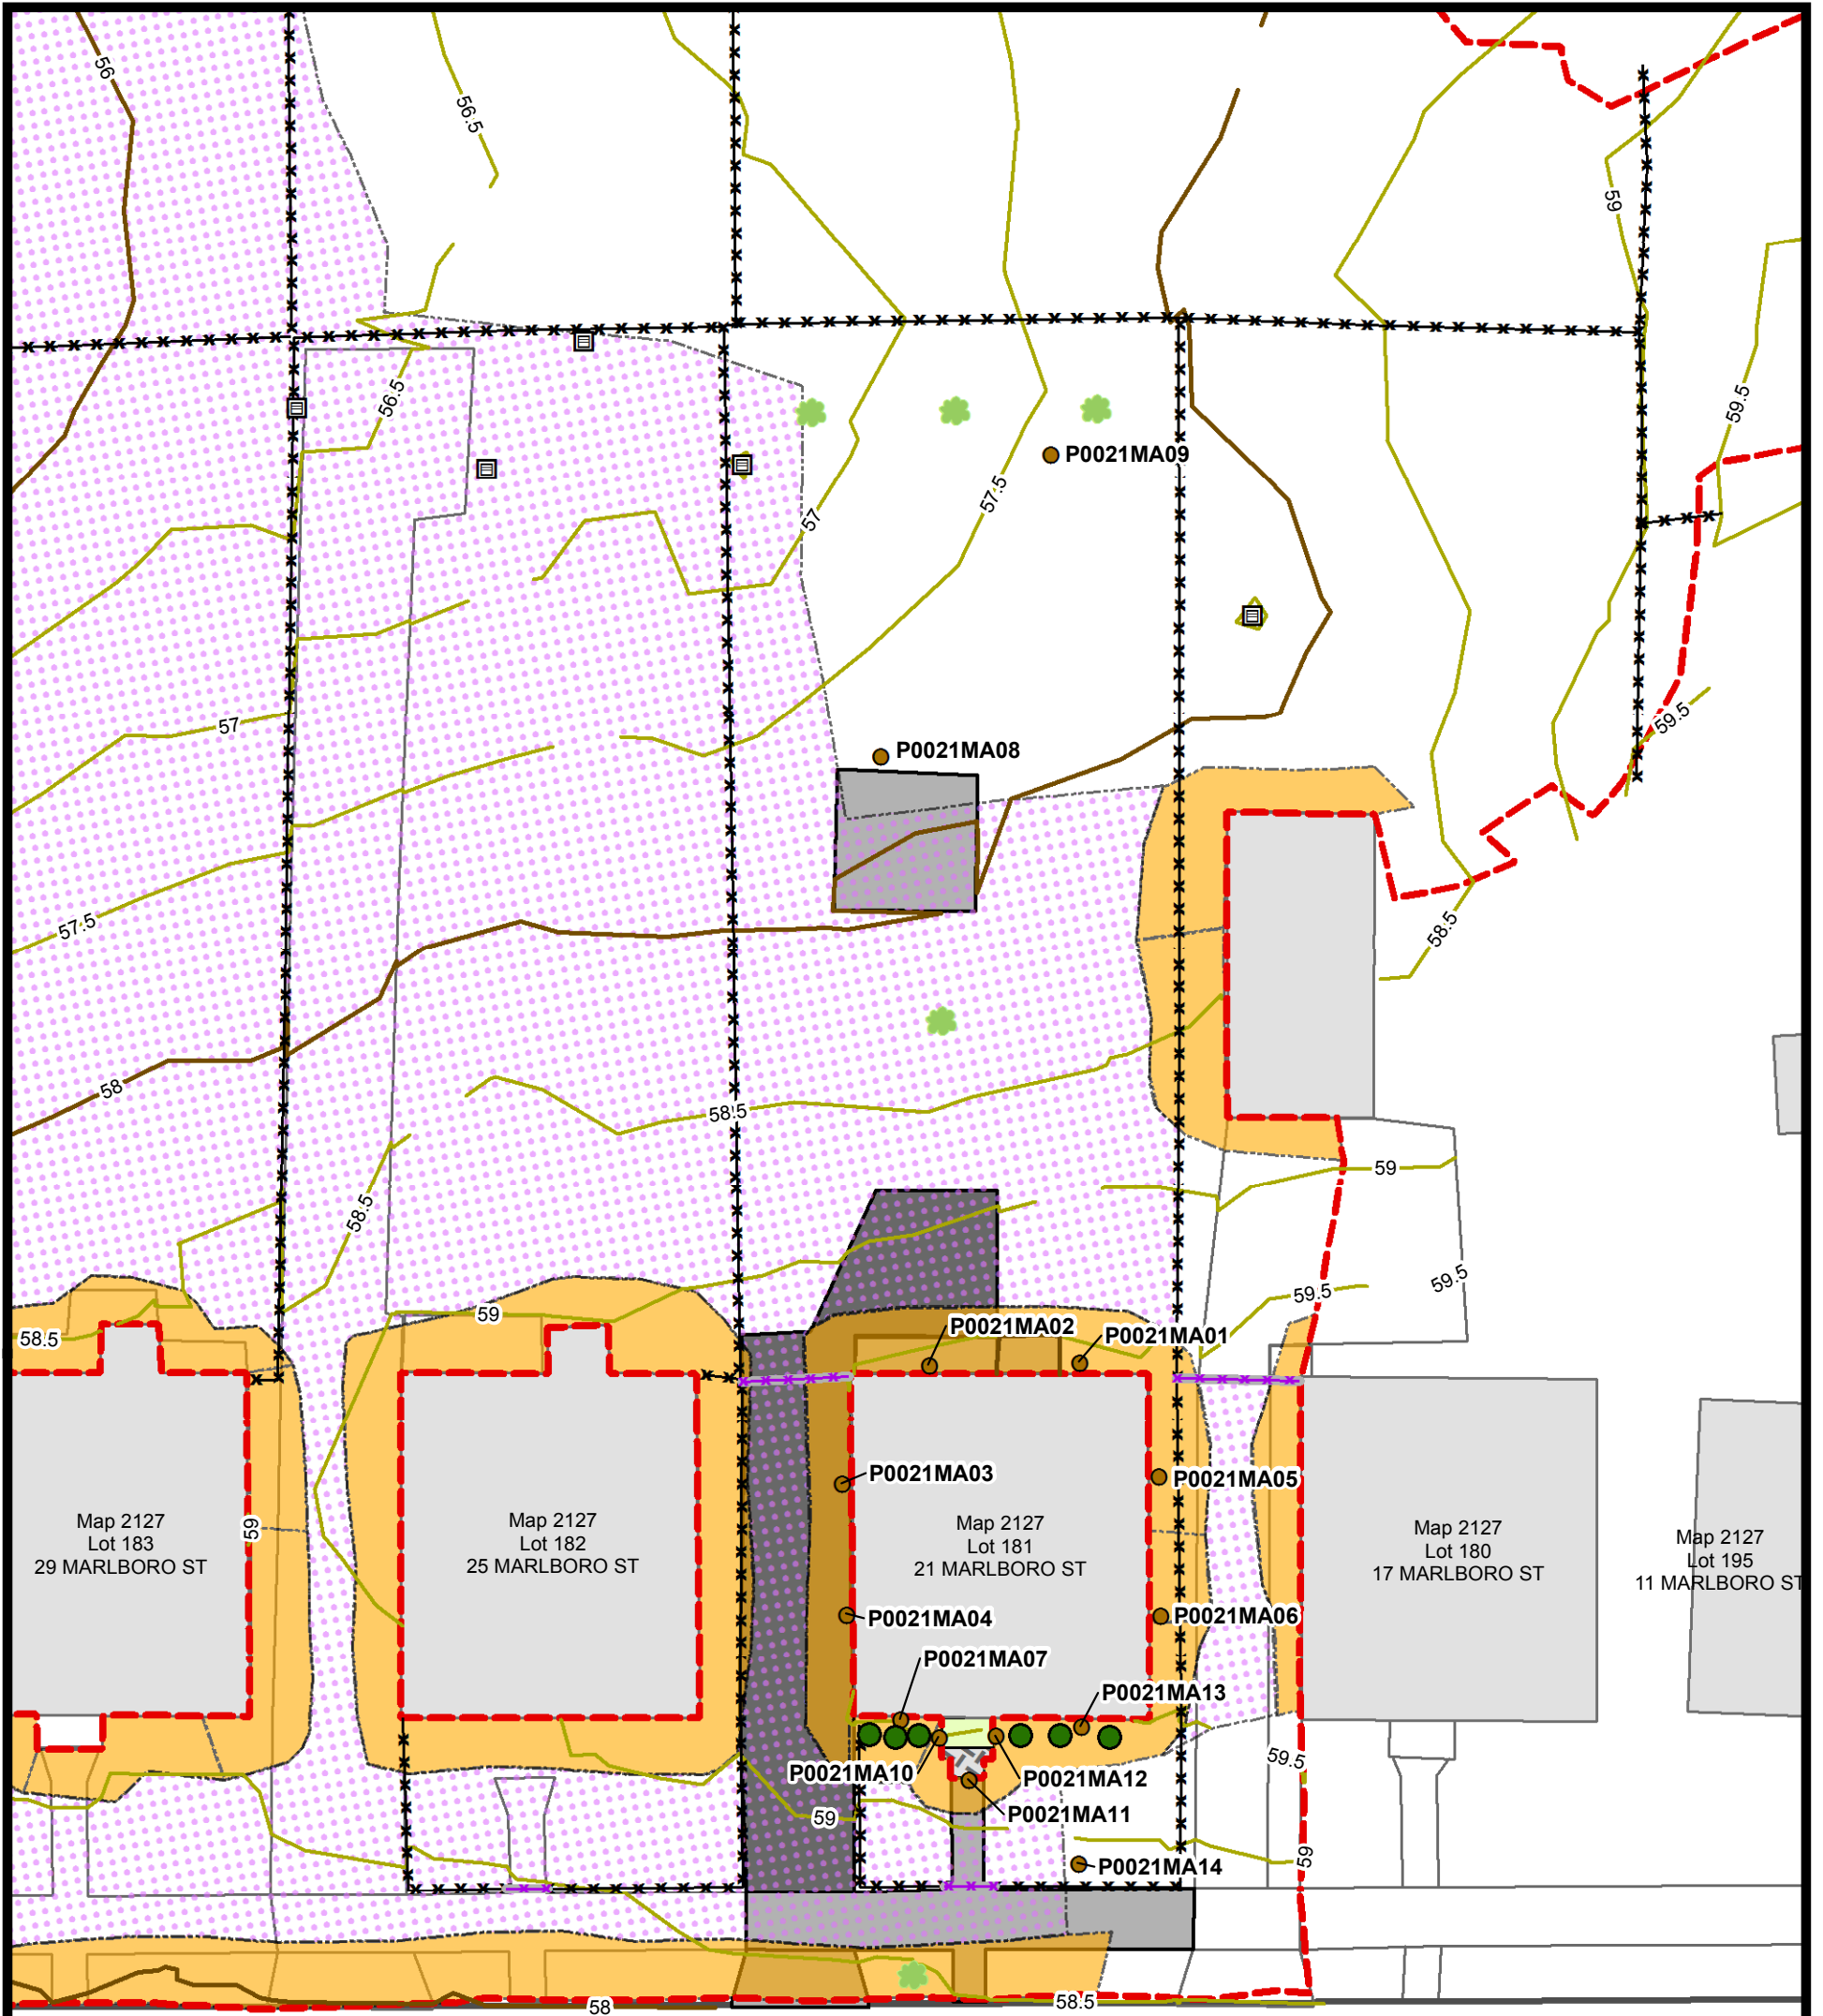
During the 2012 construction season, Olin completed the excavation, backfill, and restoration of the property in accordance with the Final Design - Generic RAP and the Property-Specific RAP. Figure 2-1 shows the areas where excavation occurred on the property and the locations of excavation confirmation samples. Excavation confirmation samples were collected in accordance with Section 3.2.3 - Confirmatory Sampling of the Final Design - Generic RAP, including adherence to the sampling frequency requirements. X-ray fluorescence (XRF) excavation confirmation sampling results are presented in Table 2-1.

- In some locations on the property, fill material was present at depths greater than 4 feet below ground surface (bgs). This fill material was left in place, covered by an orange geotextile fabric, and backfilled with clean soil in accordance with the Final Design - Generic RAP. Figure 2-1 shows the approximate area of geotextile fabric identifying the presence of fill at a depth greater than 4 feet bgs.

- In some locations, it was necessary to leave fill material in place at depths less than 4 feet bgs in order to avoid jeopardizing the integrity of a structure. This fill material was left in place, covered by an orange geotextile fabric and/or concrete, and backfilled with clean soil in accordance with the Final Design - Generic RAP. Figure 2-1 shows the approximate area of geotextile fabric/concrete identifying the presence of fill at a depth less than 4 feet bgs.

- As part of efforts to improve drainage following excavation and backfill activities, a drywell was installed in a low-lying portion of the yard. The location of this feature is shown on Figure 2-1.

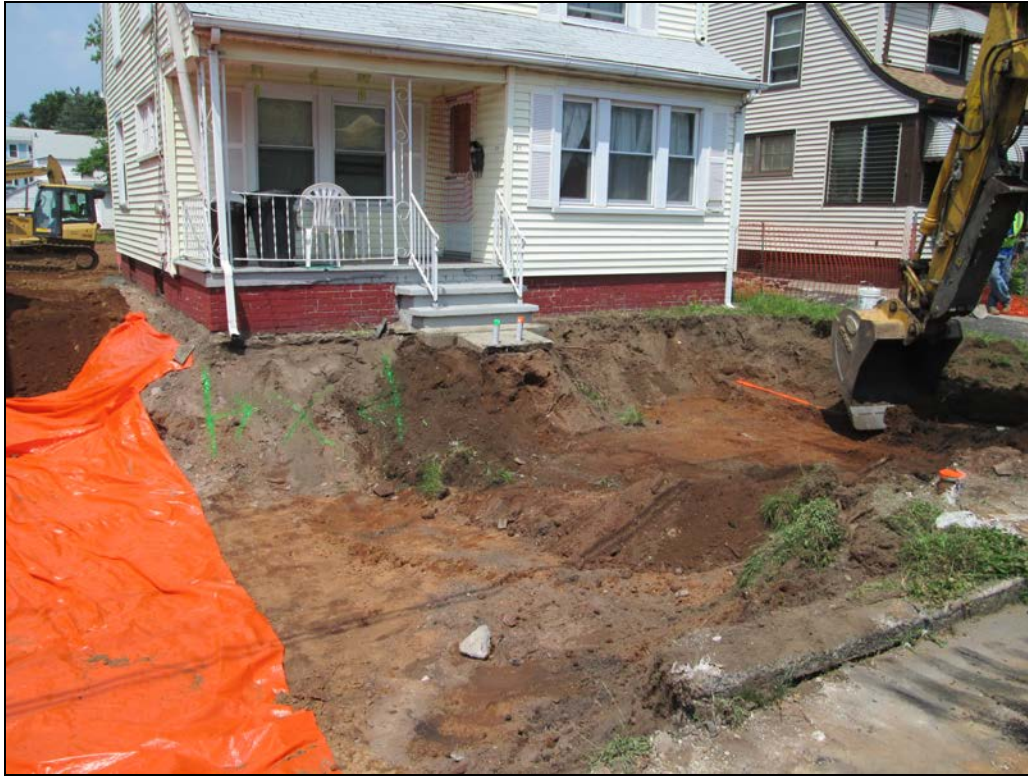
View looking north at excavated front yard prior to placement of marker barrier.

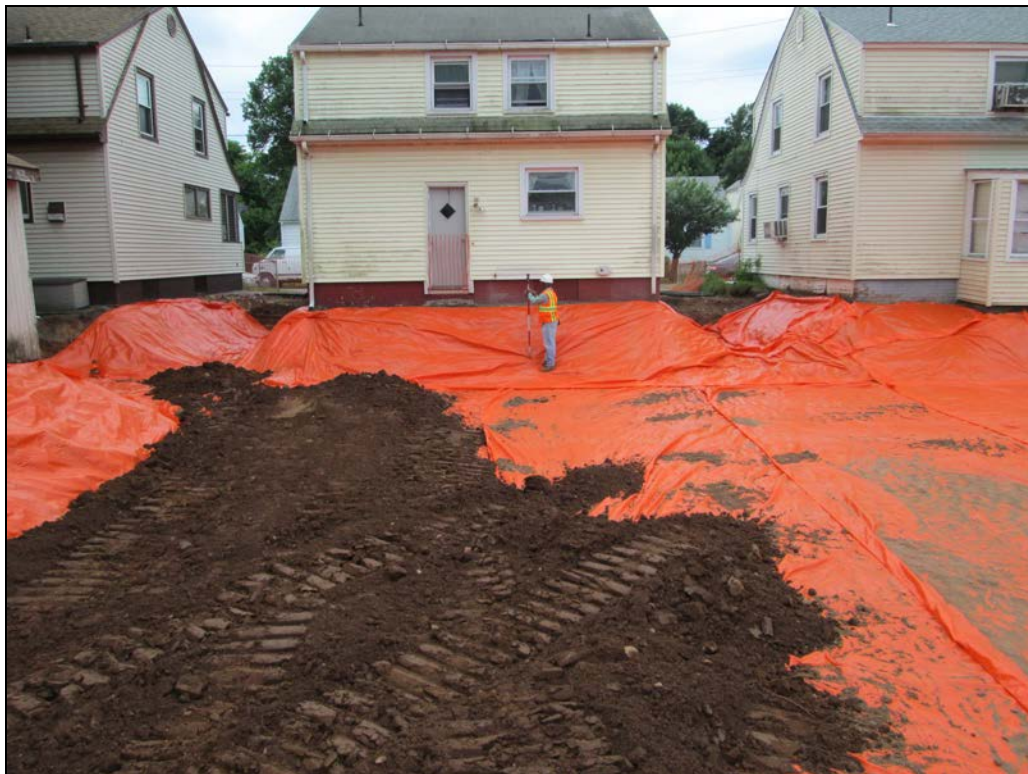
View looking south at partially backfilled yard with marker barrier covering fill left in place.

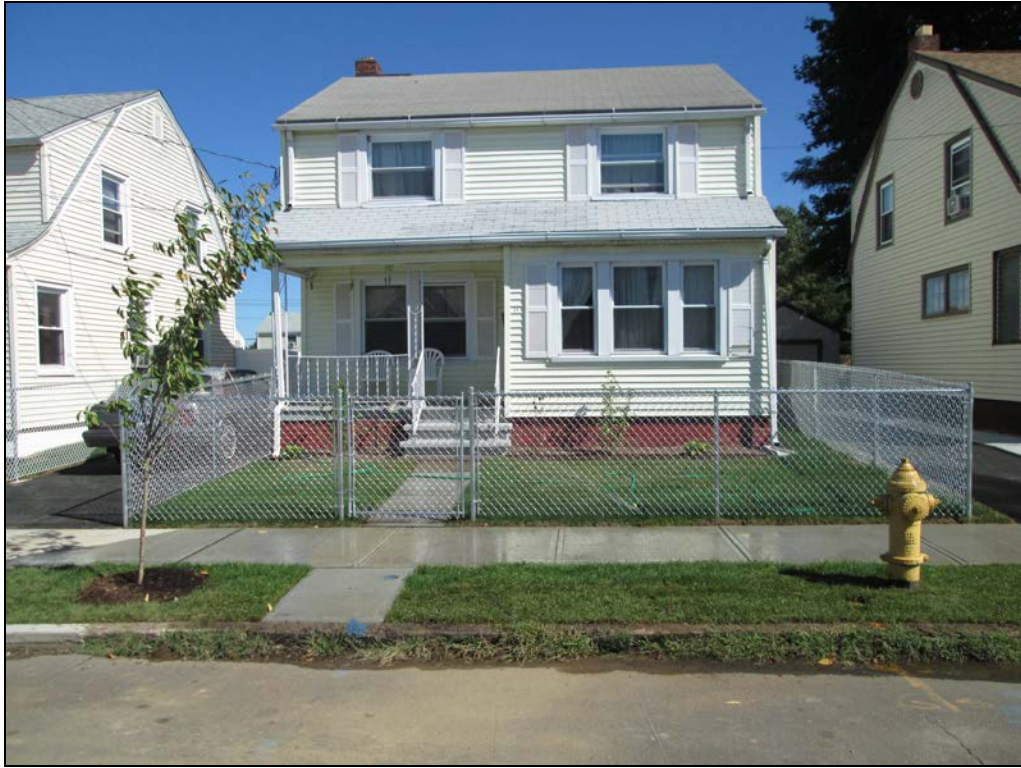
View looking north at restored front yard.

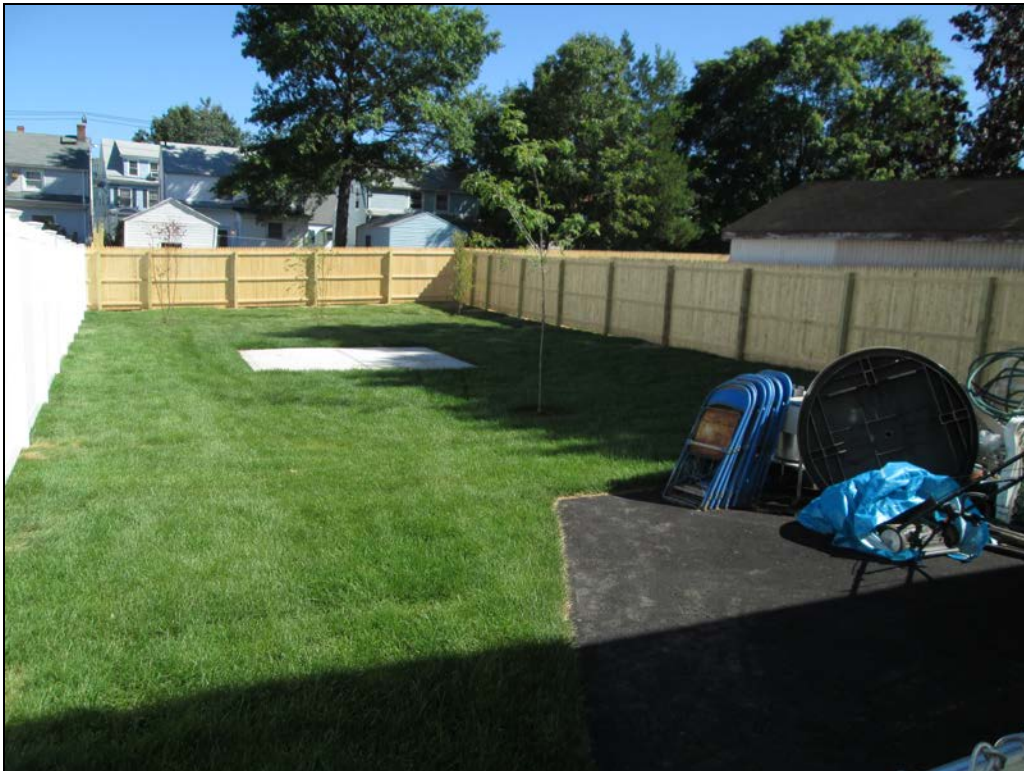
View looking north at restored back yard.

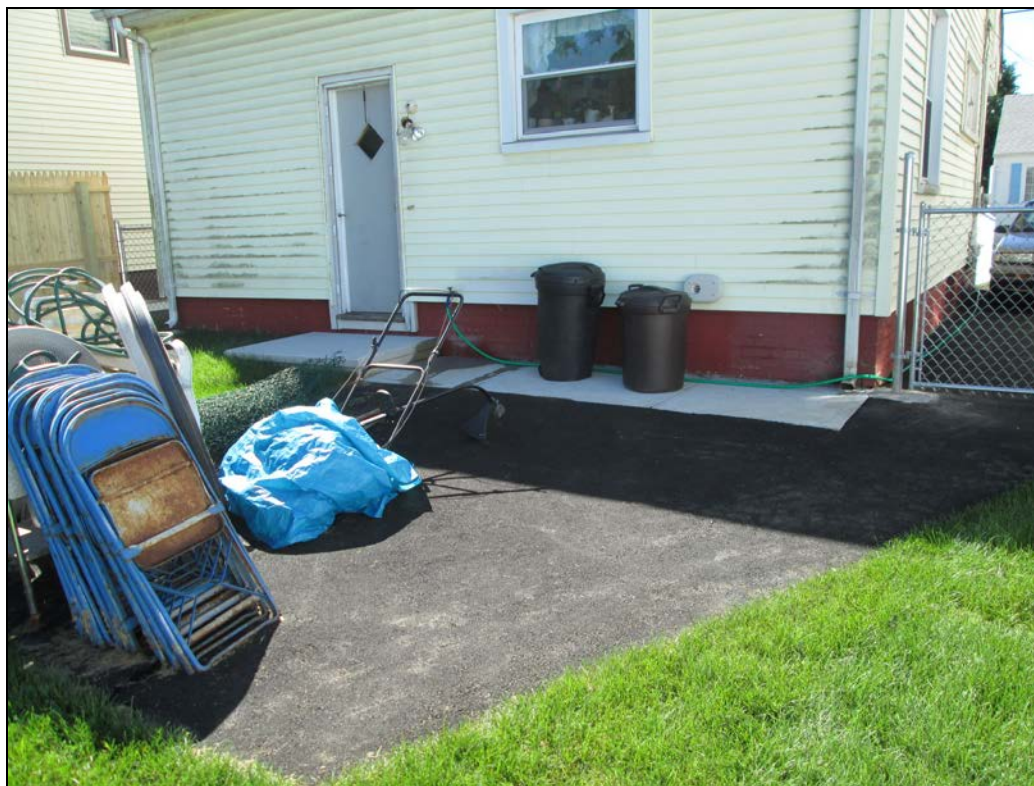
View looking southeast at restored back parking area.
