Re: Property-Specific Remedial Action Report
Newhall Street Neighborhood
230 Butler Street, Block L
Hamden, Connecticut 06517

**PROPERTY-SPECIFIC REMEDIAL ACTION REPORT
230 BUTLER STREET**

**NON-PUBLIC PROPERTIES
NEWHALL STREET NEIGHBORHOOD
HAMDEN, CONNECTICUT**

AMEC Project Number: 6107110004/125

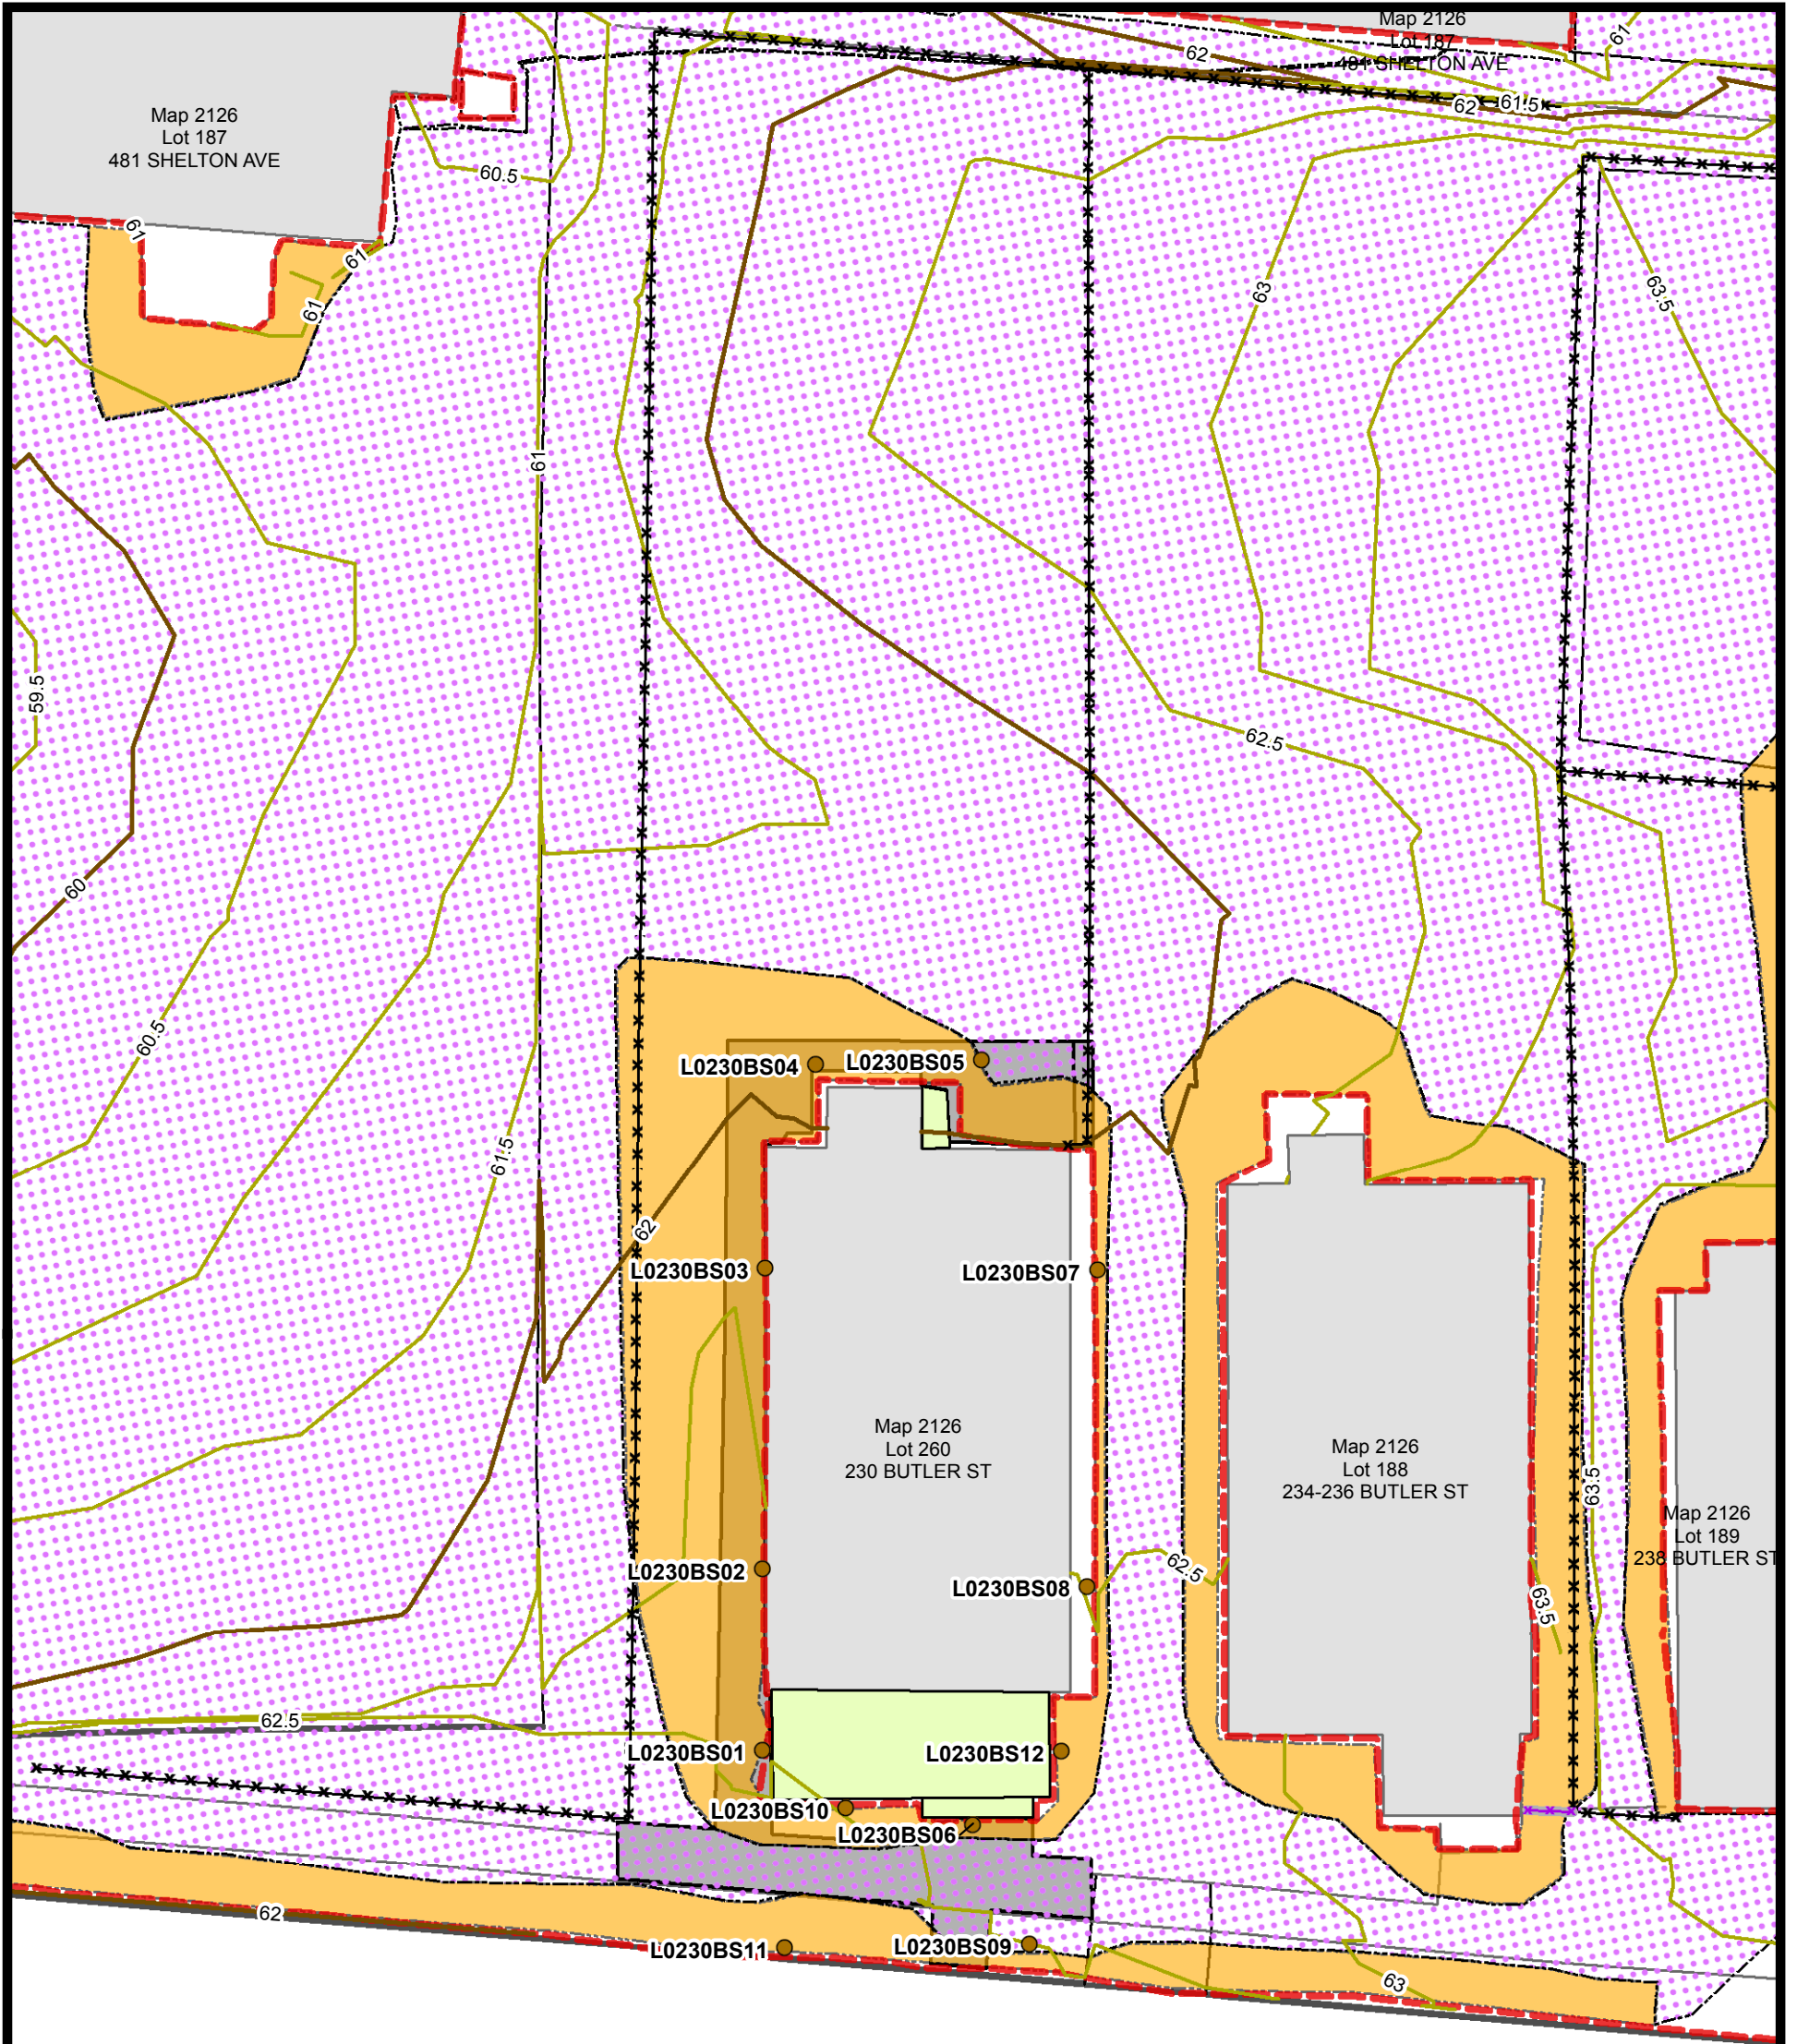
During the 2011 construction season, Olin completed the excavation, backfill, and restoration of the property in accordance with the Final Design - Generic RAP and the Property-Specific RAP. Figure 2-1 shows the areas where excavation occurred on the property and the locations of excavation confirmation samples. Excavation confirmation samples were collected in accordance with Section 3.2.3 - Confirmatory Sampling of the Final Design - Generic RAP, including adherence to the sampling frequency requirements. X-ray fluorescence (XRF) excavation confirmation sampling results are presented in Table 2-1.

- In some locations, fill material was encountered at greater than 4 feet in depth below ground surface (bgs). This fill material was left in place, covered by an orange geotextile fabric, and backfilled with clean soil in accordance with the Final Design - Generic RAP. Figure 2-1 shows the approximate area of geotextile fabric identifying the presence of fill at a depth greater than 4 feet bgs.
- In some locations, it was necessary to leave fill material in place at depths less than 4 feet bgs in order to avoid jeopardizing the integrity of a structure. This fill material was left in place, covered by a marker barrier (orange geotextile fabric and/or shotcrete), and backfilled with clean soil in accordance with the Final Design - Generic RAP. Figure 2-1 shows the approximate area of marker barrier identifying the presence of fill at a depth less than 4 feet bgs.

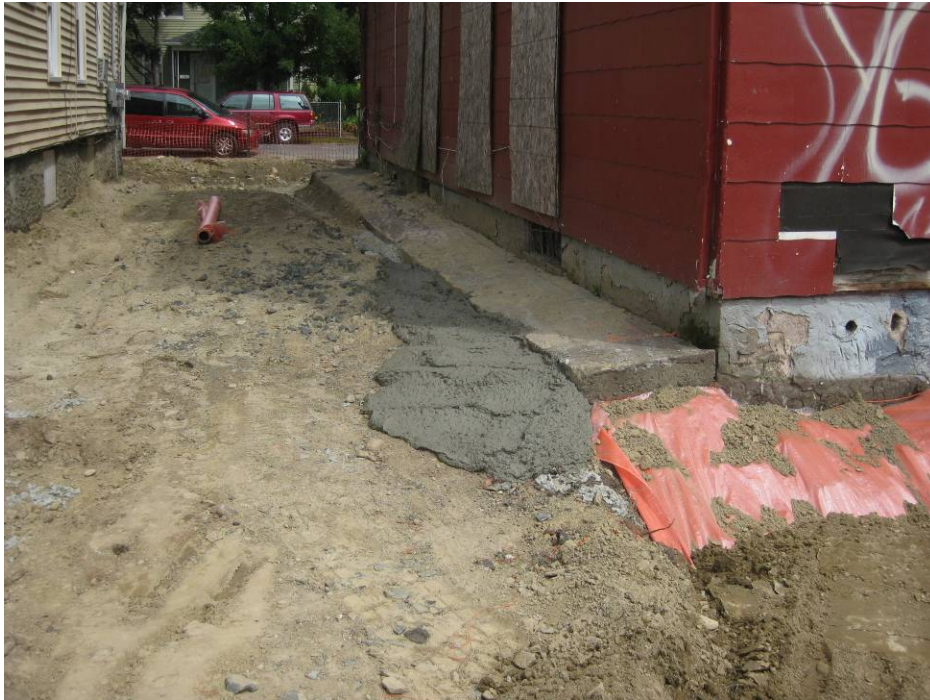
View looking East at backfilled side of house after placement of concrete and fabric

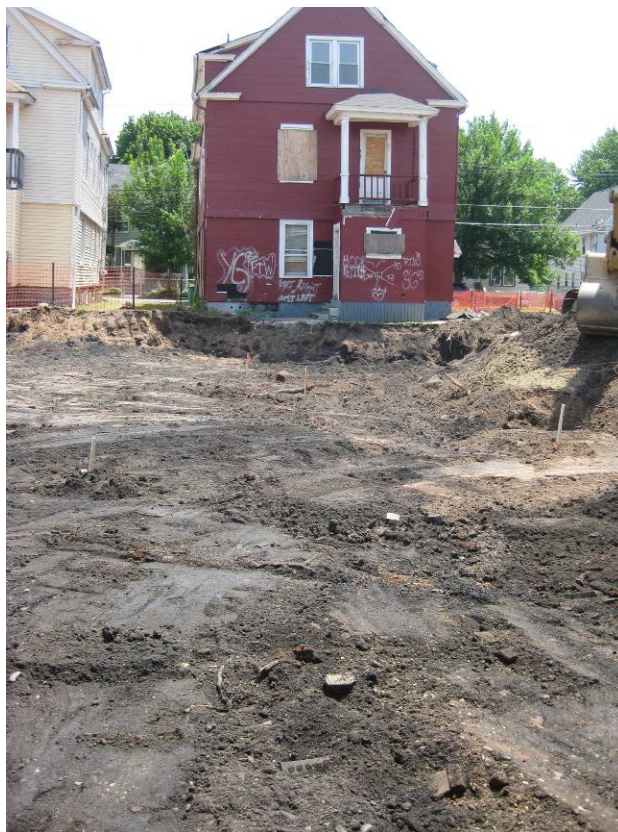
View looking East at at excavated back yard

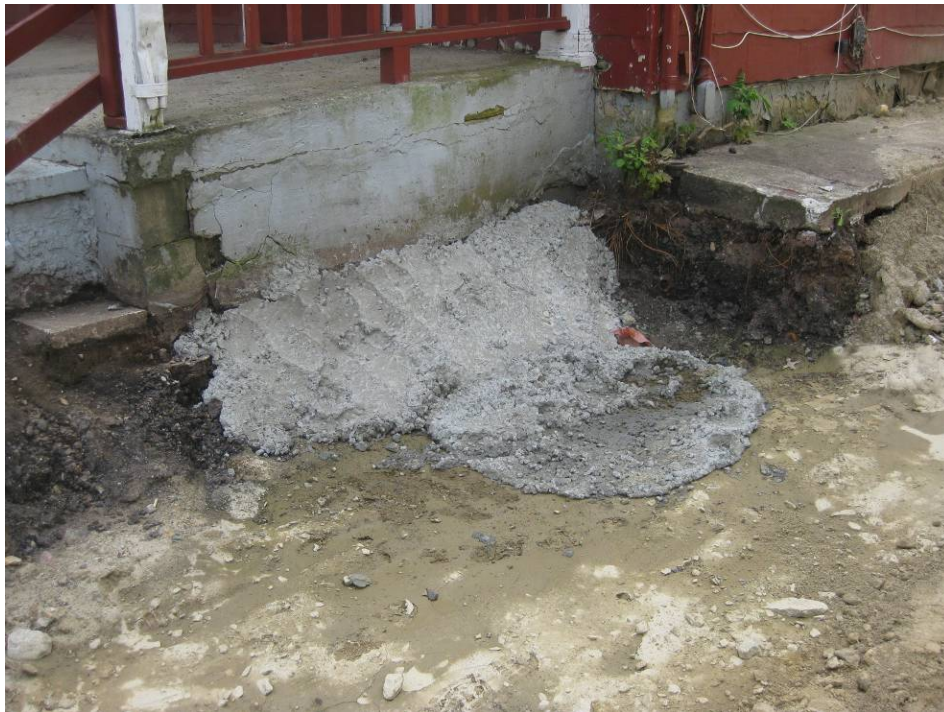
View looking Southwest at concrete along front porch

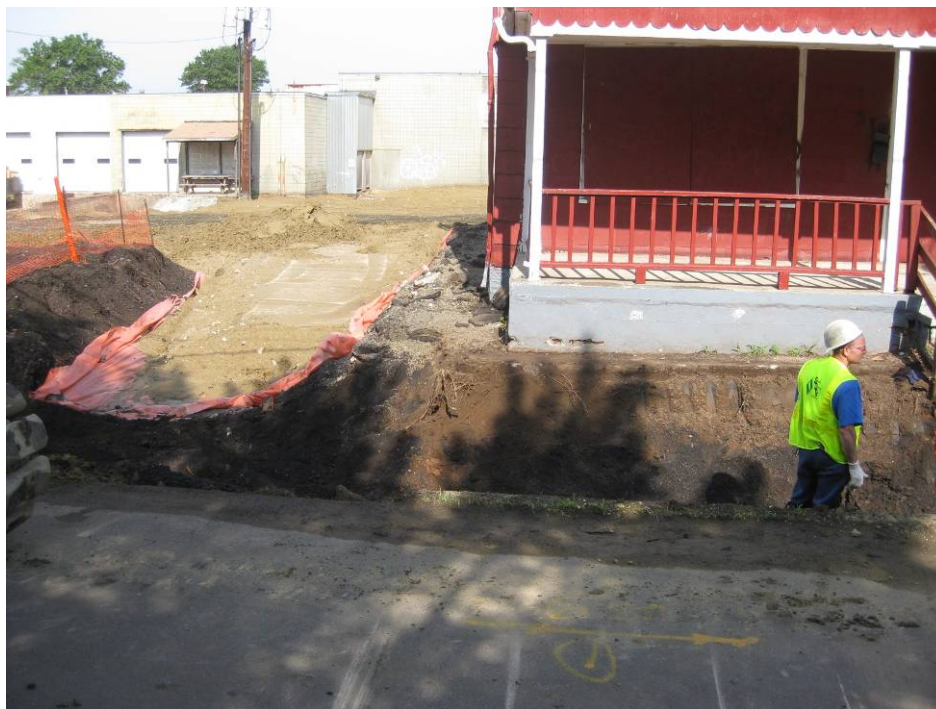
View looking West at excavated front yard

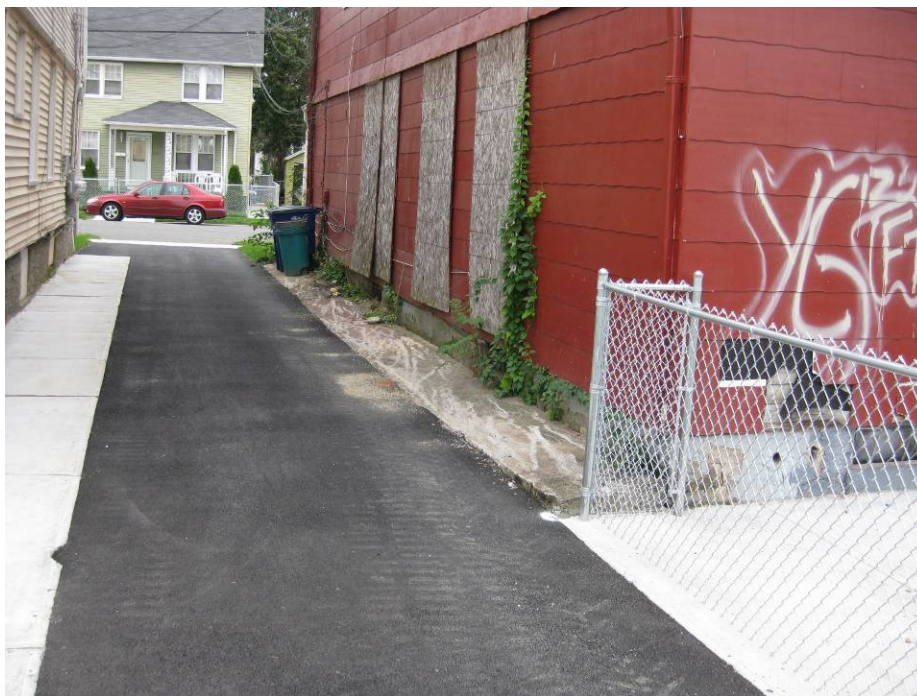
View looking East at restored driveway

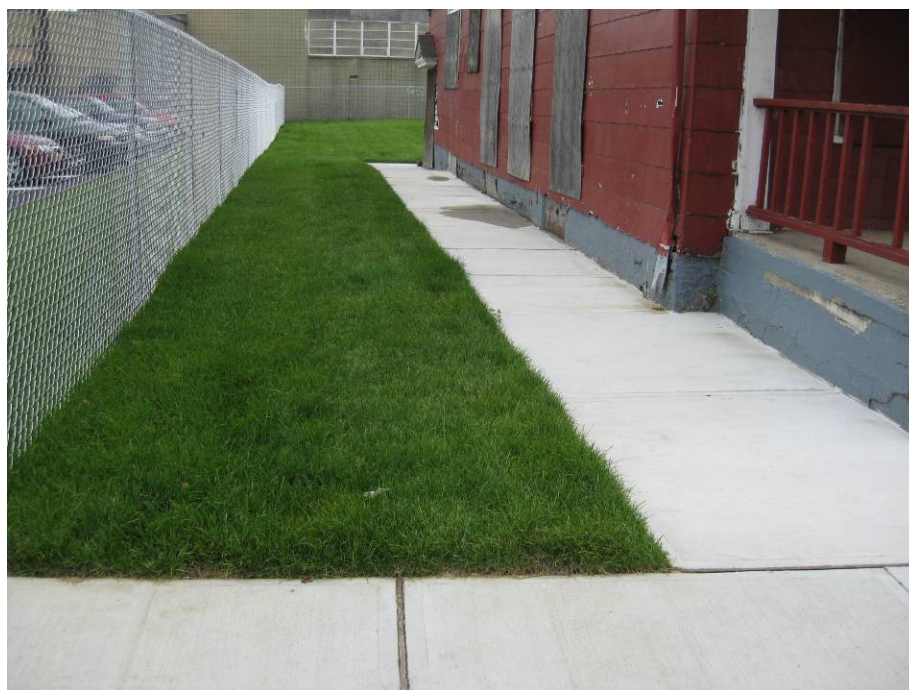
View looking West at restored side yard

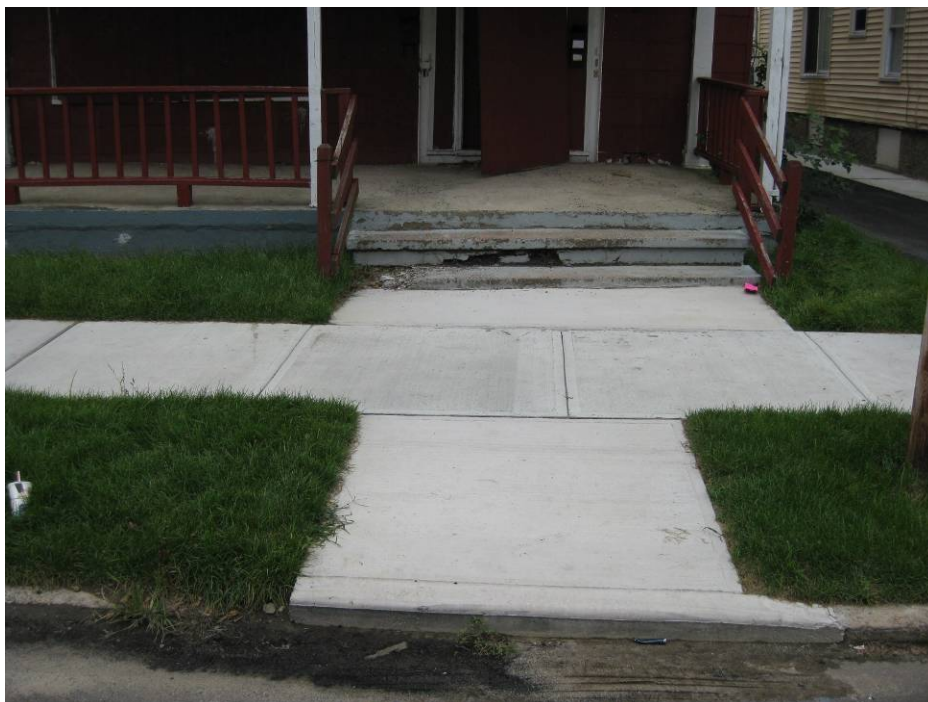
View looking West at restored front yard
