Re: Property-Specific Remedial Action Report
Newhall Street Neighborhood
308 Morse Street, Block H
Hamden, Connecticut 06517

**PROPERTY-SPECIFIC REMEDIAL ACTION REPORT
308 MORSE STREET**

**NON-PUBLIC PROPERTIES
NEWHALL STREET NEIGHBORHOOD
HAMDEN, CONNECTICUT**

AMEC Project Number: 6107110004/75

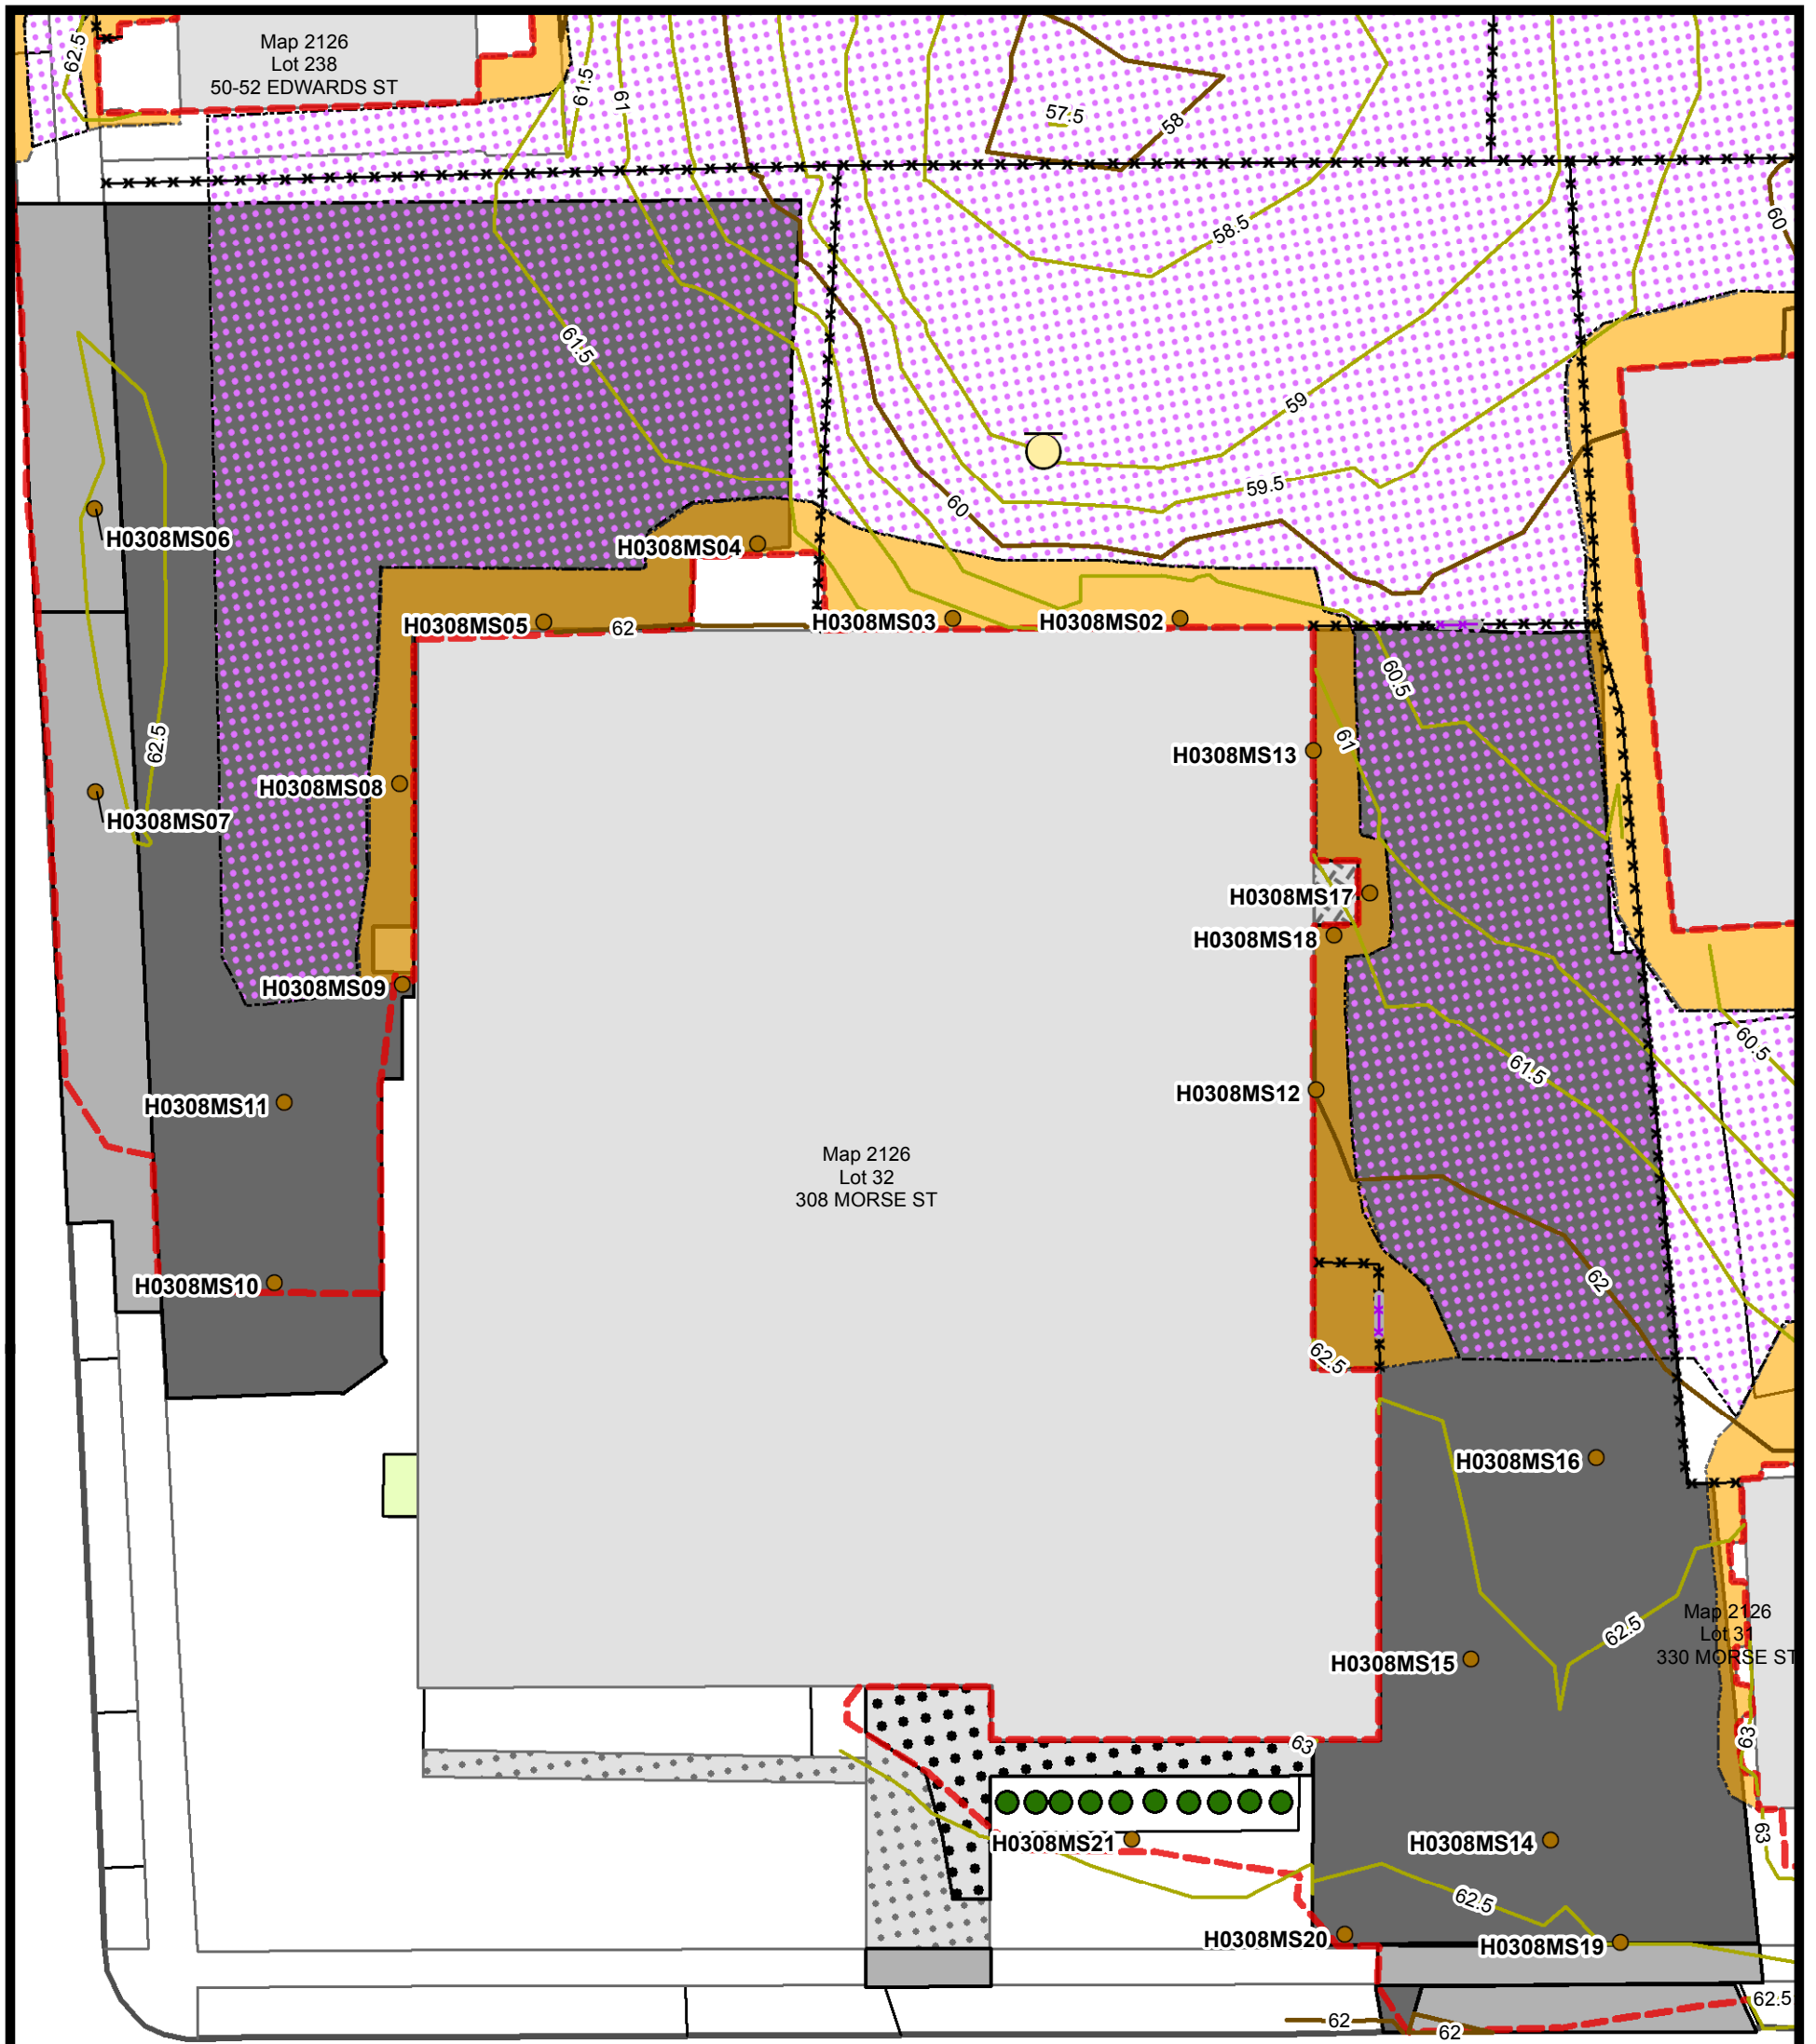
- In some locations, fill material was encountered at greater than 4 feet in depth below ground surface (bgs). This fill material was left in place, covered by an orange geotextile fabric, and backfilled with clean soil in accordance with the Final Design - Generic RAP. Figure 2-1 shows the approximate area of geotextile fabric identifying the presence of fill at a depth greater than 4 feet bgs.

- In some locations, it was necessary to leave fill material in place at depths less than 4 feet bgs in order to avoid jeopardizing the integrity of a structure. This fill material was left in place, covered by an orange geotextile fabric and/or shotcrete, and backfilled with clean soil in accordance with the Final Design - Generic RAP. Figure 2-1 shows the approximate area of geotextile fabric/shotcrete identifying the presence of fill at a depth less than 4 feet bgs.

During the 2011 construction season, Olin completed the excavation of fill material to a depth of 4 feet bgs, backfill, and restoration of the property in accordance with the Final Design - Generic RAP and the Property-Specific RAP. Figure 2-1 shows the areas where excavation occurred on the property and the locations of excavation confirmation samples. Excavation confirmation samples were collected in accordance with Section 3.2.3 - Confirmatory Sampling of the Final Design - Generic RAP, including adherence to the sampling frequency requirements. X-ray fluorescence (XRF) excavation confirmation sampling results are presented in Table 2-1.

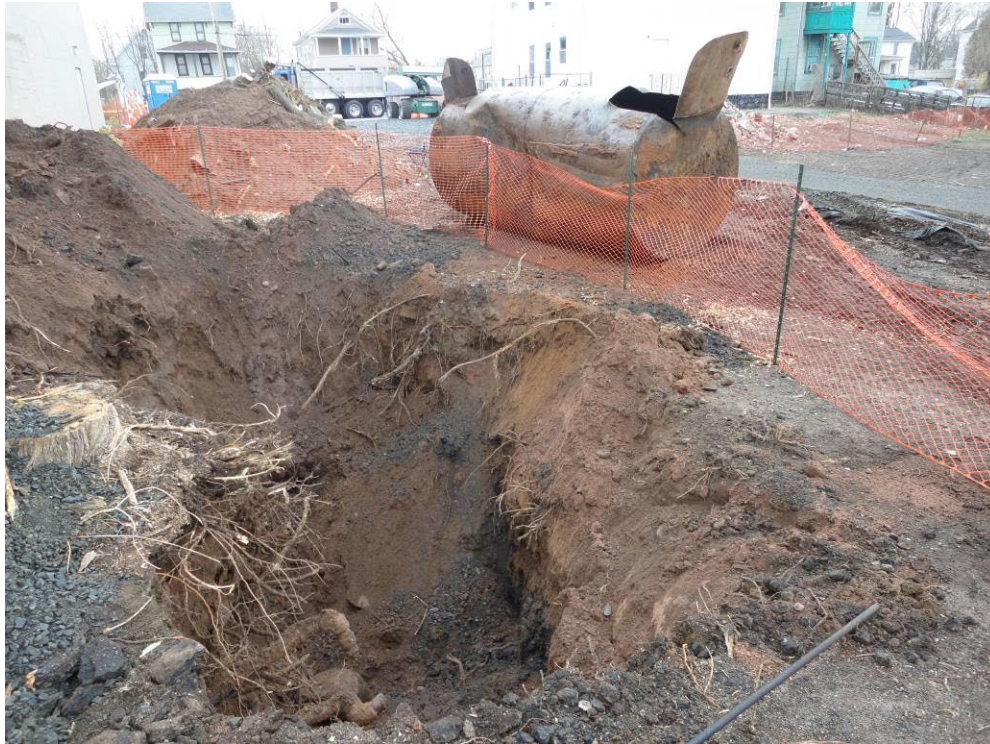
- An inactive fuel oil underground storage tank (UST) was identified in the excavation area. The property owner and the DEEP were informed and the UST was removed in accordance with the proper protocols and local approvals.

View looking East at inactive UST removed from south side of building

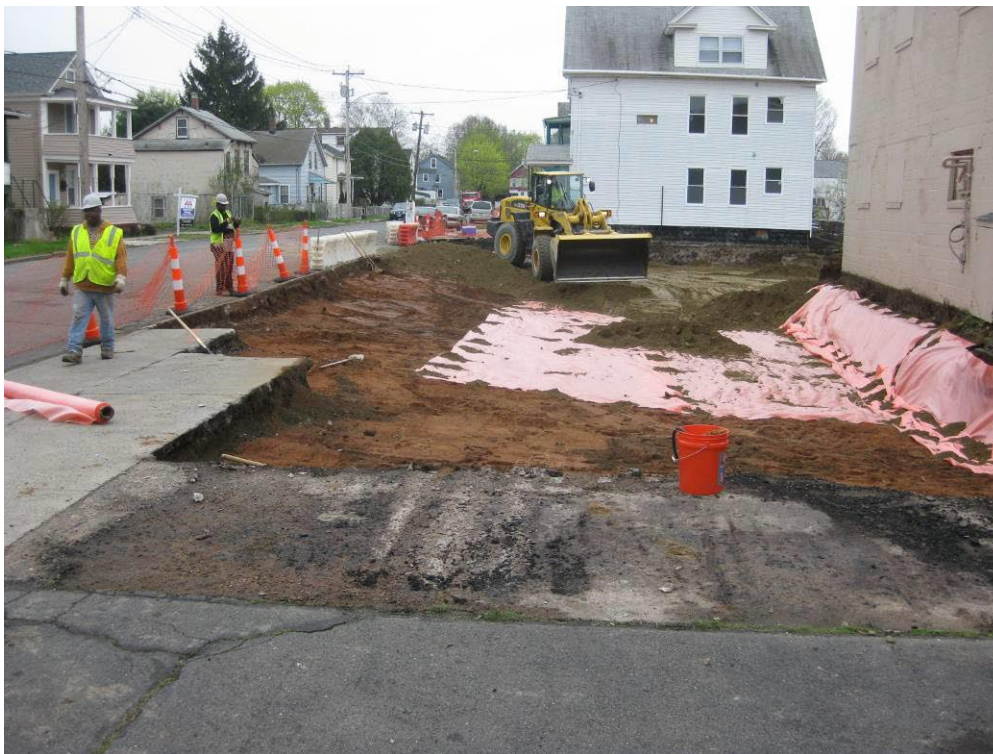
View looking North at excavated property following placement of marker barrier

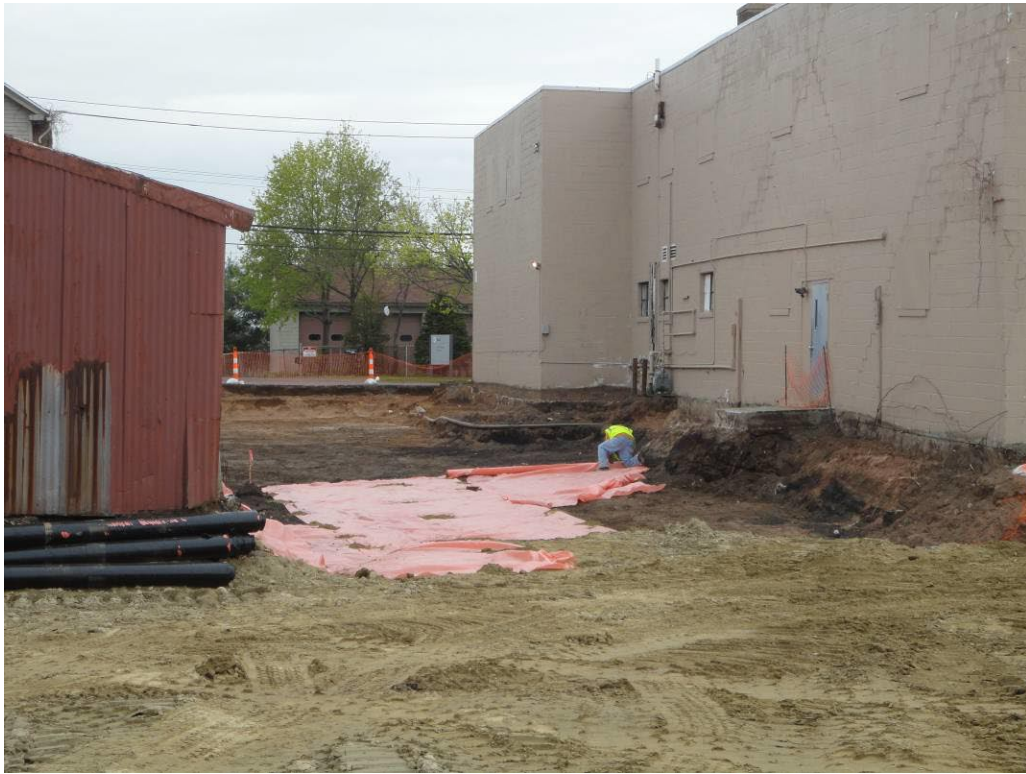
View looking West at partially backfilled area west of the building

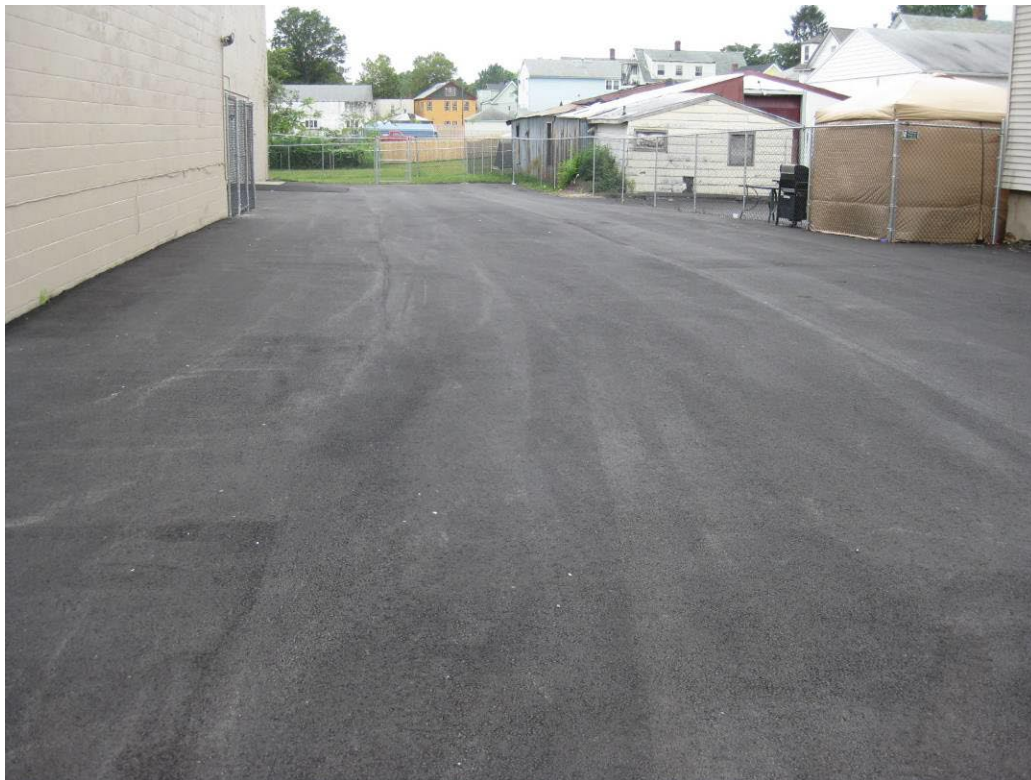
View looking North at restored parking area west of the building

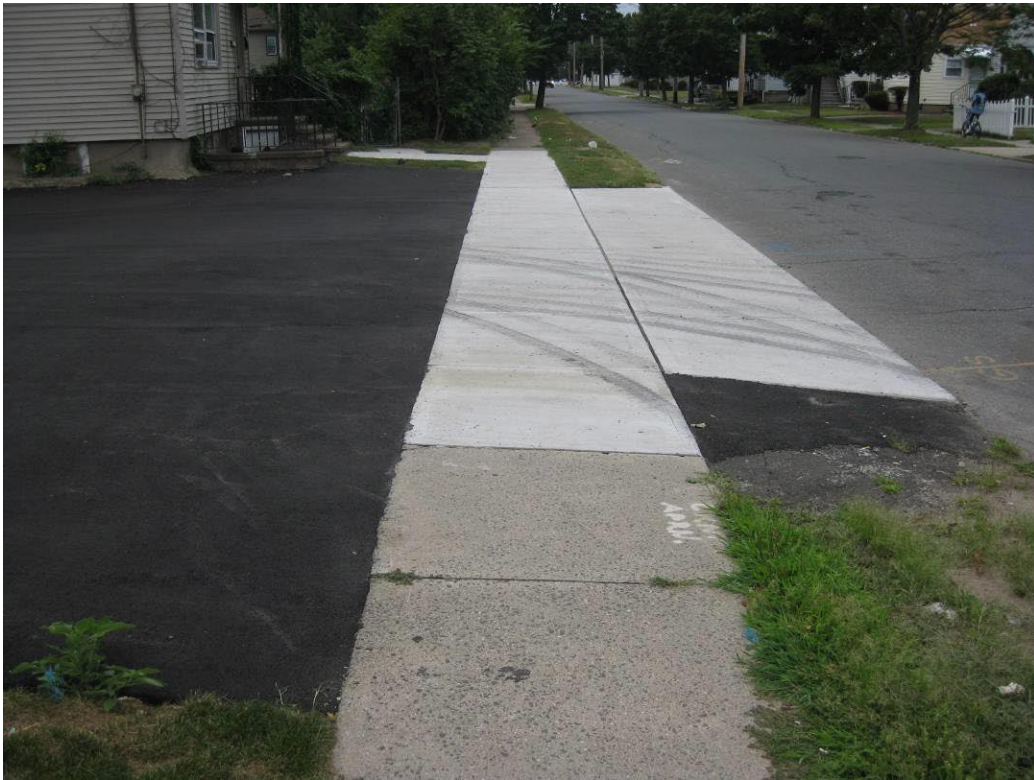
View looking South at restored driveway and sidewalk along Morse Street
