Re: Property-Specific Remedial Action Report  
Newhall Street Neighborhood  
339 Augur Street, Block T  
Hamden, Connecticut 06517

**PROPERTY-SPECIFIC REMEDIAL ACTION REPORT  
339 AUGUR STREET**

**NON-PUBLIC PROPERTIES  
NEWHALL STREET NEIGHBORHOOD  
HAMDEN, CONNECTICUT**

**AMEC Project Number: 6107120004.175**

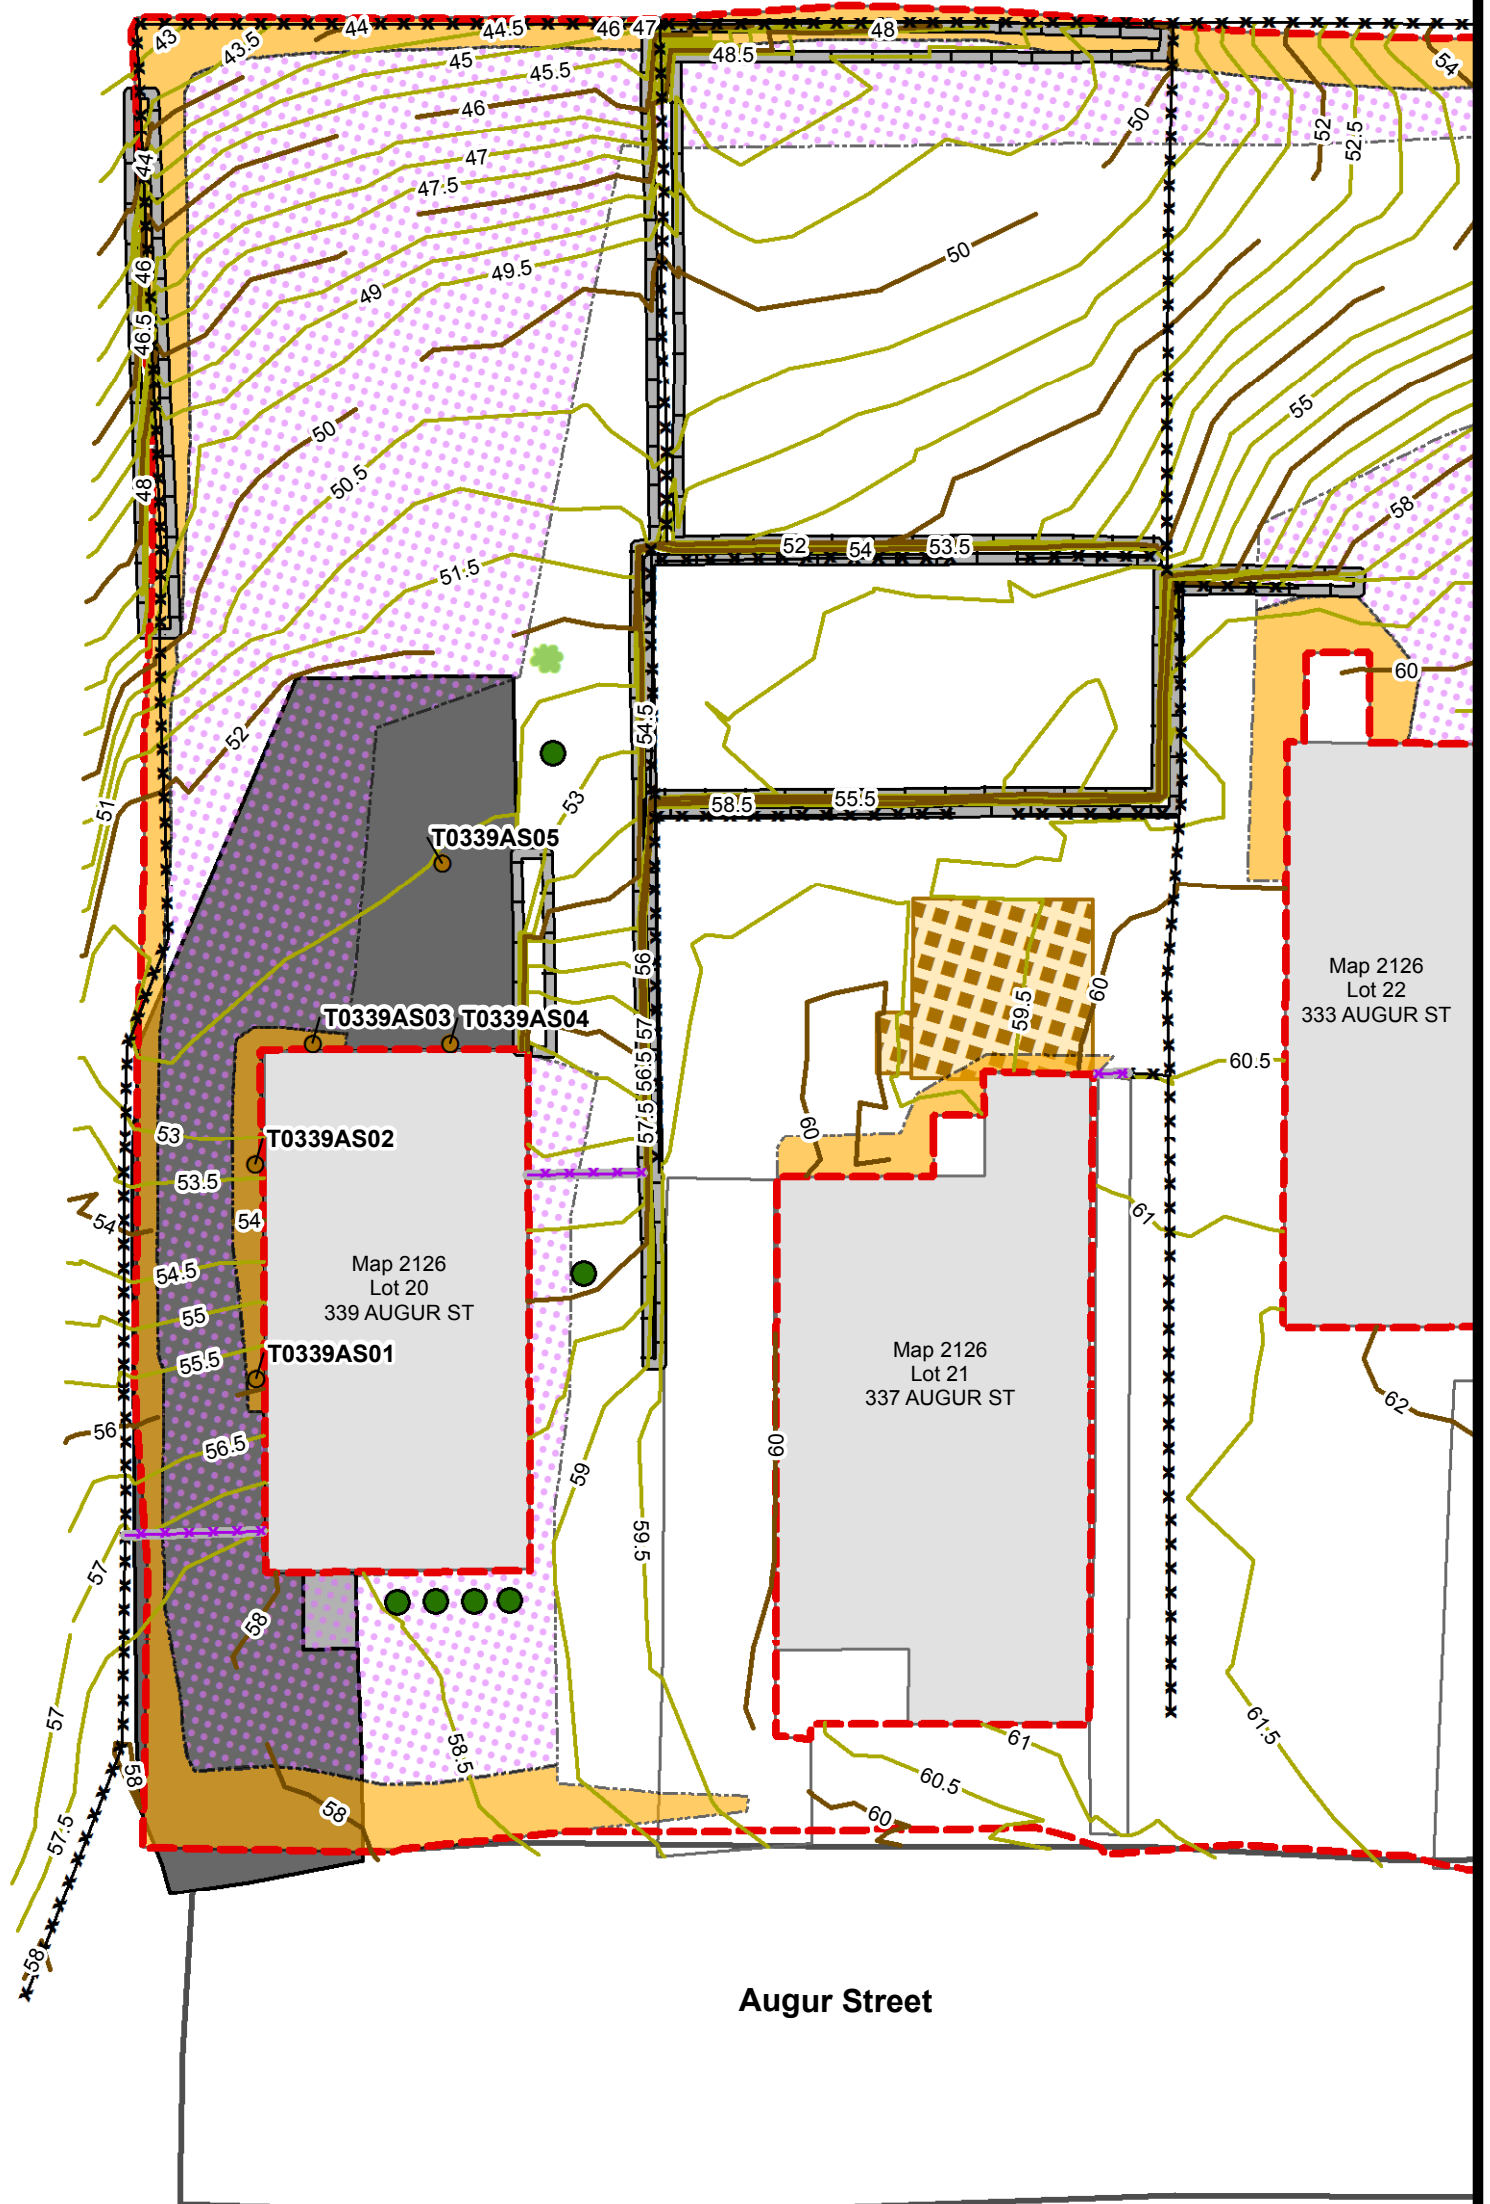
Figure 2-1 Post-Construction Conditions

During the 2012 construction season, Olin completed the excavation, backfill, and restoration of the property in accordance with the Final Design - Generic RAP and the Property-Specific RAP. Figure 2-1 shows the areas where excavation occurred on the property and the locations of excavation confirmation samples. Excavation confirmation samples were collected in accordance with Section 3.2.3 - Confirmatory Sampling of the Final Design - Generic RAP, including adherence to the sampling frequency requirements. X-ray fluorescence (XRF) excavation confirmation sampling results are presented in Table 2-1.

As indicated in Table 2-1, one of the samples collected from the perimeter of the excavated area indicated total lead concentrations that exceeded 400 mg/kg. Additional soil could not be removed from these locations, because continued excavation could jeopardize the integrity of a structure or undermine a feature that was to be left in place.

- In some locations on the property, fill material was present at depths greater than 4 feet below ground surface (bgs). This fill material was left in place, covered by an orange geotextile fabric, and backfilled with clean soil in accordance with the Final Design - Generic RAP. Figure 2-1 shows the approximate area of geotextile fabric identifying the presence of fill at a depth greater than 4 feet bgs.
- In some locations, it was necessary to leave fill material in place at depths less than 4 feet bgs in order to avoid jeopardizing the integrity of a structure. This fill material was left in place, covered by an orange geotextile fabric and/or concrete, and backfilled with clean soil in accordance with the Final Design - Generic RAP. Figure 2-1 shows the approximate area of geotextile fabric/concrete identifying the presence of fill at a depth less than 4 feet bgs.

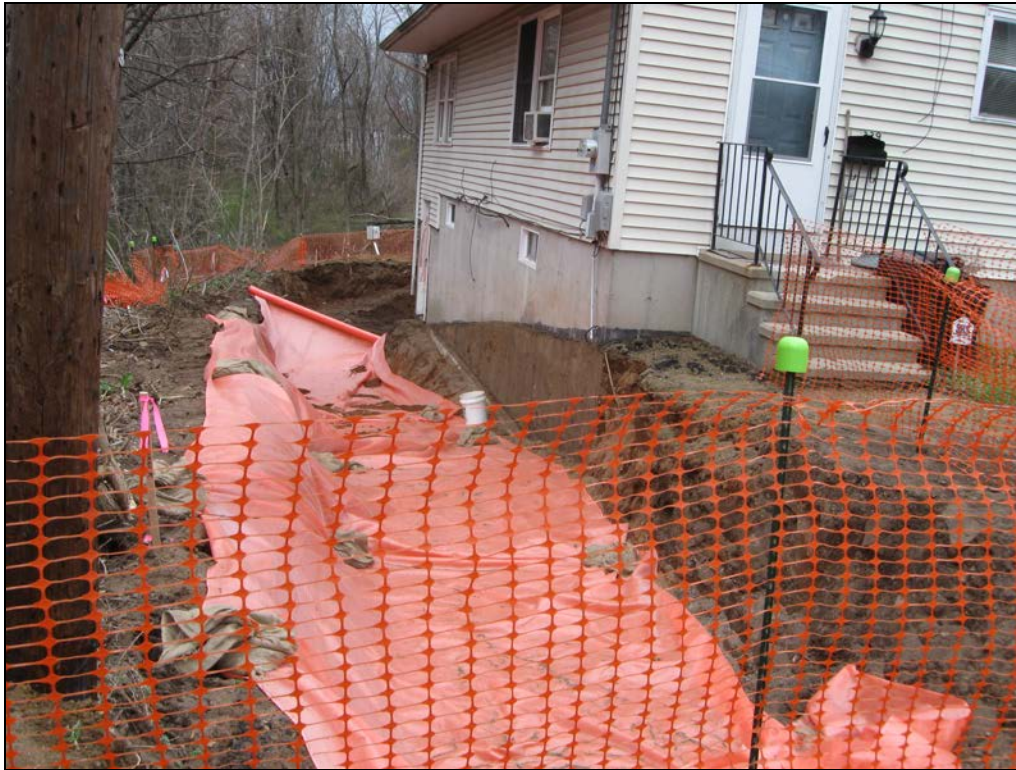
**View looking north at excavation of driveway following placement of marker barrier.**

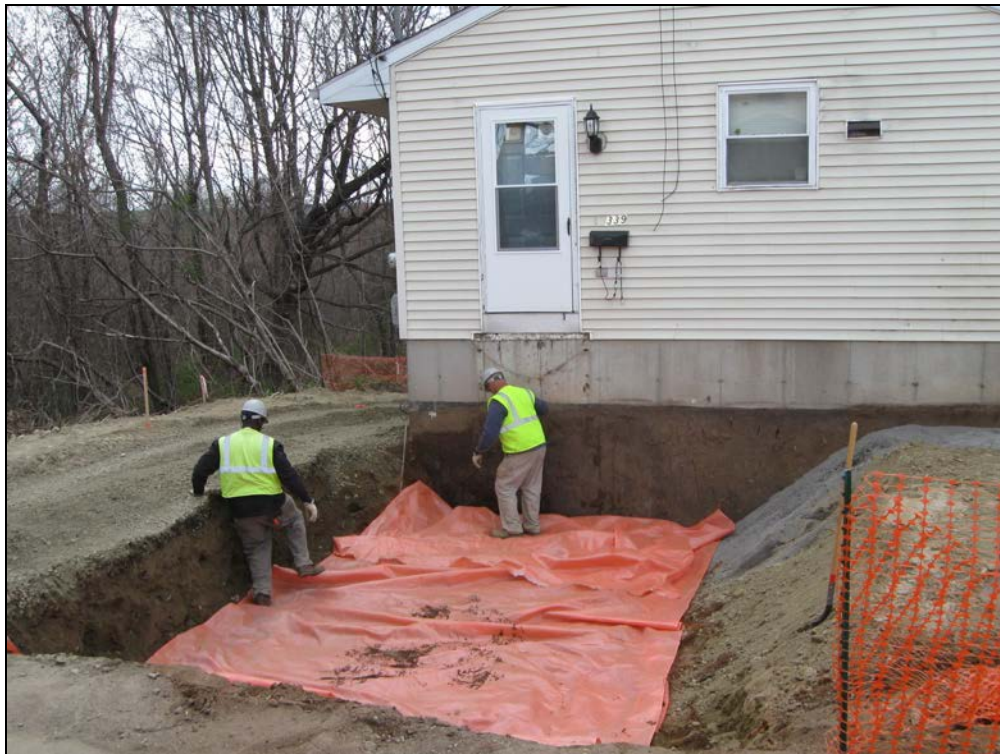
**View looking north at excavated front yard with marker barrier being installed.**

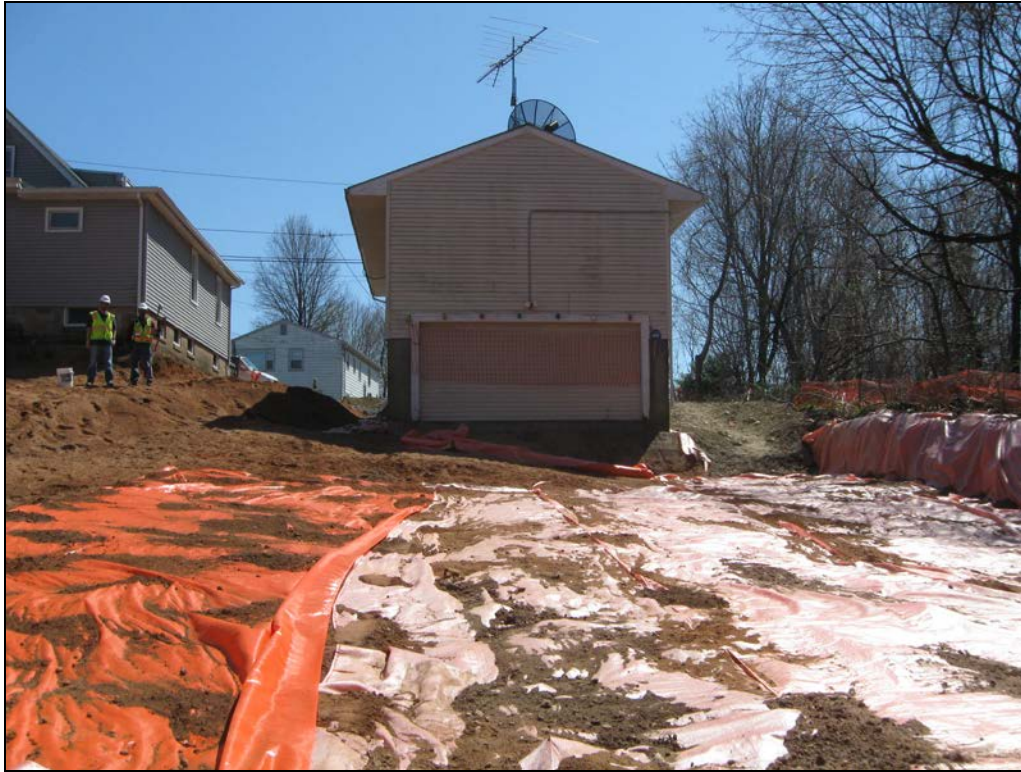
**View looking south at marker barrier at the base of excavation.**

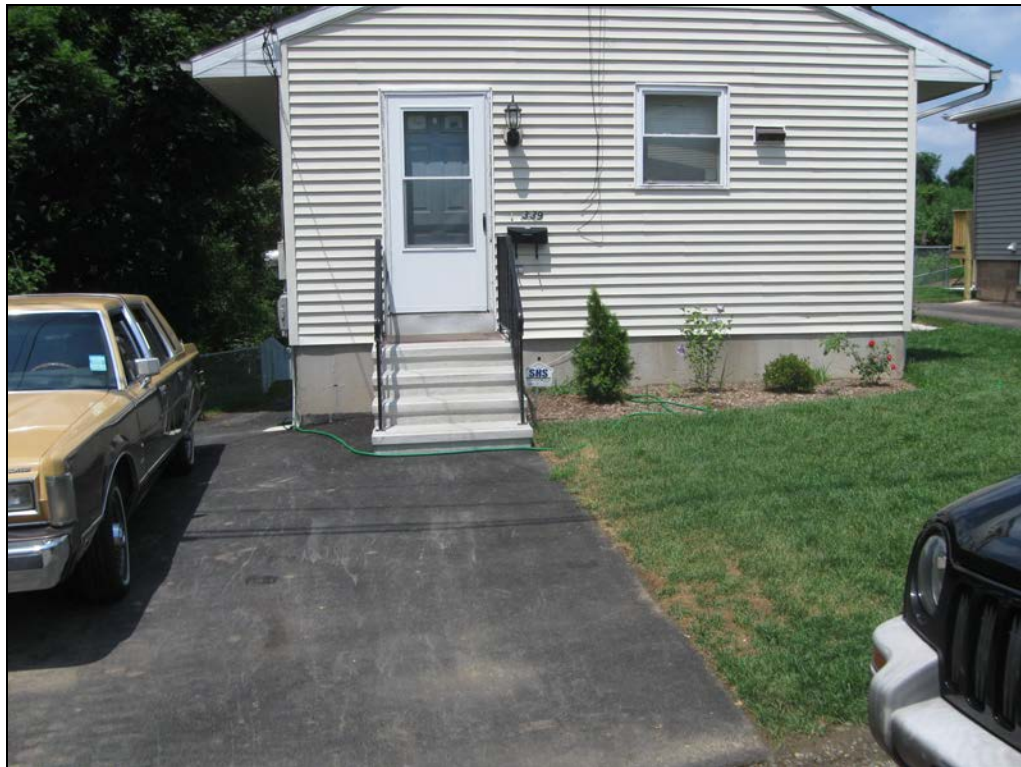
**View looking north at restored front yard.**

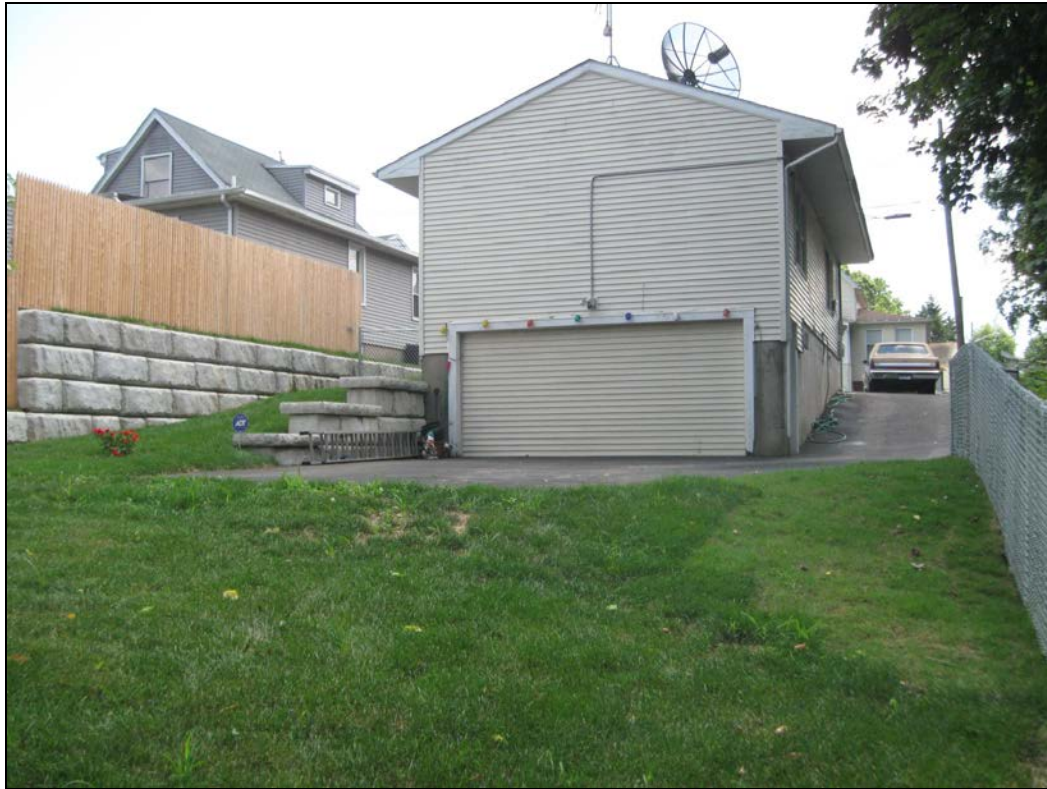
**View looking south at restored back yard.**
