Re: Property-Specific Remedial Action Report
Newhall Street Neighborhood
39 Saint Mary Street, Block H
Hamden, Connecticut 06517

**PROPERTY-SPECIFIC REMEDIAL ACTION REPORT
39 SAINT MARY STREET**

**NON-PUBLIC PROPERTIES
NEWHALL STREET NEIGHBORHOOD
HAMDEN, CONNECTICUT**

AMEC Project Number: 6107110004/75

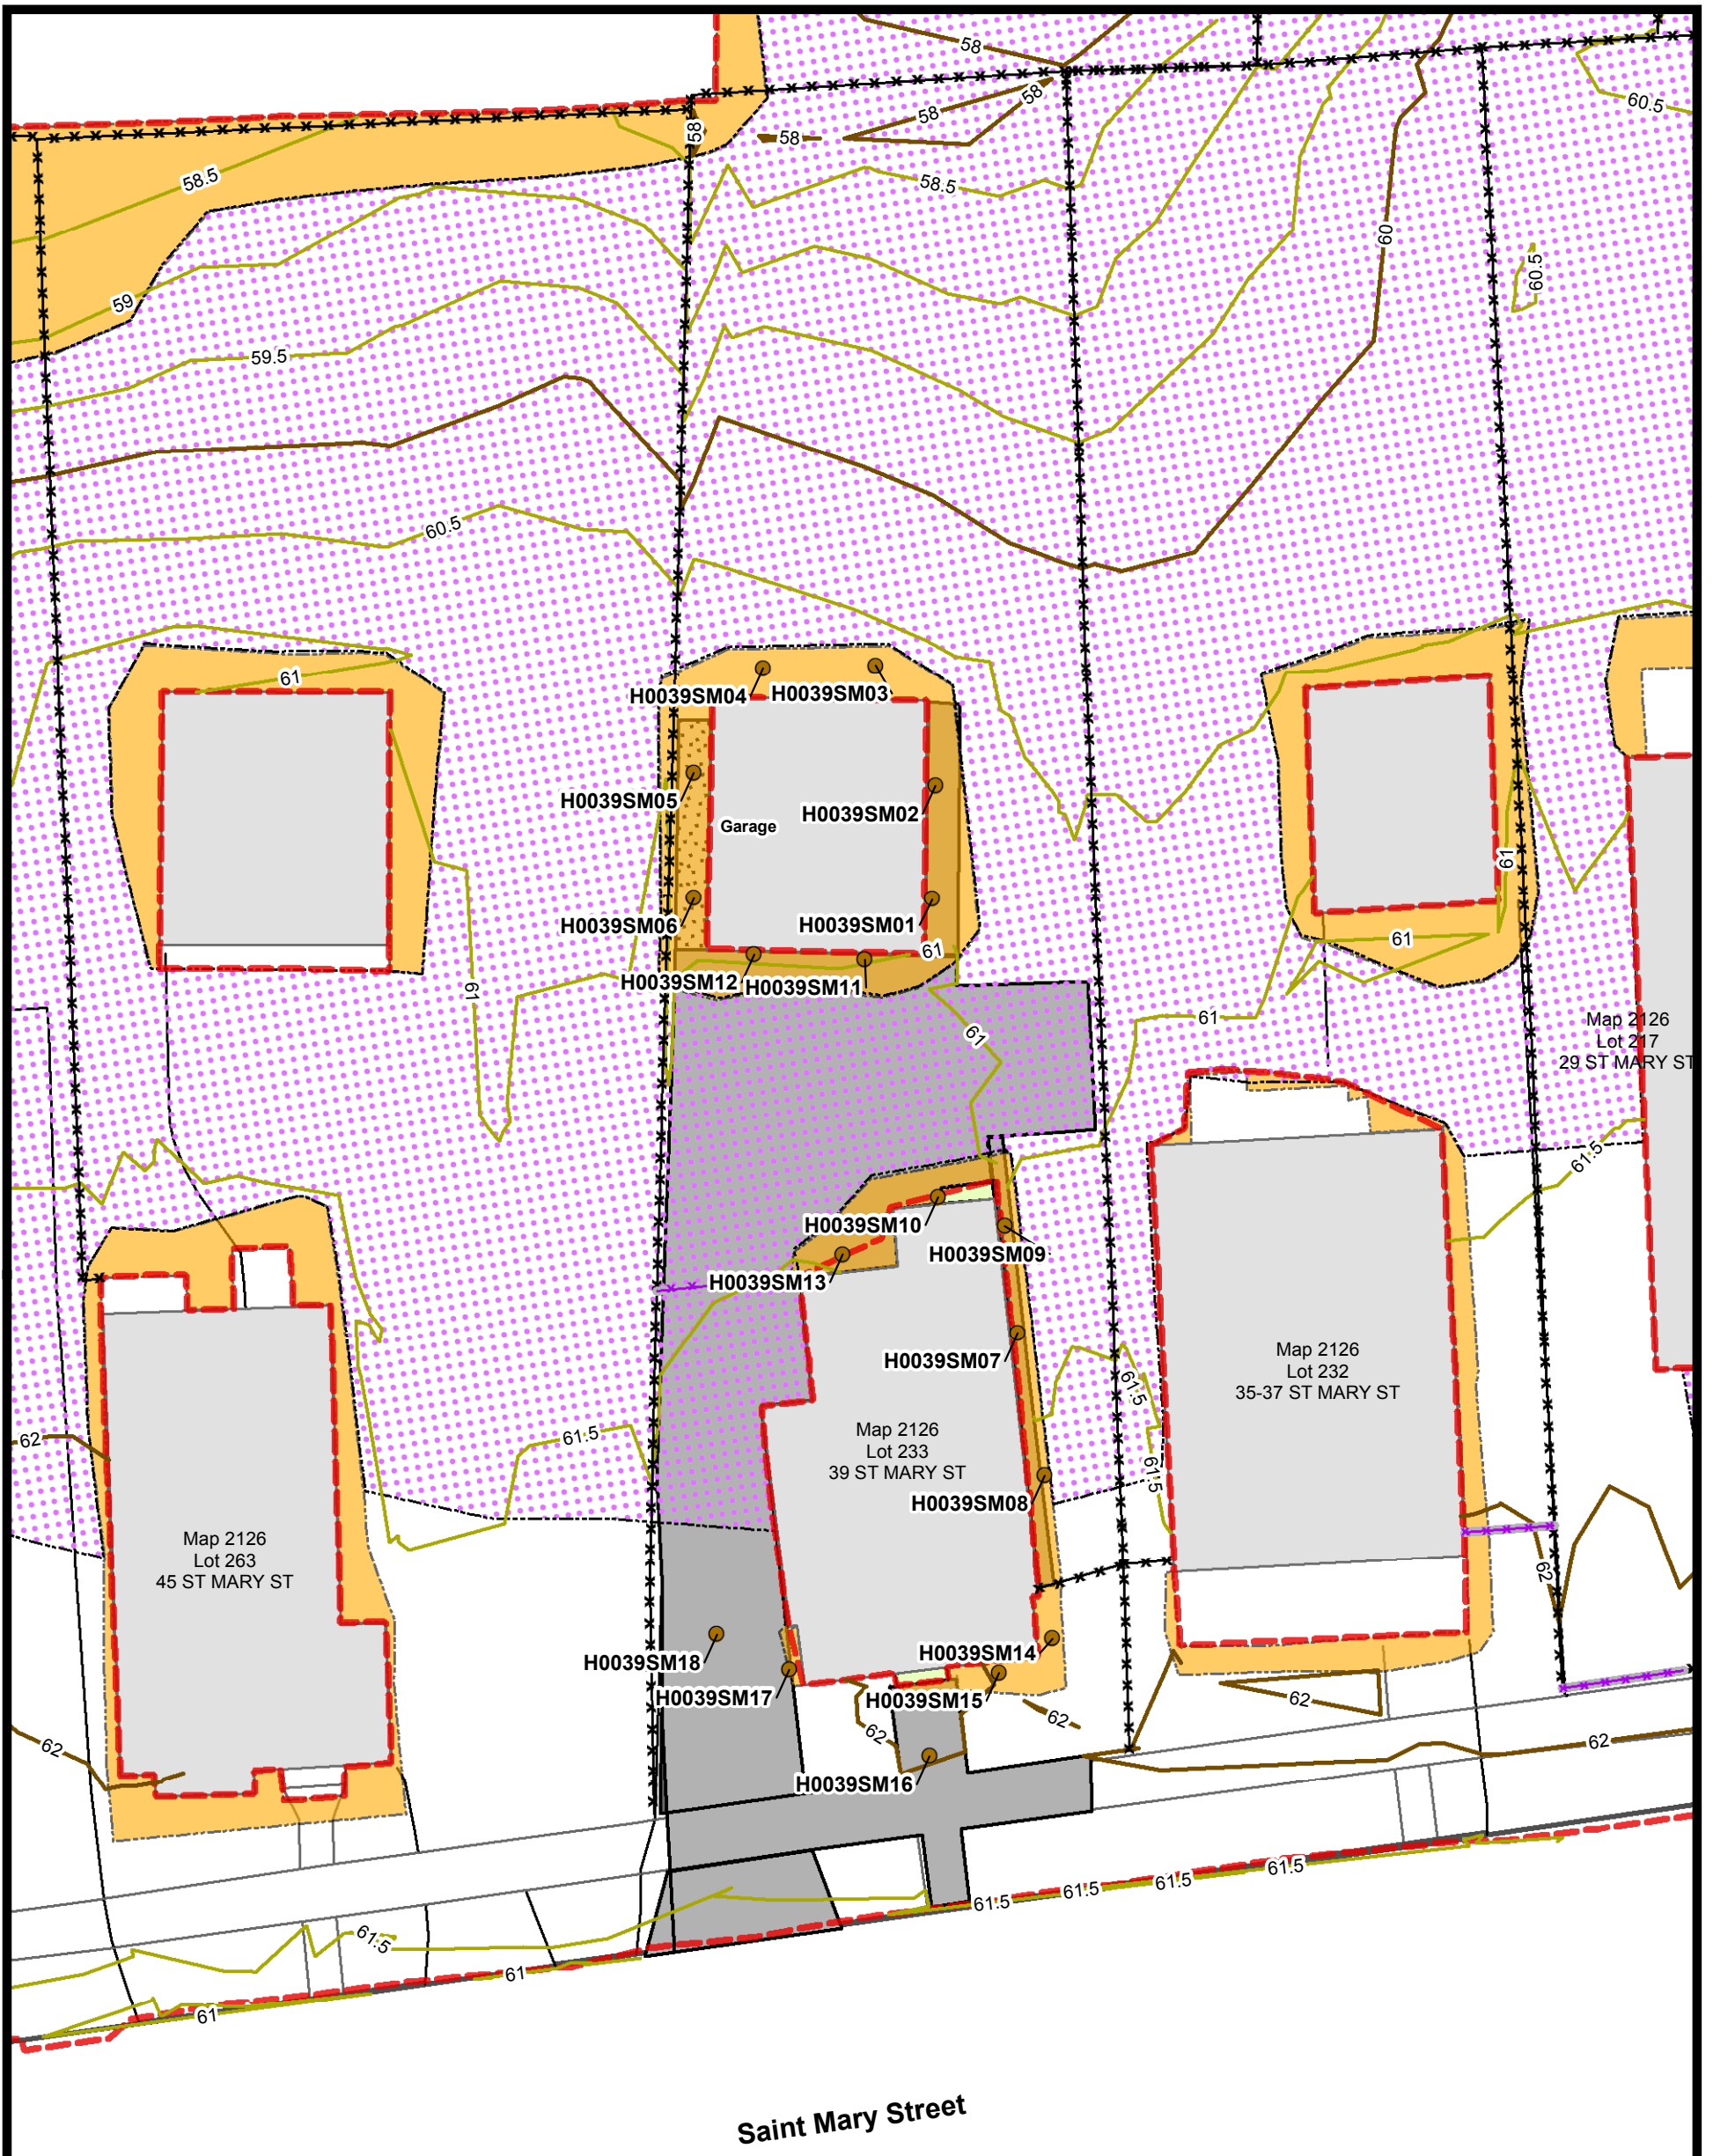
Figure 2-1 Post-Construction Conditions

During the 2011 construction season, Olin completed the excavation of fill material to a depth of 4 feet bgs, backfill, and restoration of the property in accordance with the Final Design - Generic RAP and the Property-Specific RAP. Figure 2-1 shows the areas where excavation occurred on the property and the locations of excavation confirmation samples. Excavation confirmation samples were collected in accordance with Section 3.2.3 - Confirmatory Sampling of the Final Design - Generic RAP, including adherence to the sampling frequency requirements. X-ray fluorescence (XRF) excavation confirmation sampling results are presented in Table 2-1.

As indicated in Table 2-1, most confirmation sampling results indicate total lead concentrations less than the criteria of 400 mg/kg approved by CTDEP in the Final Design - Generic RAP. Several samples collected from the perimeter of the excavated area indicated total lead concentrations that exceeded 400 mg/kg. Additional soil could not be removed from these locations around the perimeter of the house and garage, because continued excavation could jeopardize the integrity of the structure. Additional soil could not be removed from the rear property line because additional excavation in this location would disrupt the adjacent property which was excluded from the remedy.

- In some locations, fill material was encountered at greater than 4 feet in depth below ground surface (bgs). This fill material was left in place, covered by an orange geotextile fabric, and backfilled with clean soil in accordance with the Final Design - Generic RAP. Figure 2-1 shows the approximate area of geotextile fabric identifying the presence of fill at a depth greater than 4 feet bgs.
- In some locations, it was necessary to leave fill material in place at depths less than 4 feet bgs in order to avoid jeopardizing the integrity of a structure. This fill material was left in place, covered by an orange geotextile fabric and/or shotcrete, and backfilled with clean soil in accordance with the Final Design - Generic RAP. Figure 2-1 shows the approximate area of geotextile fabric/shotcrete identifying the presence of fill at a depth less than 4 feet bgs.

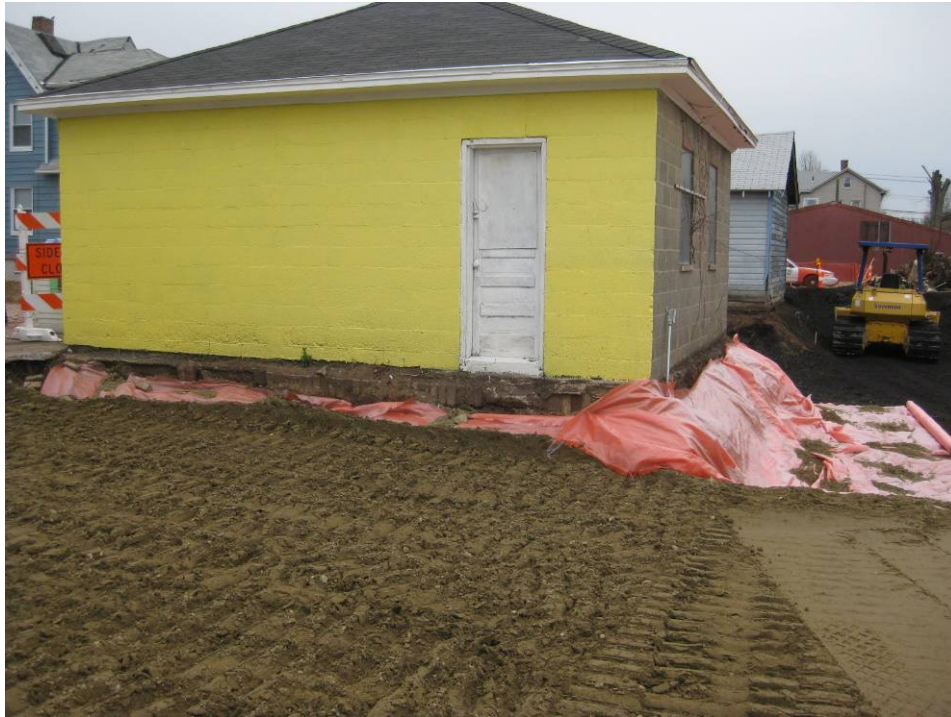
View looking South at excavation area around garage

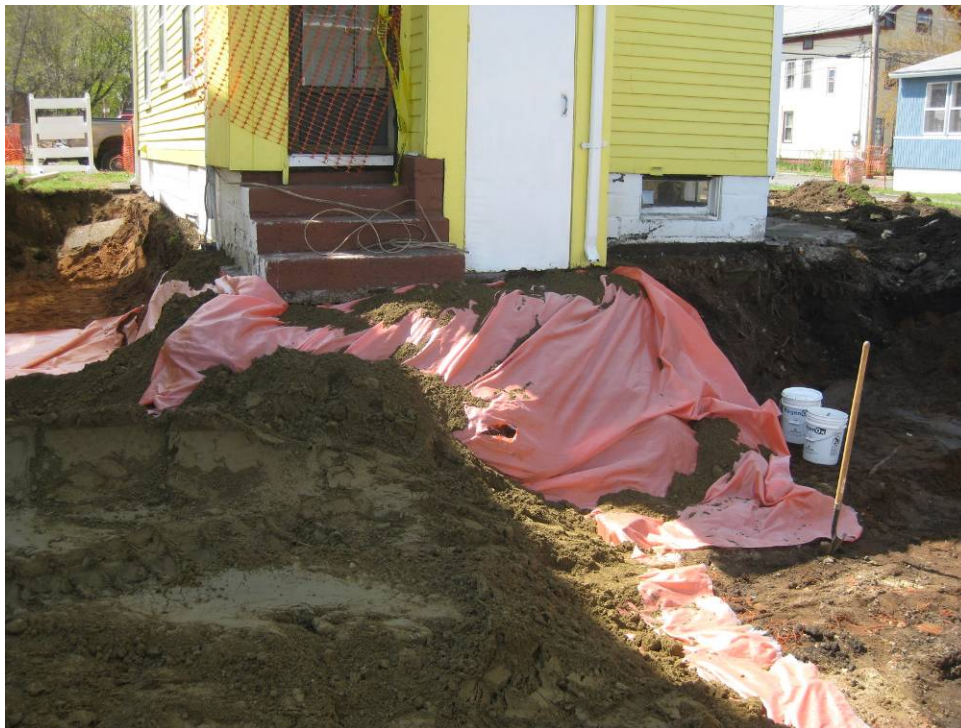
View looking West at excavation area at rear of house following placement of marker barrier

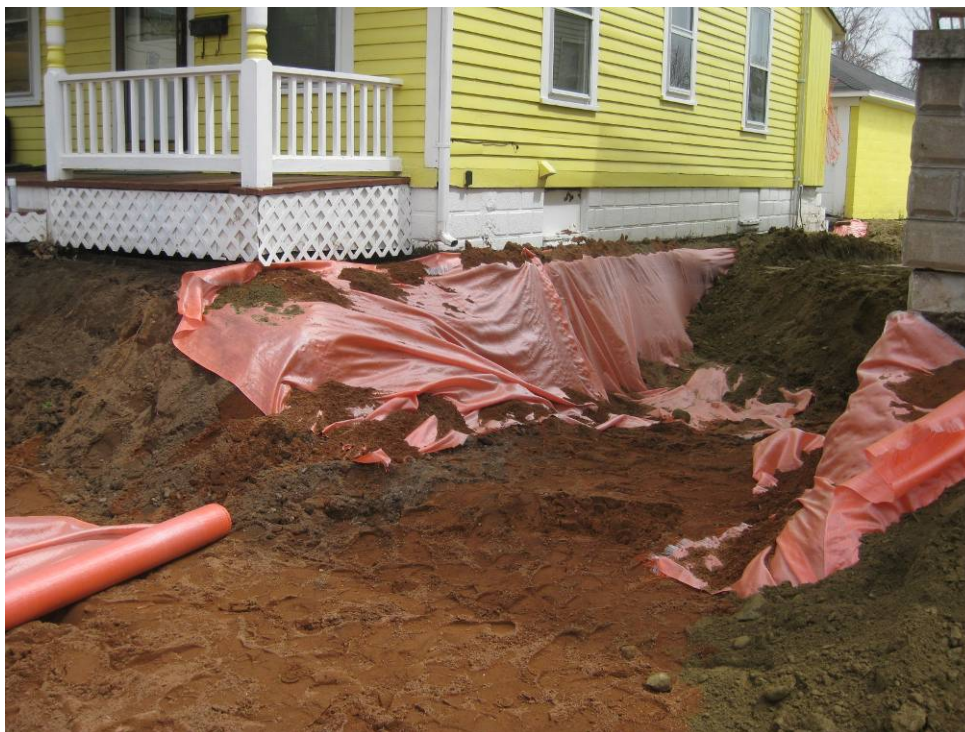
View looking Northeast at excavation area following placement of marker barrier

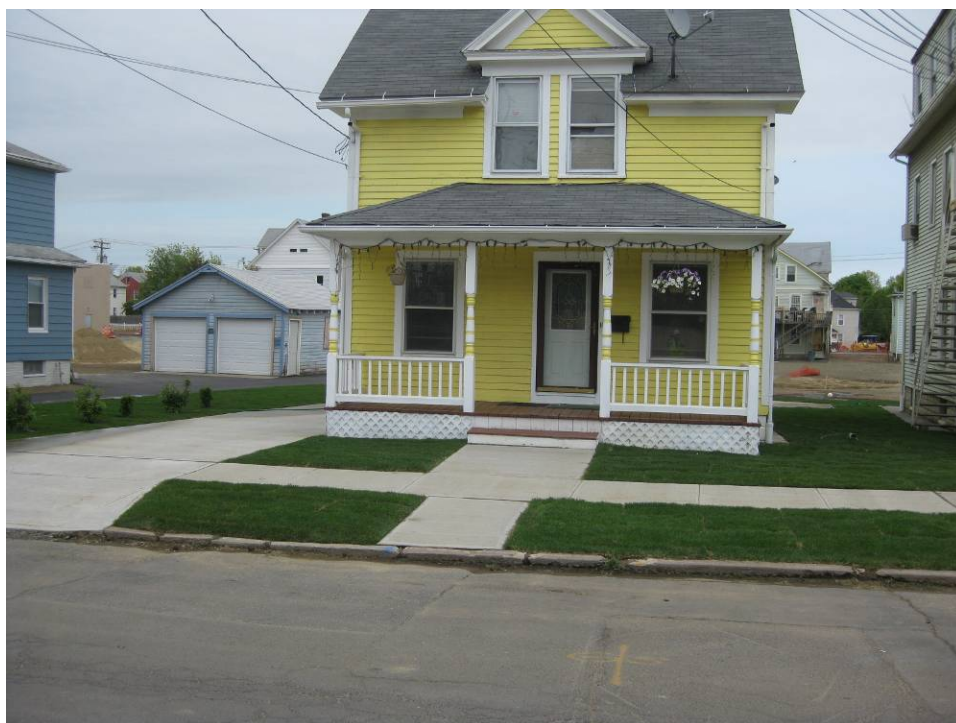
View looking East at restored property

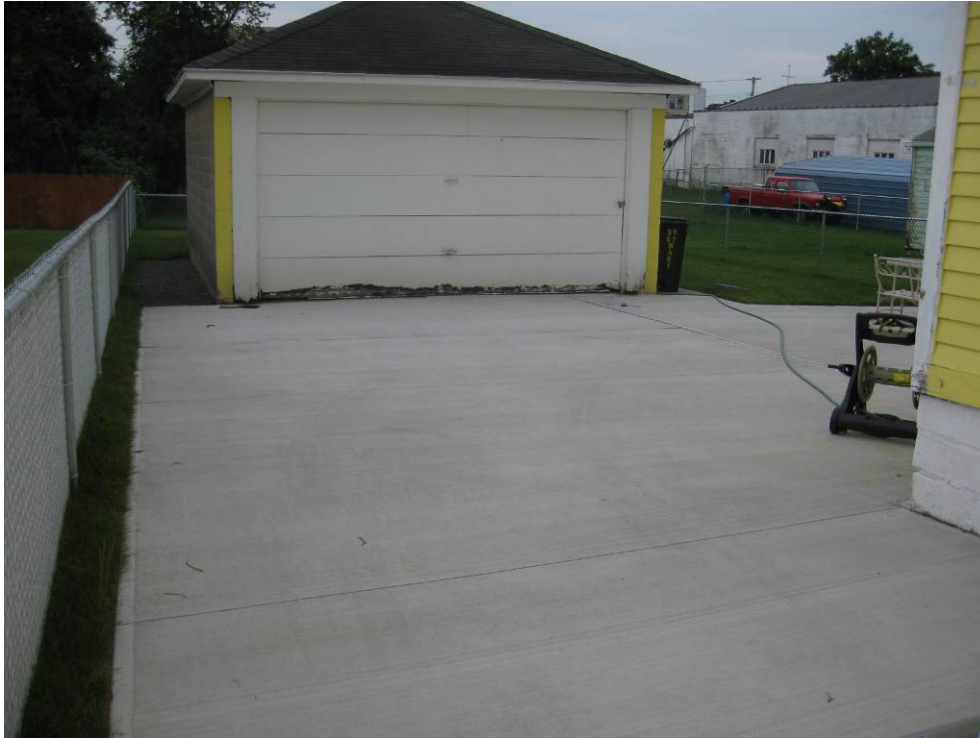
View looking East at restored driveway

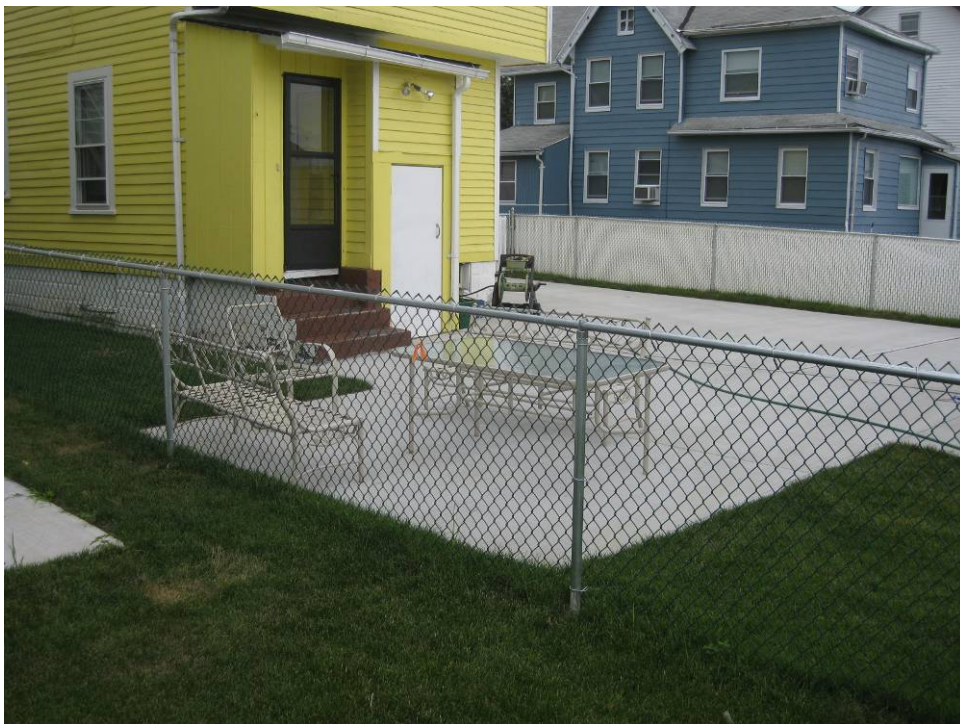
View looking Northwest at restored patio and driveway
