RE: Pre-Acquisition Hazardous Building Materials Assessment
High Meadows
825 Hartford Turnpike
Hamden, Connecticut 06517
BL Project No. 2000201

PRE-ACQUISITION HAZARDOUS BUILDING MATERIALS ASSESSMENT

High Meadows
825 Hartford Turnpike
Hamden, Connecticut

Date: April 2020
BL Companies Project No. 2000201

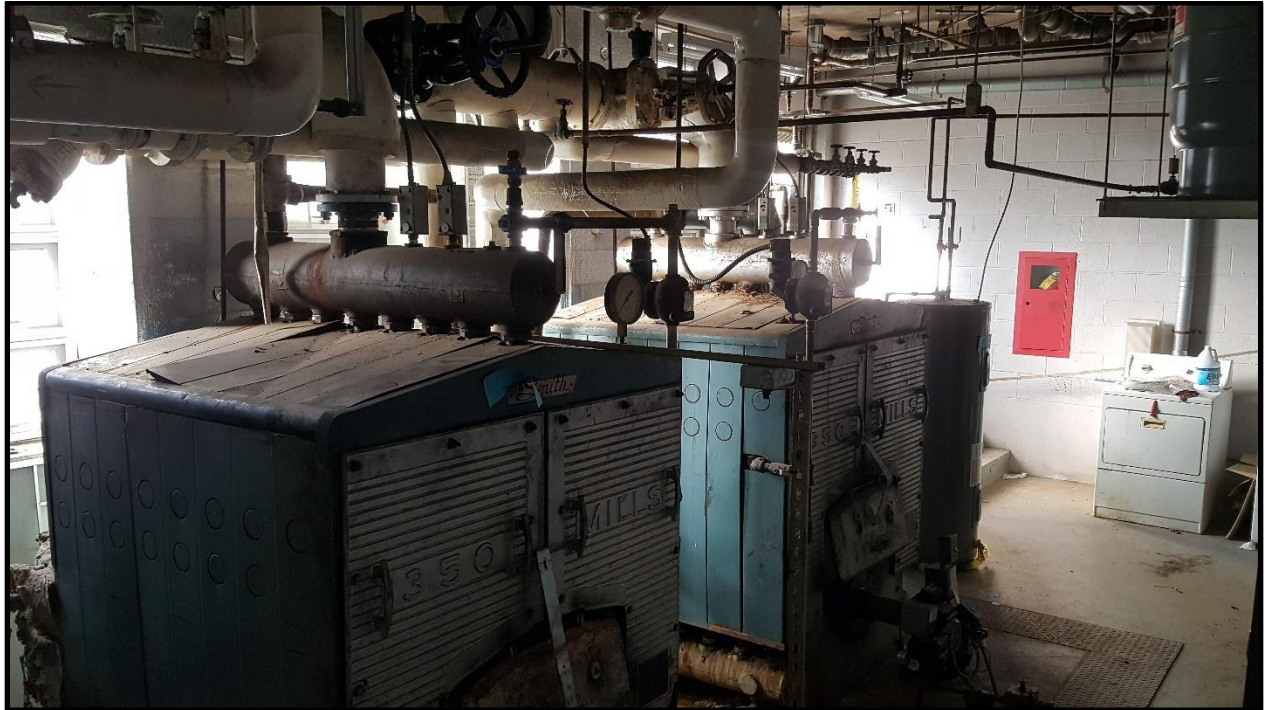
Building #3 Senn Building - Basement – Boiler Insulation (ACM)

The ACMs identified in this report require abatement in accordance with Federal and State regulations if they will be disturbed by renovation. Material quantities listed in this report are estimates only and are not guaranteed.

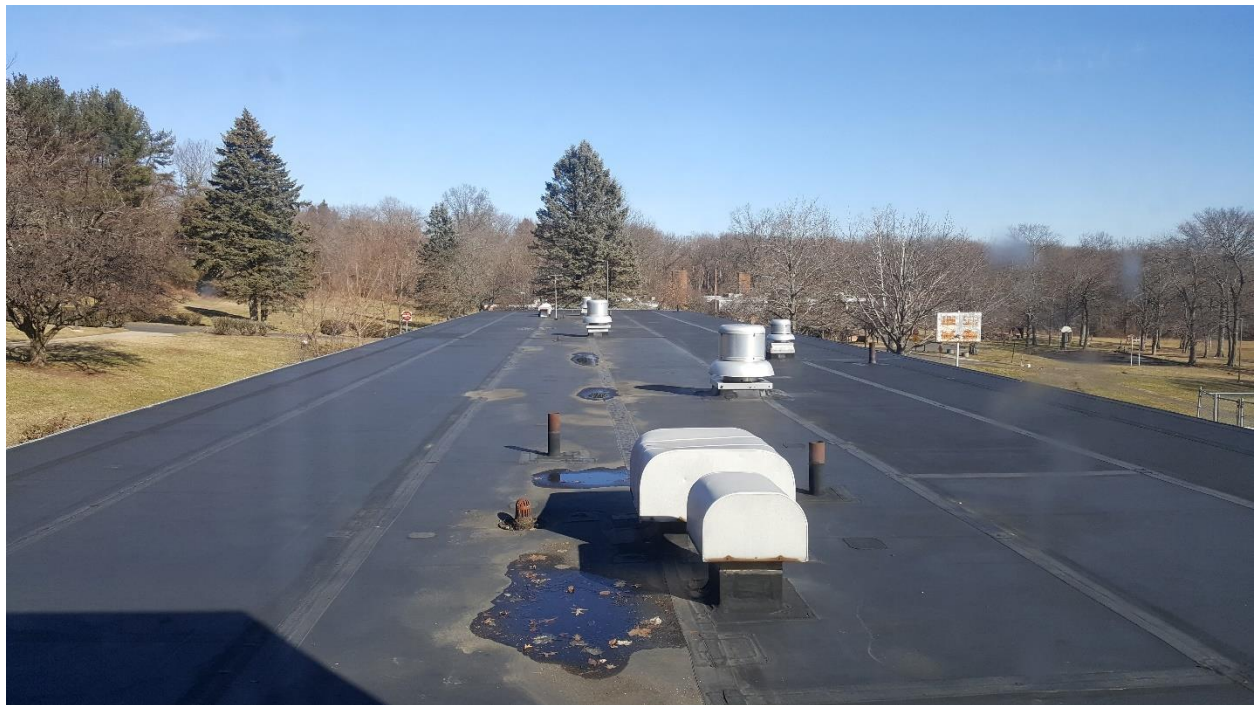
The window and door caulks/glazing have been assumed to be ACM as well as expansion caulks located at the exterior of the buildings. The roofing has been assumed to be ACM and if intact and nonfriable could be removed during demolition.

Building #3 Senn Building - Roof – Roofing (PACM)

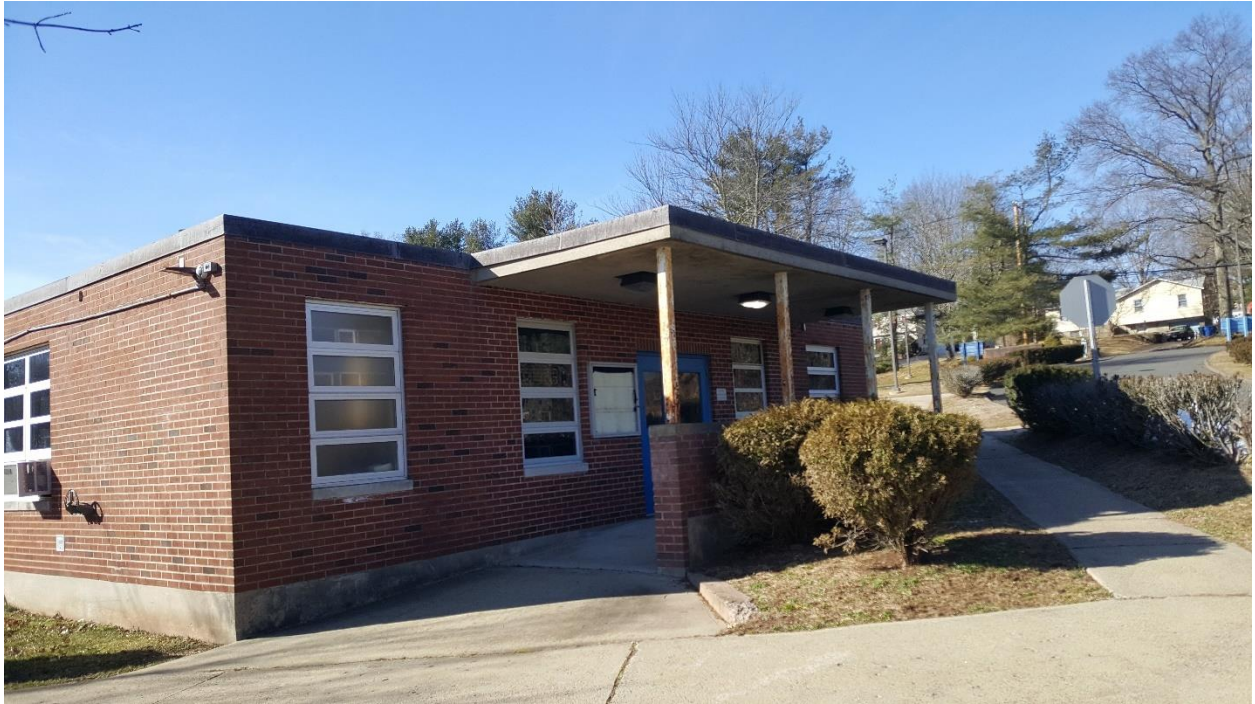
There could be PCBs associated with caulks, glazing and adhesives at the Site. The largest concern is any caulk/sealants associated with the windows and doors. Windows typically require ongoing maintenance that may have introduced PCB-containing caulks over the years. There are some areas where there appears to be sealant applied over the original installation as repair for leaks. These sealants/caulks may have PCBs if they were installed prior to 1978 when the use of PCBs in these applications were banned.

Building #3 Senn Building - Elevation – Window Caulk/Glazing, Blind Flashing (PACM/Suspect PCB)

The original caulks and sealants could be PCB-containing. Until these materials are impacted it is recommended to assume they are PCB-containing and not perform sampling unless necessary. The suspect PCB source materials may be removed as assumed PCB Bulk Product Waste under 40 CFR 761.62.

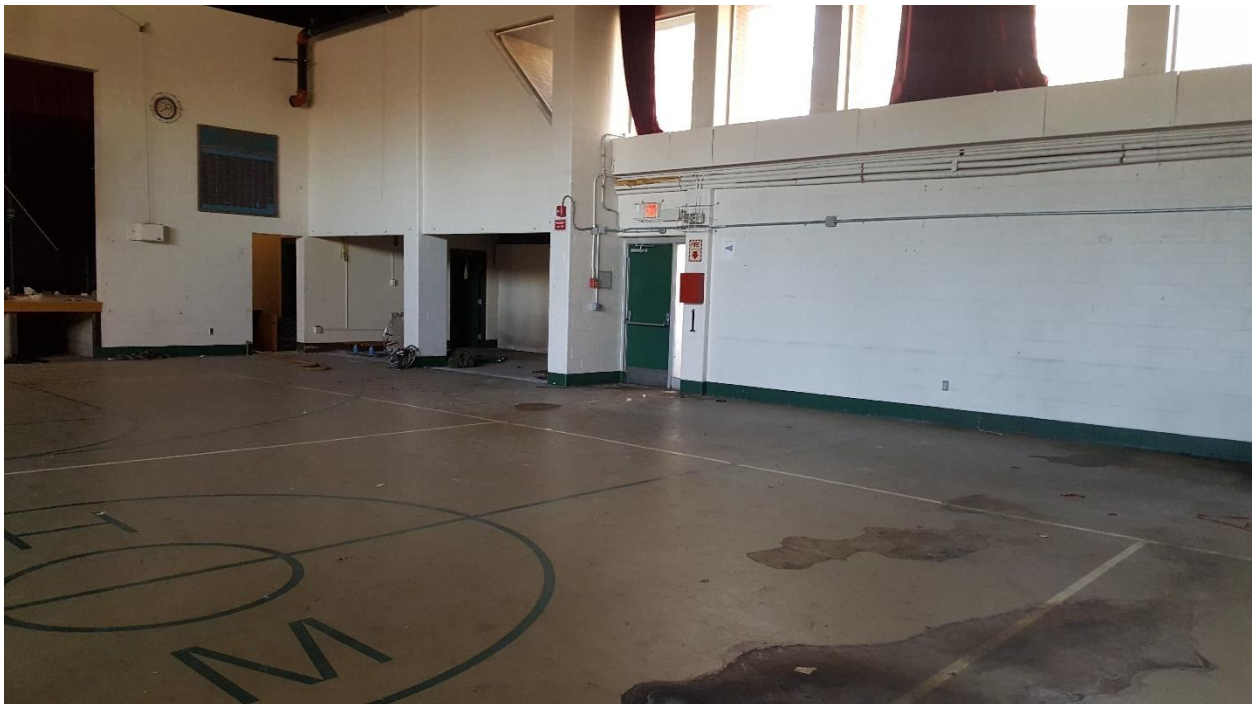
On April 1, 2020 Ms. Olesen visited the Site to return documents and verify Site conditions after document review. At the time of the assessment, the Site was unoccupied, and the buildings were observed to be in good condition with the exception of the gymnasium. The gymnasium had indications of roof deterioration and leaking. The rubber floor in the gymnasium had staining and puddled water and was heaved and uneven.

The flooring has not been sampled for mercury contamination. Since this flooring is in poor condition it will likely be removed as part of a renovation or demolition of the Gymnasium – Building #4. This flooring and the associated substrate should be sampled for mercury prior to removal of these materials. See **Appendix B** for representative photos of the flooring.

Building #4 - Gymnasium – Suspect Mercury Flooring

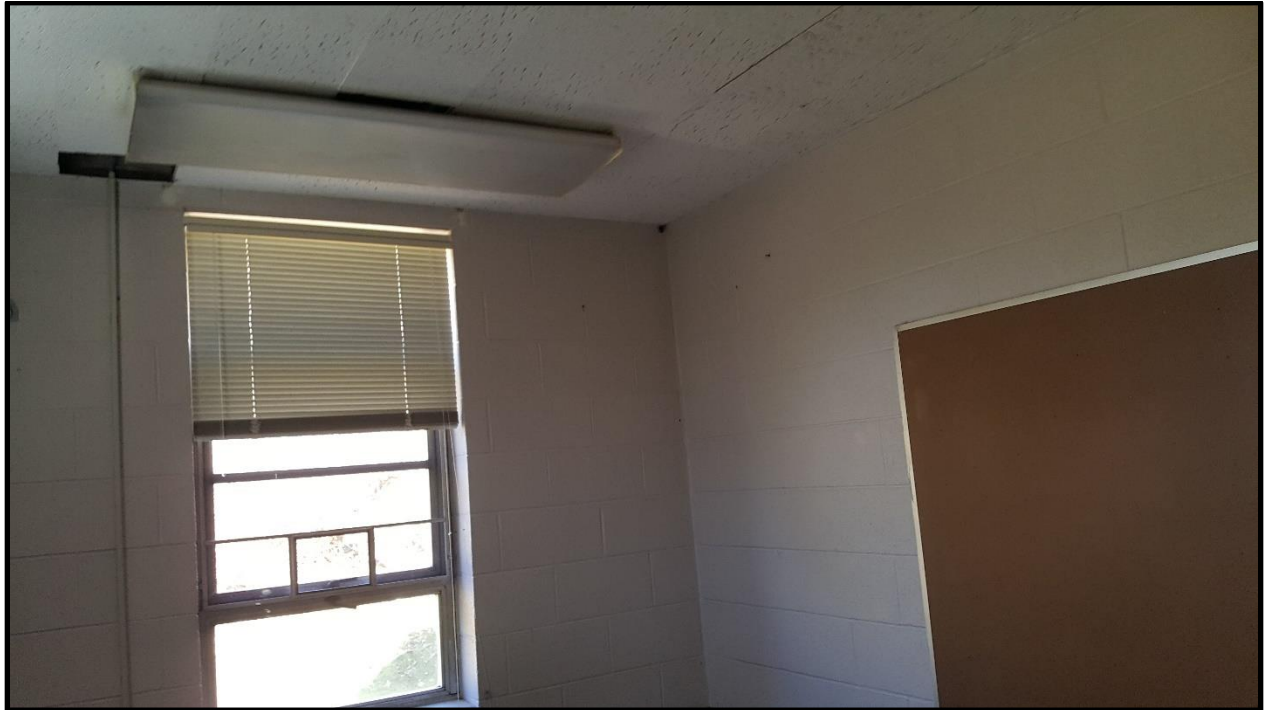
Building #5 Kitchen/Dining – First Floor – 1'x1' Ceiling Tile with Glue Daubs (ACM)

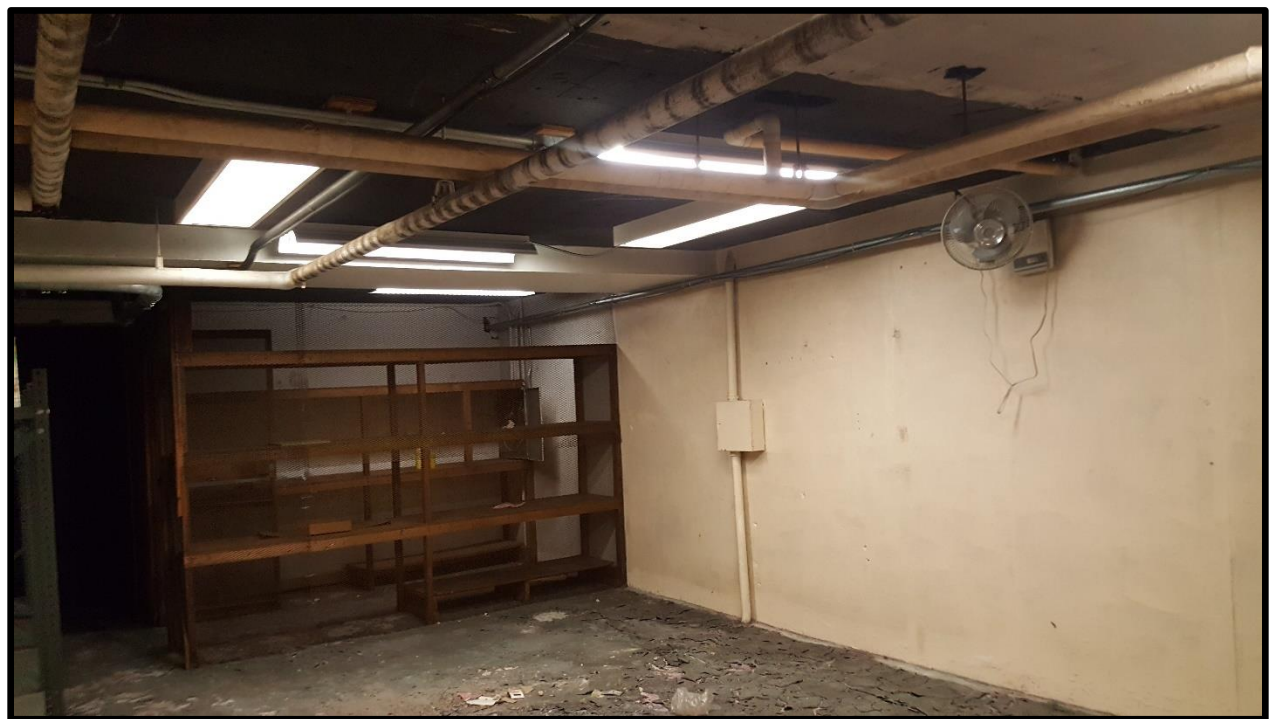
Building #5 Kitchen/Dining - Basement – Pipe Insulation (ACM & NonACM))

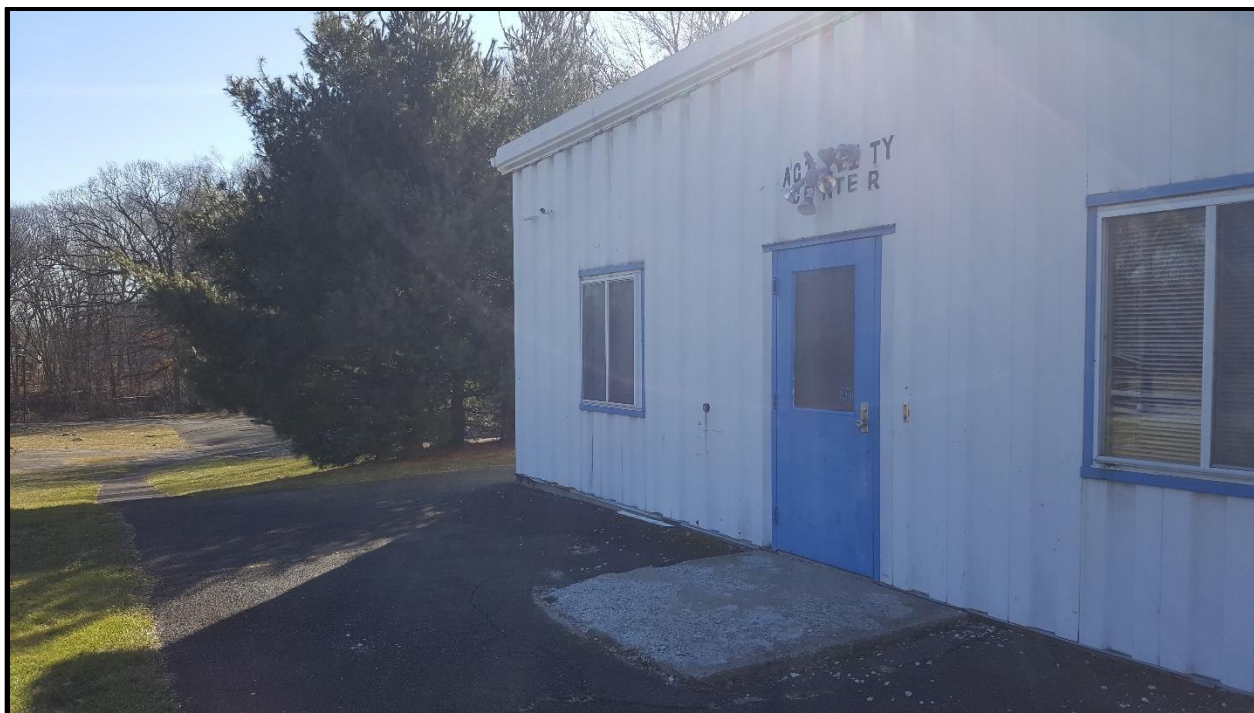
Building #6 – Activity Center – Exterior Caulks (PACM, Suspect PCB)

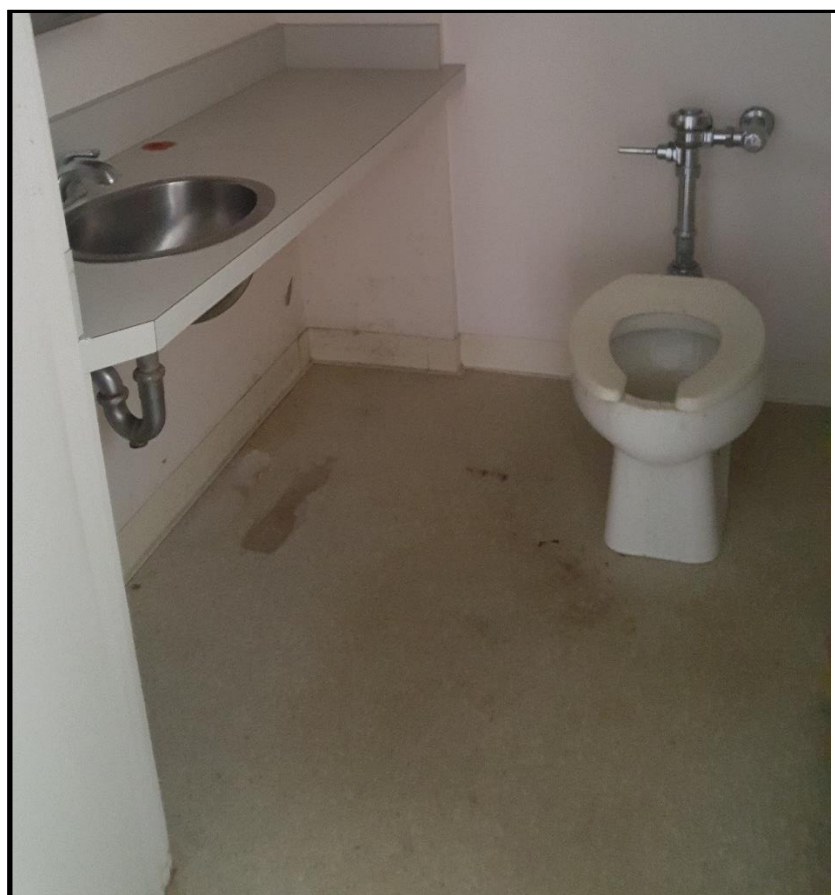
Building #7 – Cottage - Pebble Flooring (ACM)

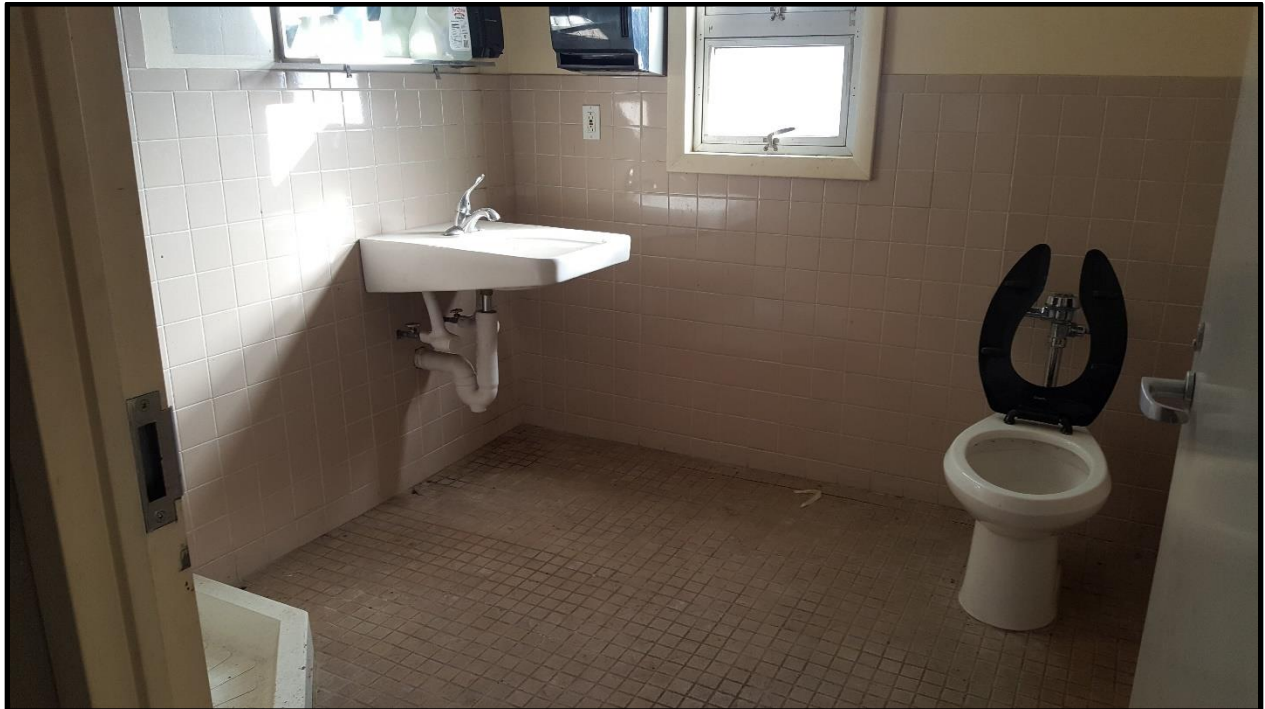
Building #9 – Maintenance/HVAC – Ceramic Tile Grout/Adhesive (ACM)

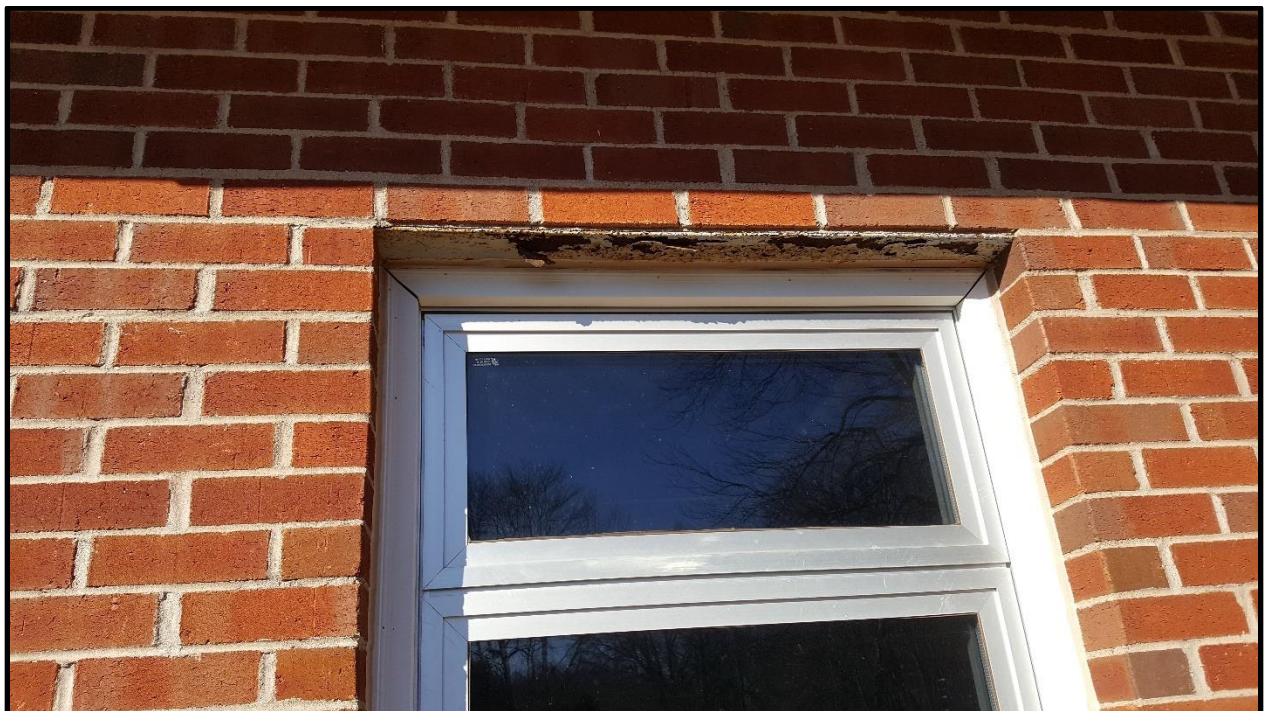
Building #9 – Maintenance/HVAC – Exterior Window Caulk (PACM/ Suspect PCB)
