Re: Property-Specific Remedial Action Report  
Newhall Street Neighborhood  
121 Morse Street, Block F  
Hamden, Connecticut 06517

**PROPERTY-SPECIFIC REMEDIAL ACTION REPORT  
121 MORSE STREET**

**NON-PUBLIC PROPERTIES  
NEWHALL STREET NEIGHBORHOOD  
HAMDEN, CONNECTICUT**

**AMEC Project Number: 6107120004.115**

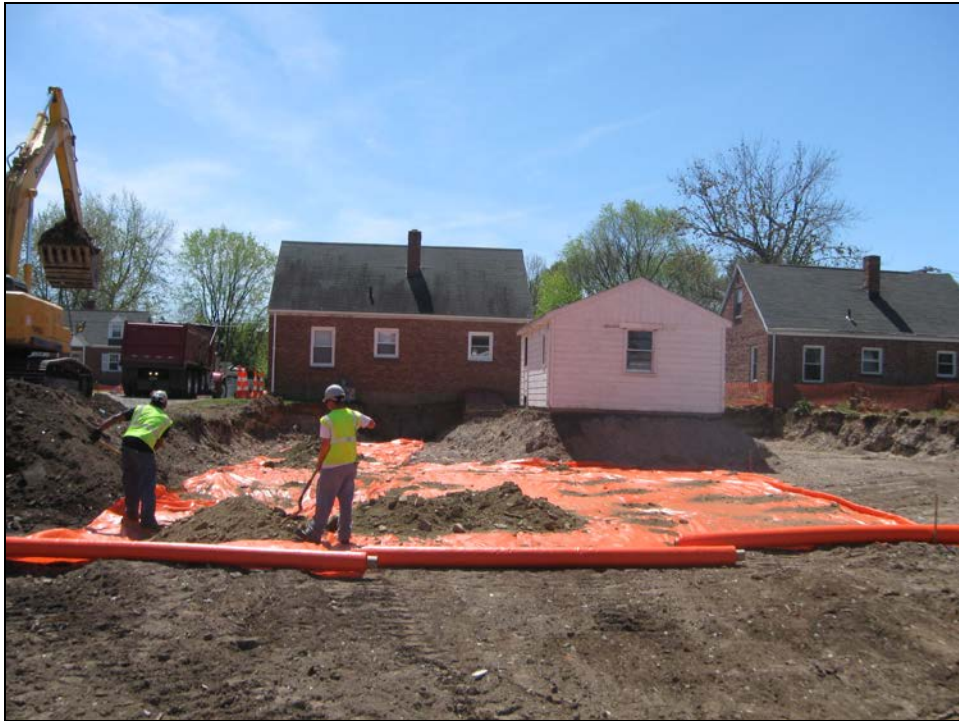
**View facing south at marker barrier being installed in the back yard.**

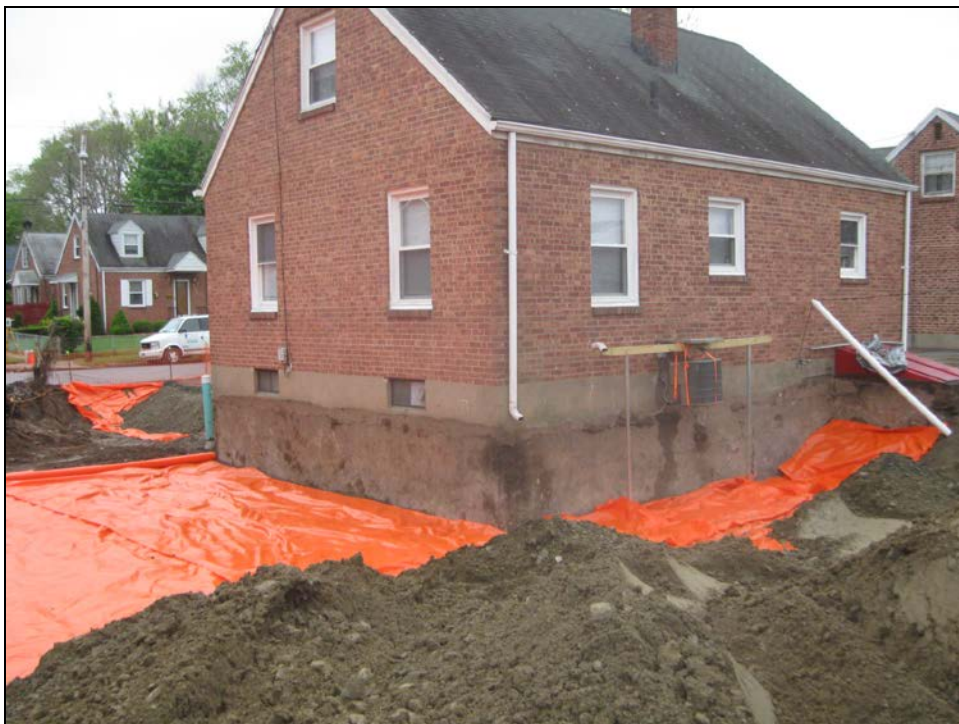
**View looking southwest at partially backfilled side and back yard.**

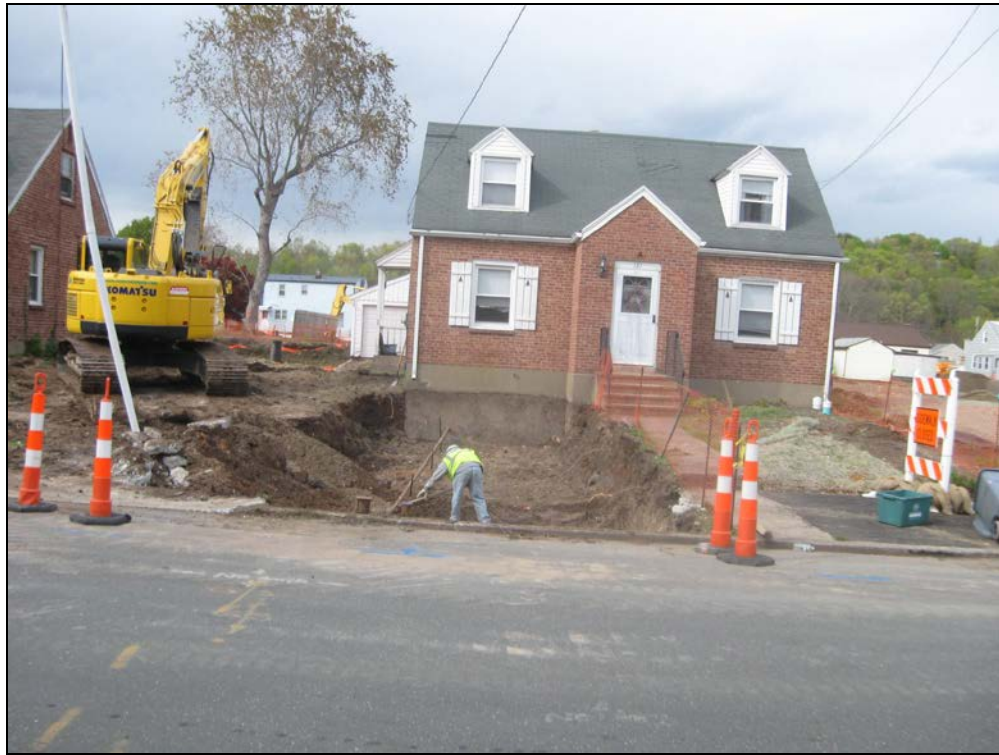
**View looking north at partially excavated front yard.**

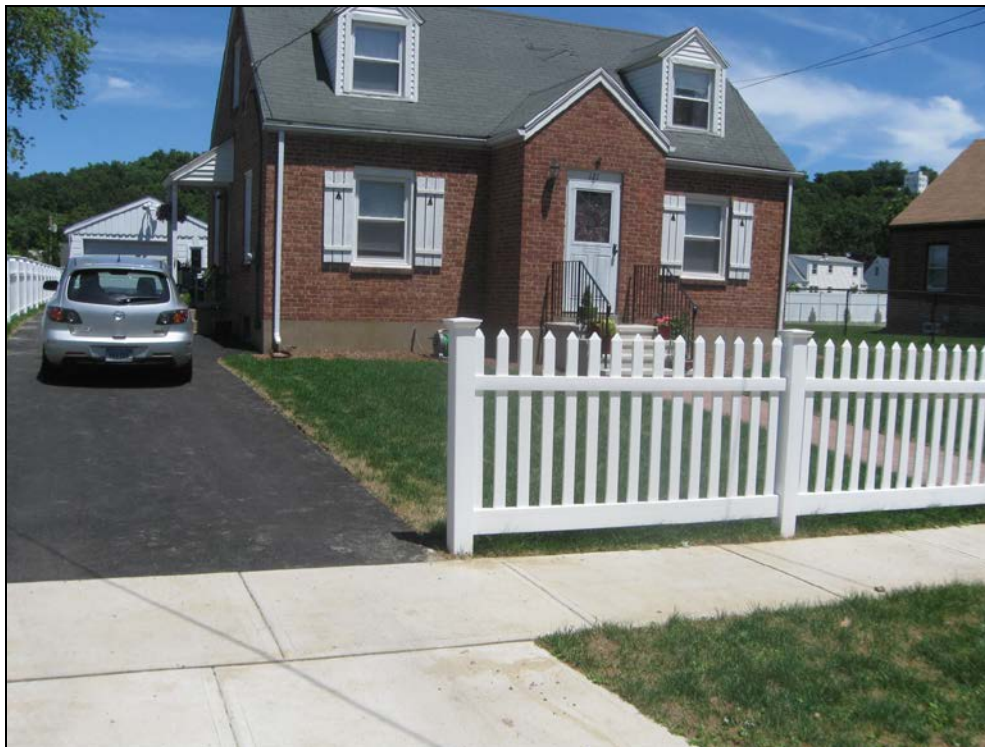
**View looking northeast at restored front yard.**

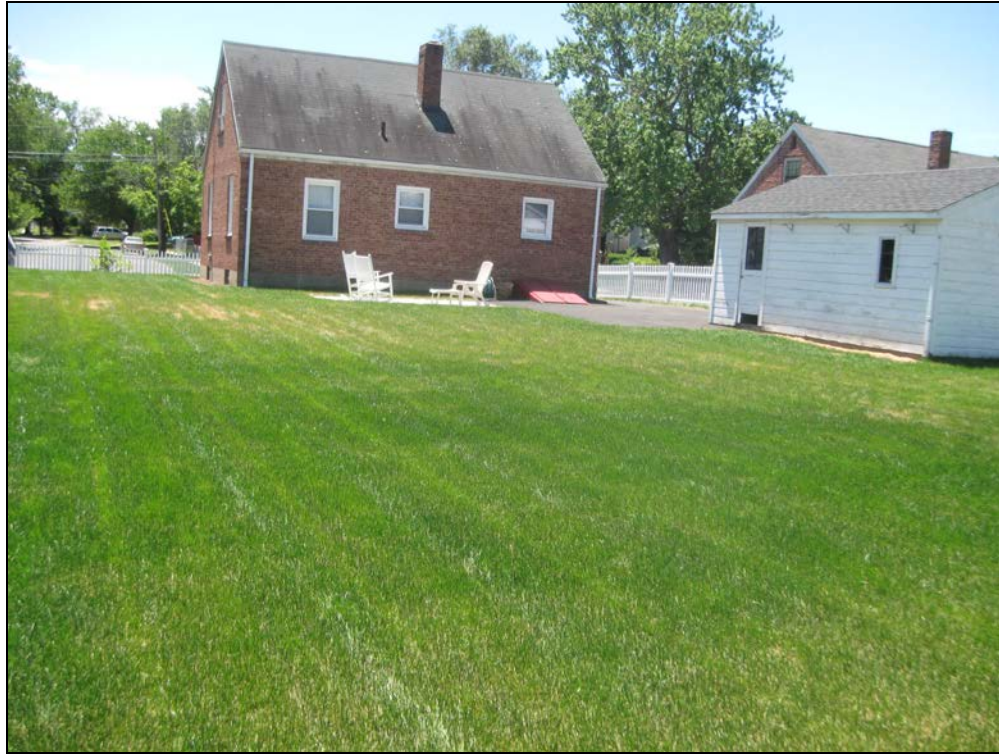
**View looking south at restored back yard.**

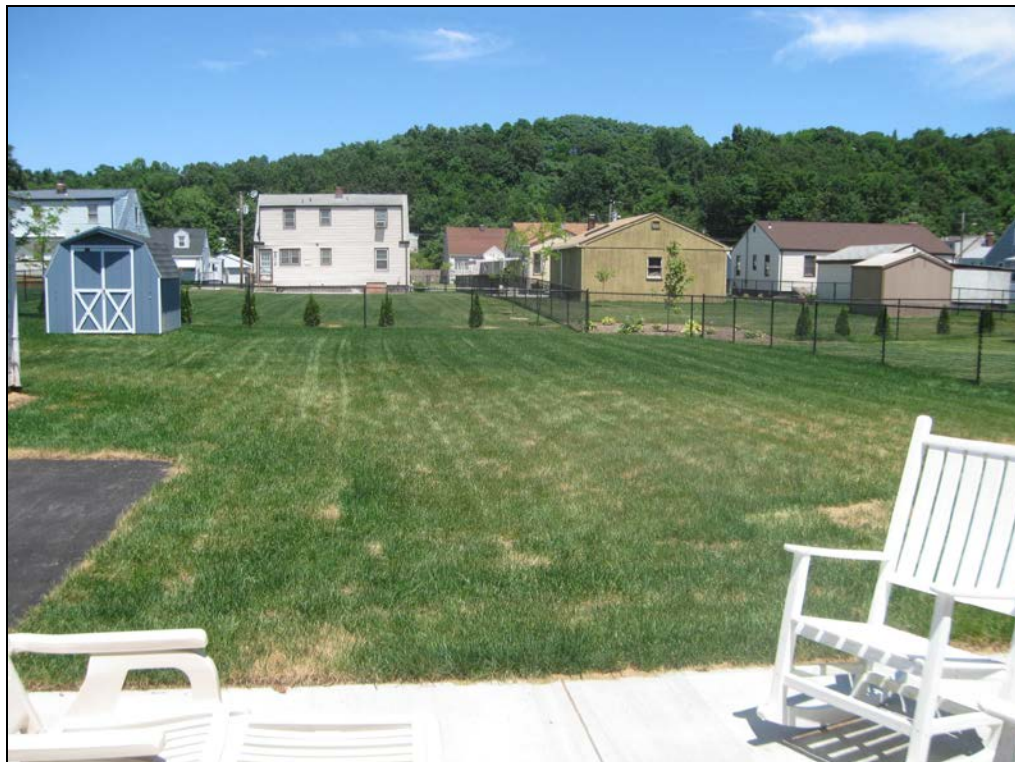
**View looking north at restored back yard.**
