Re: Property-Specific Remedial Action Report
Newhall Street Neighborhood
125 Bryden Terrace, Block C
Hamden, Connecticut 06517

**PROPERTY-SPECIFIC REMEDIAL ACTION REPORT
125 BRYDEN TERRACE**

**NON PUBLIC PROPERTIES
NEWHALL STREET NEIGHBORHOOD
HAMDEN, CONNECTICUT**

AMEC Project Number: 6107120004/105

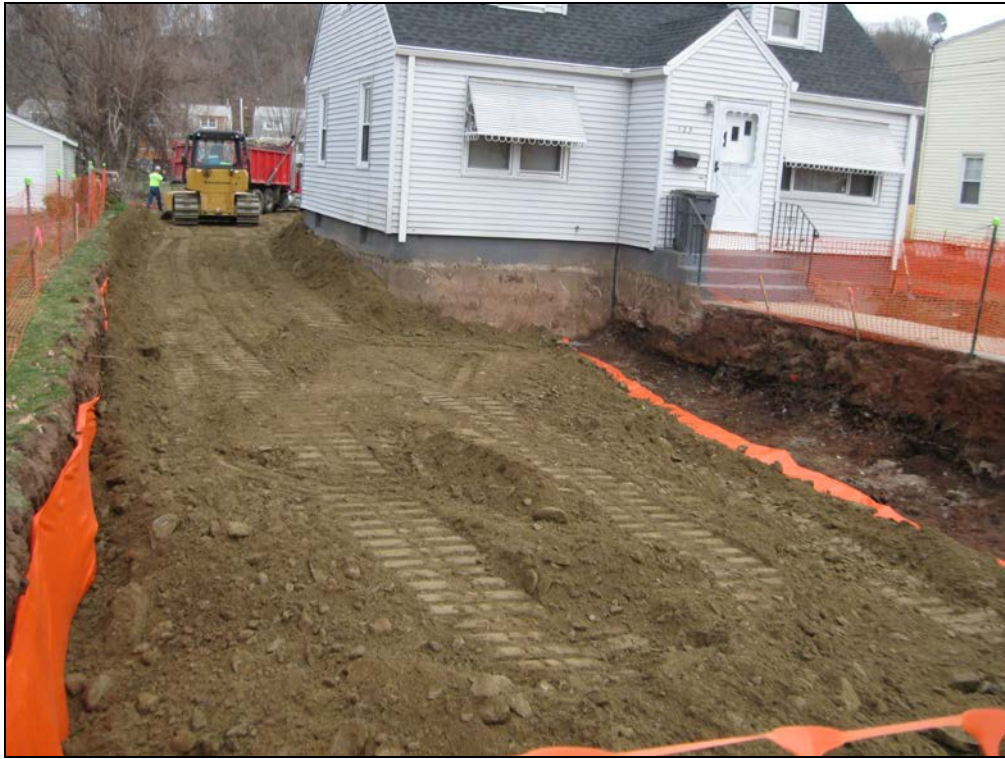
View looking northeast at placement of backfill material in front yard following placement of orange marker barrier.

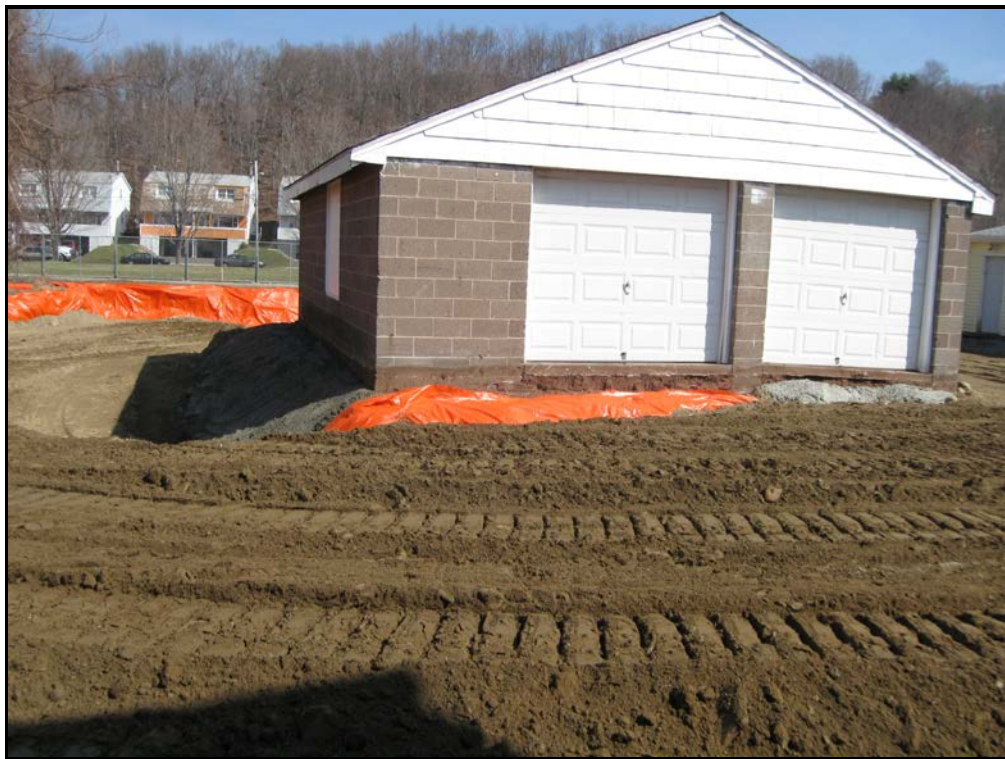
View looking north at partially backfilled back yard showing concrete and marker barrier.

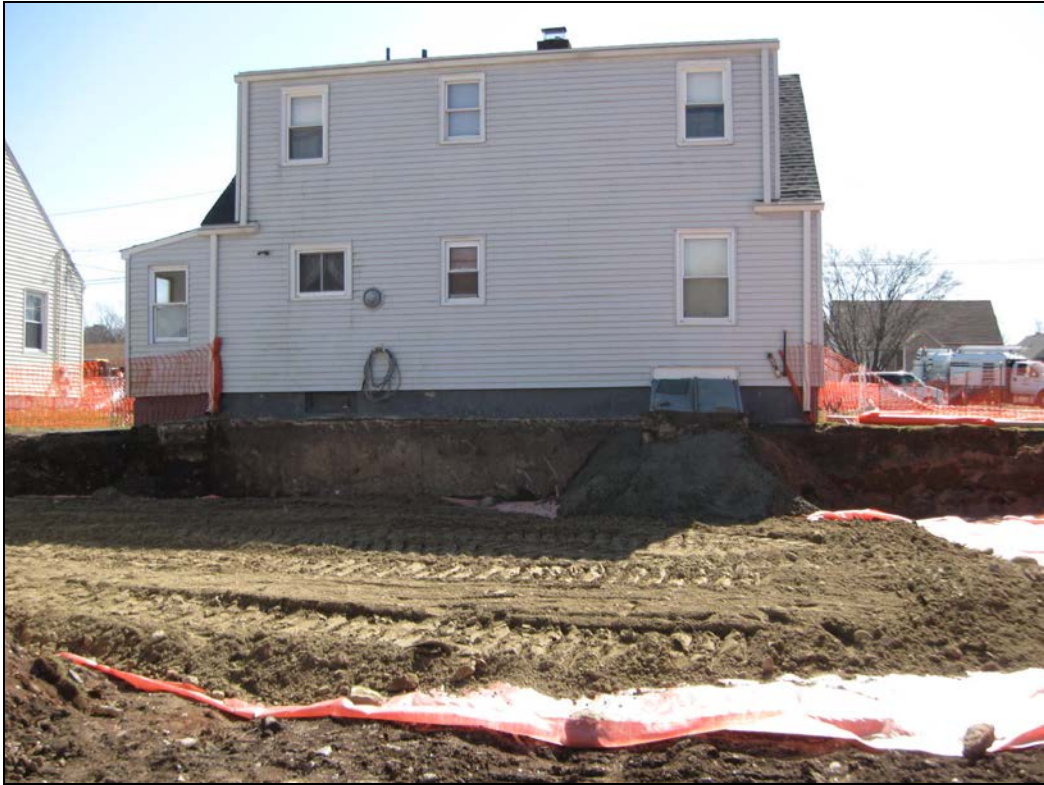
View looking south at marker barrier and concrete in the excavated back yard.

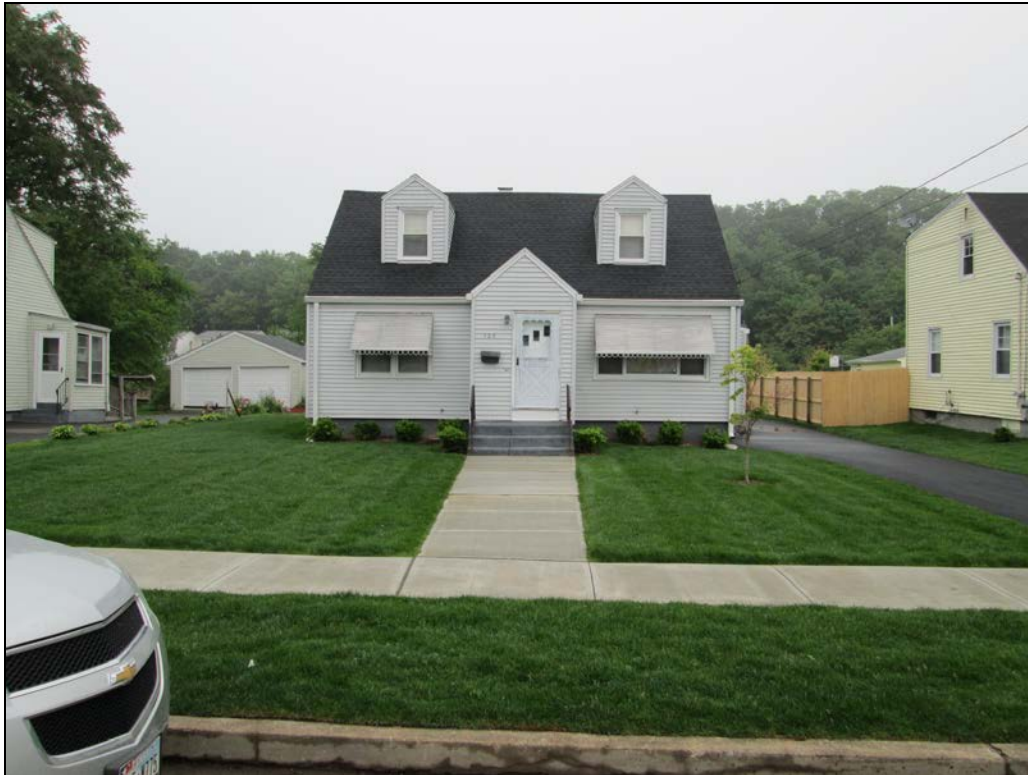
View looking north at restored front yard.

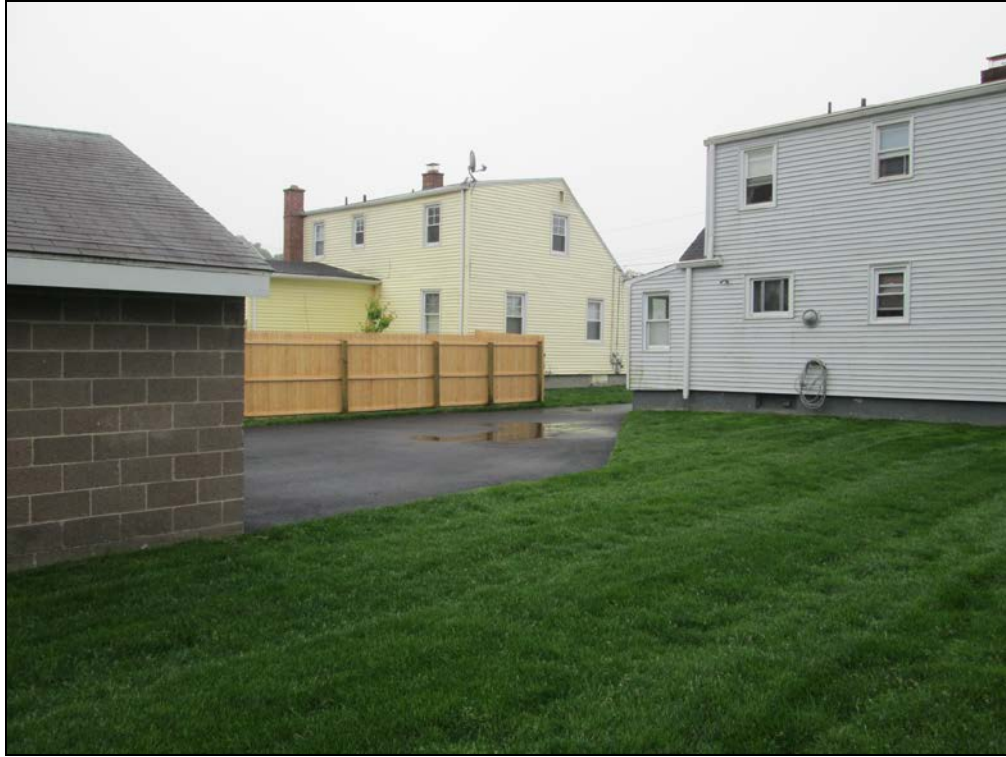
View looking southeast at restored driveway and back yard.

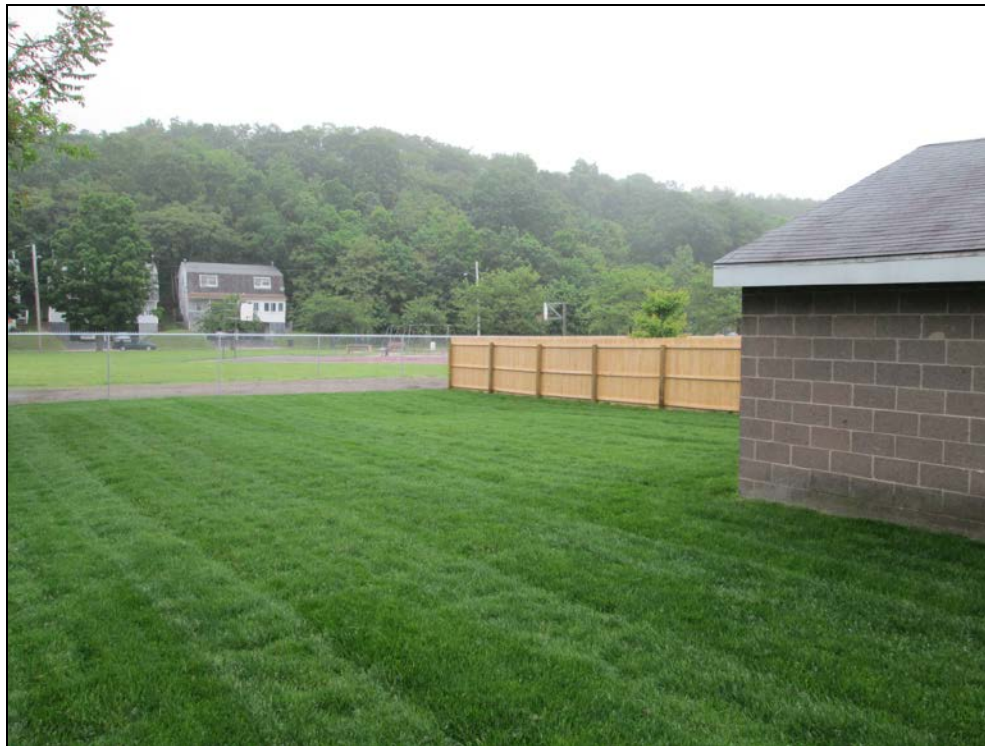
View looking north at restored back yard at 125 Bryden Terrace.
