Re: Property-Specific Remedial Action Report
Newhall Street Neighborhood
20 Wadsworth Street, Block F
Hamden, Connecticut 06517

**PROPERTY-SPECIFIC REMEDIAL ACTION REPORT
20 WADSWORTH STREET**

**NON-PUBLIC PROPERTIES
NEWHALL STREET NEIGHBORHOOD
HAMDEN, CONNECTICUT**

AMEC Project Number: 6107120004.115

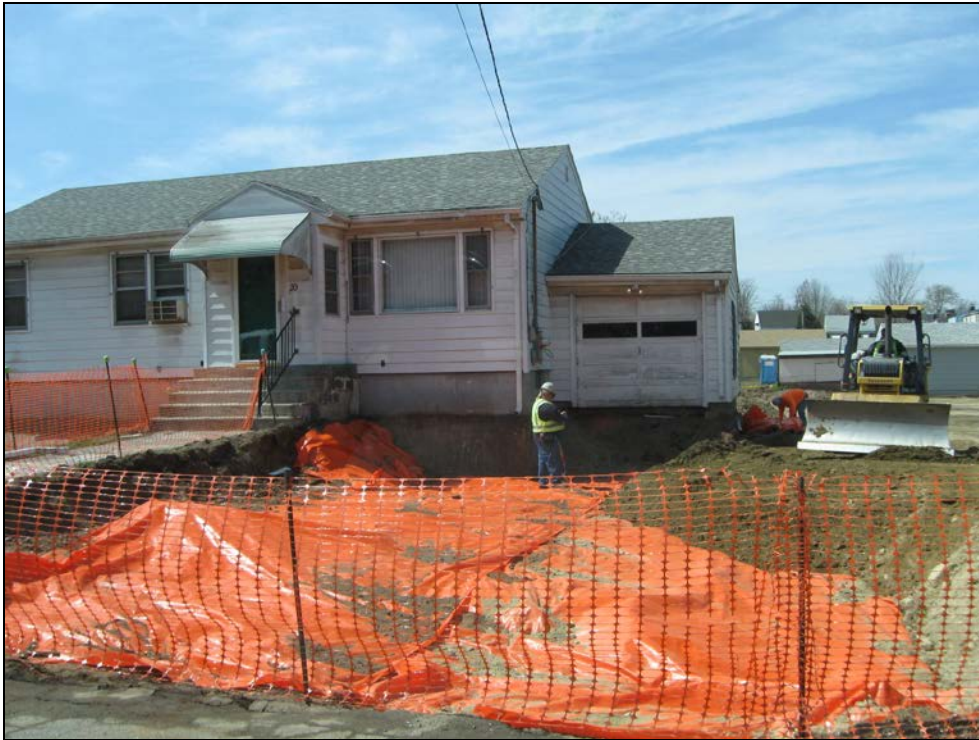
View looking west at excavation of front yard.

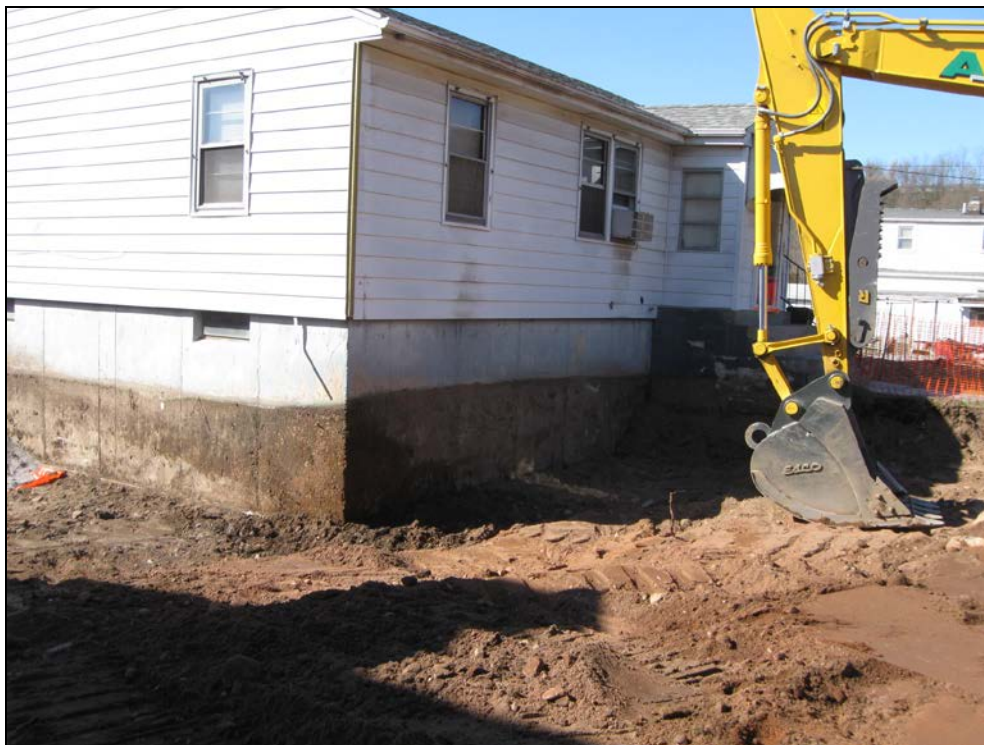
View looking northwest at excavated front yard prior to marker barrier being installed.

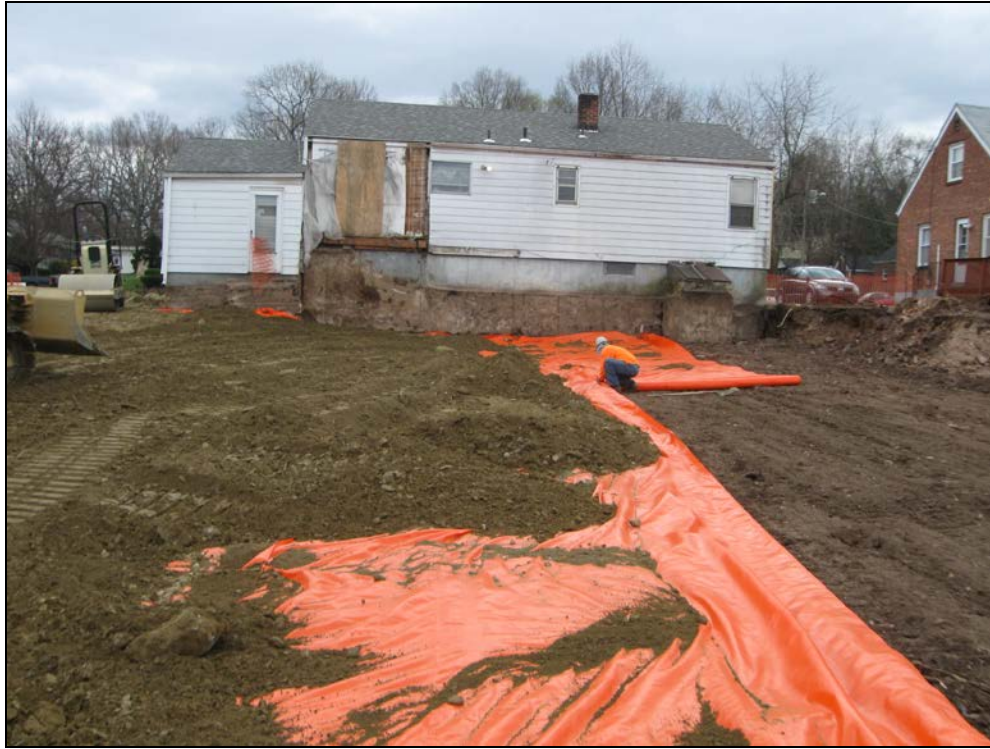
View looking east at marker barrier being installed in the back yard.

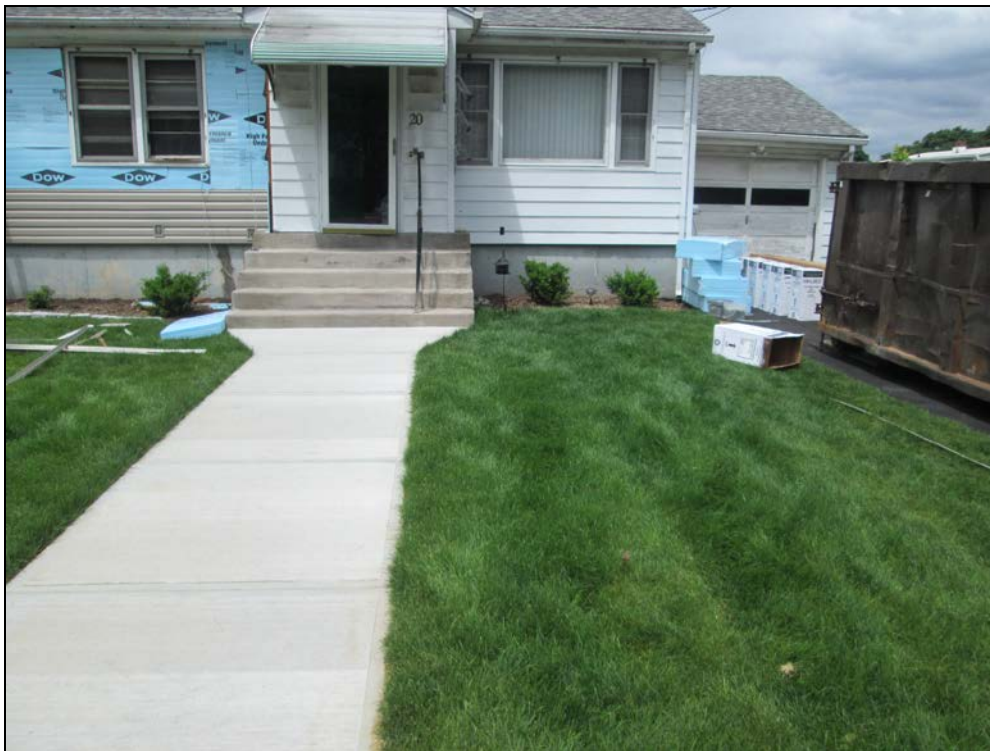
View looking west at restored front yard.

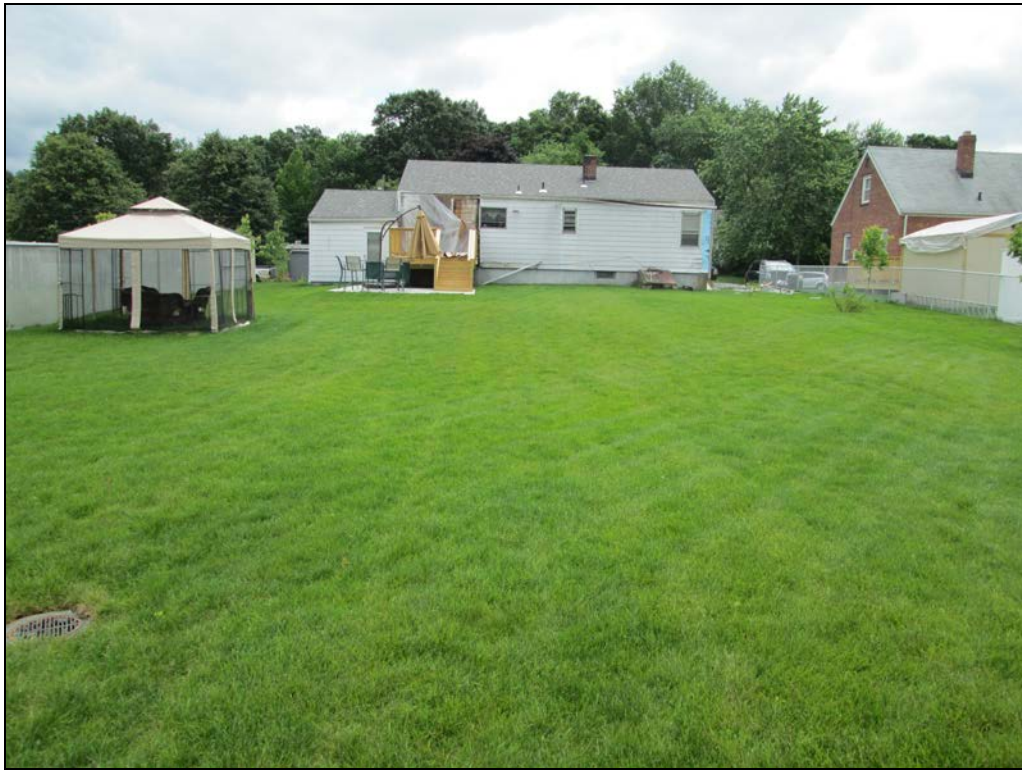
View looking east at restored back yard.
