Re: Property-Specific Remedial Action Report
Newhall Street Neighborhood
462-464 Shelton Ave, Block J
Hamden, Connecticut 06517

**PROPERTY-SPECIFIC REMEDIAL ACTION REPORT
462-464 SHELTON AVENUE**

**NON-PUBLIC PROPERTIES
NEWHALL STREET NEIGHBORHOOD
HAMDEN, CONNECTICUT**

AMEC Project Number: 6107110004/65

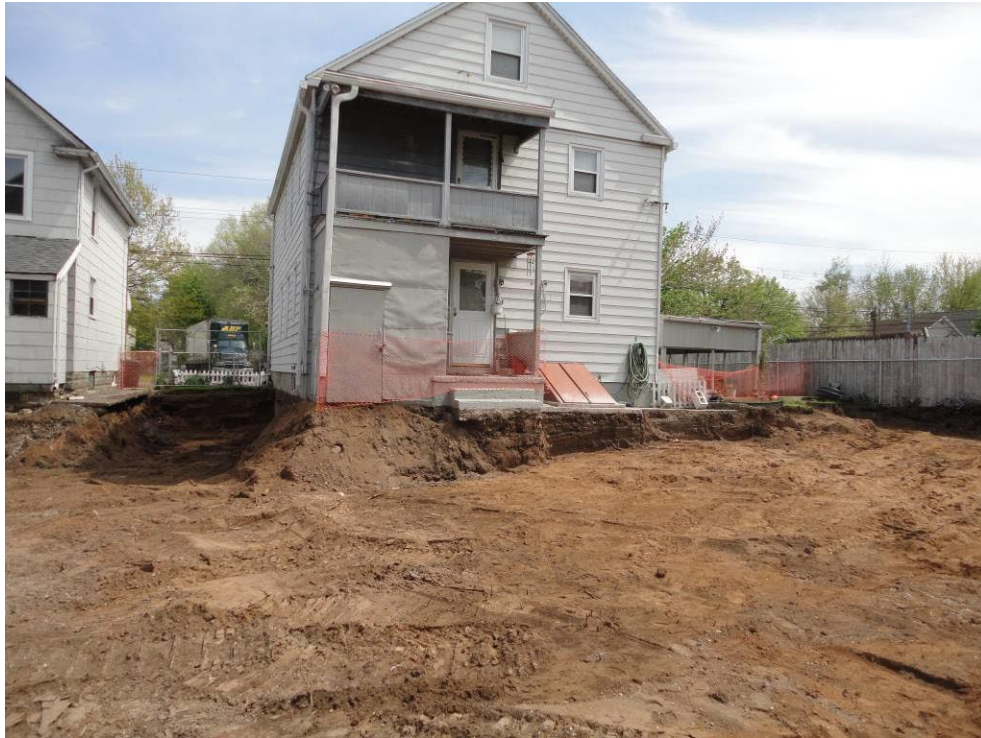
View looking East at excavation area in back yard

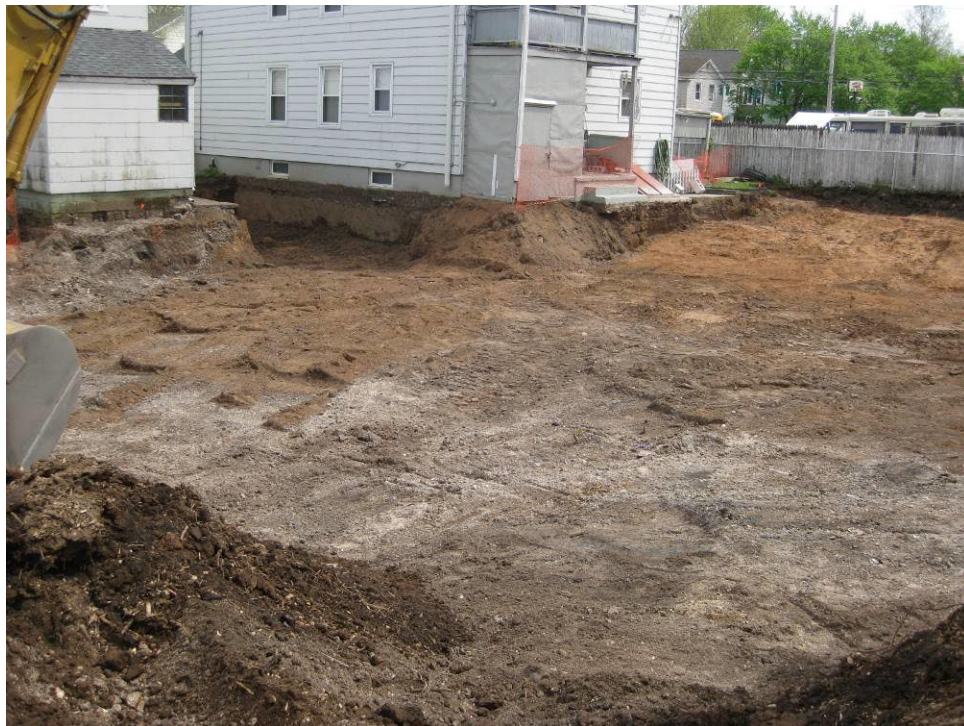
View looking Southeast at excavation area including soil wedge left in place around back stairs

As indicated in Table 2-1, most confirmation sampling results indicate total lead concentrations less than the criteria of 400 milligrams per kilogram (mg/kg) approved by DEEP in the Final Design - Generic RAP. Several samples collected from the perimeter of the excavated area indicated total lead concentrations that exceeded 400 mg/kg. Additional soil could not be removed from these locations because continued excavation could jeopardize the integrity of the structure.

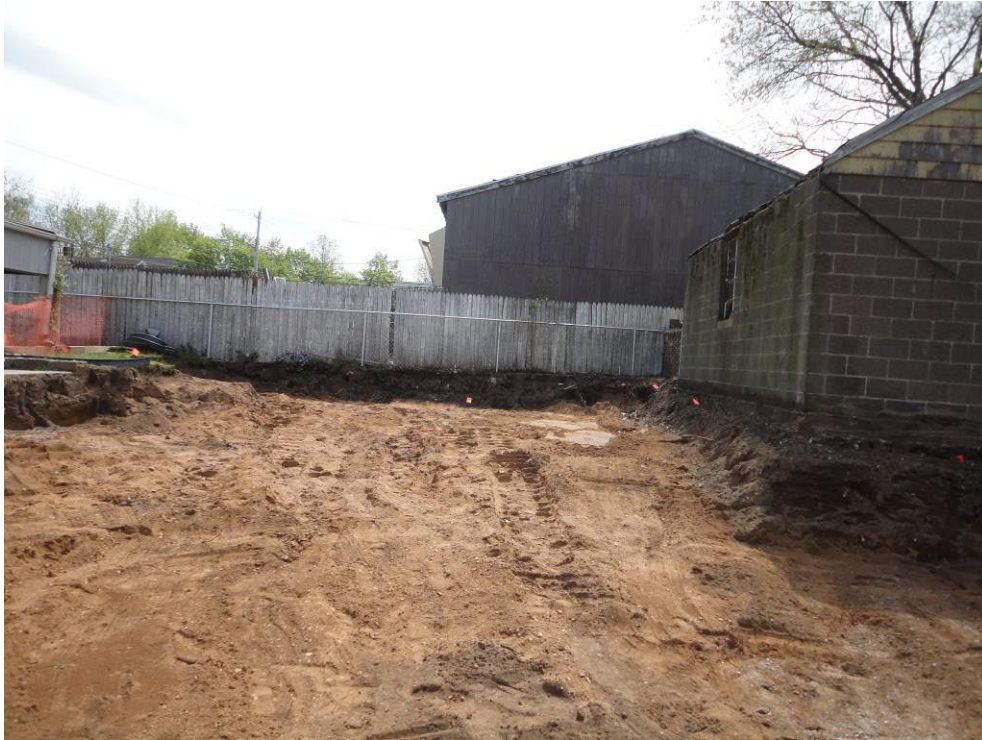
View looking South at excavated back yard
