Re: Property-Specific Remedial Action Report
Newhall Street Neighborhood
1019 Winchester Avenue, Block F
Hamden, Connecticut 06517

**PROPERTY-SPECIFIC REMEDIAL ACTION REPORT
1019 WINCHESTER AVENUE**

**NON-PUBLIC PROPERTIES
NEWHALL STREET NEIGHBORHOOD
HAMDEN, CONNECTICUT**

AMEC Project Number: 6107120004.115

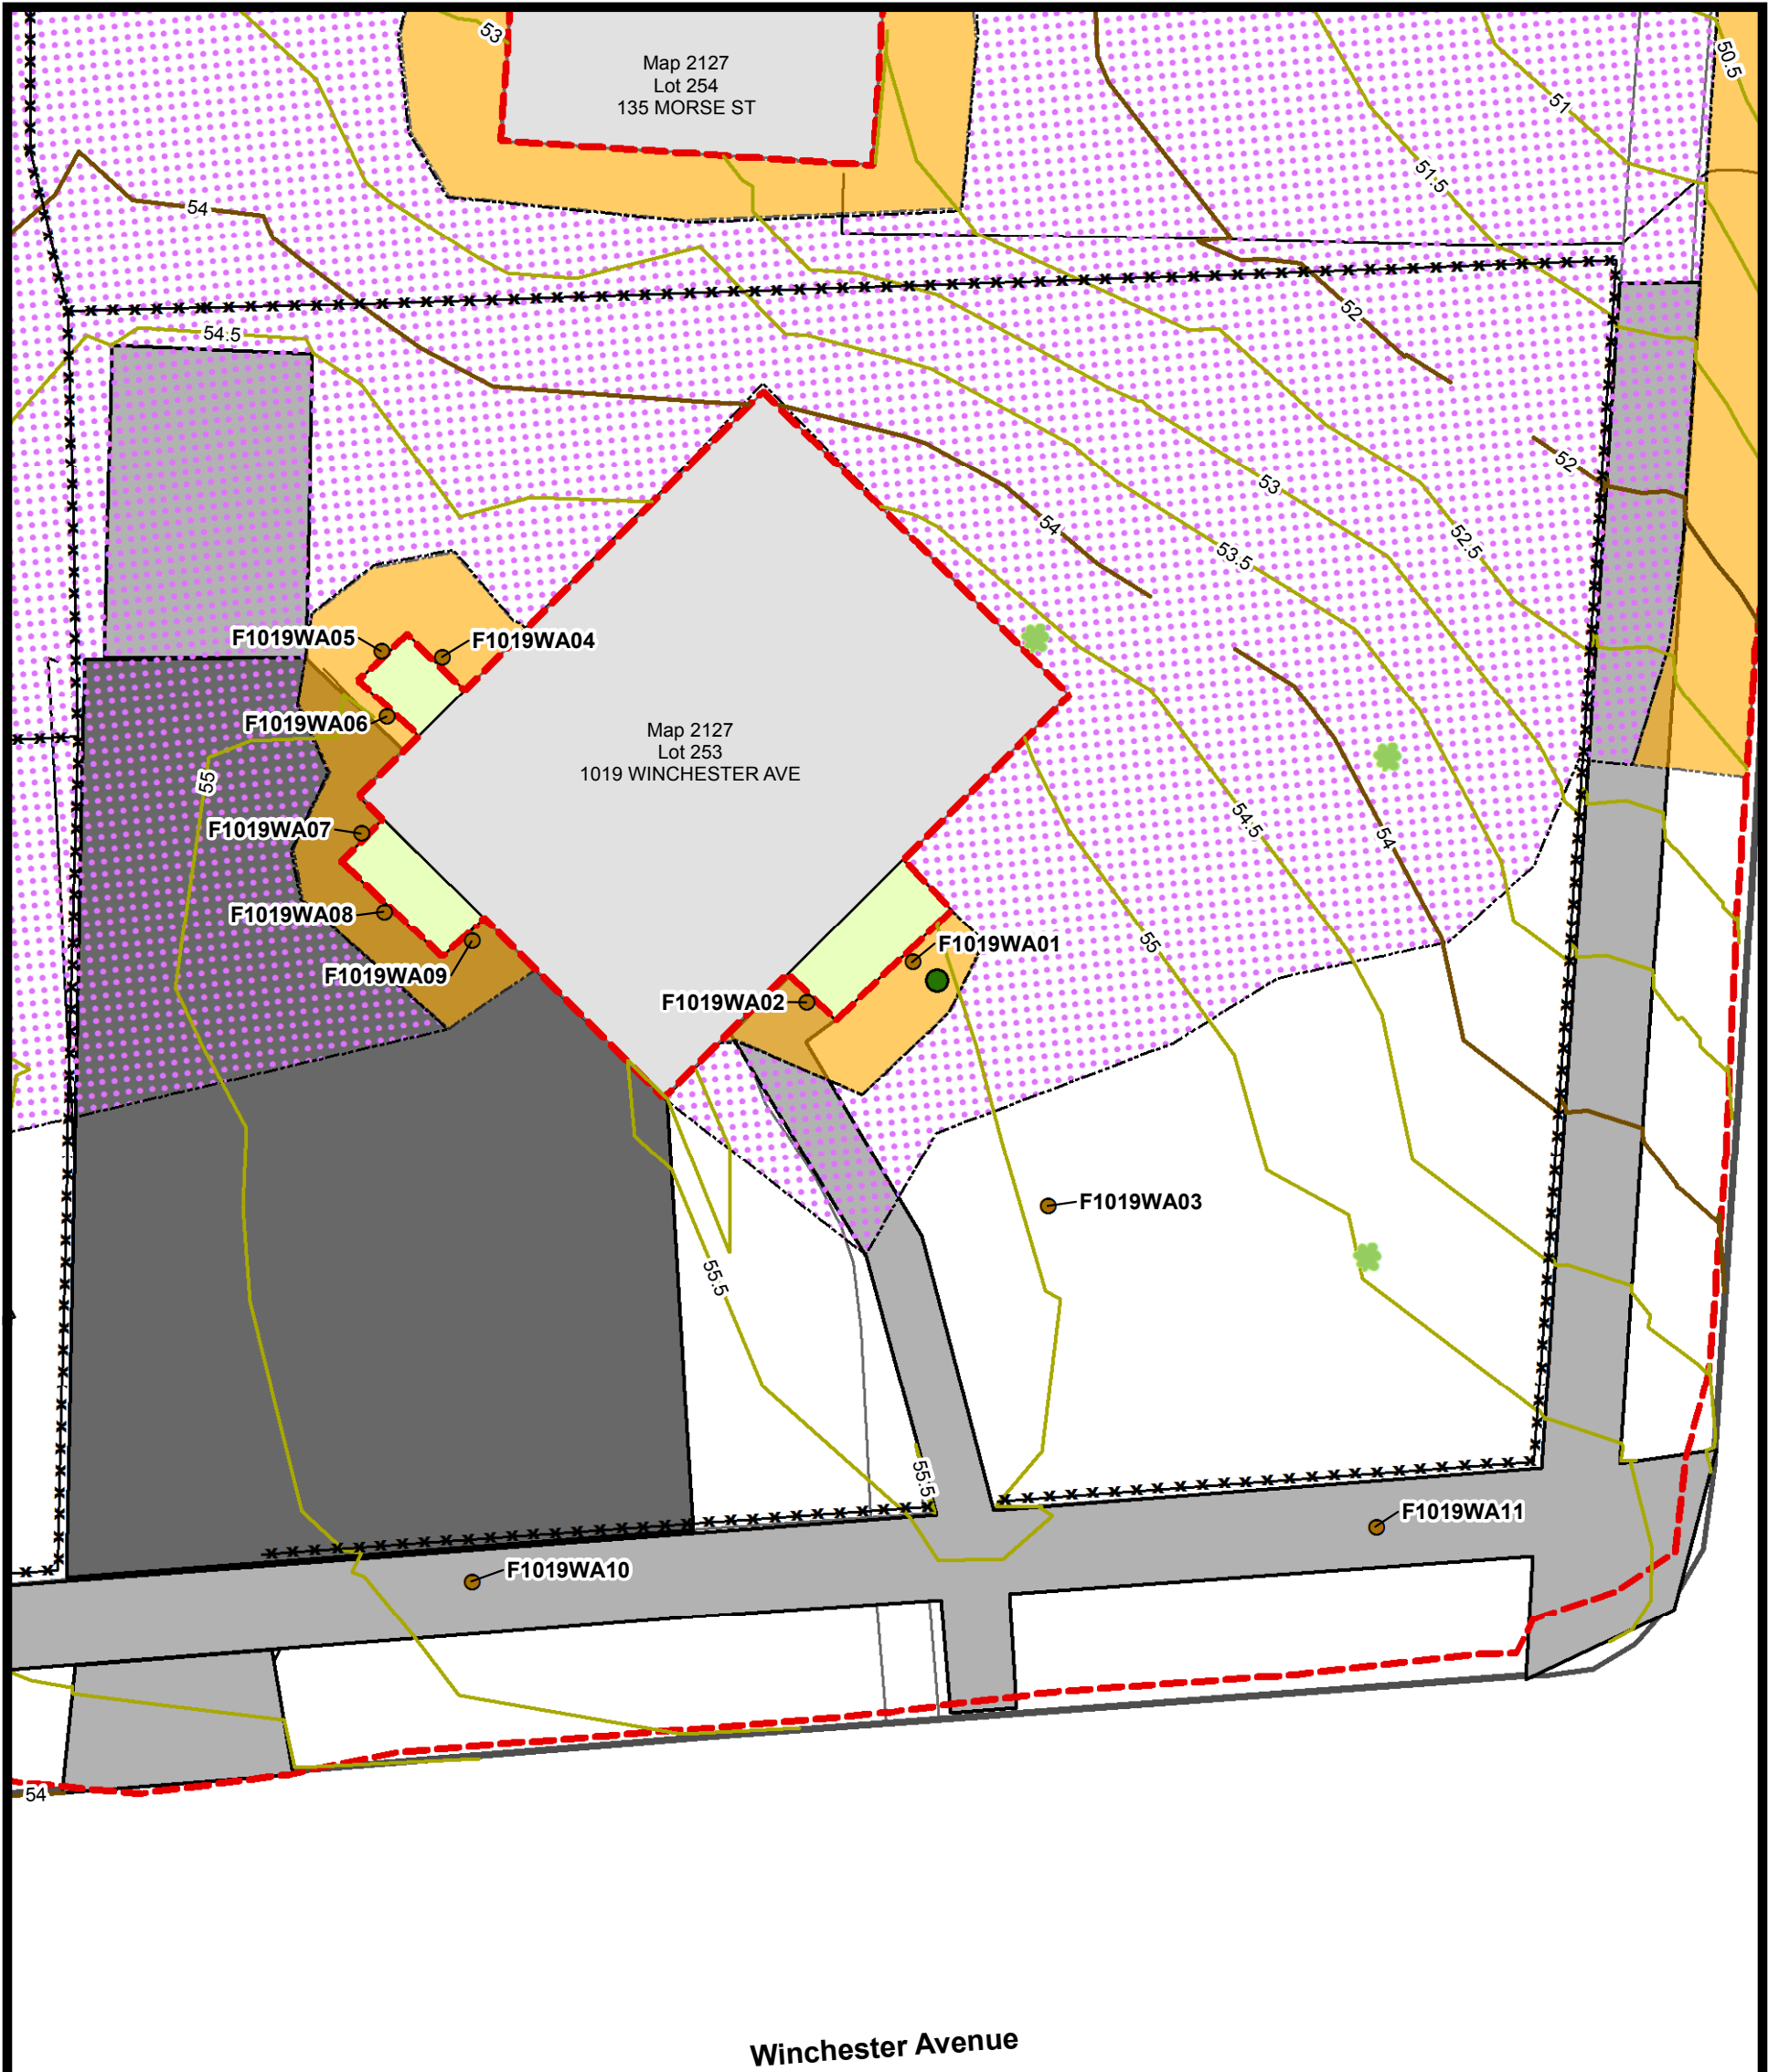
During the 2012 construction season, Olin completed the excavation, backfill, and restoration of the property in accordance with the Final Design - Generic RAP and the Property-Specific RAP. Figure 2-1 shows the areas where excavation occurred on the property and the locations of excavation confirmation samples. Excavation confirmation samples were collected in accordance with Section 3.2.3 - Confirmatory Sampling of the Final Design - Generic RAP, including adherence to the sampling frequency requirements. X-ray fluorescence (XRF) excavation confirmation sampling results are presented in Table 2-1.

- In certain locations on the property, fill material was present at depths greater than 4 feet below ground surface (bgs). This fill material was left in place, covered by an orange geotextile fabric, and backfilled with clean soil in accordance with the Final Design - Generic RAP. Figure 2-1 shows the approximate area of geotextile fabric identifying the presence of fill at a depth greater than 4 feet bgs.
- In some locations, it was necessary to leave fill material in place at depths less than 4 feet bgs in order to avoid jeopardizing the integrity of a structure. This fill material was left in place, covered by an orange geotextile fabric and/or concrete, and backfilled with clean soil in accordance with the Final Design - Generic RAP. Figure 2-1 shows the approximate area of geotextile fabric/concrete identifying the presence of fill at a depth less than 4 feet bgs.

As indicated in Table 2-1, some of the samples collected from the perimeter of the excavated area indicated total lead concentrations that exceeded 400 mg/kg. Additional soil could not be removed from these locations, because continued excavation could jeopardize the integrity of a structure or undermine a feature that was to be left in place.

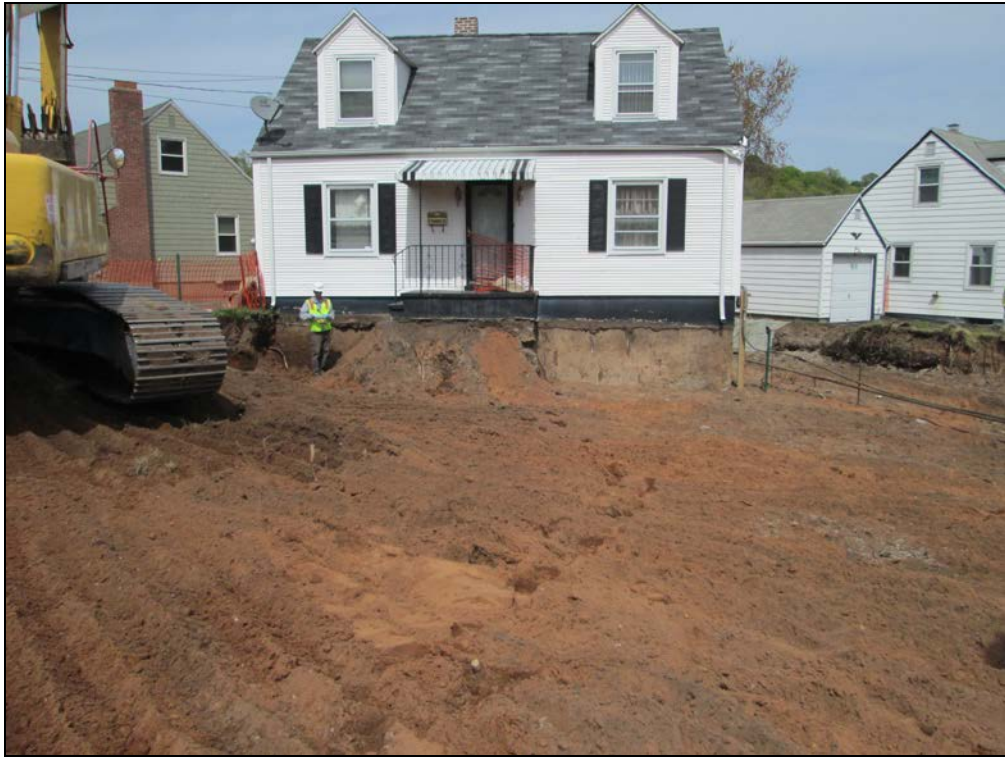
View facing northeast at excavated front yard prior to the placement of marker barrier.

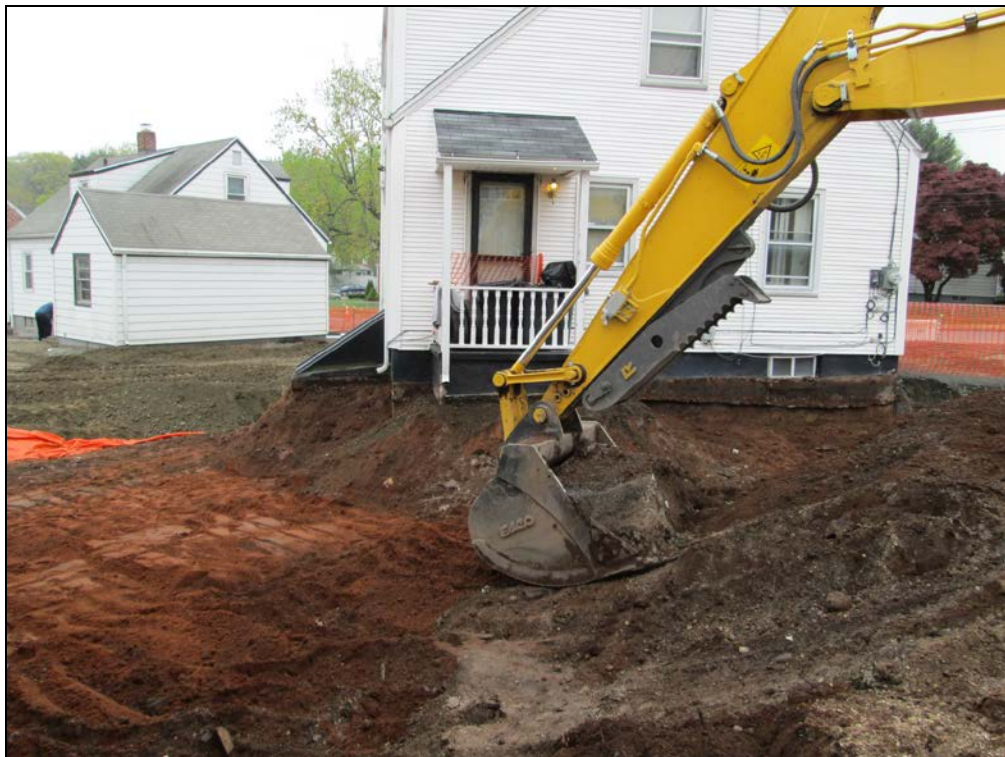
View looking southeast at excavated side yard prior to placement of marker barrier.

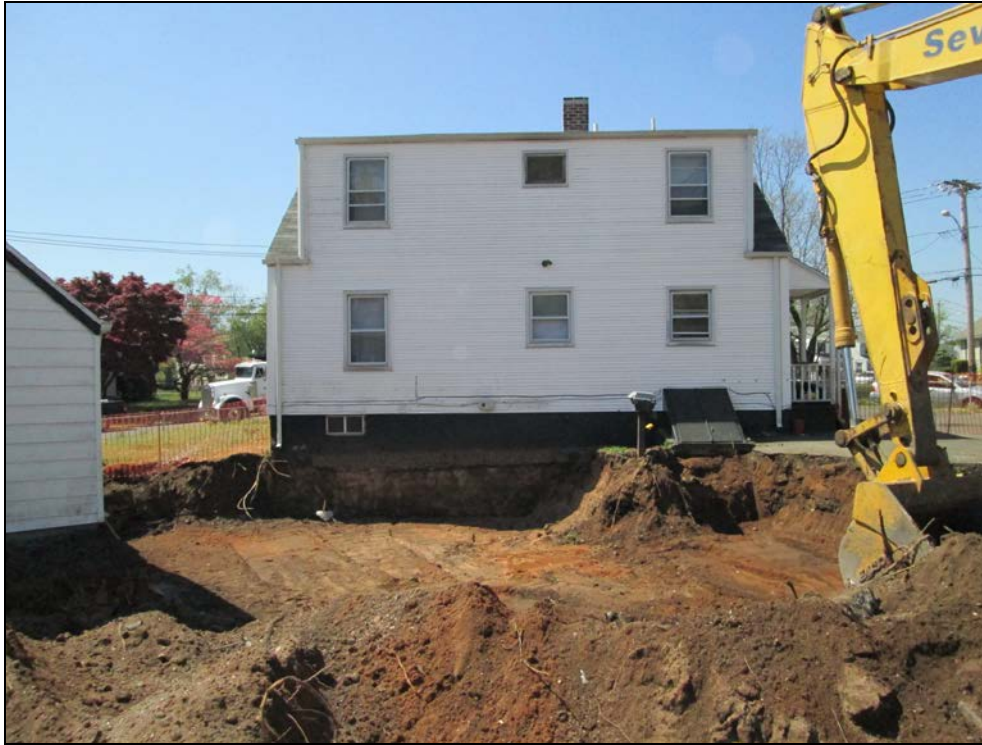
View looking southwest at excavated back yard prior to placement of marker barrier.

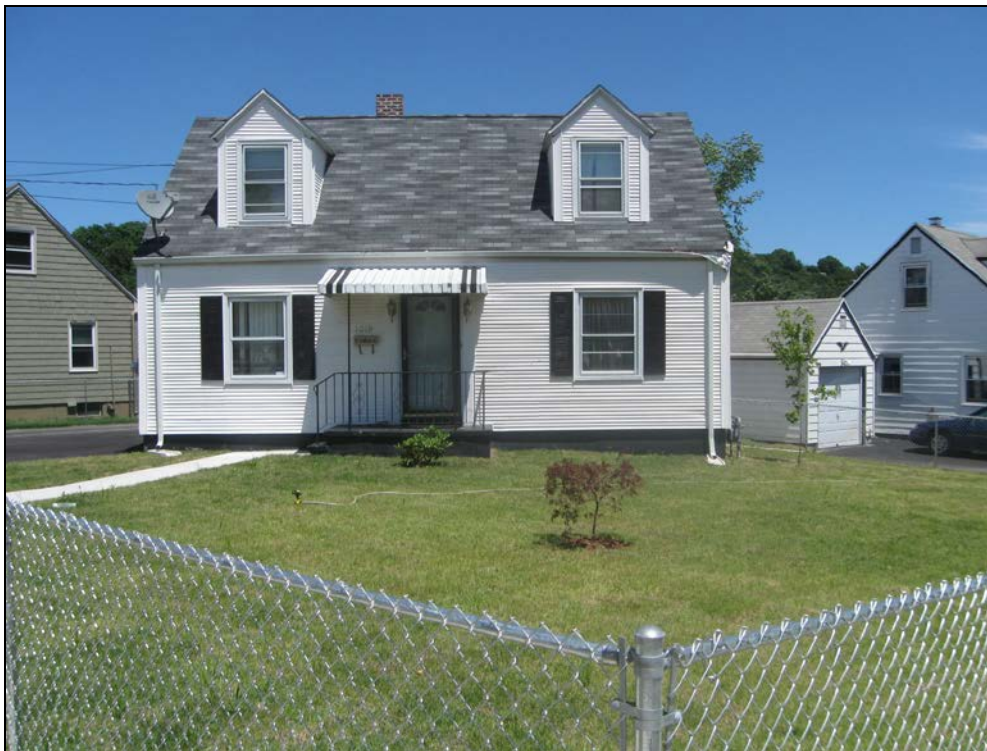
View looking northeast at restored front yard.

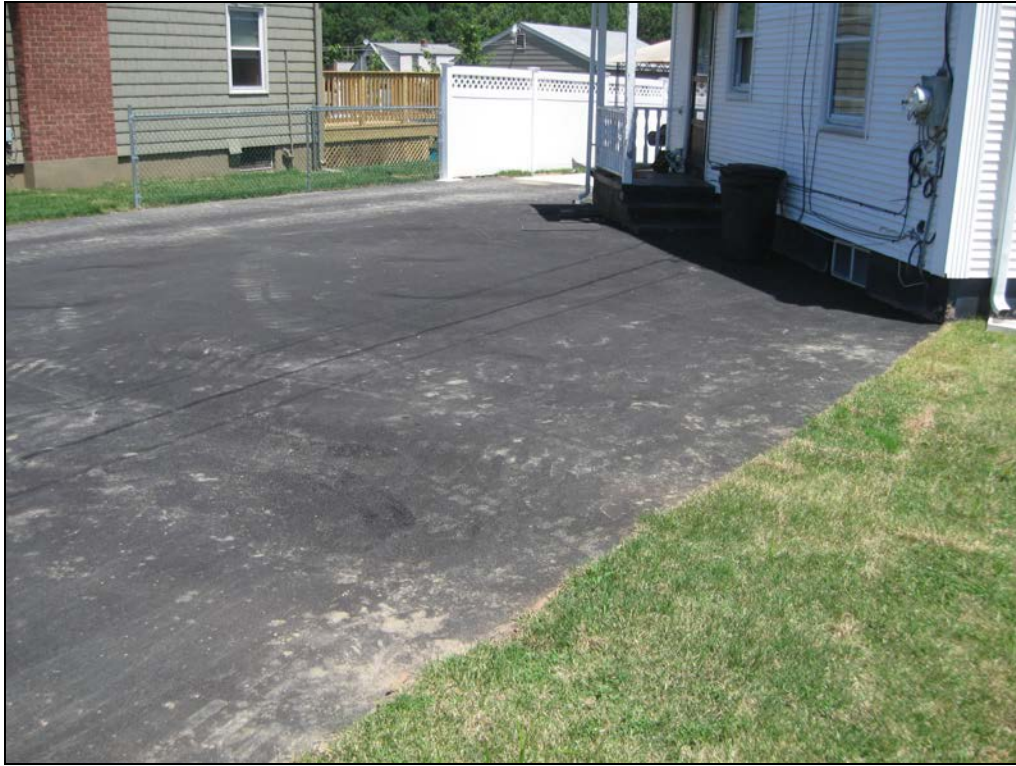
View looking northeast at restored driveway.

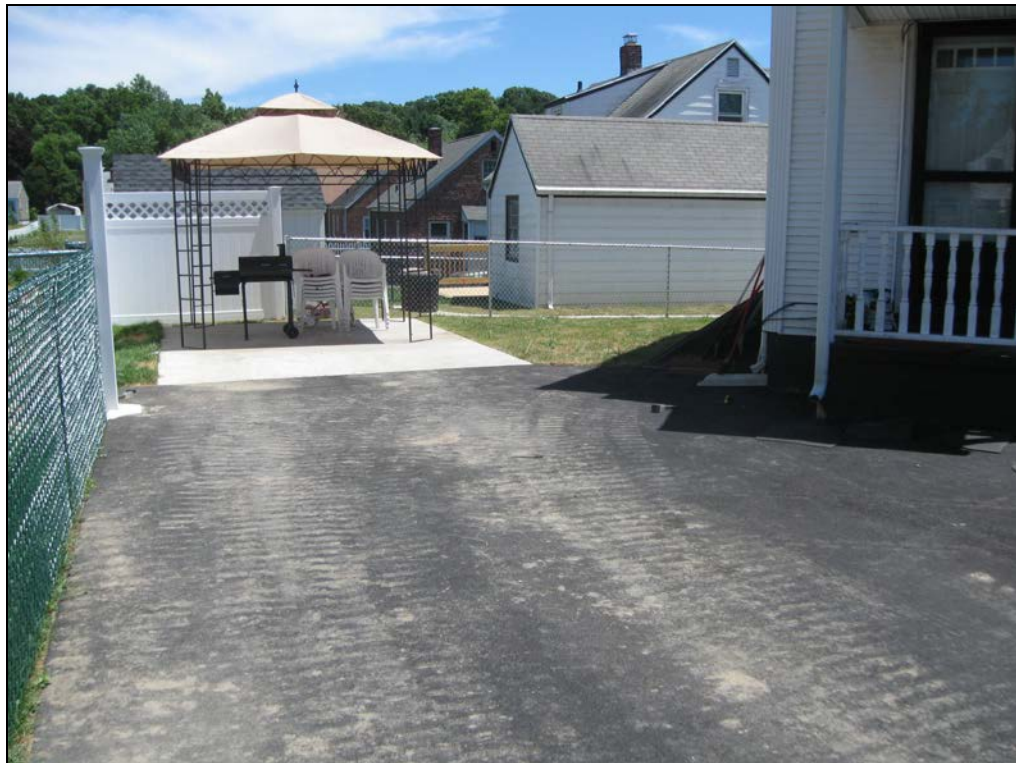
View looking southeast at restored back yard.
