Re: Property-Specific Remedial Action Report
Newhall Street Neighborhood
1027 Winchester Avenue, Block F
Hamden, Connecticut 06517

**PROPERTY-SPECIFIC REMEDIAL ACTION REPORT
1027 WINCHESTER AVENUE**

**NON-PUBLIC PROPERTIES
NEWHALL STREET NEIGHBORHOOD
HAMDEN, CONNECTICUT**

AMEC Project Number: 6107120004.115

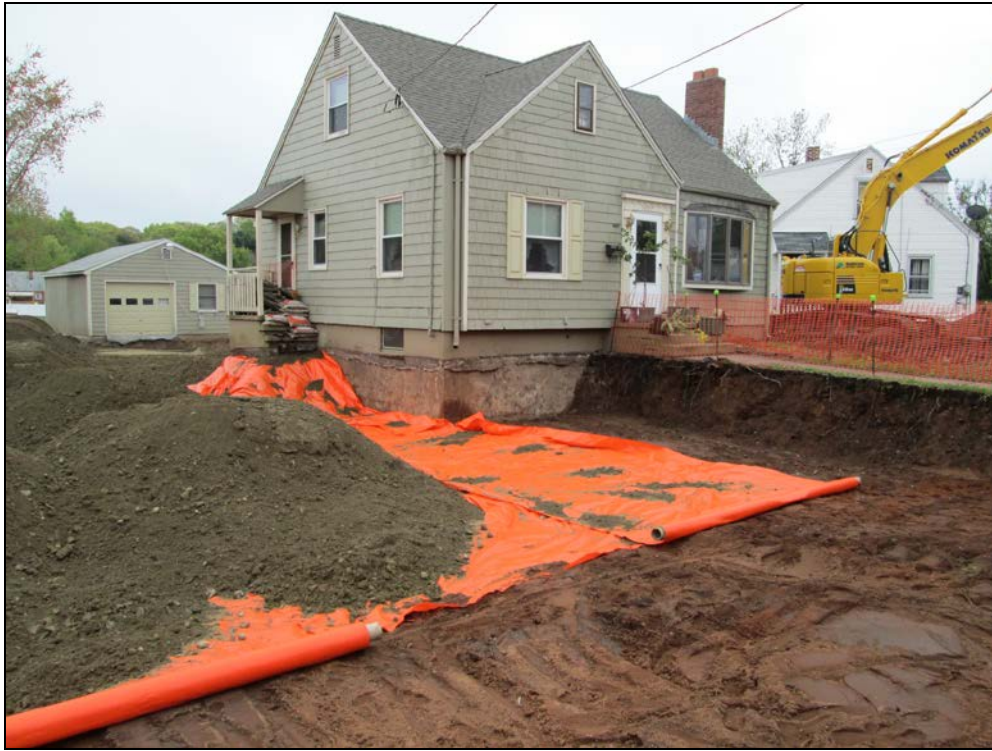
View facing southeast at excavated front yard with marker barrier being installed.

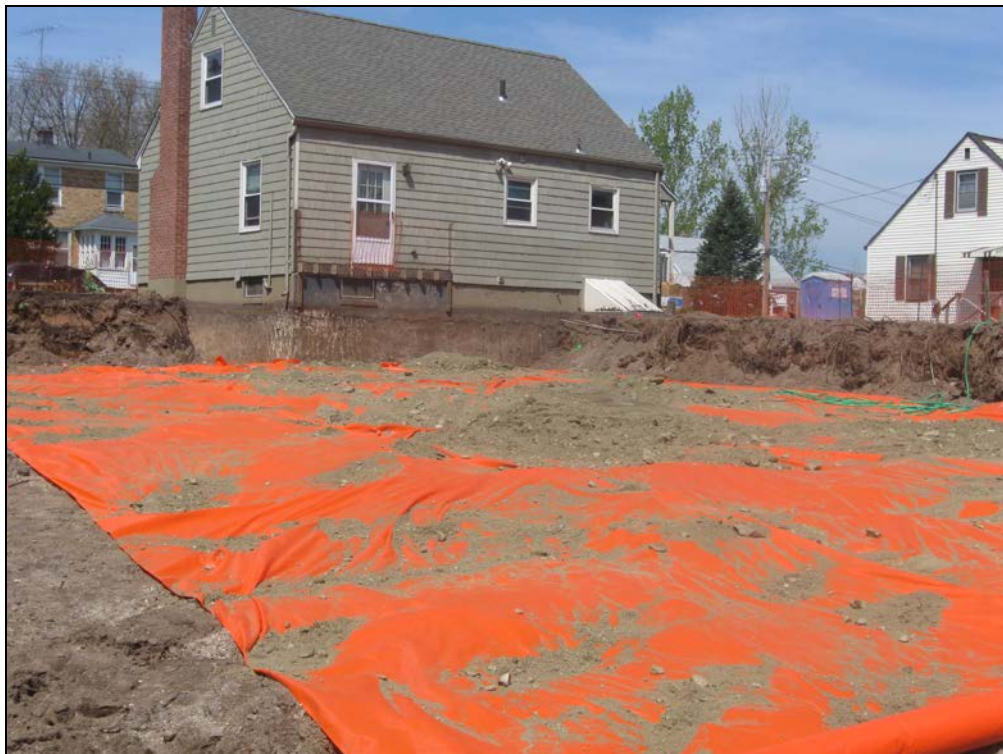
View looking northwest at excavated back yard.

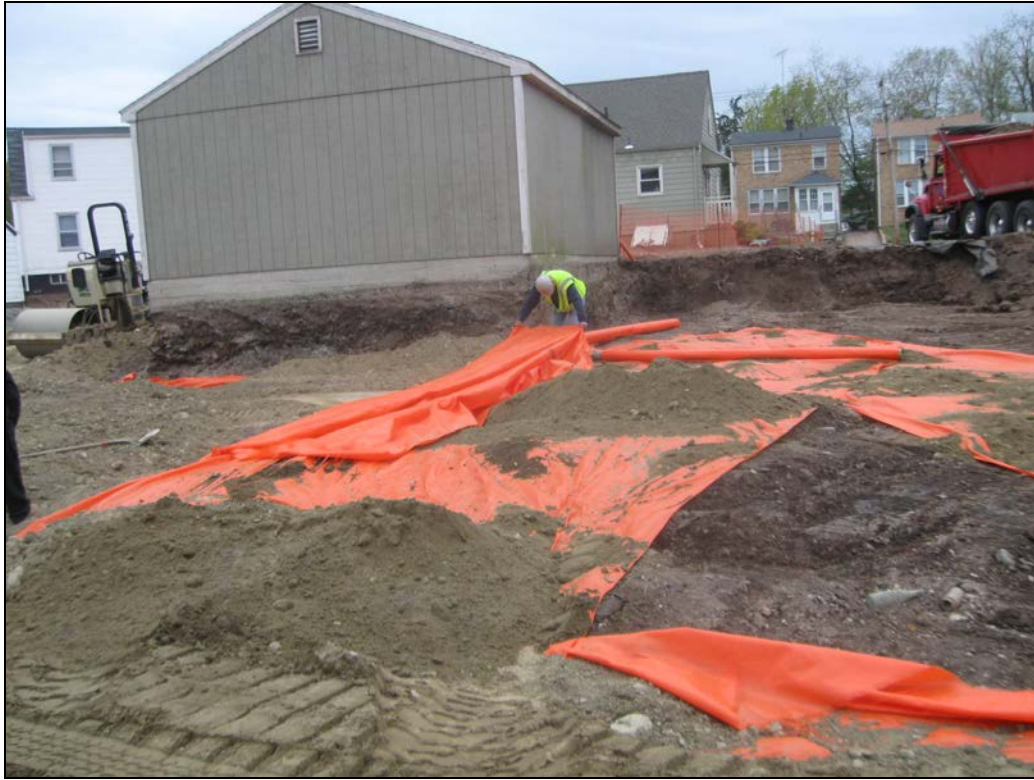
View looking west at marker barrier being installed around garage.

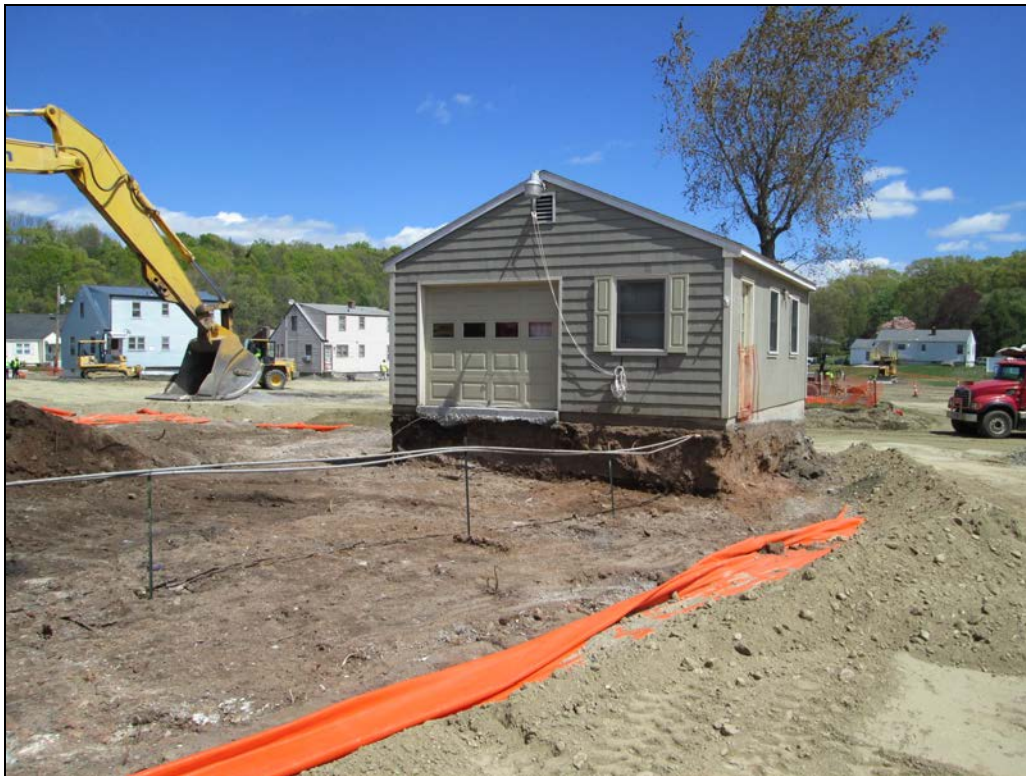
View looking east at excavated back yard.

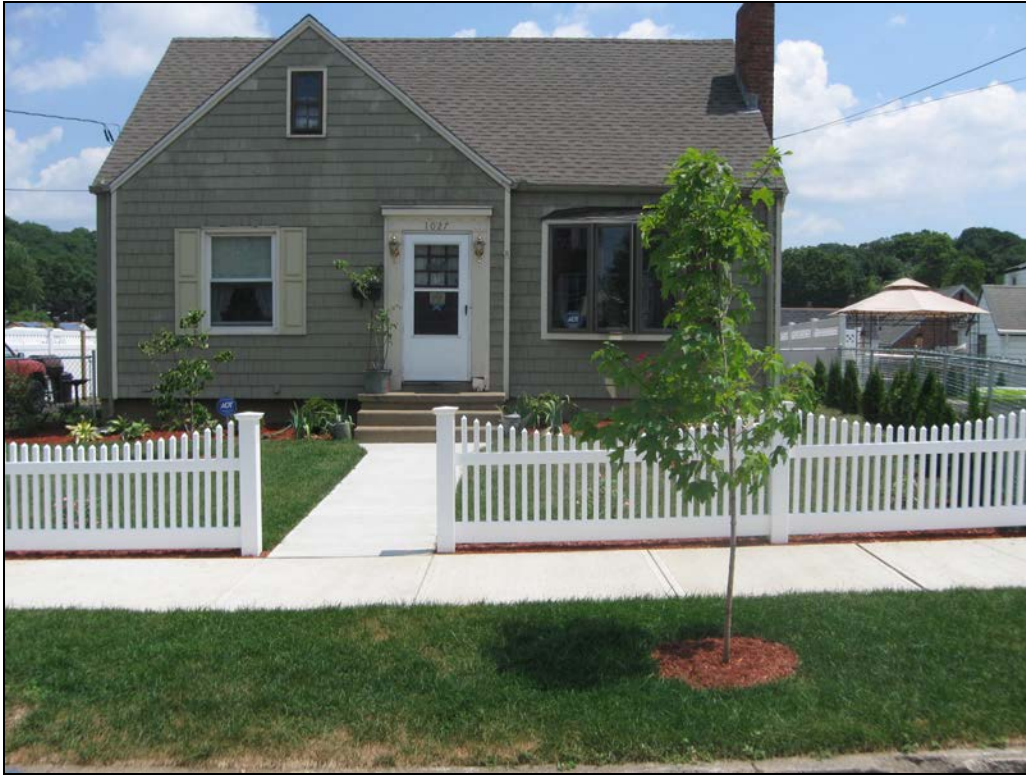
View looking east at restored front yard.

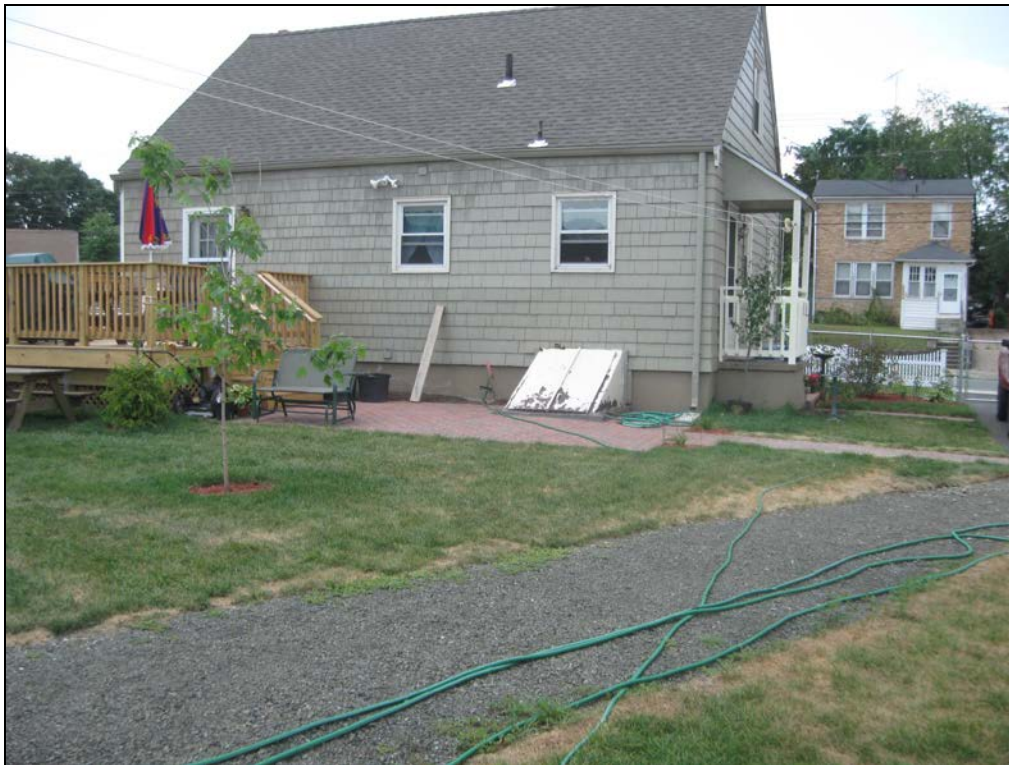
View looking west at restored back yard.

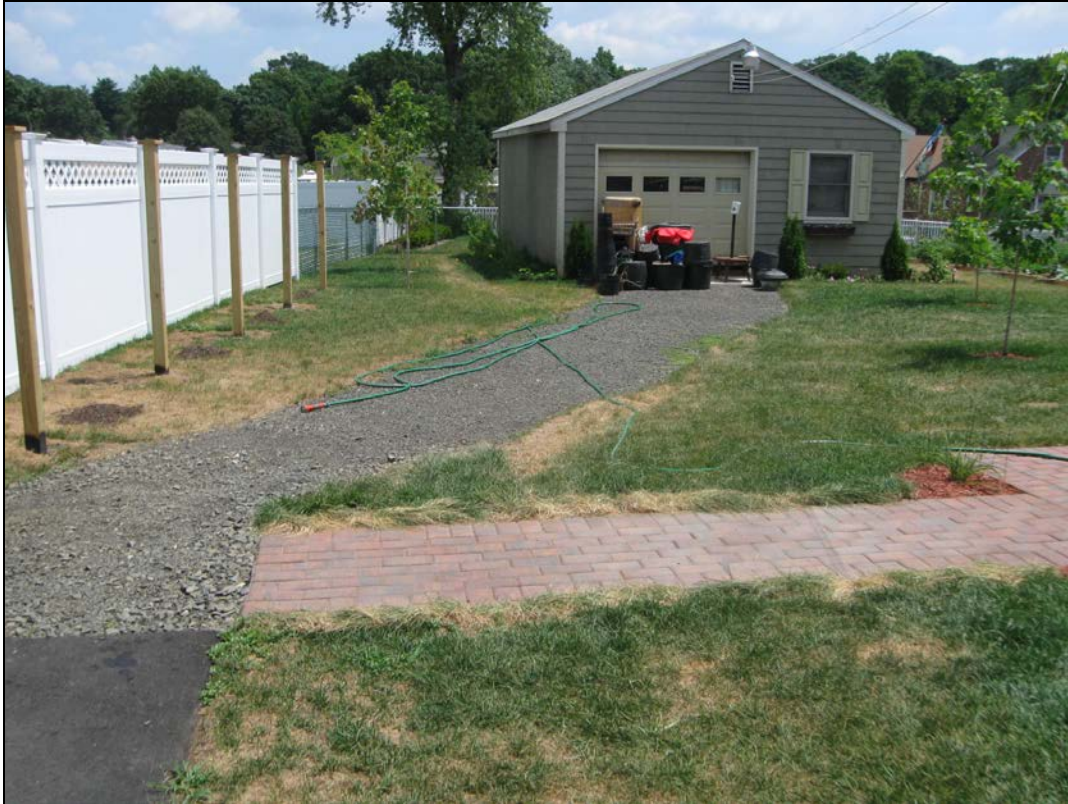
View looking east at restored back yard.
