Re: Property-Specific Remedial Action Report  
Newhall Street Neighborhood  
1071 Winchester Avenue, Block C  
Hamden, Connecticut 06517

**PROPERTY-SPECIFIC REMEDIAL ACTION REPORT  
1071 WINCHESTER AVENUE**

**NON PUBLIC PROPERTIES  
NEWHALL STREET NEIGHBORHOOD  
HAMDEN, CONNECTICUT**

AMEC Project Number: 6107120004/105

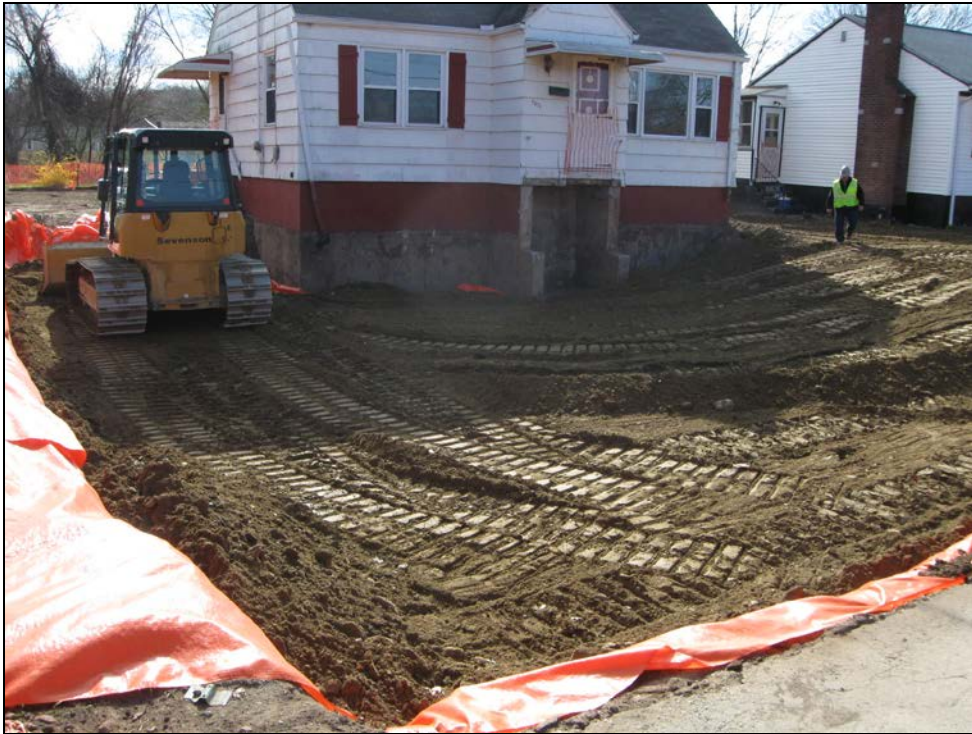
**View looking east at partially backfilled front yard with marker barrier at limits of excavation.**

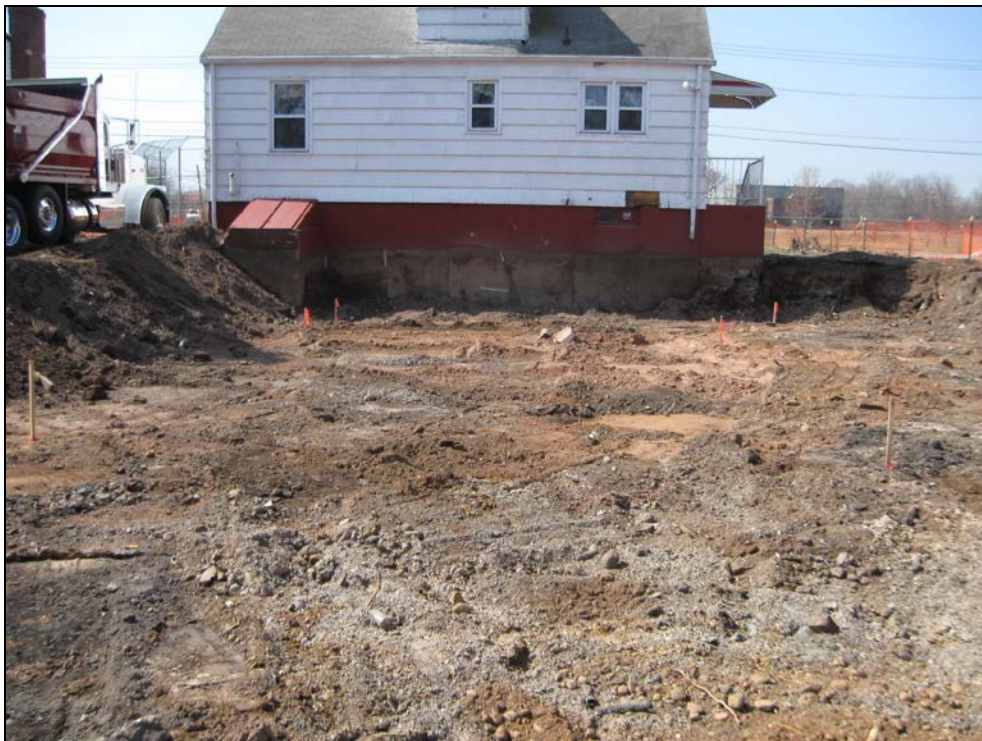
**View looking west at excavated back yard prior to marker barrier being placed at the base.**

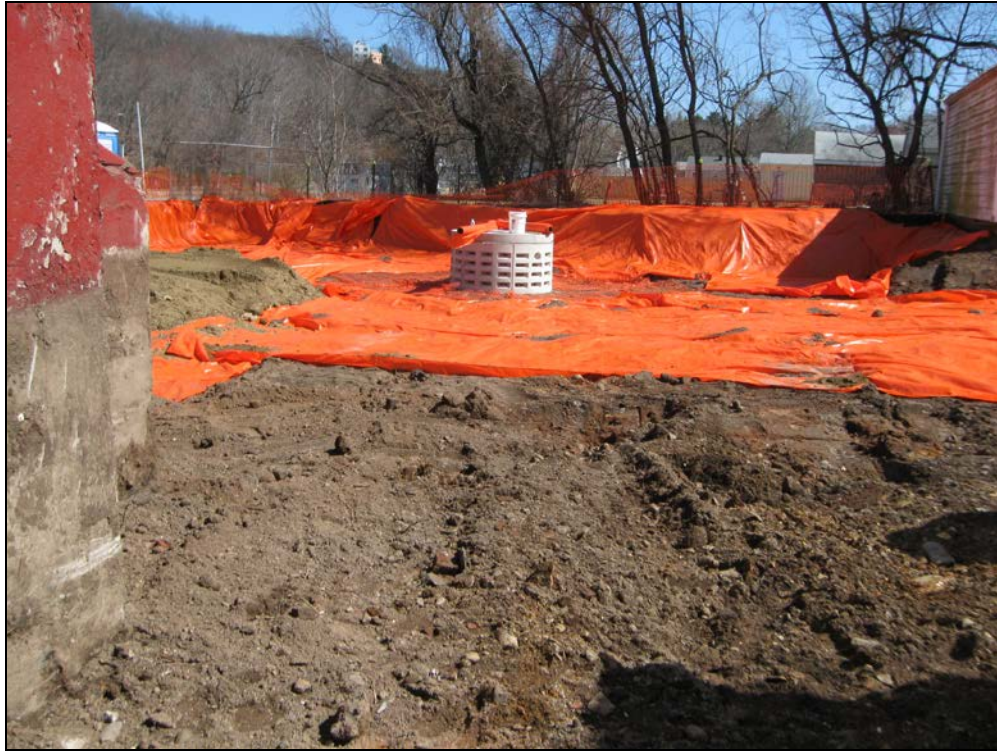
View looking east at new drywell and marker barrier being placed at excavation limits.

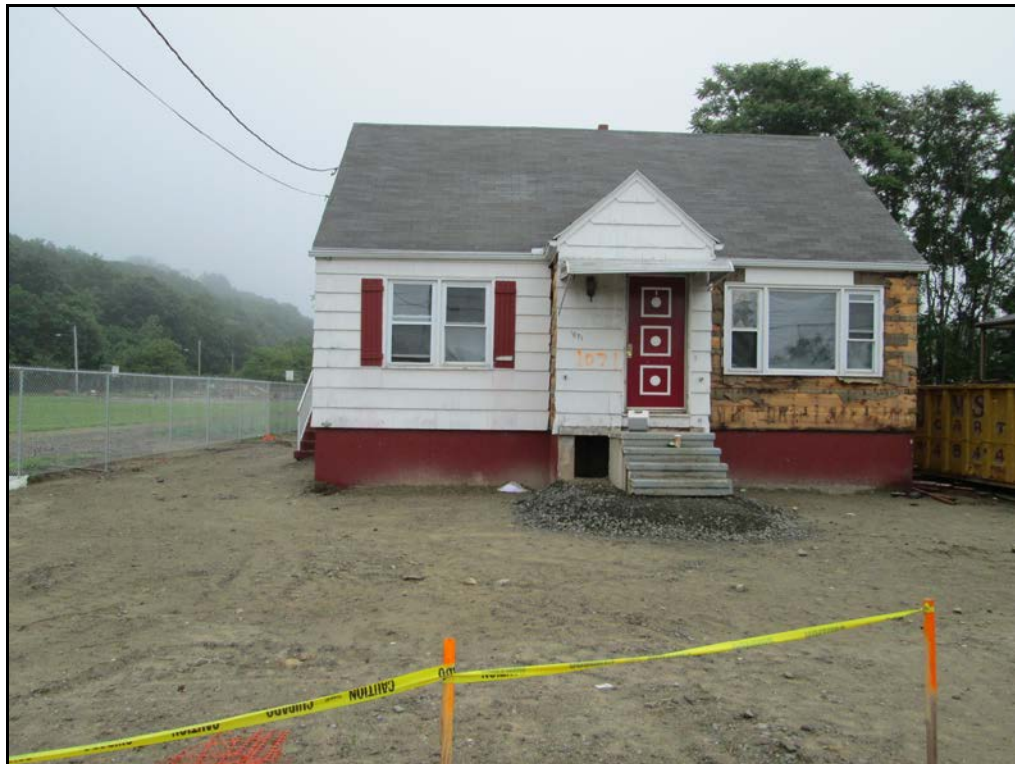
View looking east at backfilled front yard.

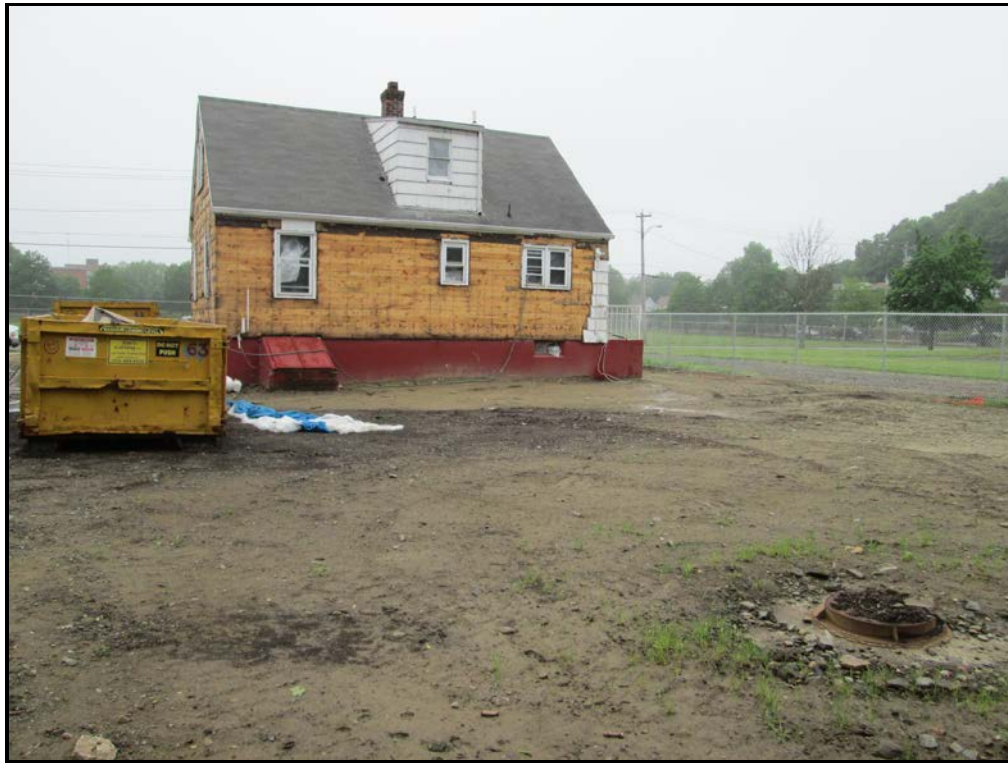
**View looking west at backfilled back yard and new drywell.**
