Re: Property-Specific Remedial Action Report
Newhall Street Neighborhood
109 Marlboro Street, Block K
Hamden, Connecticut 06517

**PROPERTY-SPECIFIC REMEDIAL ACTION REPORT
109 MARLBORO STREET**

**NON-PUBLIC PROPERTIES
NEWHALL STREET NEIGHBORHOOD
HAMDEN, CONNECTICUT**

AMEC Project Number: 6107110004/95

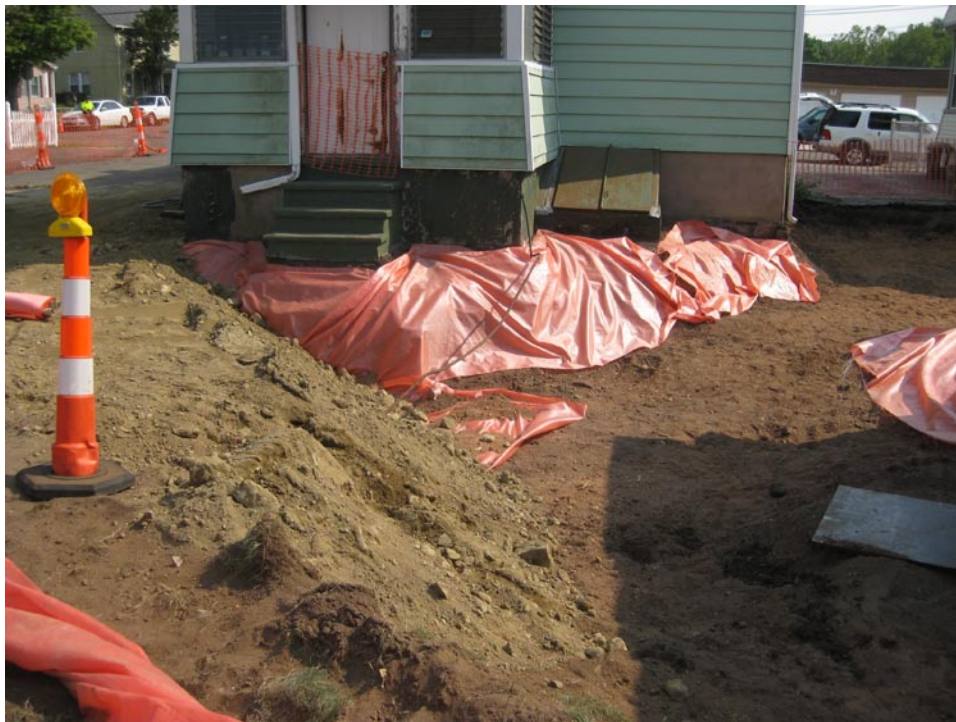
View looking South at excavation in back yard following placement of marker barrier

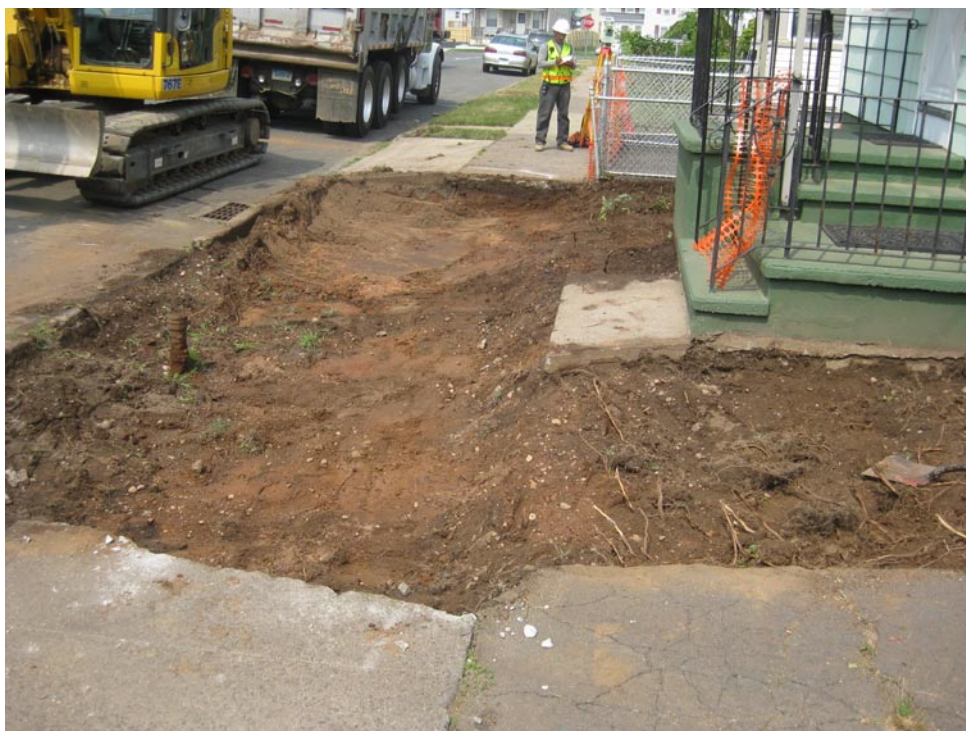
View looking West at excavation of front yard

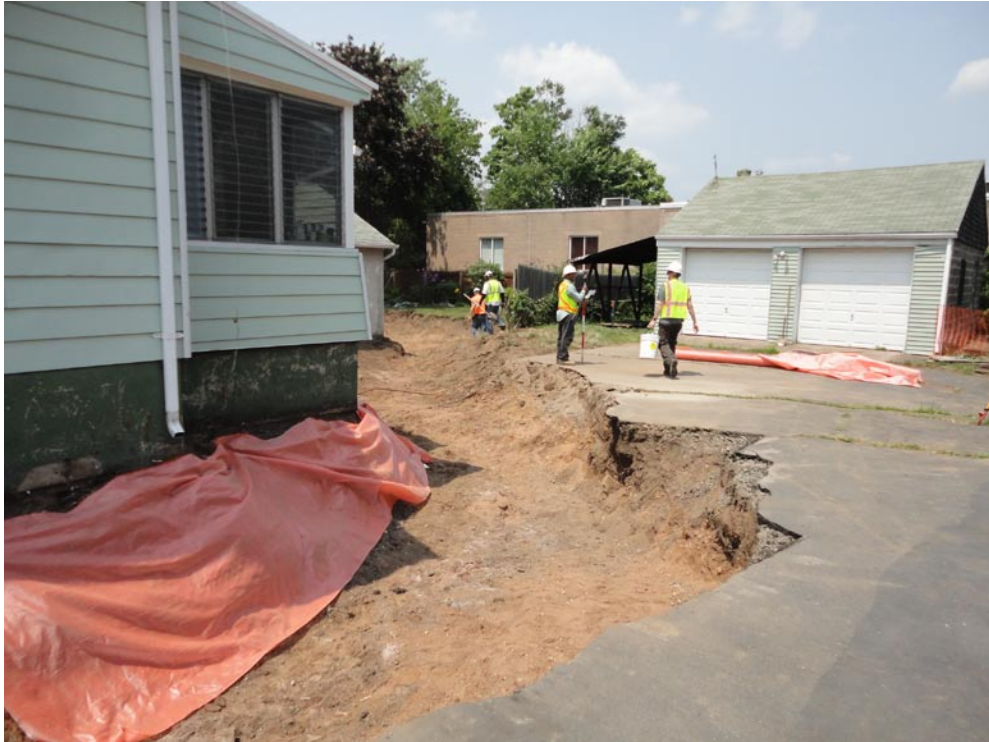
View looking Northwest at excavation area

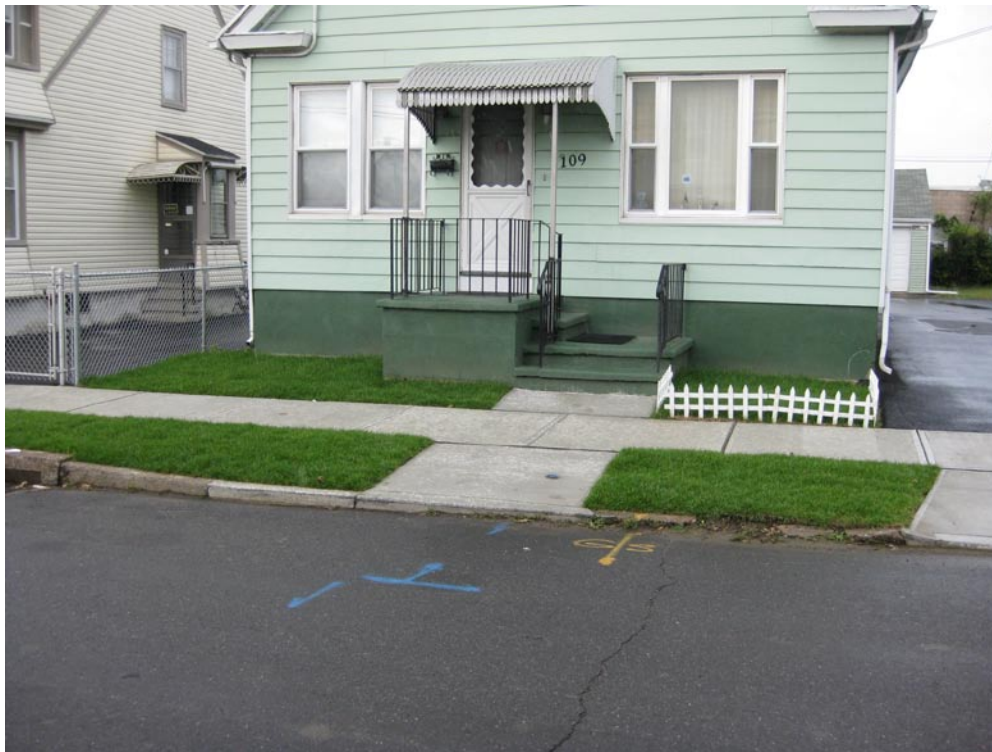
View looking North at restored front yard

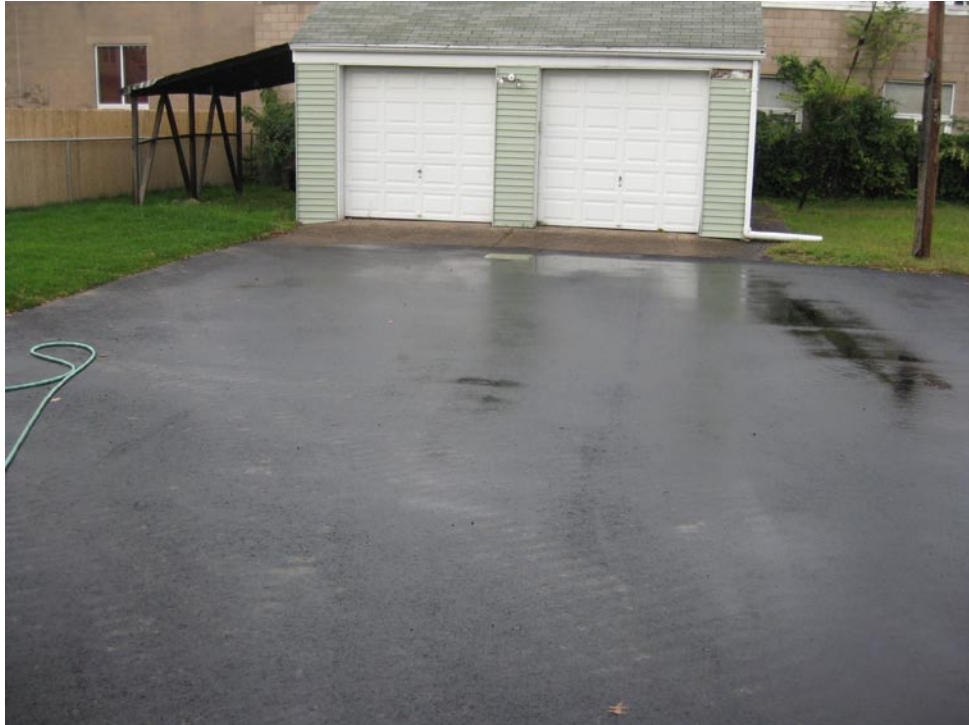
View looking North at restored driveway

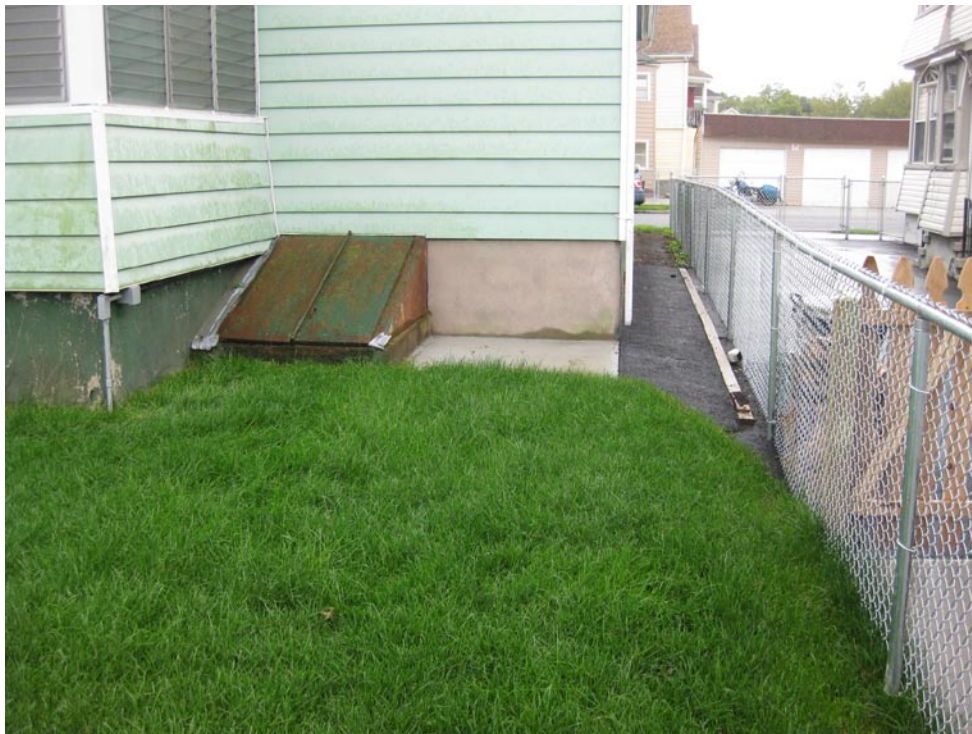
View looking South at restored back yard
