Re: Property-Specific Remedial Action Report
Newhall Street Neighborhood
112 Bryden Terrace, Block F
Hamden, Connecticut 06517

**PROPERTY-SPECIFIC REMEDIAL ACTION REPORT
112 BRYDEN TERRACE**

**NON-PUBLIC PROPERTIES
NEWHALL STREET NEIGHBORHOOD
HAMDEN, CONNECTICUT**

AMEC Project Number: 6107120004.115

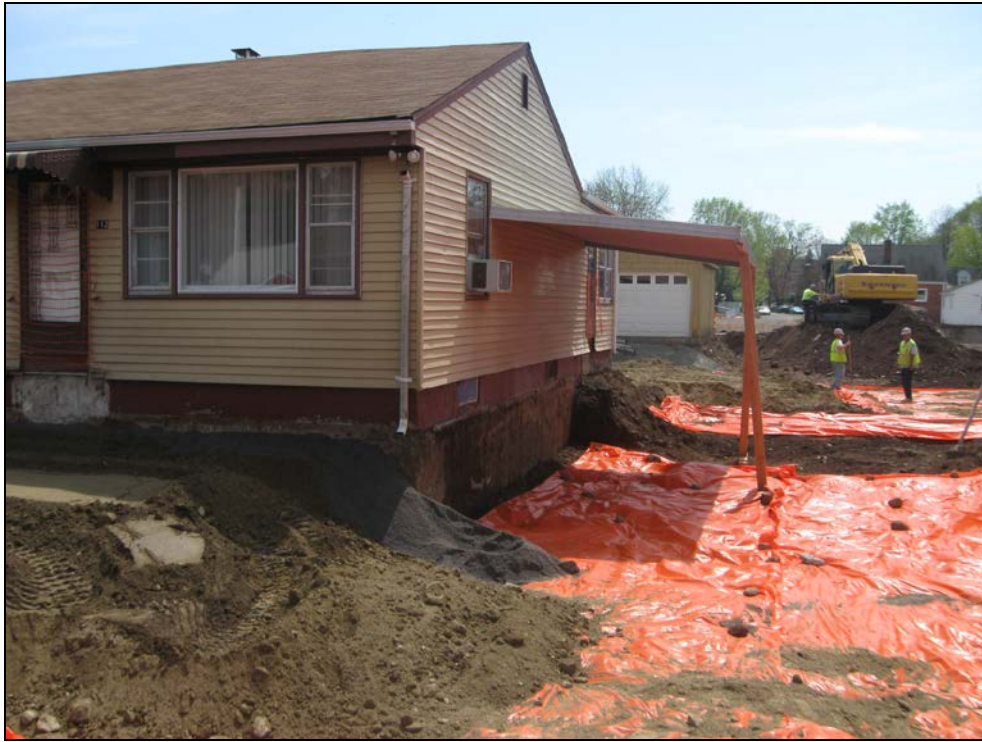
View facing south at excavated side yard under car port.

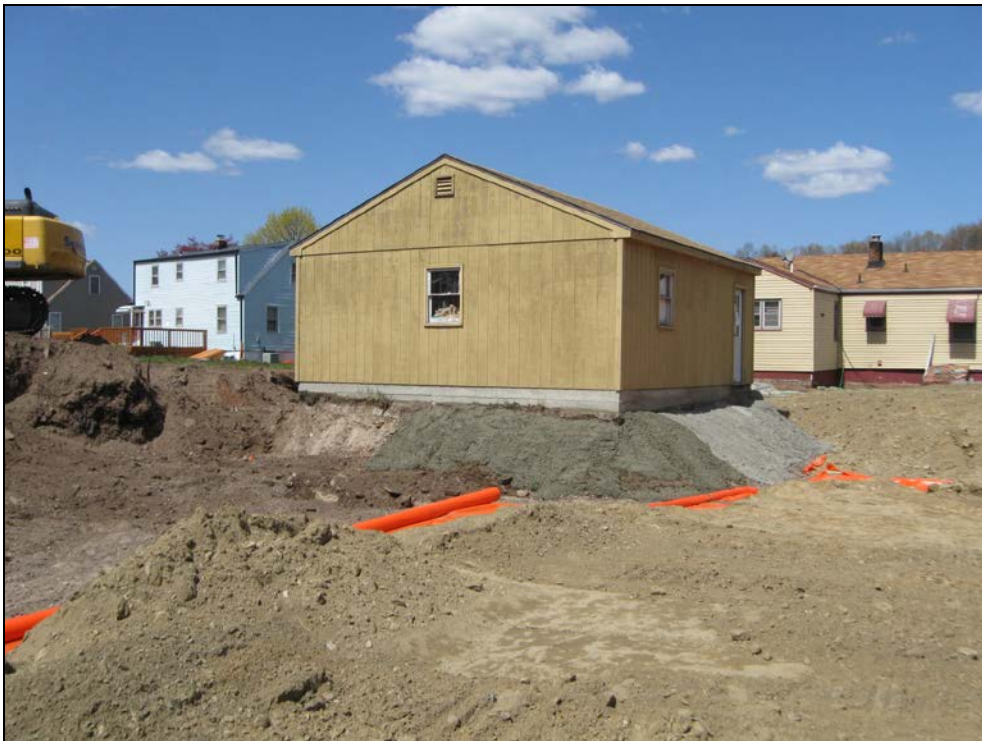
View looking north at excavated back yard with marker barrier over remaining fill.

- Throughout the entire property, fill material was present at depths greater than 4 feet below ground surface (bgs). This fill material was left in place, covered by an orange geotextile fabric, and backfilled with clean soil in accordance with the Final Design - Generic RAP. Figure 2-1 shows the approximate area of geotextile fabric identifying the presence of fill at a depth greater than 4 feet bgs.

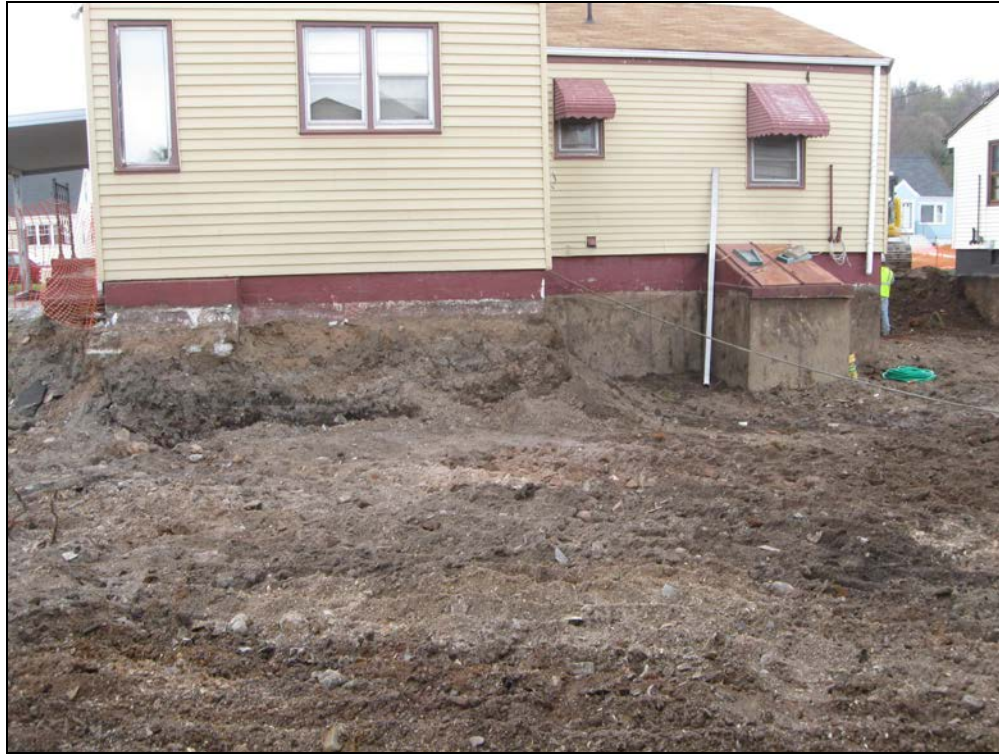
View looking north at excavated back yard prior to marker barrier being installed.

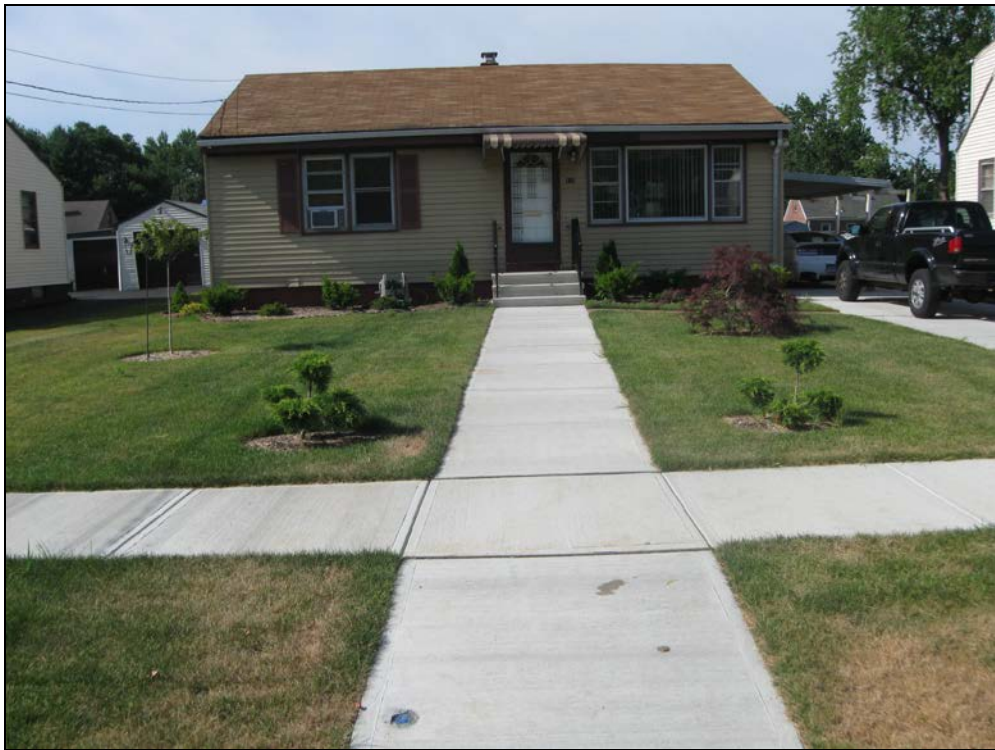
View looking south at restored front yard.

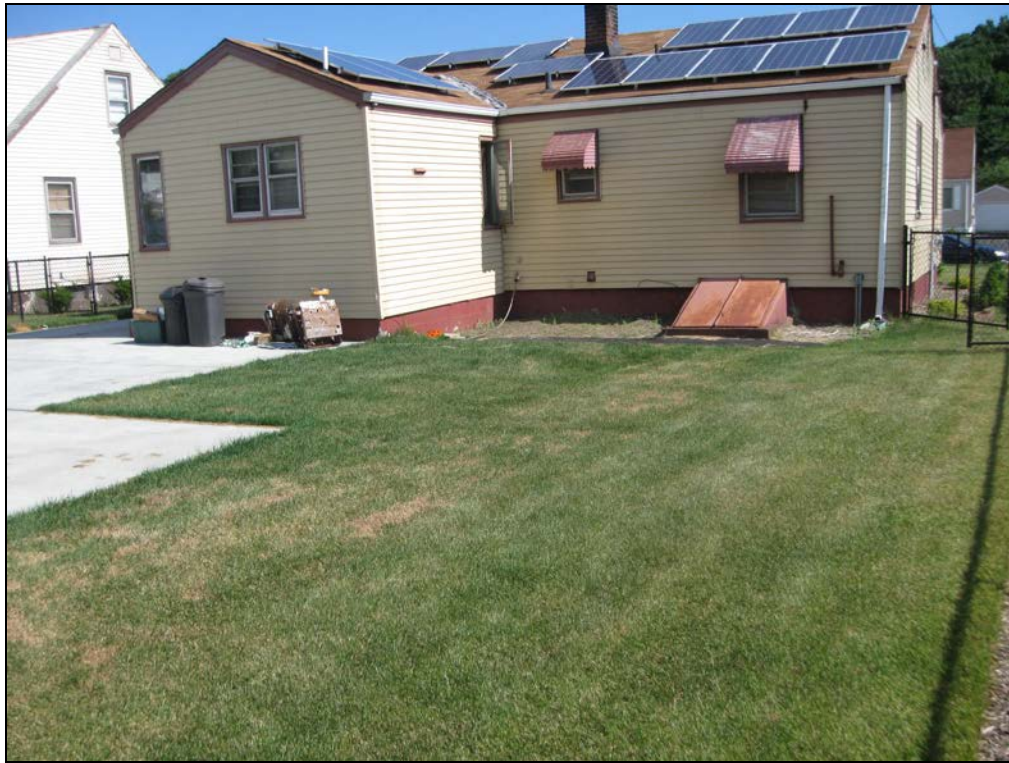
View looking north at restored back yard.

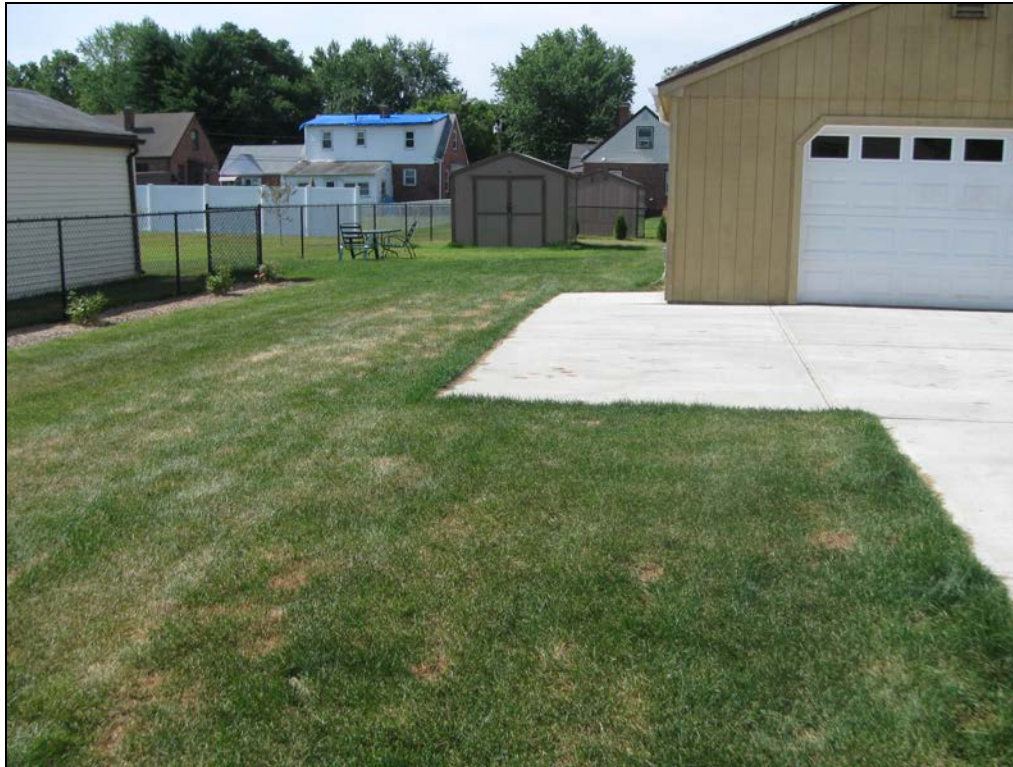
View looking south at restored back yard.
