Re: Property-Specific Remedial Action Report
Newhall Street Neighborhood
124 Bryden Terrace, Block F
Hamden, Connecticut 06517

**PROPERTY-SPECIFIC REMEDIAL ACTION REPORT
124 BRYDEN TERRACE**

**NON-PUBLIC PROPERTIES
NEWHALL STREET NEIGHBORHOOD
HAMDEN, CONNECTICUT**

AMEC Project Number: 6107120004.115

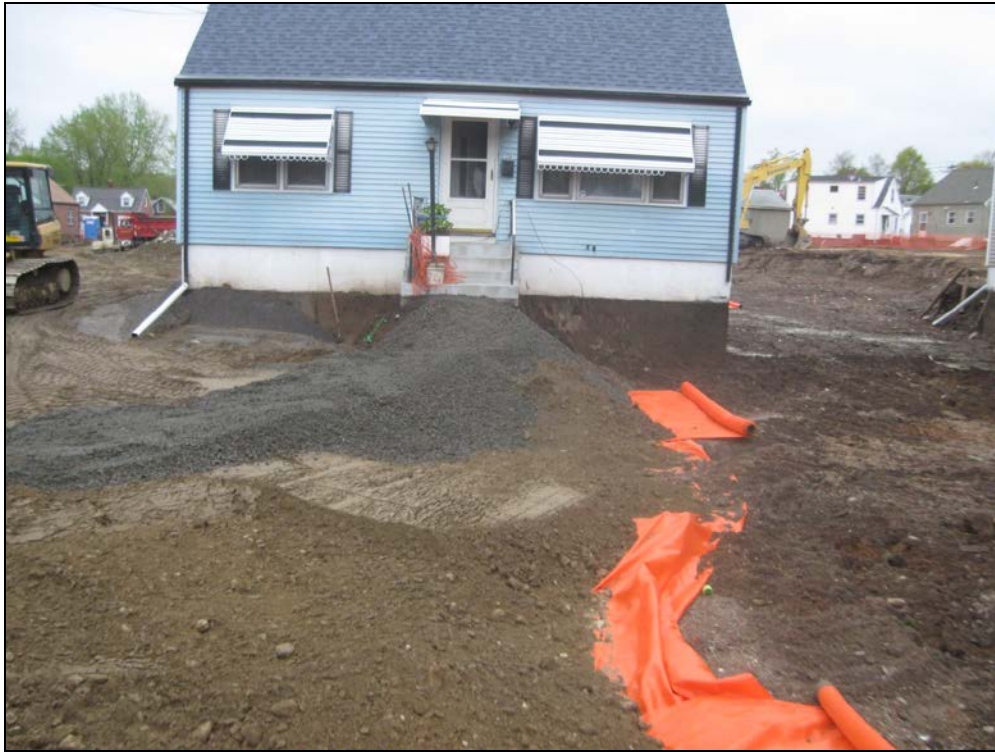
View facing south at partially backfilled front yard.

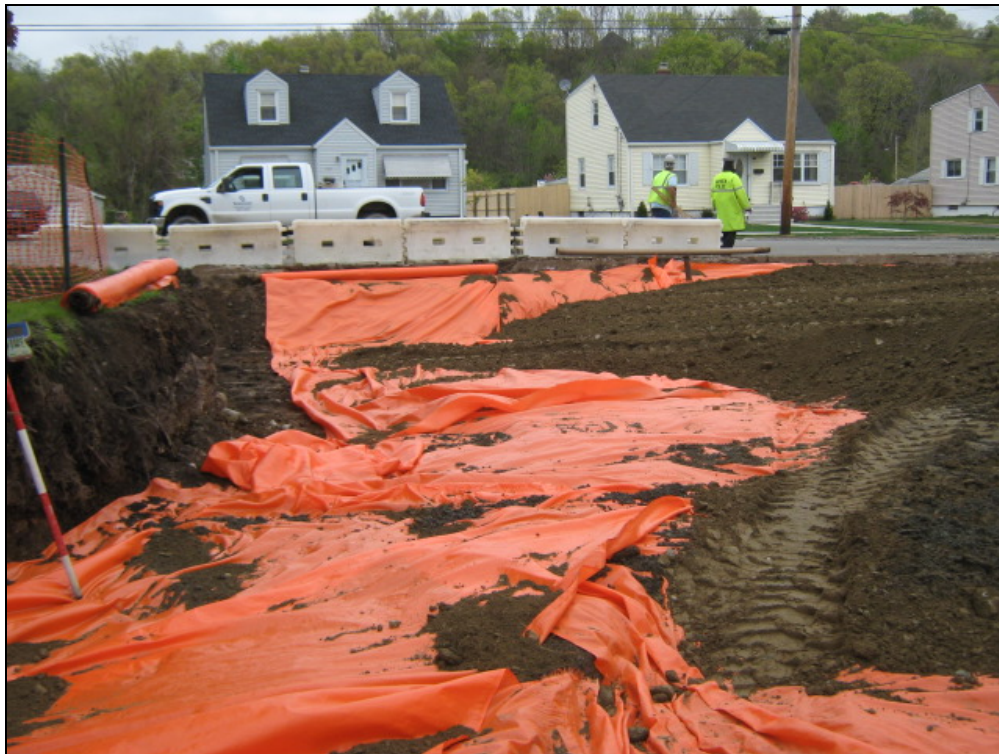
View looking north at excavated front yard towards Bryden Terrace.

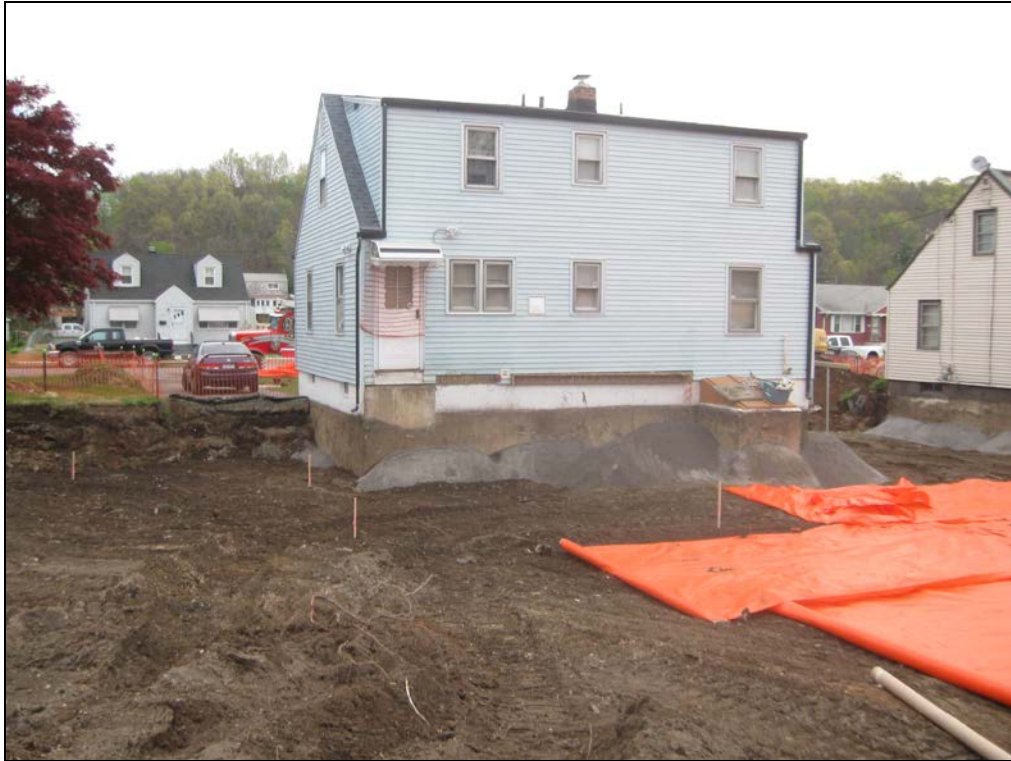
View looking north at excavated back yard.

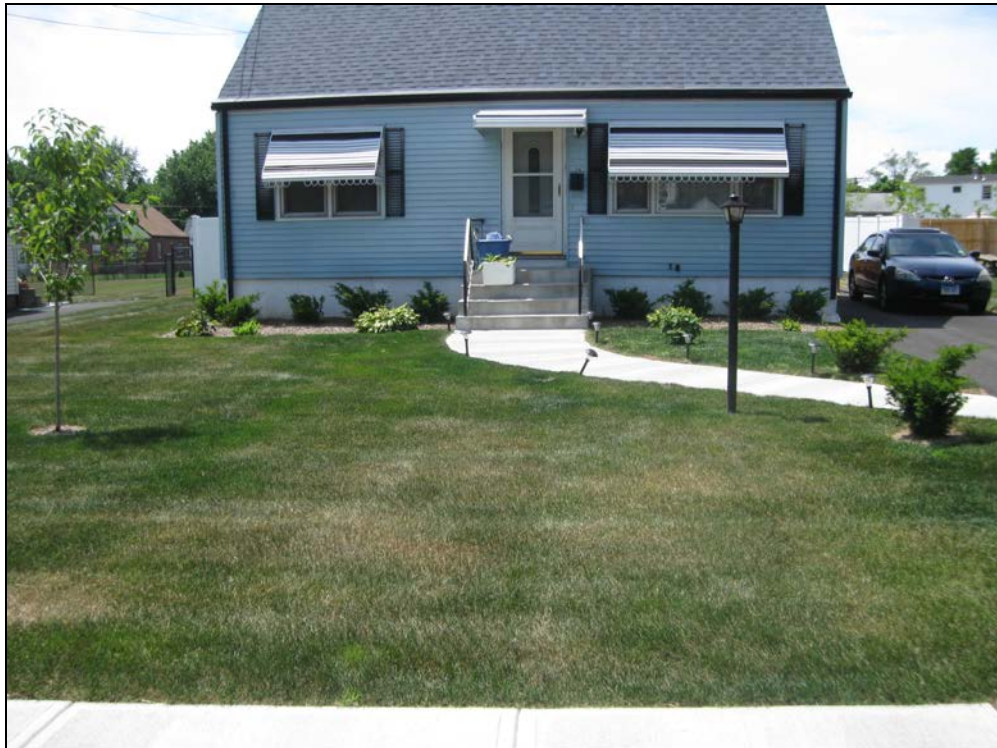
View looking south at restored front yard.

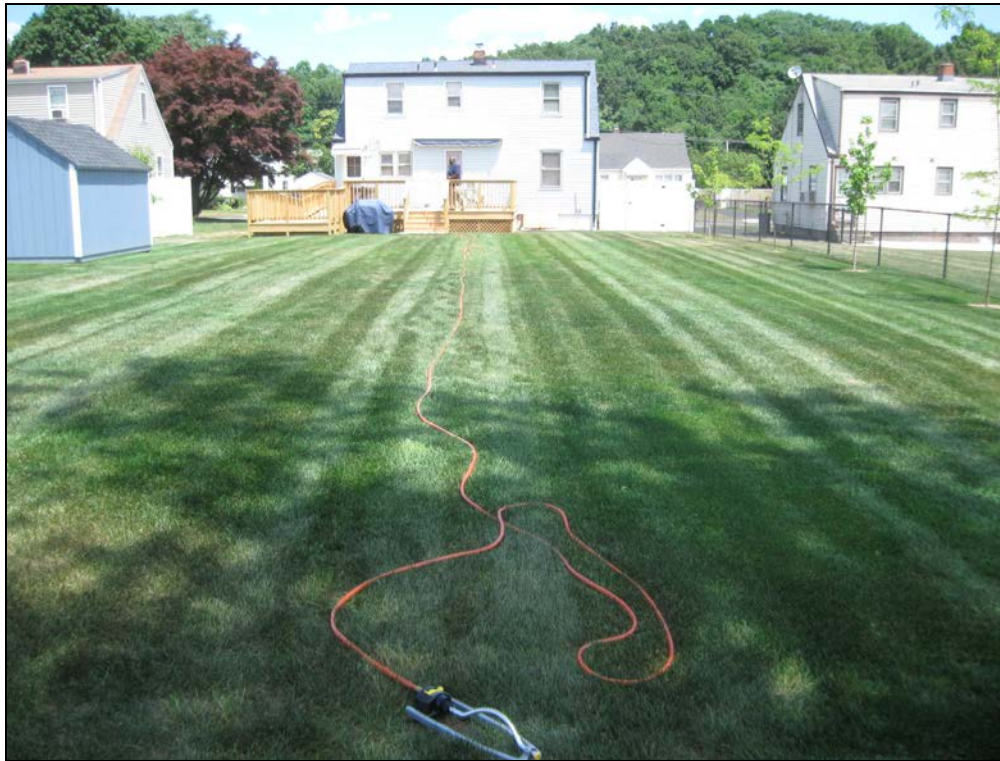
View looking north at restored back yard.

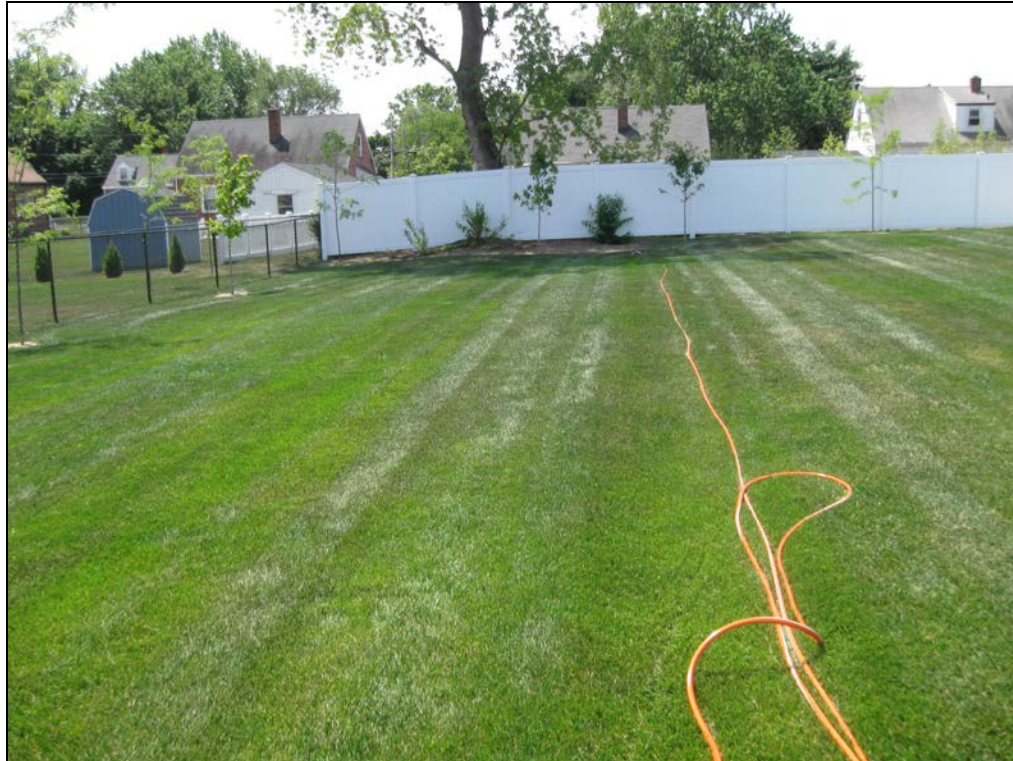
View looking south at restored back yard.
