Re: Property-Specific Remedial Action Report  
Newhall Street Neighborhood  
12 Wadsworth Street, Block F  
Hamden, Connecticut 06517

**PROPERTY-SPECIFIC REMEDIAL ACTION REPORT  
12 WADSWORTH STREET**

**NON-PUBLIC PROPERTIES  
NEWHALL STREET NEIGHBORHOOD  
HAMDEN, CONNECTICUT**

**AMEC Project Number: 6107120004.115**

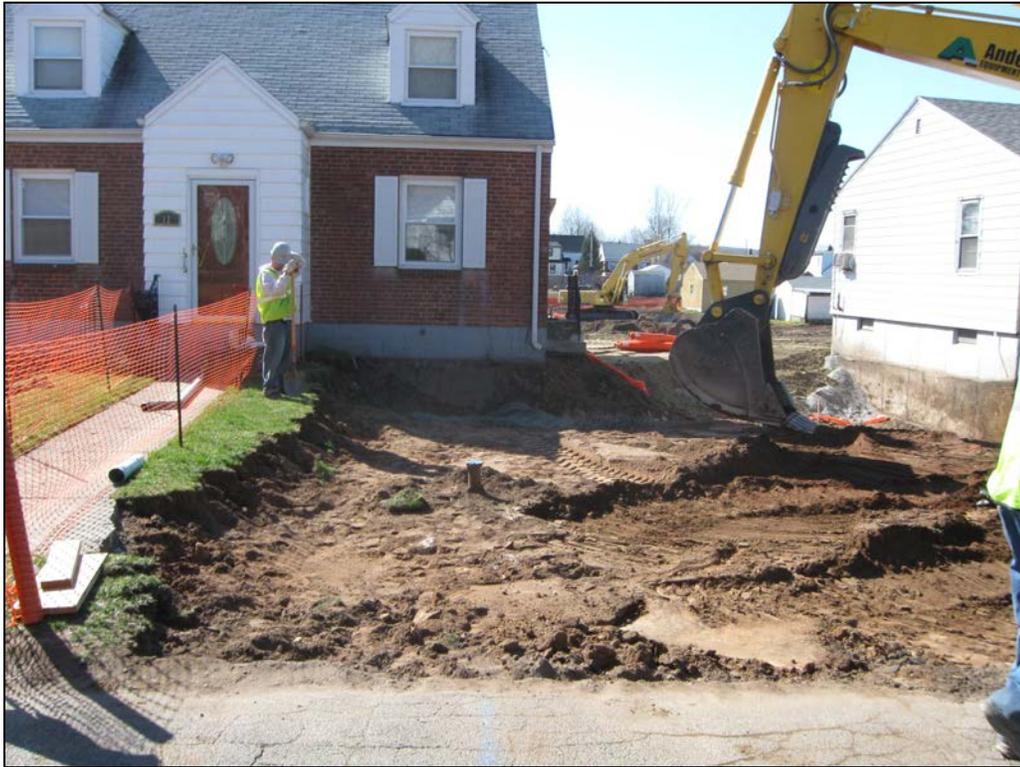
**View looking west at excavation of front yard.**

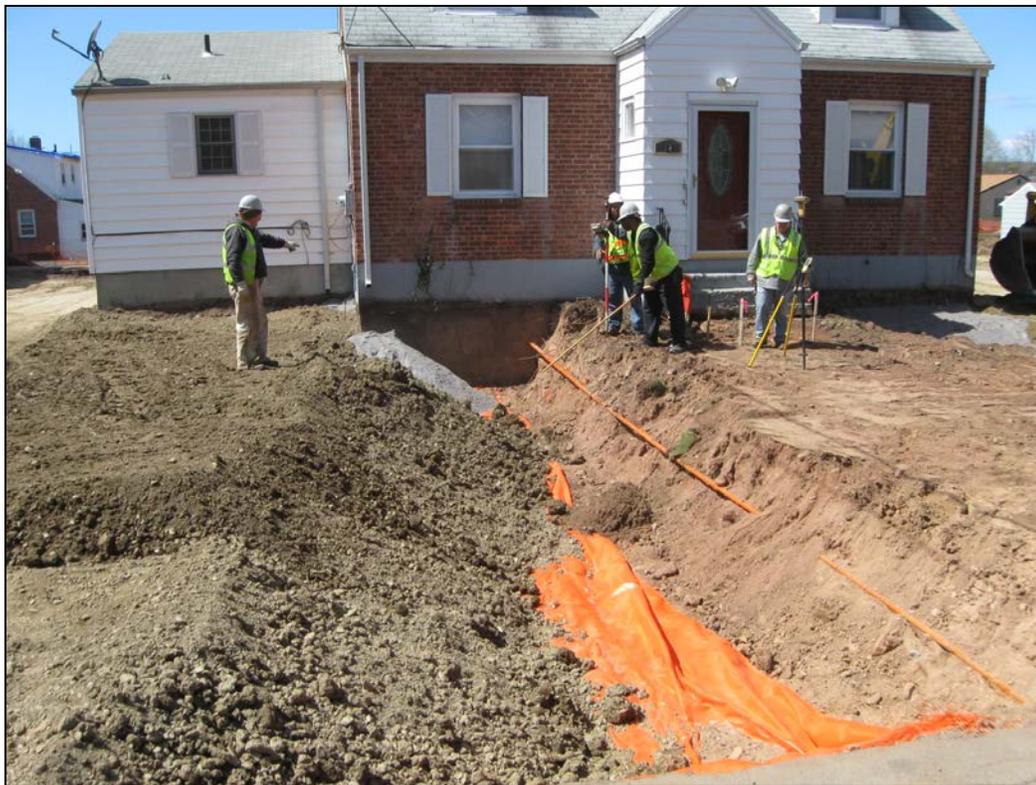
**View looking west at partially backfilled front yard.**

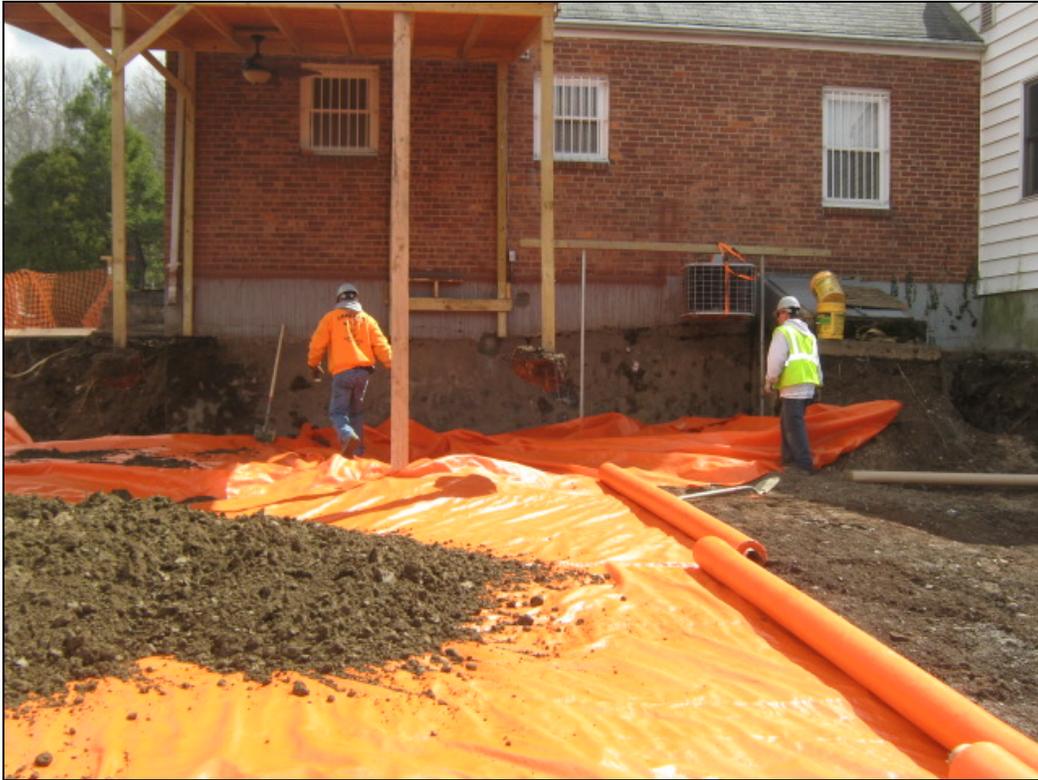
View looking east at marker barrier being installed around back of the house.

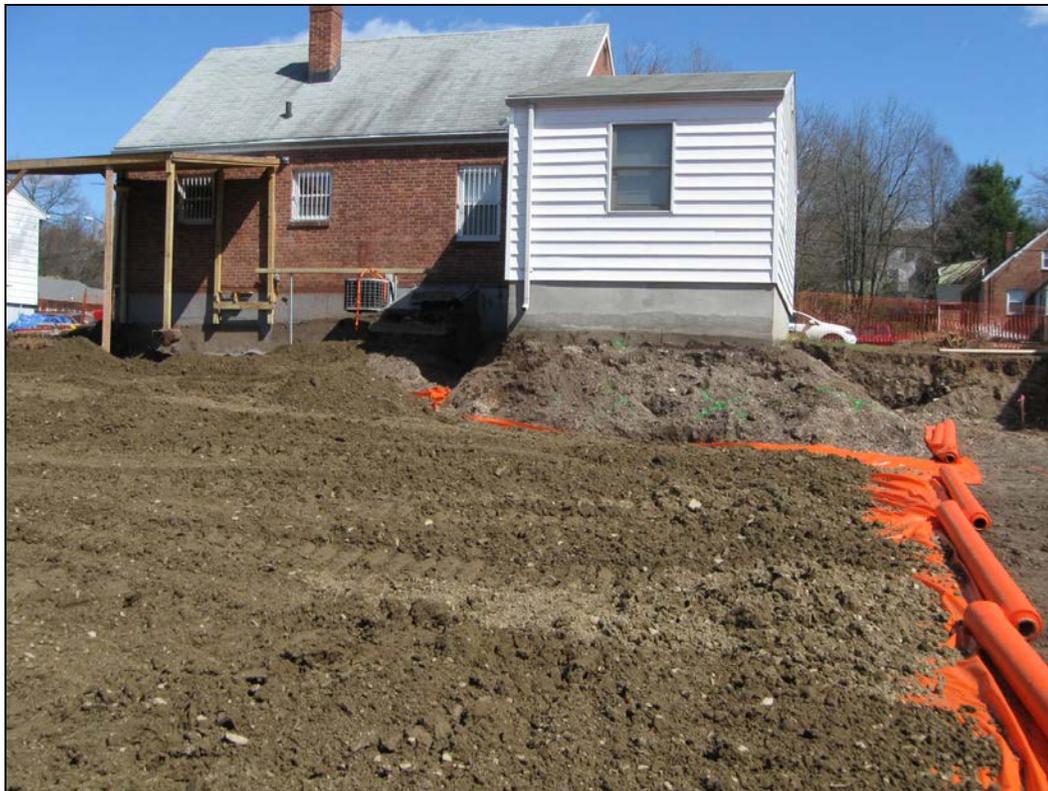
View looking east at partially backfilled back yard.

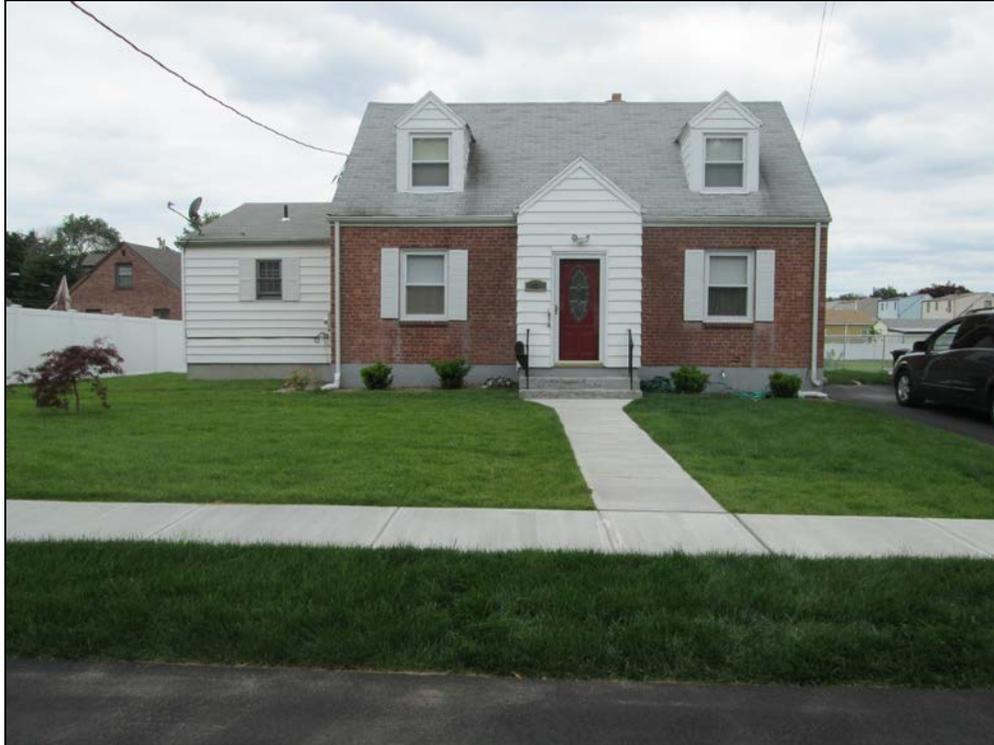
**View looking west at restored front yard.**

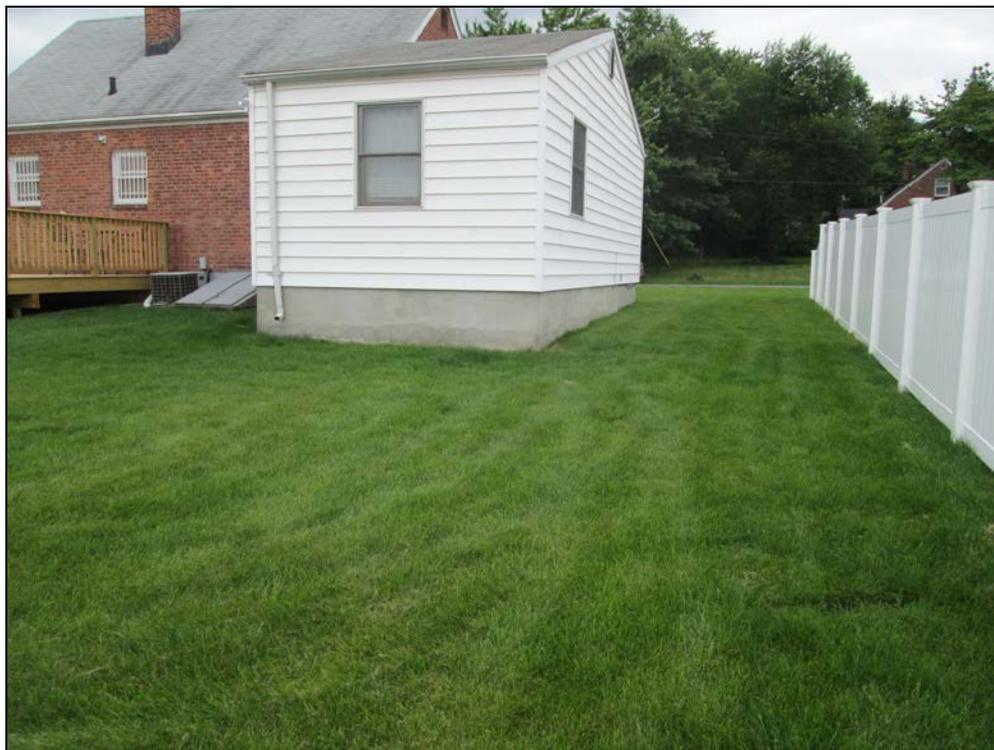
**View looking east at restored back yard.**

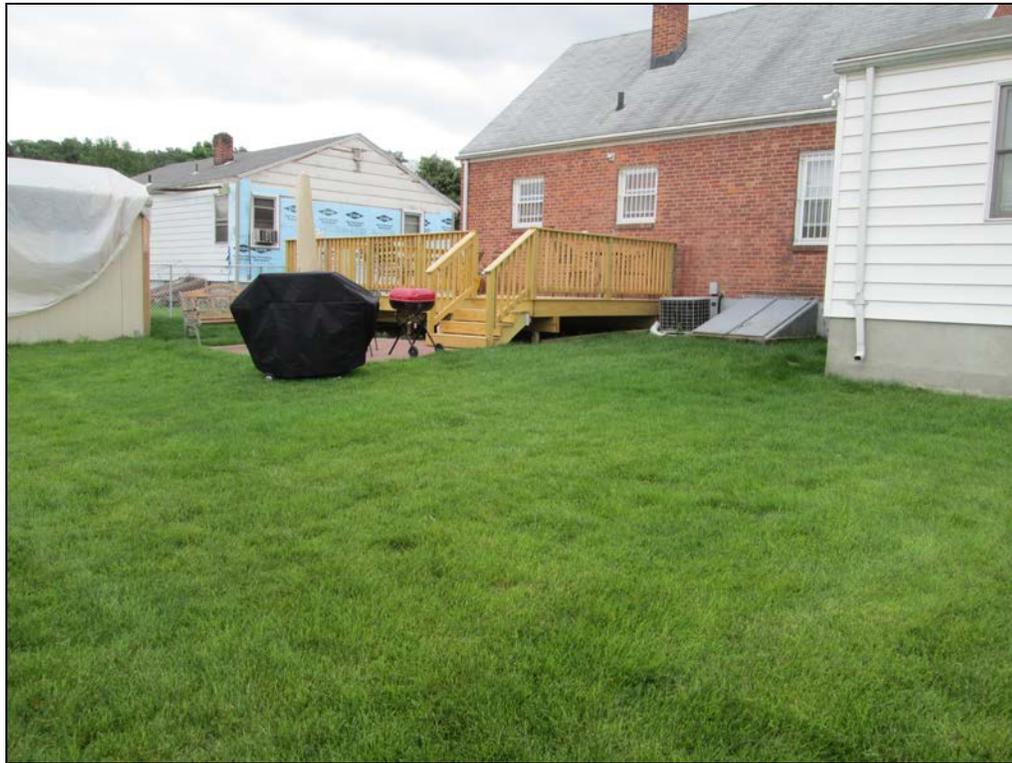
**View facing northeast at restored back yard.**
