Re: Property-Specific Remedial Action Report
Newhall Street Neighborhood
136 Bryden Terrace, Block F
Hamden, Connecticut 06517

**PROPERTY-SPECIFIC REMEDIAL ACTION REPORT
136 BRYDEN TERRACE**

**NON-PUBLIC PROPERTIES
NEWHALL STREET NEIGHBORHOOD
HAMDEN, CONNECTICUT**

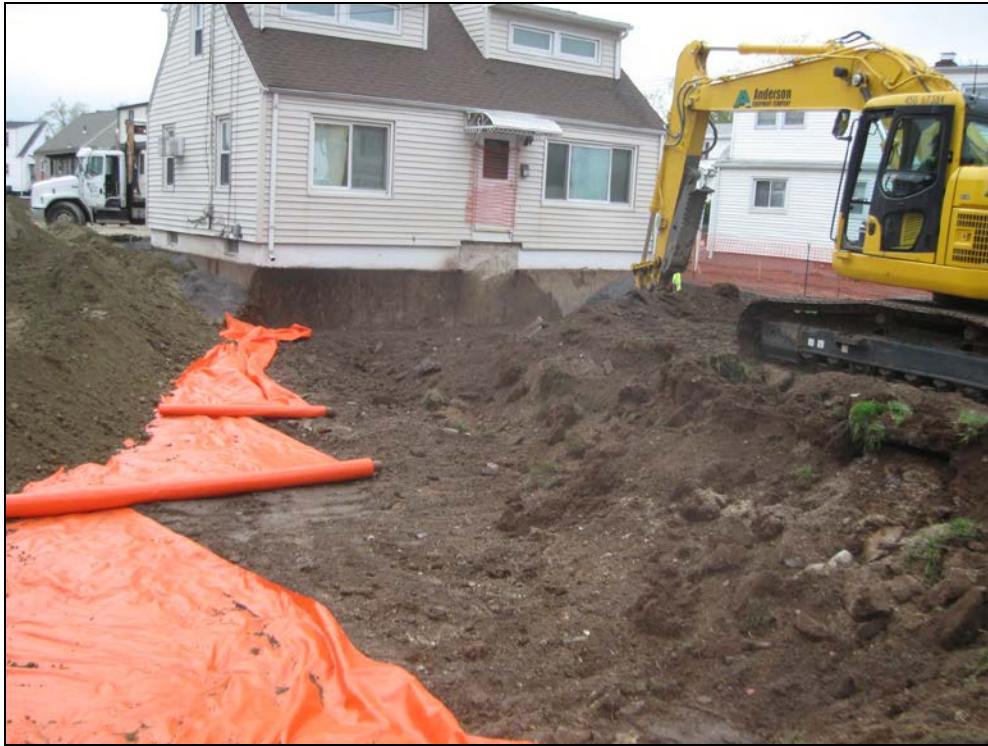
View facing southwest at the excavation and marker barrier installation in the front yard.

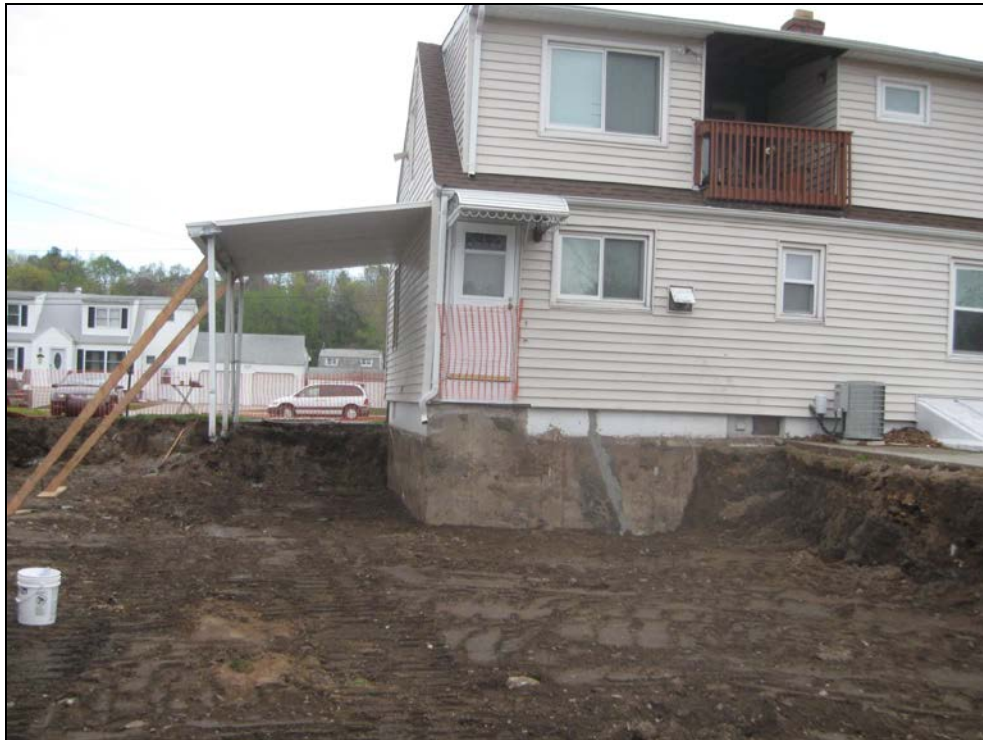
View looking north at excavated back of the house prior to marker barrier being installed.

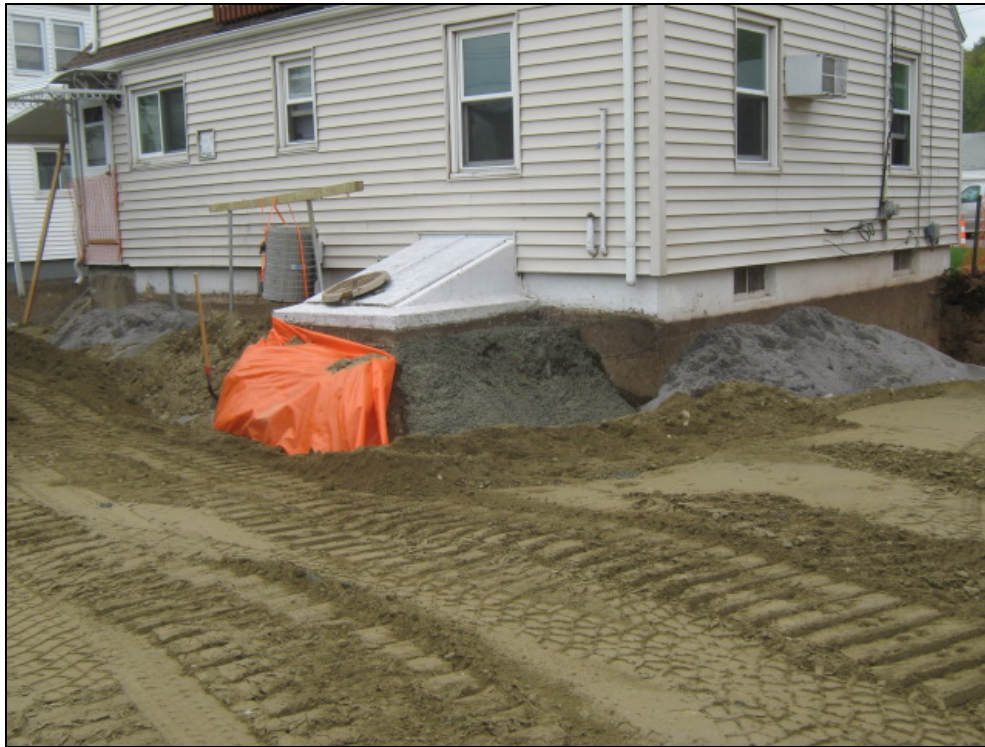
View looking northwest at the partially backfilled back and side yard.

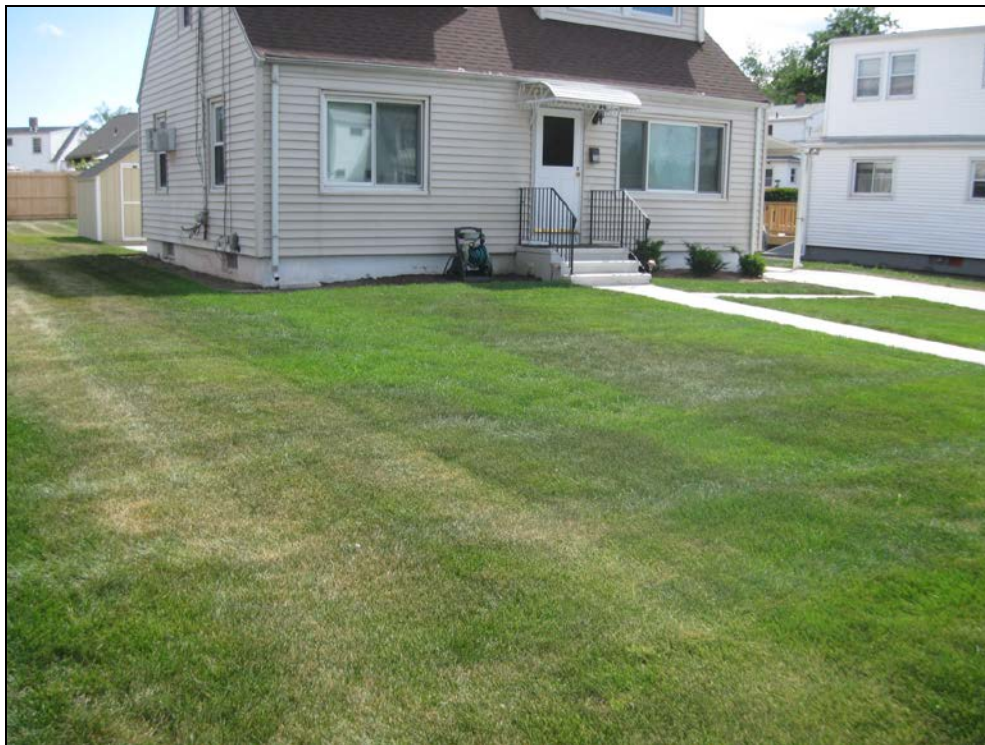
View looking southwest at restored front yard.

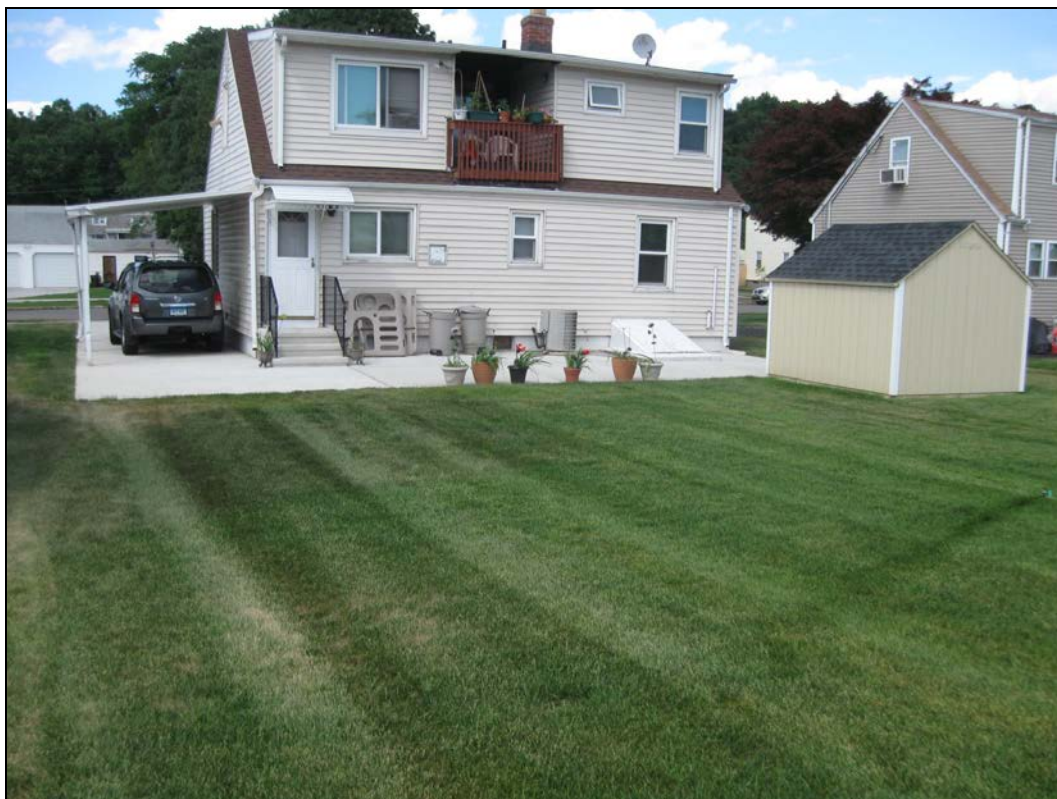
View looking north at restored back yard.
