Re: Property-Specific Remedial Action Report  
Newhall Street Neighborhood  
18 Marlboro Street, Block Q  
Hamden, Connecticut 06517

**PROPERTY-SPECIFIC REMEDIAL ACTION REPORT  
18 MARLBORO STREET**

**NON-PUBLIC PROPERTIES  
NEWHALL STREET NEIGHBORHOOD  
HAMDEN, CONNECTICUT**

**AMEC Project Number: 6107120004.165**

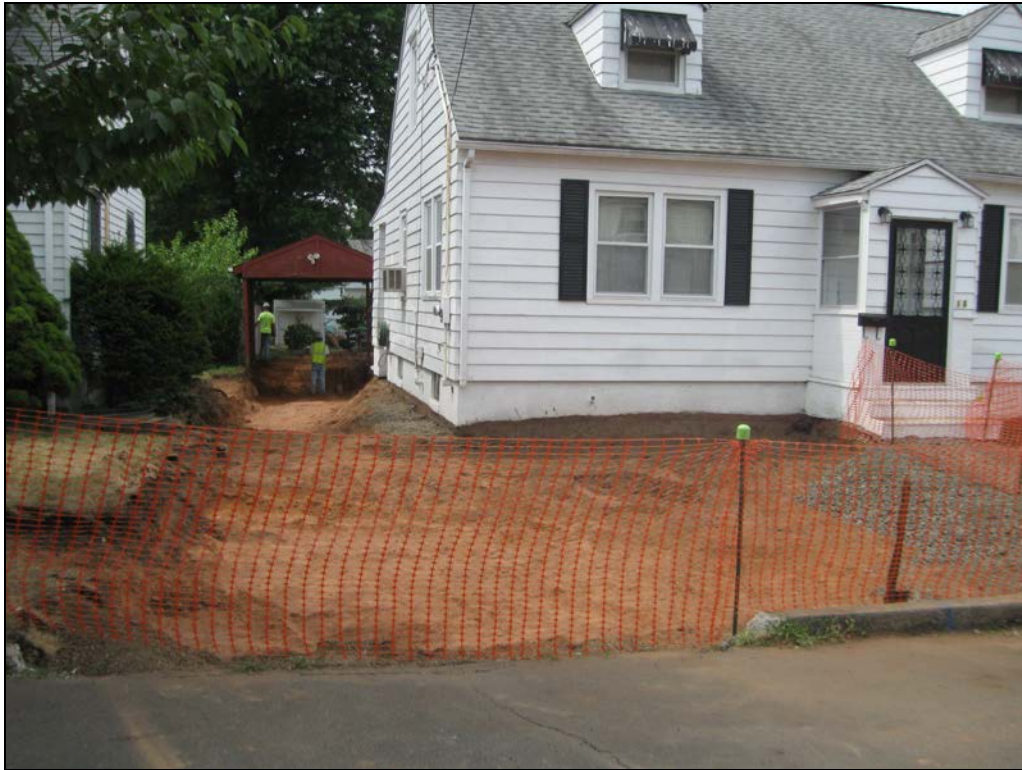
**View looking south at excavated driveway area.**

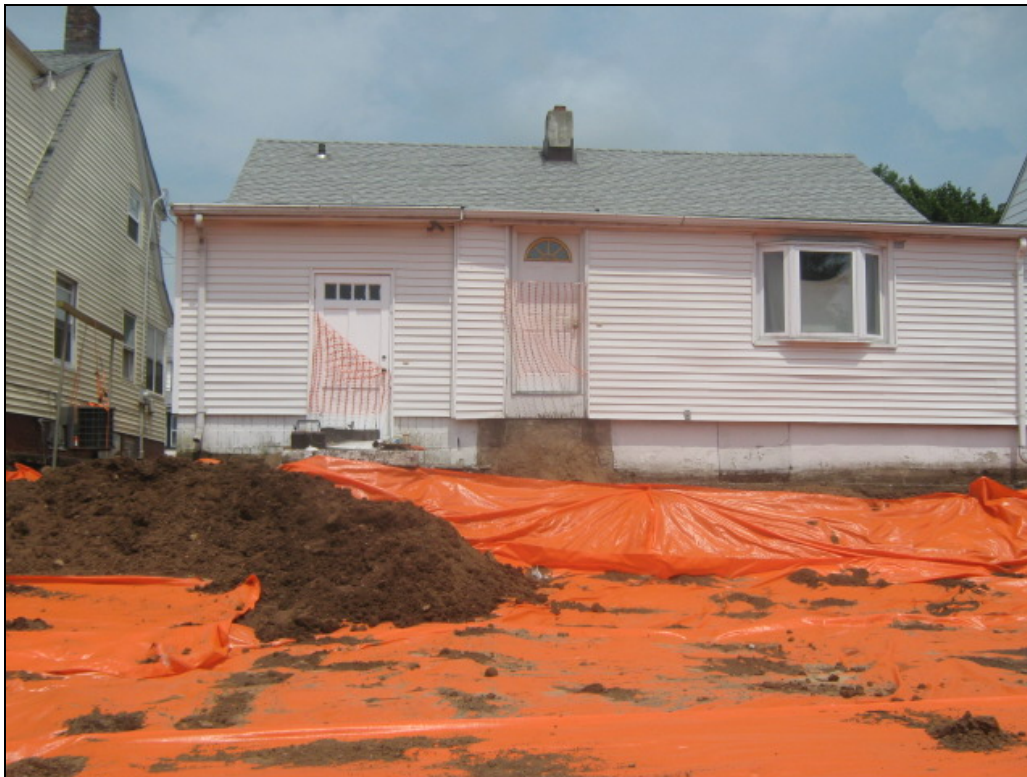
**View looking north at excavated back yard following placement of marker barrier.**

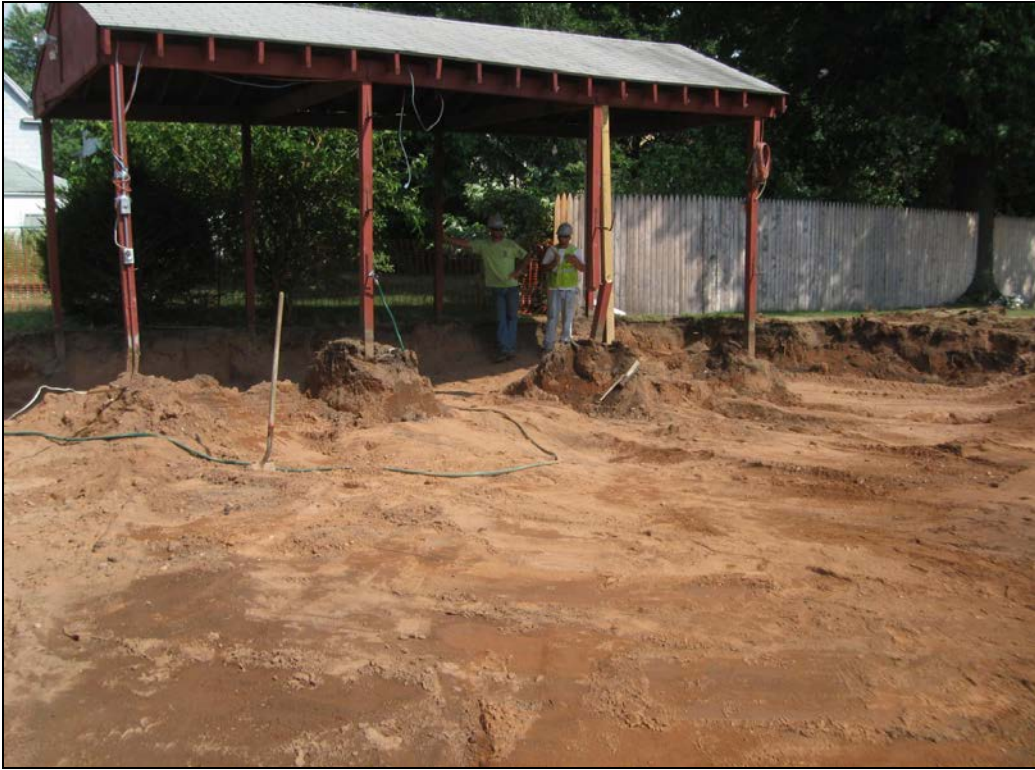
**View looking southeast at excavated carport area.**

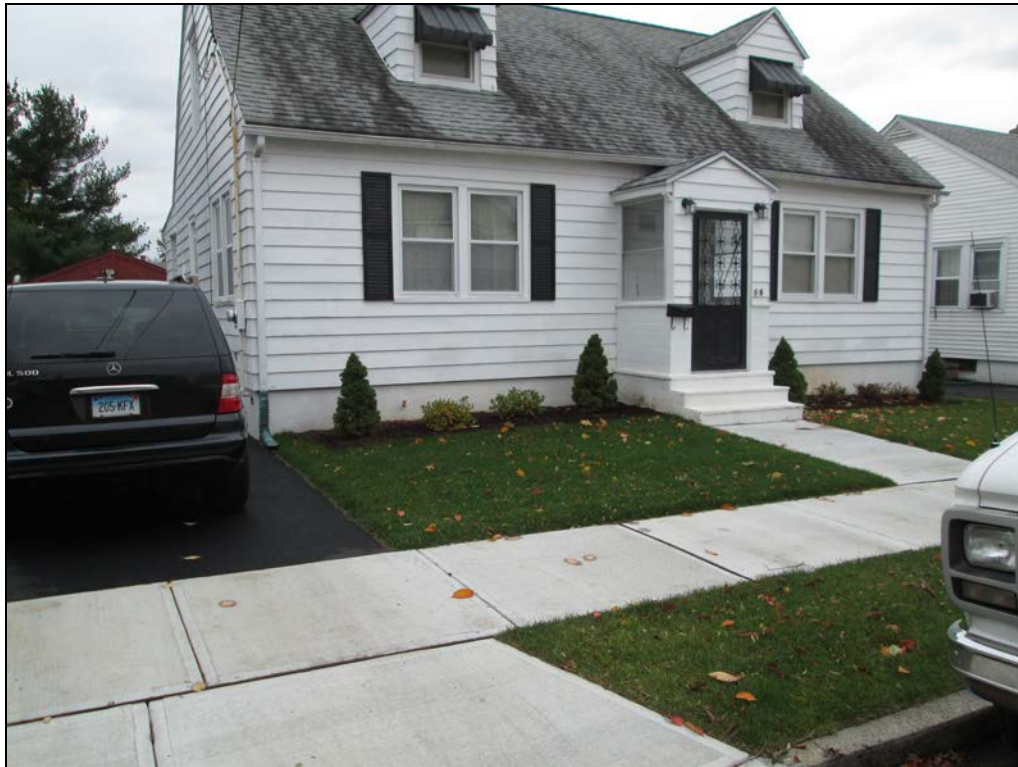
**View looking south at restored front yard.**

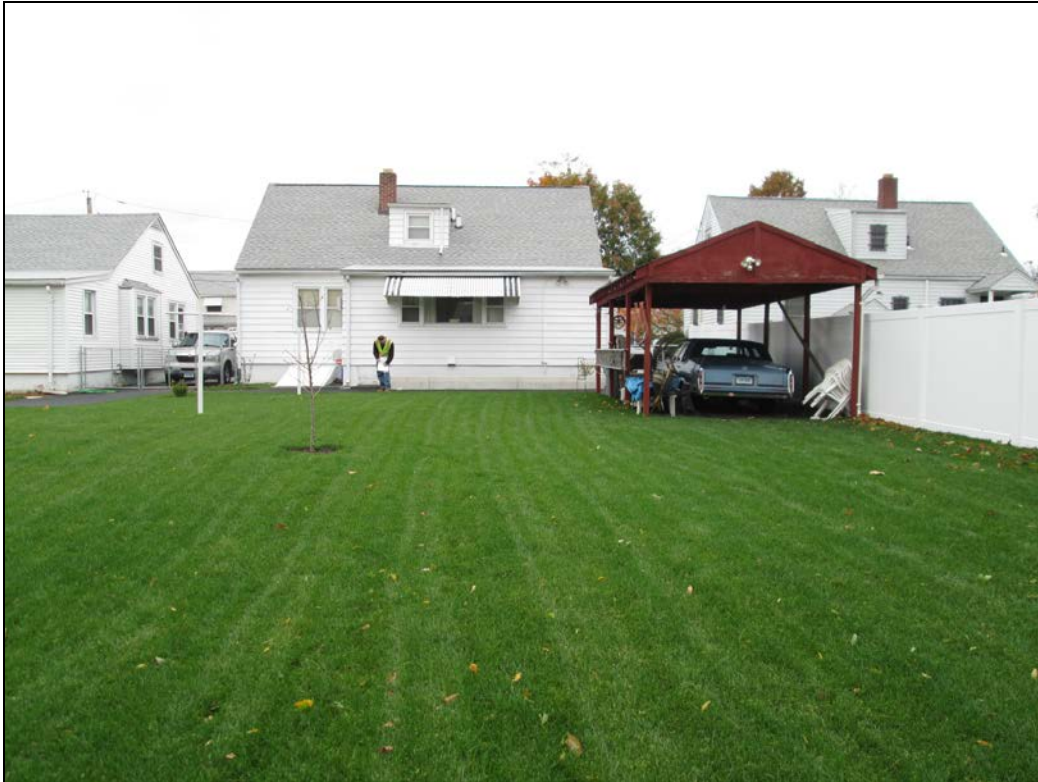
**View looking north at restored back yard.**

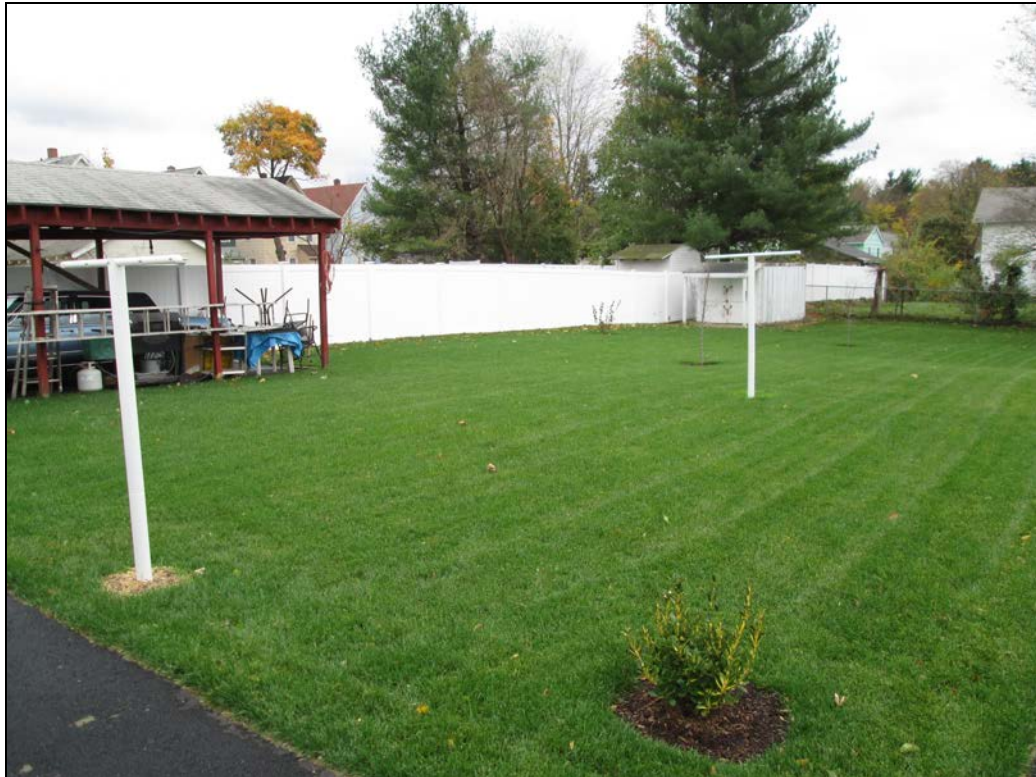
**View looking southeast at restored back yard.**
