Re: Property-Specific Remedial Action Report
Newhall Street Neighborhood
213-215 Butler Street, Block M
Hamden, Connecticut 06517

**PROPERTY-SPECIFIC REMEDIAL ACTION REPORT
213-215 BUTLER STREET**

**NON-PUBLIC PROPERTIES
NEWHALL STREET NEIGHBORHOOD
HAMDEN, CONNECTICUT**

AMEC Project Number: 6107110004/135

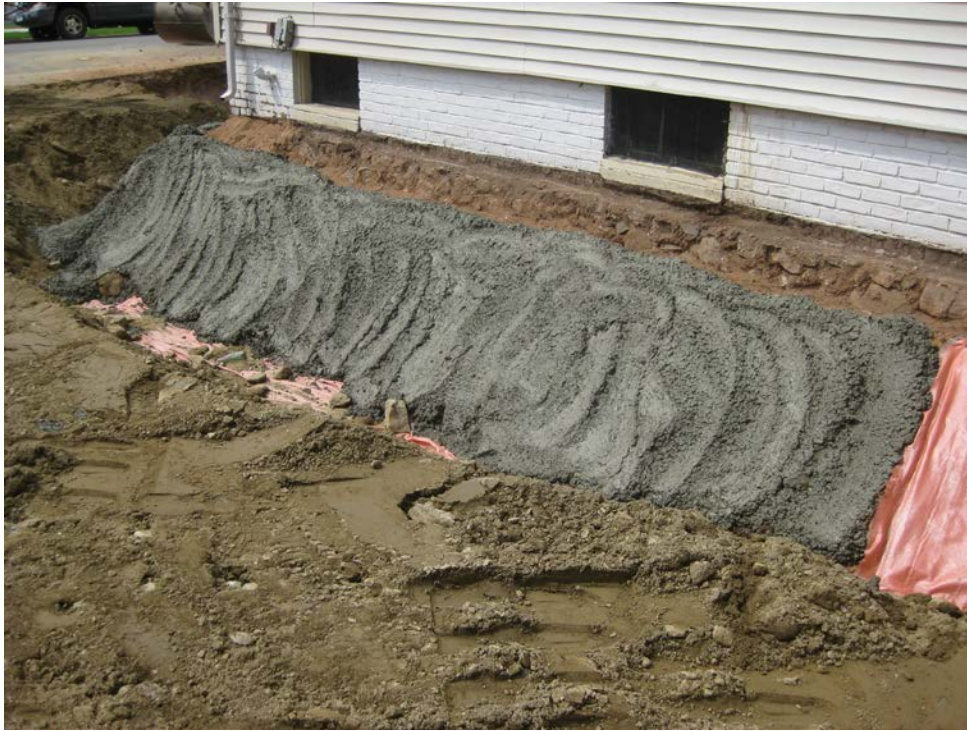
View looking Northwest at side yard

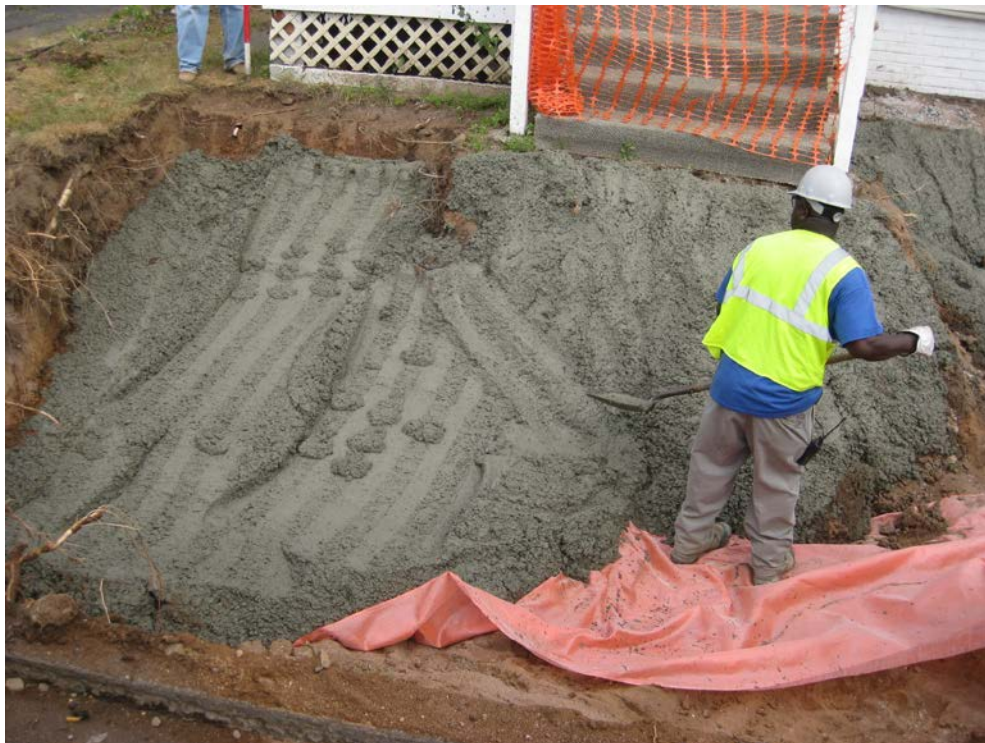
View looking East at front steps with concrete

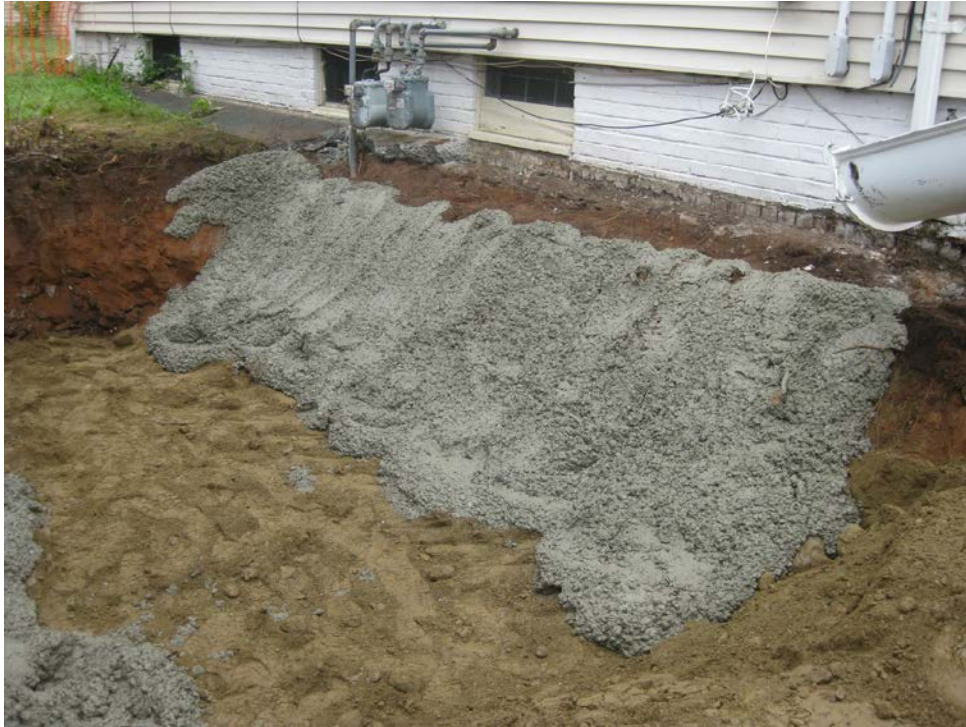
View looking south at extent of excavation adjacent to house during placement of concrete barrier

As indicated in Table 2-1, most confirmation sampling results indicate total lead concentrations less than the criteria of 400 milligrams per kilogram (mg/kg) approved by DEEP in the Final Design - Generic RAP. Several samples collected from the perimeter of the excavated area indicated total lead concentrations that exceeded 400 mg/kg. Additional soil could not be removed from these locations around the perimeter of the house and garage, because continued excavation could jeopardize the integrity of the structure.

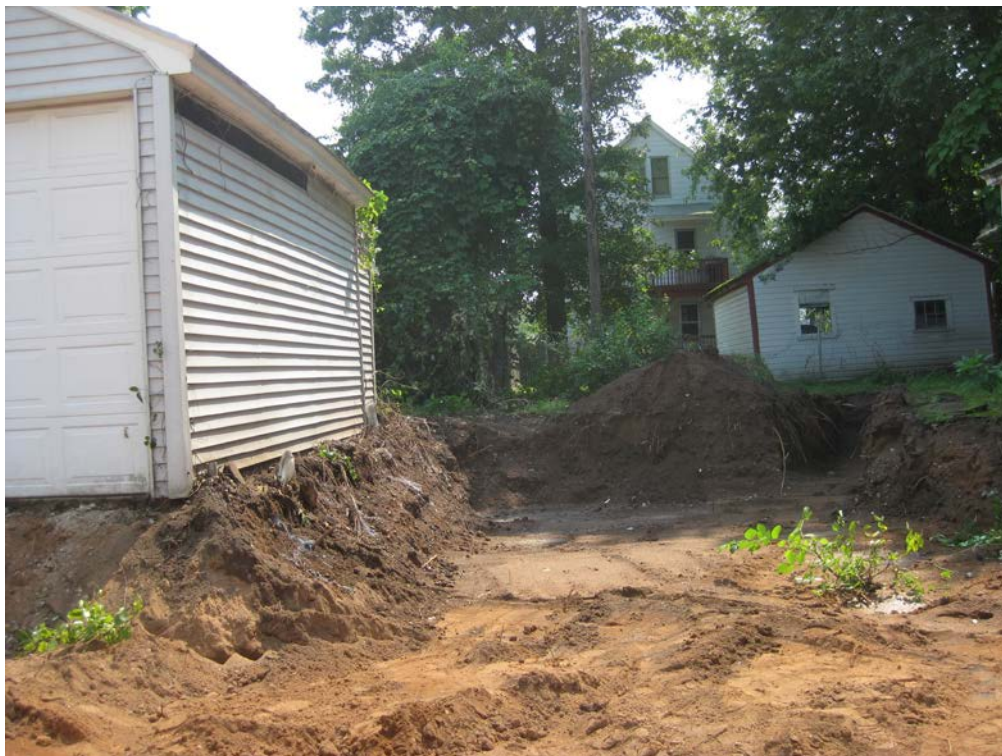
View looking East at excavated back yard and garage marked for concrete

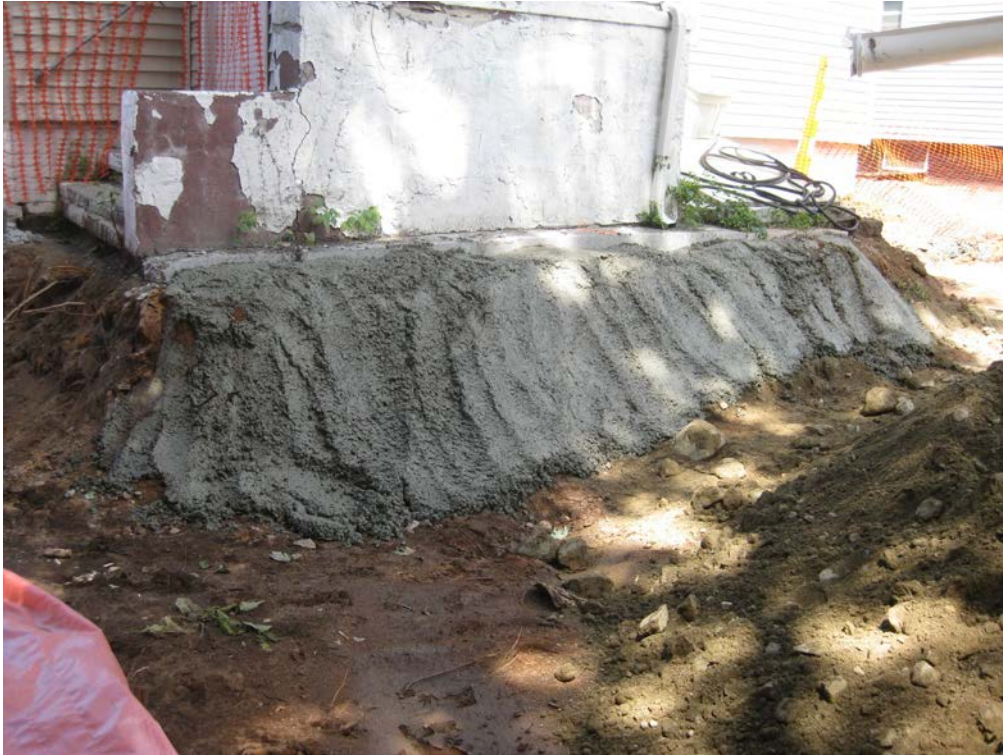
View looking West at concrete along back steps

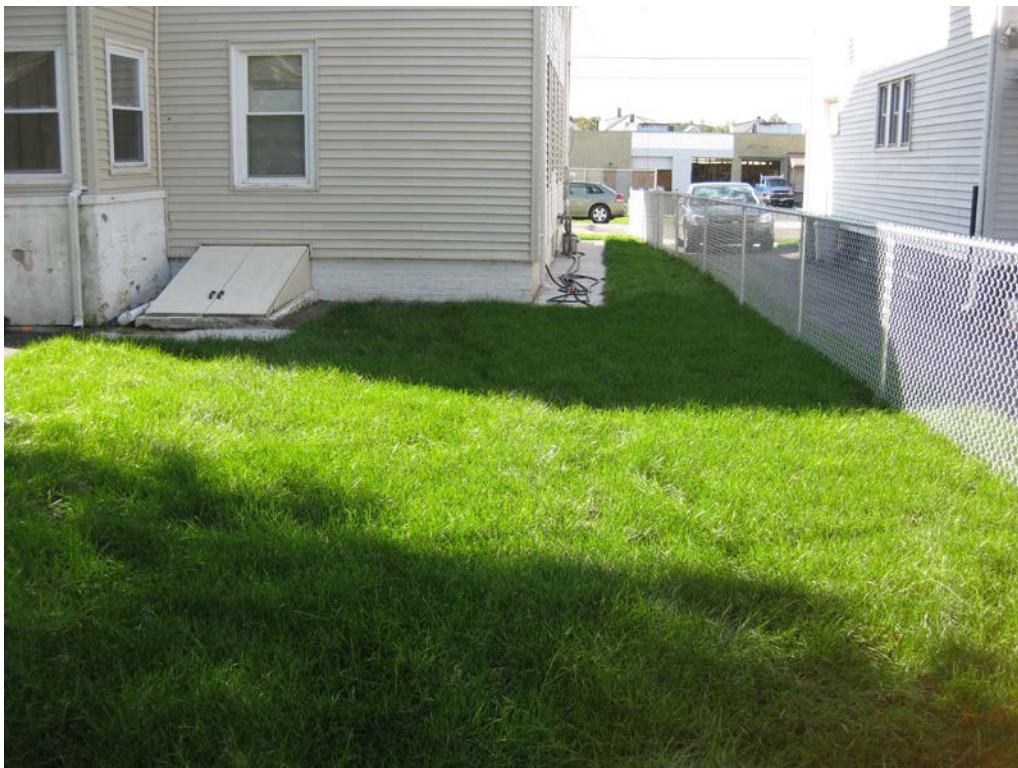
View looking West at restored back and side yard

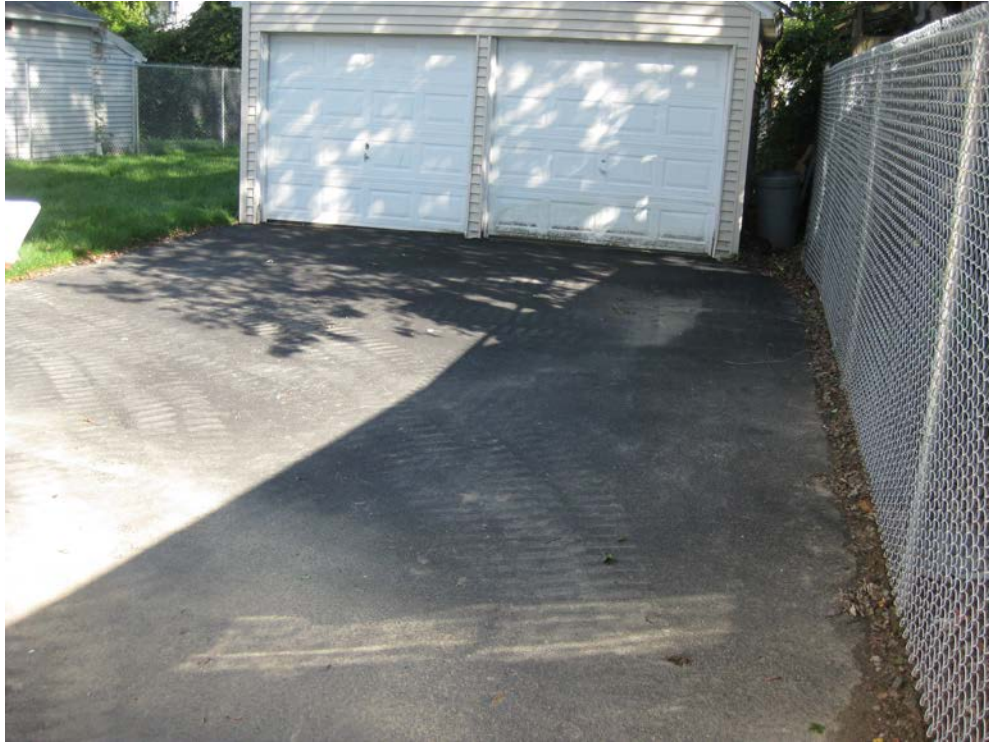
View looking East at restored driveway

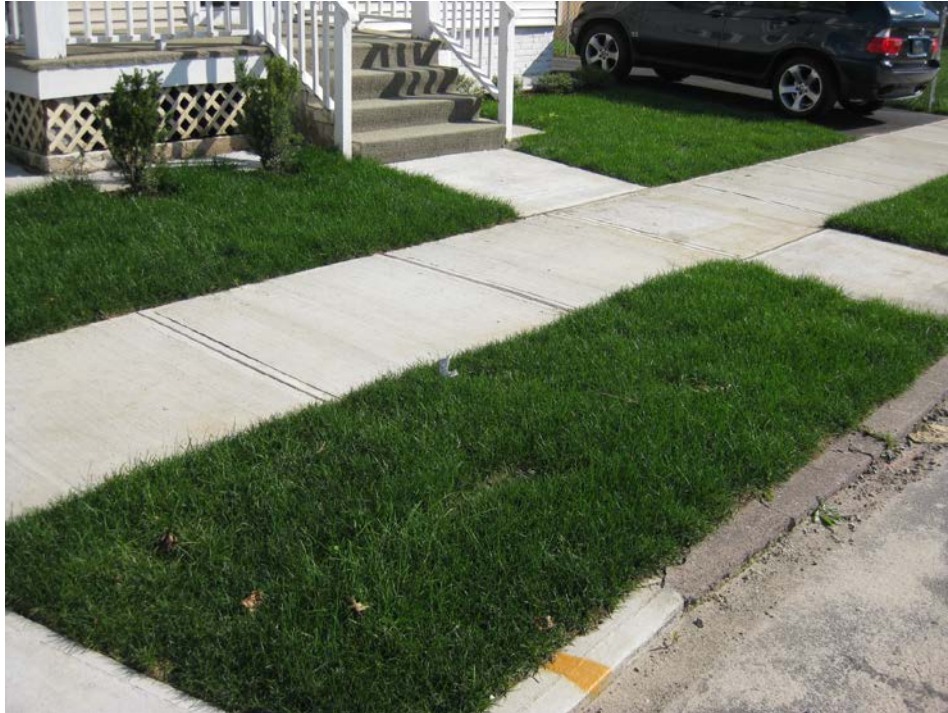
View looking Southeast at restored front yard
