Re: Property-Specific Remedial Action Report  
Newhall Street Neighborhood  
217-219 Butler Street, Block M  
Hamden, Connecticut 06517

**PROPERTY-SPECIFIC REMEDIAL ACTION REPORT  
217-219 BUTLER STREET**

**NON-PUBLIC PROPERTIES  
NEWHALL STREET NEIGHBORHOOD  
HAMDEN, CONNECTICUT**

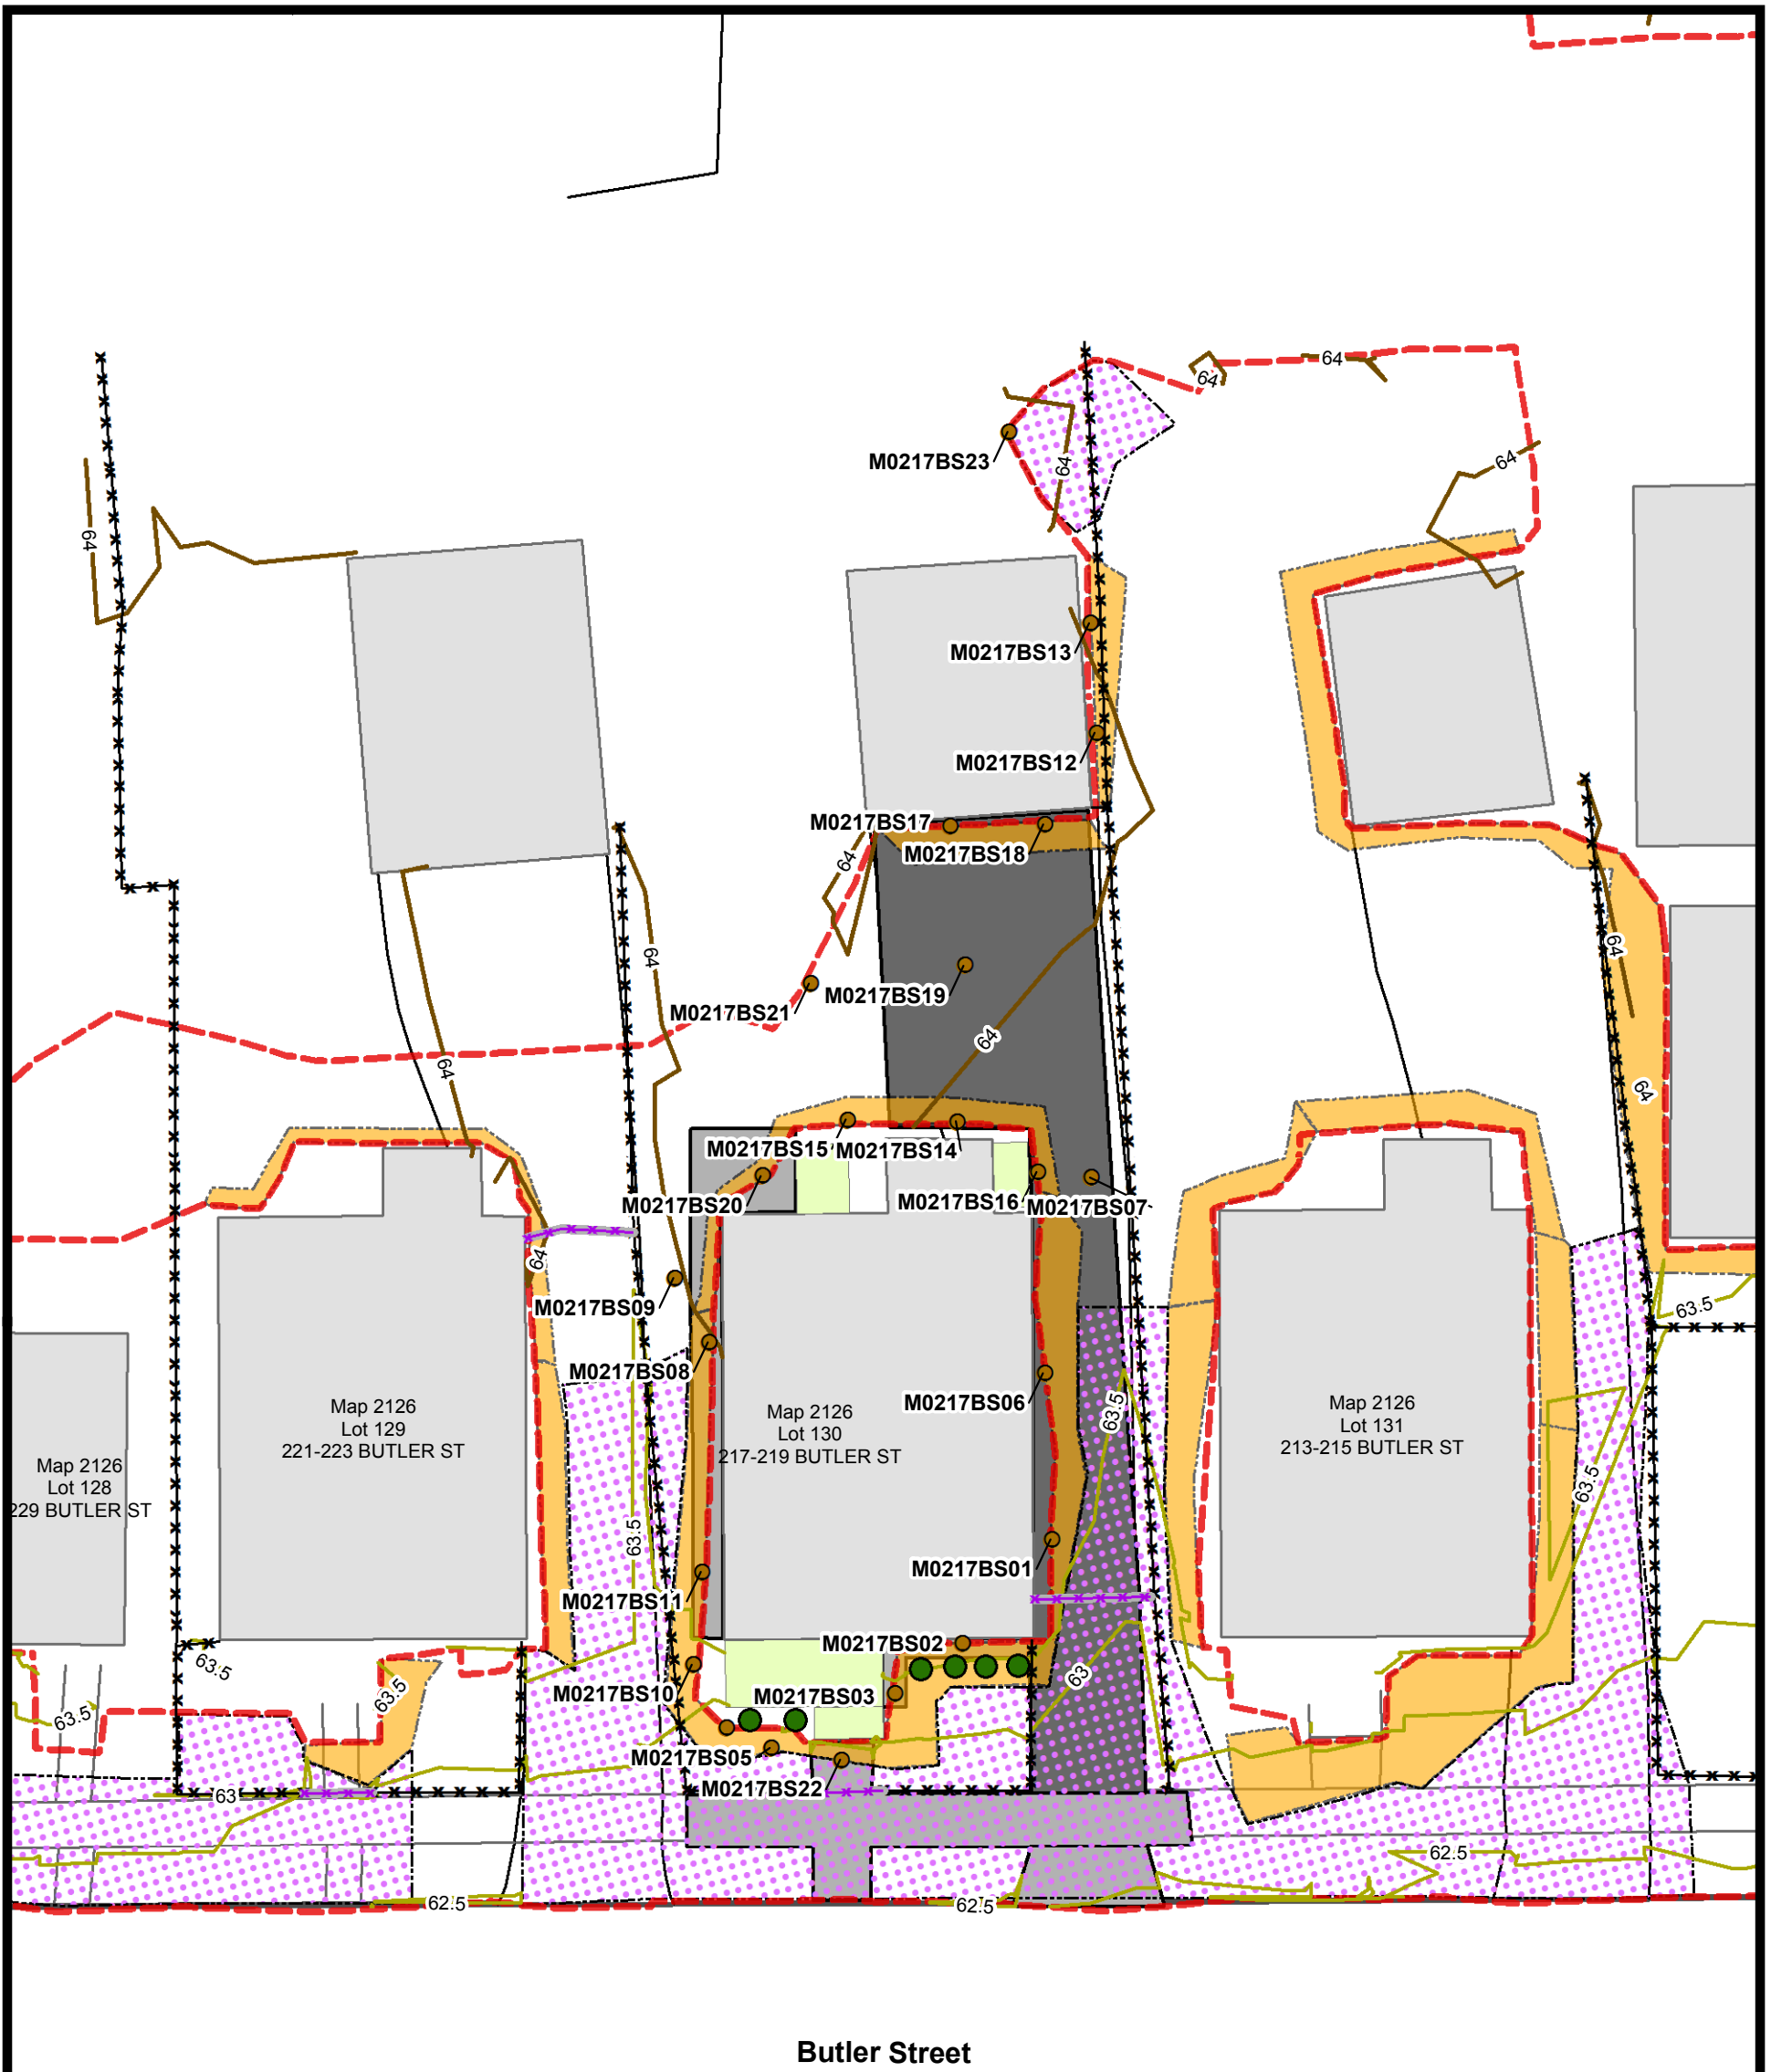
Figure 2-1 Post-Construction Conditions

During the 2011 construction season, Olin completed the excavation, backfill, and restoration of the property in accordance with the Final Design - Generic RAP and the Property-Specific RAP. Figure 2-1 shows the areas where excavation occurred on the property and the locations of excavation confirmation samples. Excavation confirmation samples were collected in accordance with Section 3.2.3 - Confirmatory Sampling of the Final Design - Generic RAP, including adherence to the sampling frequency requirements. X-ray fluorescence (XRF) excavation confirmation sampling results are presented in Table 2-1.

- In some locations, fill material was encountered at greater than 4 feet in depth below ground surface (bgs). This fill material was left in place, covered by an orange geotextile fabric, and backfilled with clean soil in accordance with the Final Design - Generic RAP. Figure 2-1 shows the approximate area of geotextile fabric identifying the presence of fill at a depth greater than 4 feet bgs.
- In some locations, it was necessary to leave fill material in place at depths less than 4 feet bgs in order to avoid jeopardizing the integrity of a structure. This fill material was left in place, covered by an orange geotextile fabric and/or shotcrete, and backfilled with clean soil in accordance with the Final Design - Generic RAP. Figure 2-1 shows the approximate area of geotextile fabric/shotcrete identifying the presence of fill at a depth less than 4 feet bgs.

As indicated in Table 2-1, most confirmation sampling results indicate total lead concentrations less than the criteria of 400 milligrams per kilogram (mg/kg) approved by DEEP in the Final Design - Generic RAP. Several samples collected from the perimeter of the excavated area indicated total lead concentrations that exceeded 400 mg/kg. Additional soil could not be removed from these locations around the perimeter of the house, because continued excavation could jeopardize the integrity of the structure.

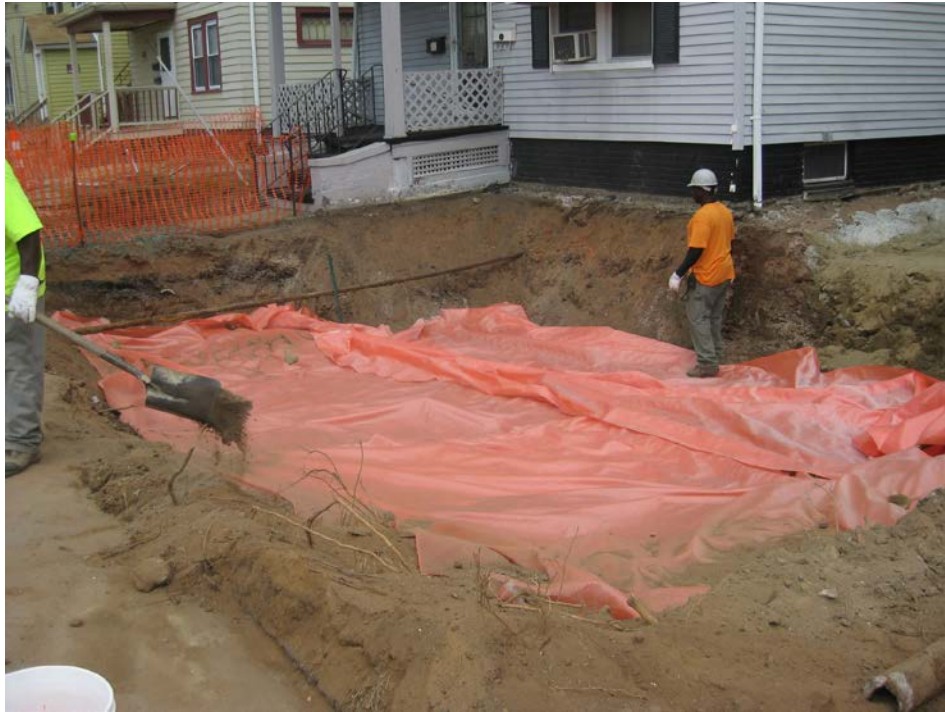
**View looking Northeast at marker barriers along side and front of house**

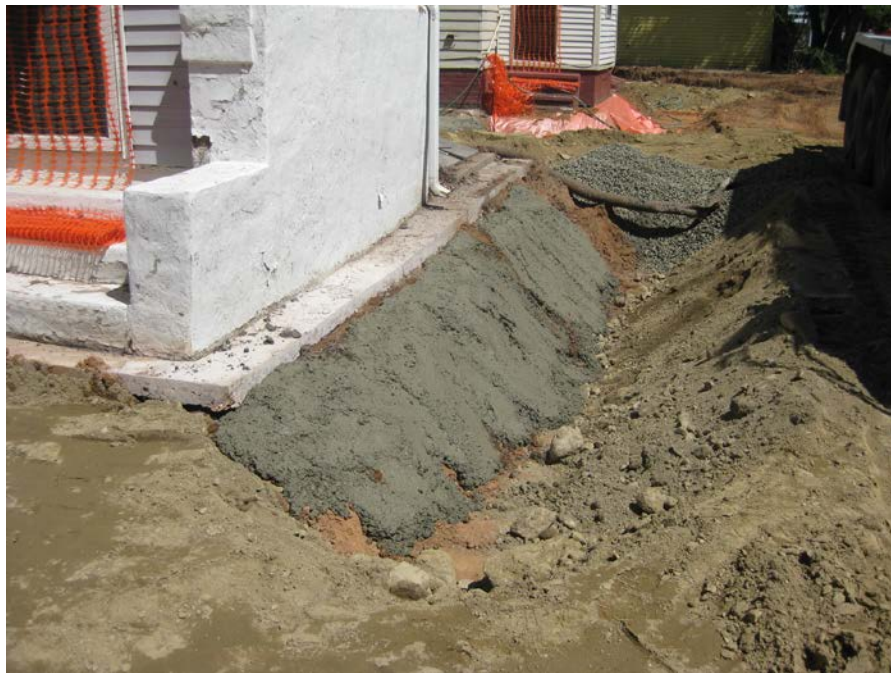
**View looking North at concrete along back of house**

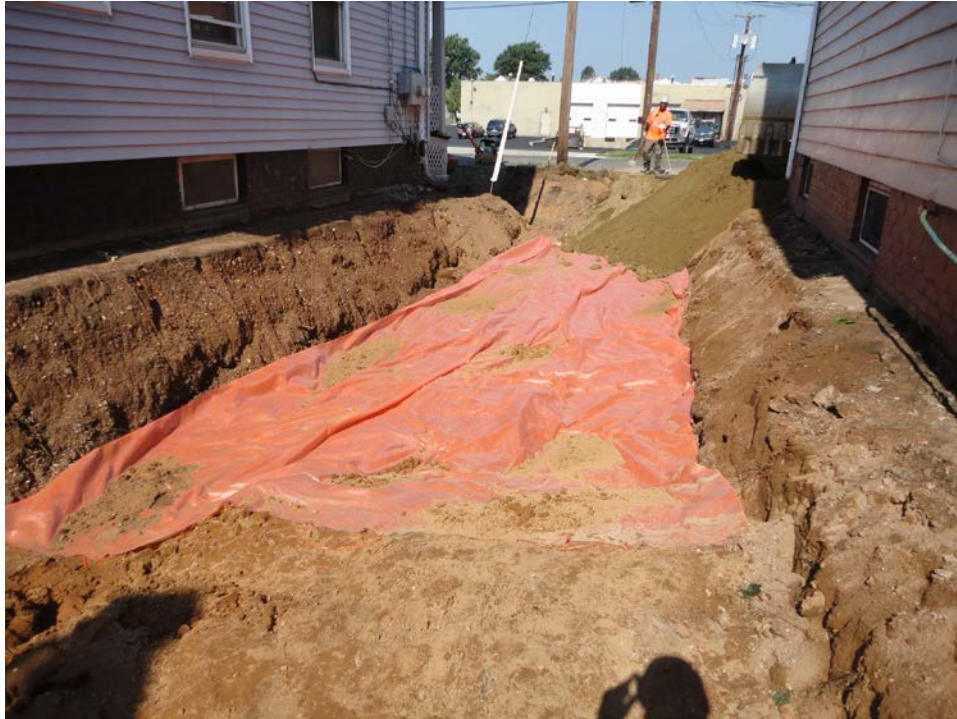
**View looking West at excavated side yard with marker barrier**

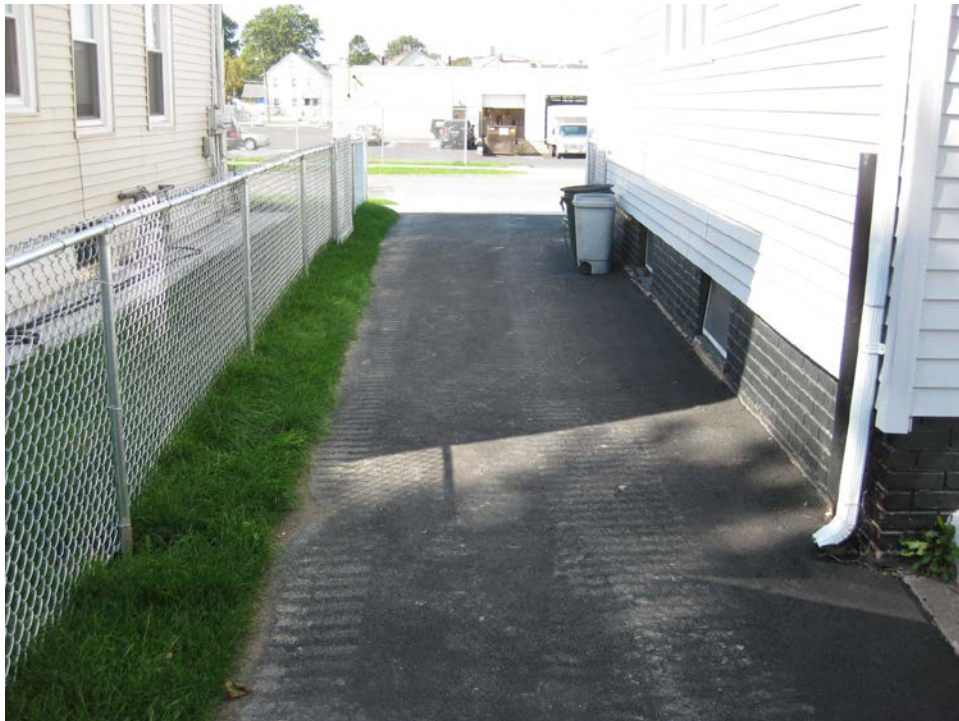
**View looking West at restored driveway**

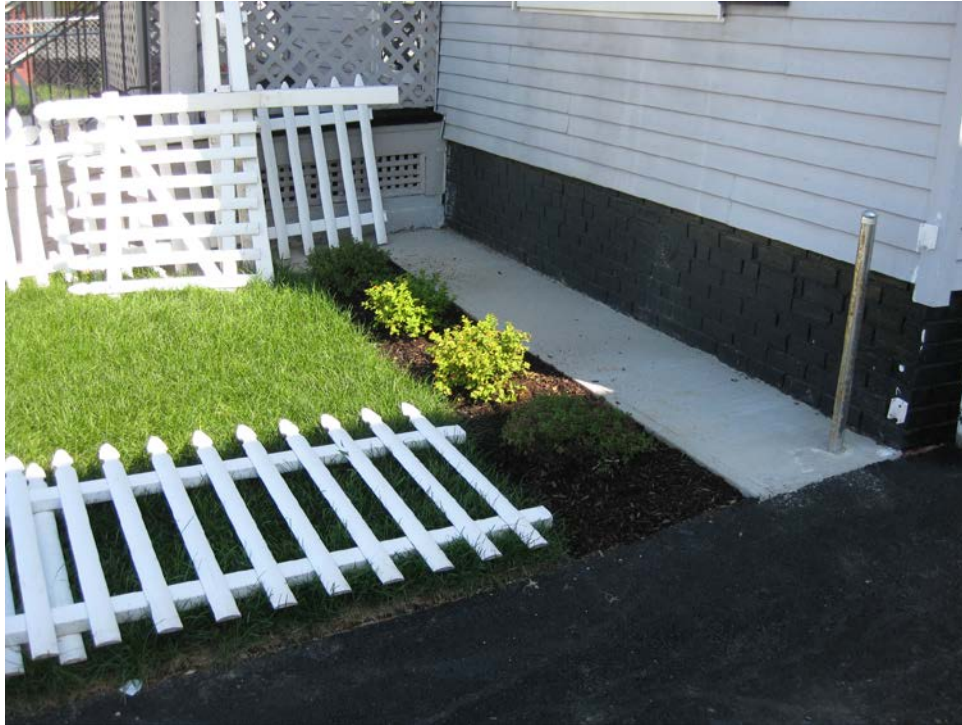
**View looking North at restored front yard**

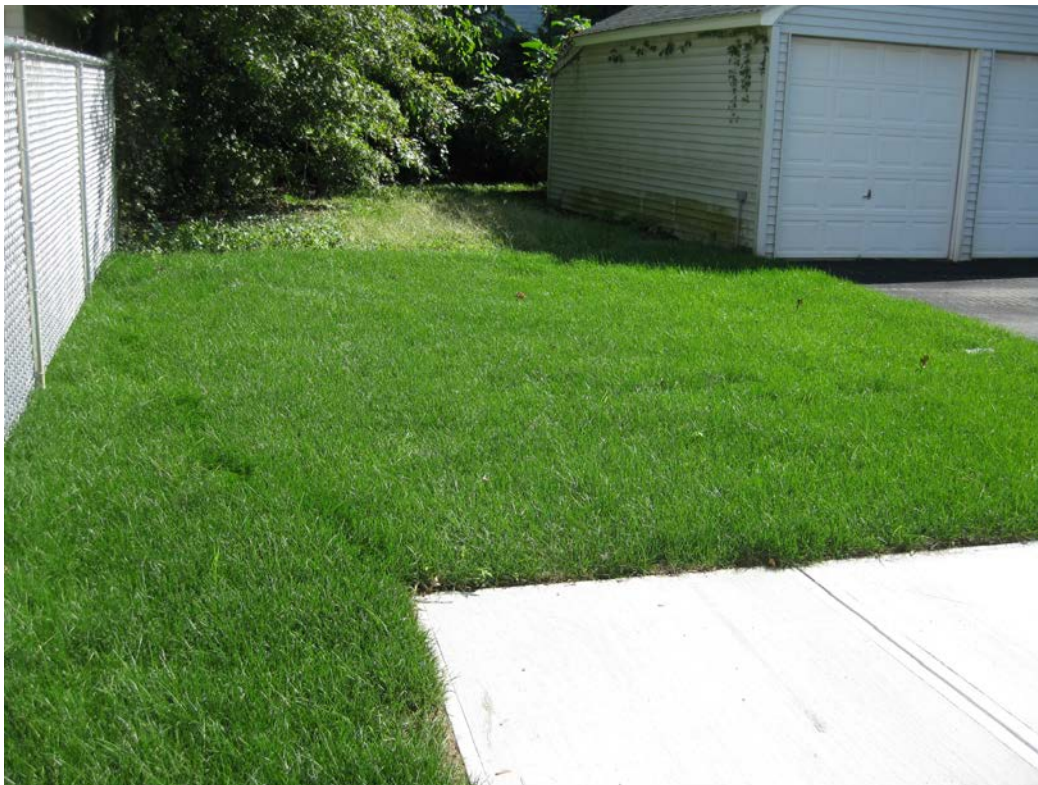
**View looking East at restored back yard**
