Re: Property-Specific Remedial Action Report
Newhall Street Neighborhood
229 Butler Street, Block M
Hamden, Connecticut 06517

**PROPERTY-SPECIFIC REMEDIAL ACTION REPORT
229 BUTLER STREET**

**NON-PUBLIC PROPERTIES
NEWHALL STREET NEIGHBORHOOD
HAMDEN, CONNECTICUT**

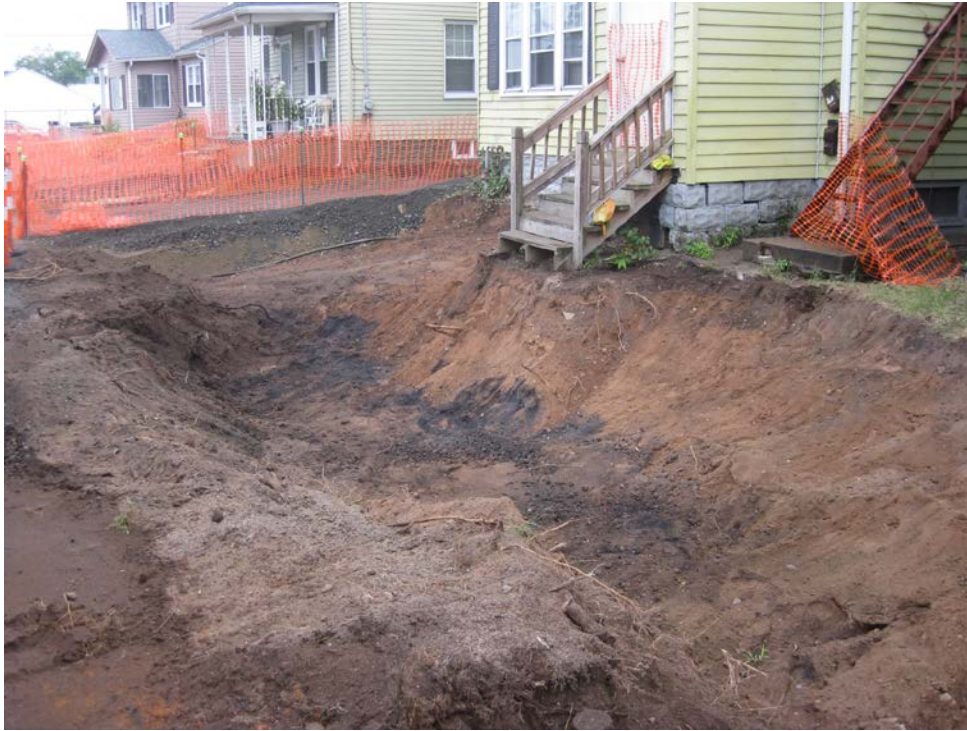
View looking Northeast at excavated front yard

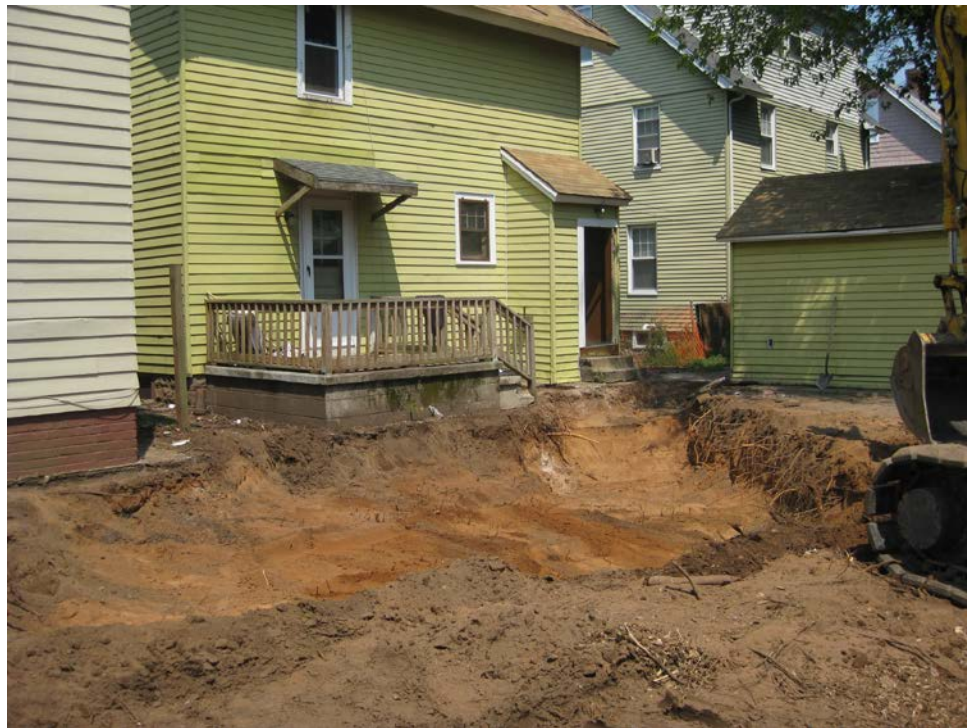
View looking Northwest towards back of house

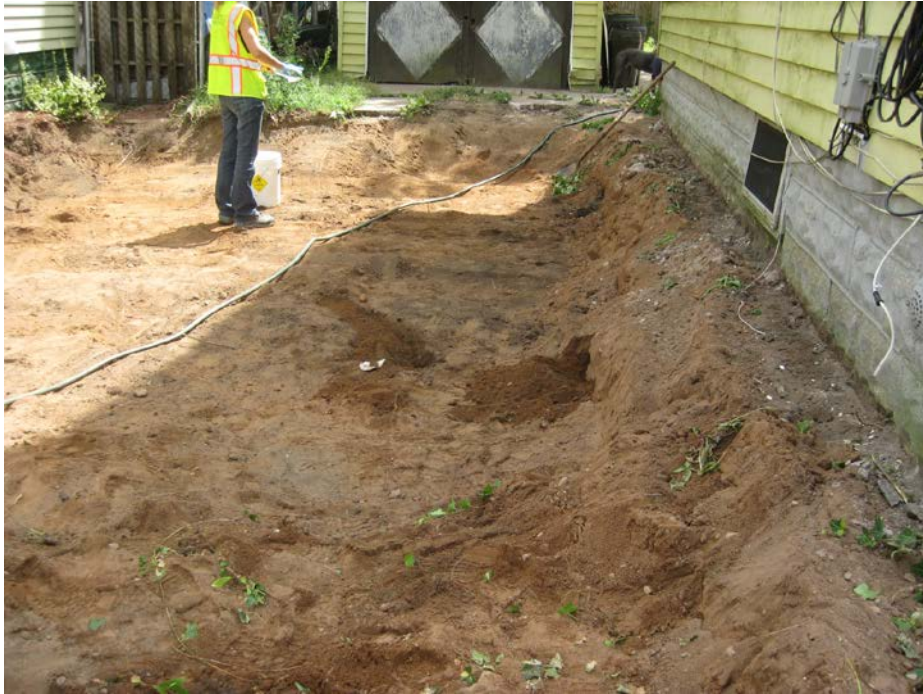
View looking East at excavated side yard

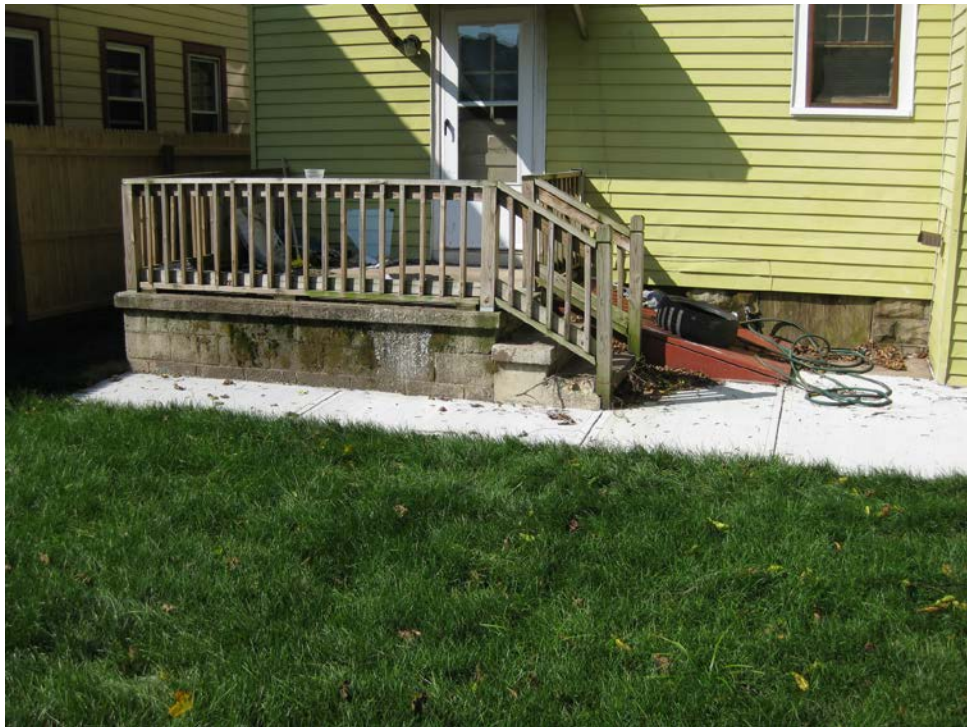
View looking West at restored back of property

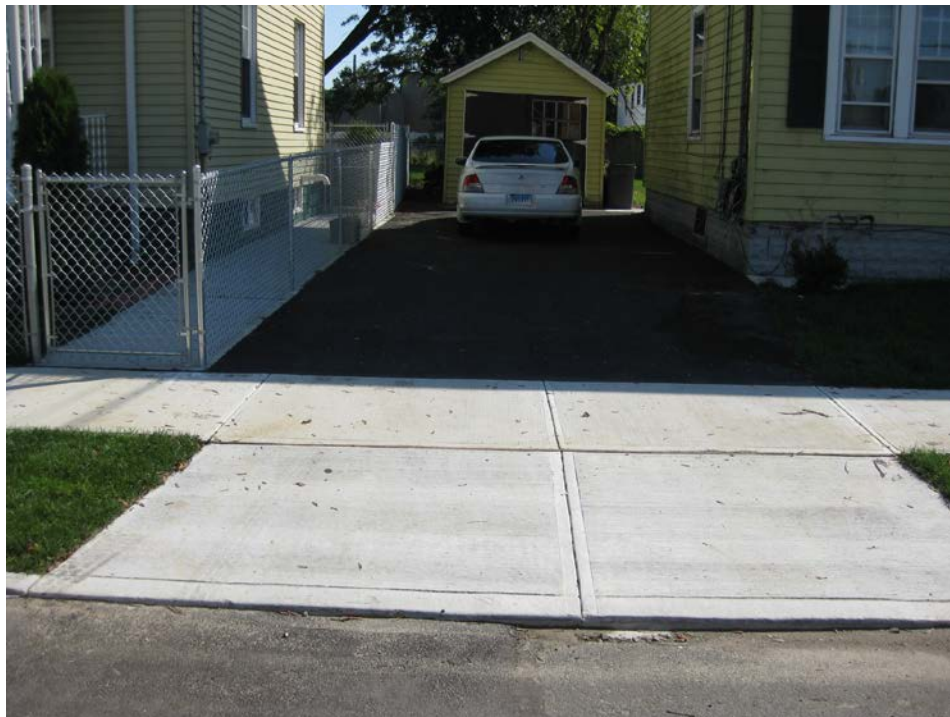
View looking East at restored driveway
