Re: Property-Specific Remedial Action Report  
Newhall Street Neighborhood  
22 Remington Street, Block T  
Hamden, Connecticut 06517

**PROPERTY-SPECIFIC REMEDIAL ACTION REPORT  
22 REMINGTON STREET**

**NON-PUBLIC PROPERTIES  
NEWHALL STREET NEIGHBORHOOD  
HAMDEN, CONNECTICUT**

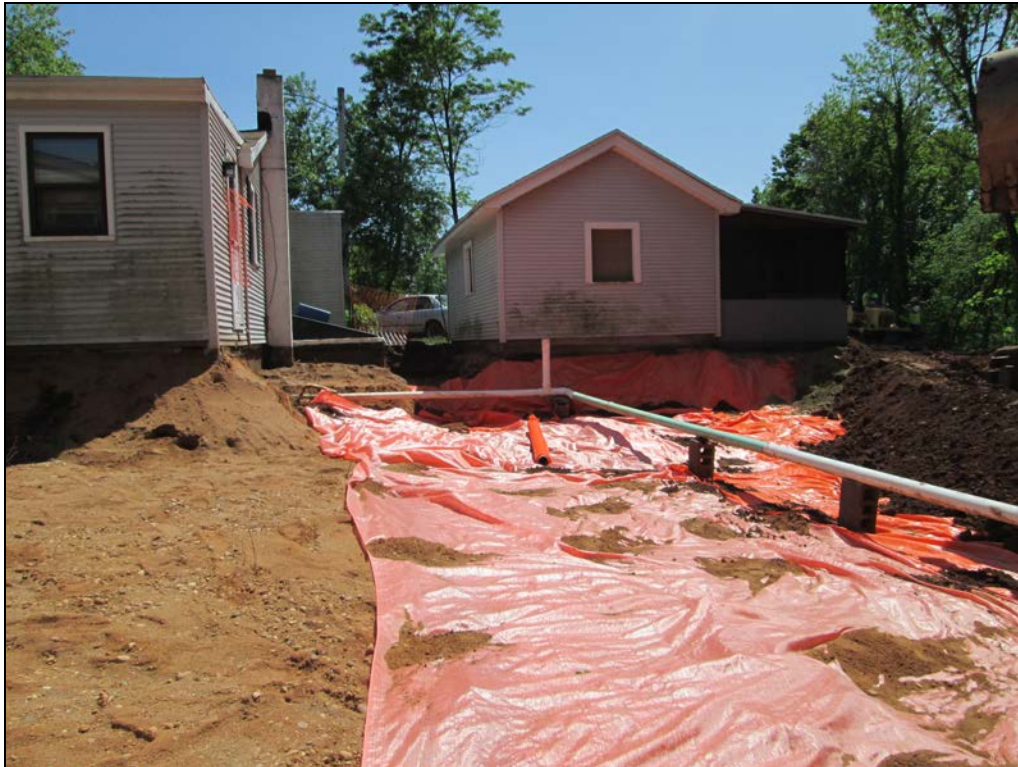
**View looking south at excavated yard from the adjacent property.**

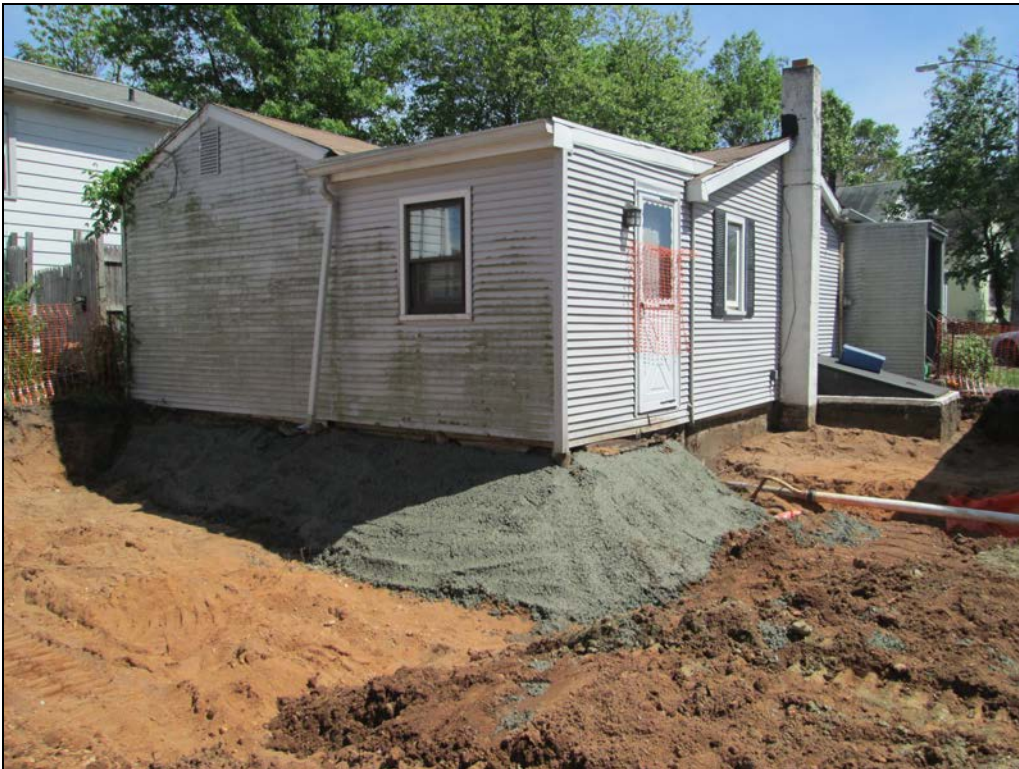
**View looking southeast at excavated yard following placement of concrete marker barrier.**

- In some locations, it was necessary to leave fill material in place at depths less than 4 feet bgs in order to avoid jeopardizing the integrity of a structure or a feature that was to be left in place. This fill material was left in place, covered by an orange geotextile fabric and/or concrete, and backfilled with clean soil in accordance with the Final Design - Generic RAP. Figure 2-1 shows the approximate area of geotextile fabric/concrete identifying the presence of fill at a depth less than 4 feet bgs.

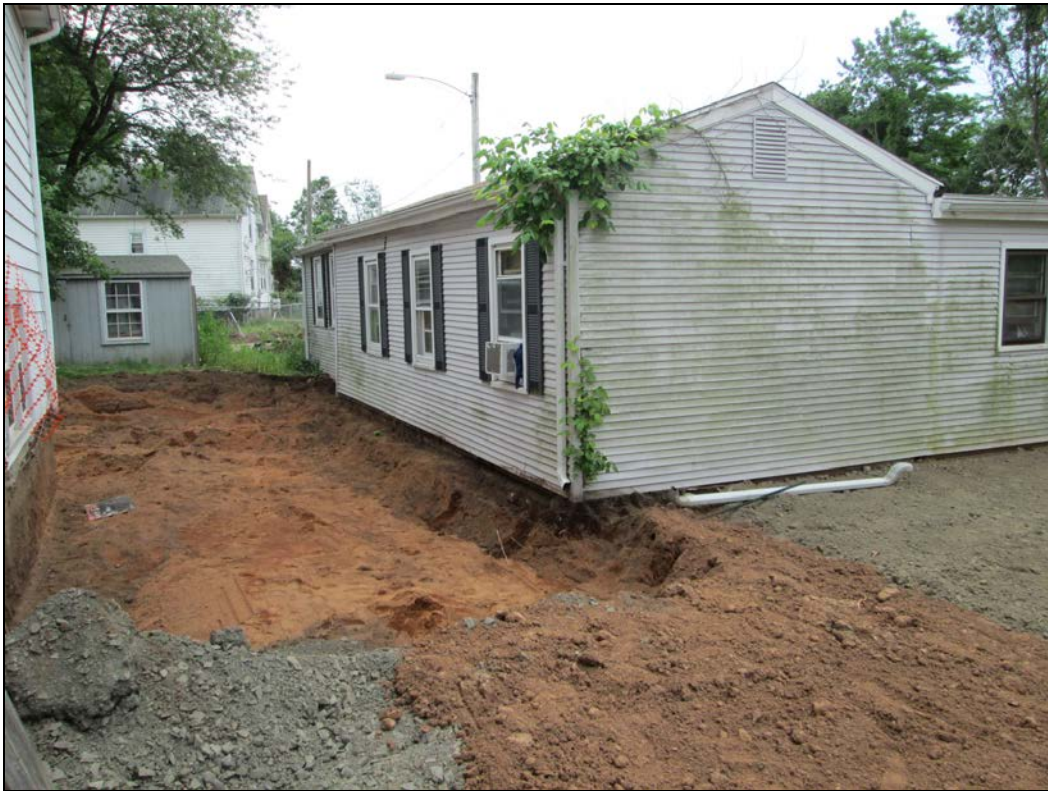
**View looking north at excavated back yard.**

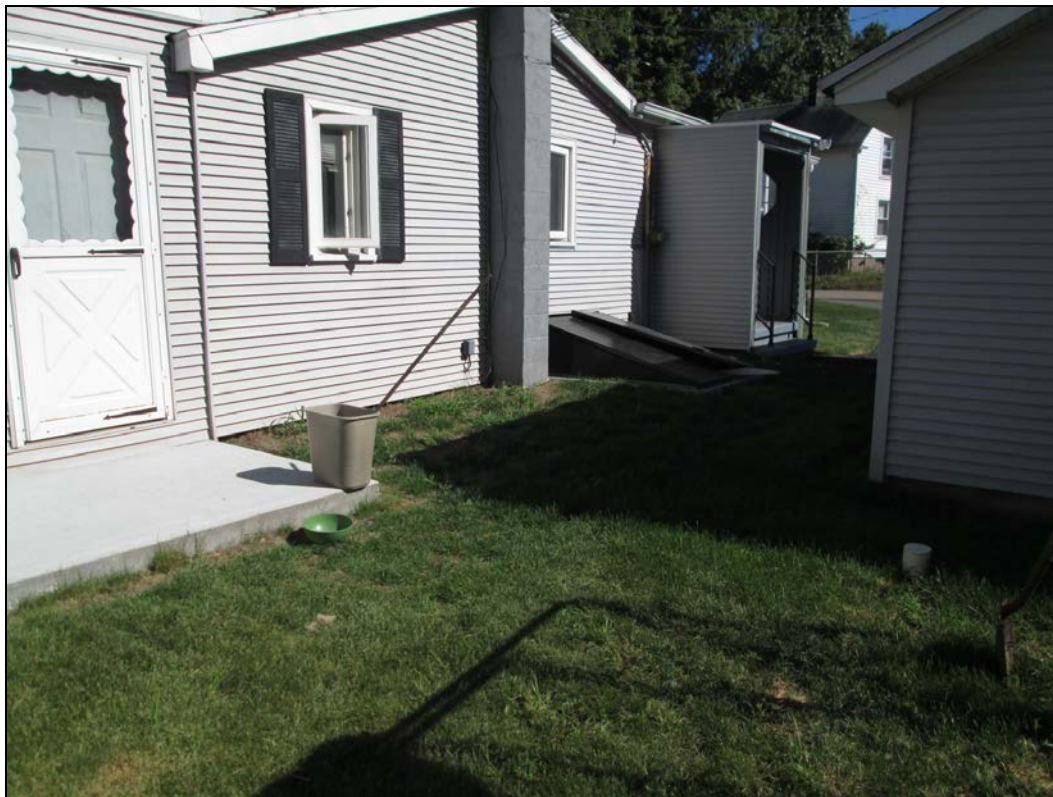
**View looking south at partially restored front yard.**

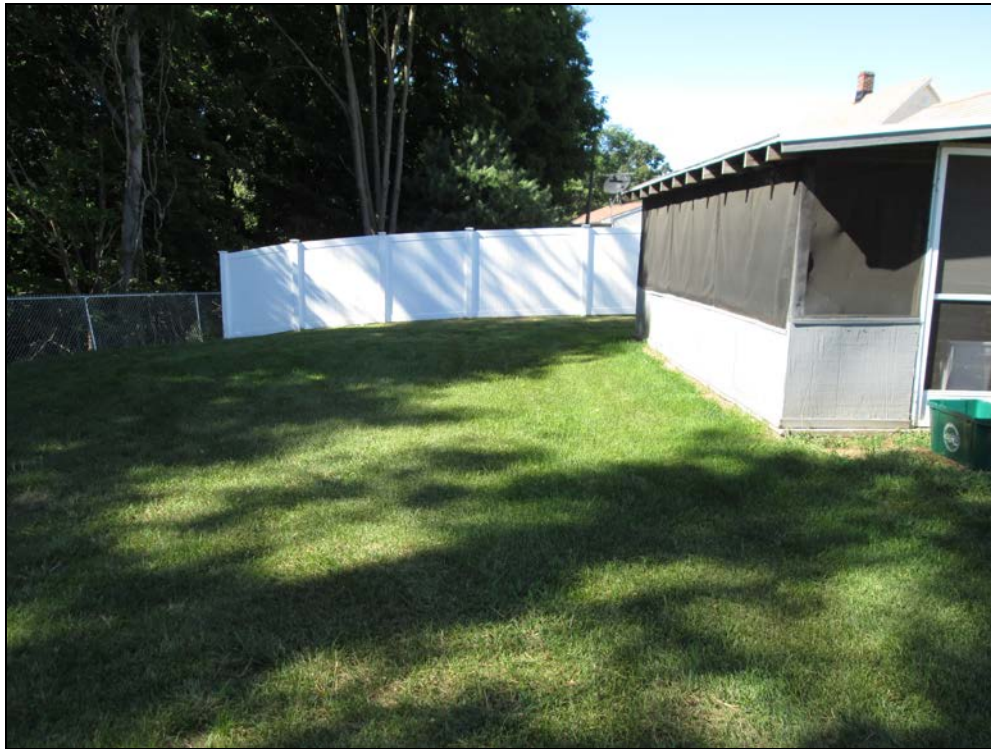
**View looking north at restored yard.**

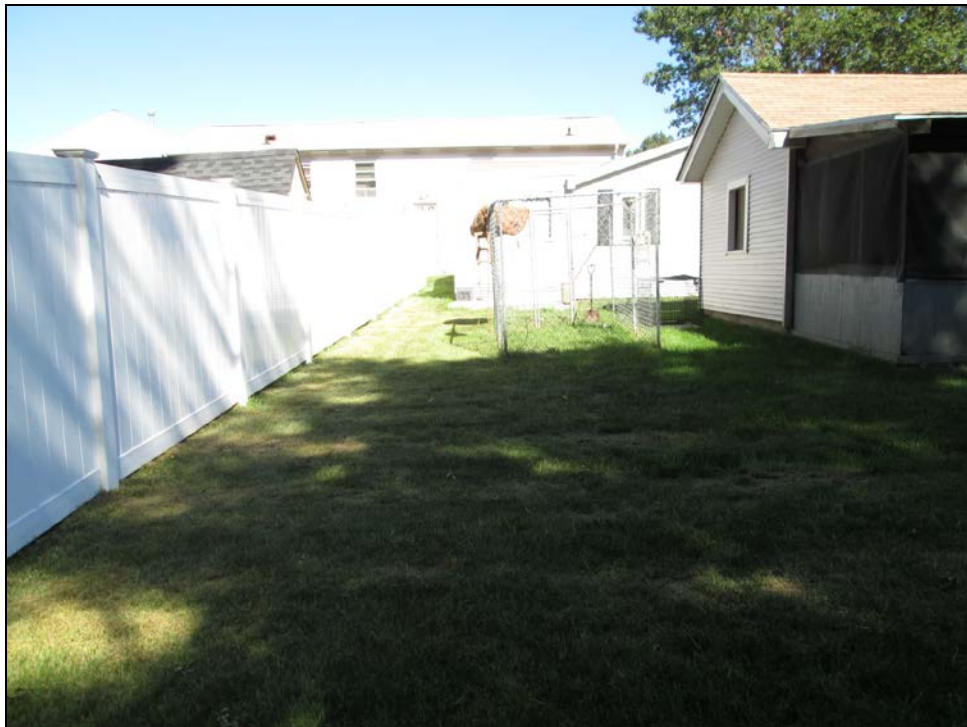
**View looking east at restored back yard.**
