Re: Property-Specific Remedial Action Report
Newhall Street Neighborhood
267 Morse Street, Block A
Hamden, Connecticut 06517

**PROPERTY-SPECIFIC REMEDIAL ACTION REPORT
267 MORSE STREET**

**NON-PUBLIC PROPERTIES
NEWHALL STREET NEIGHBORHOOD
HAMDEN, CONNECTICUT**

AMEC Project Number: 6107110004/85

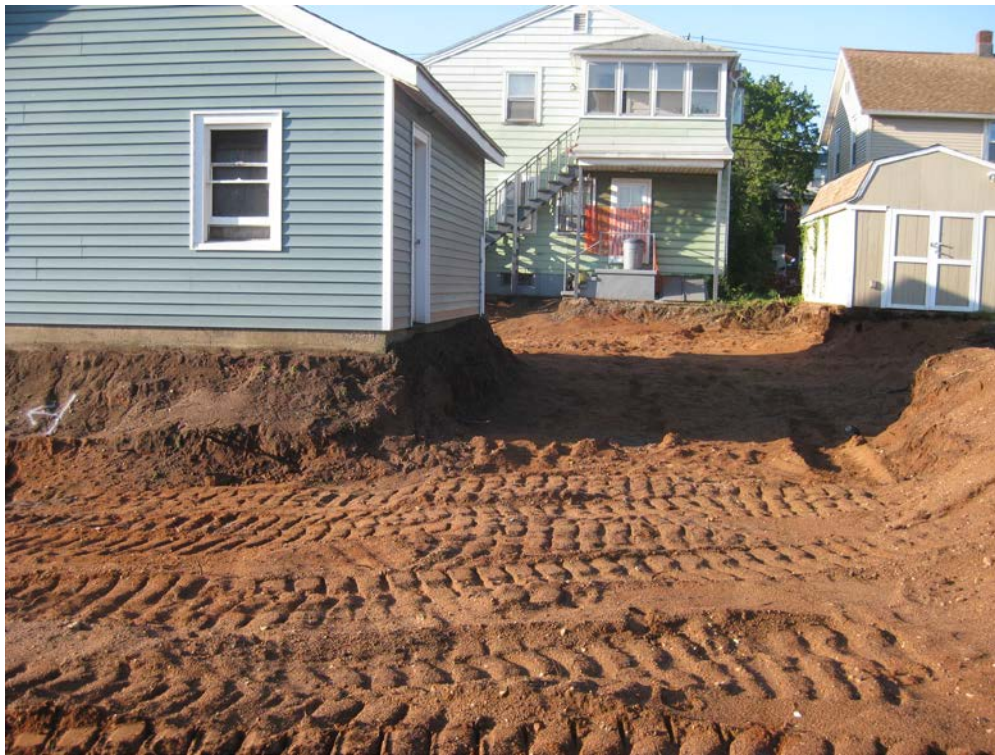
View looking South at excavated back yard

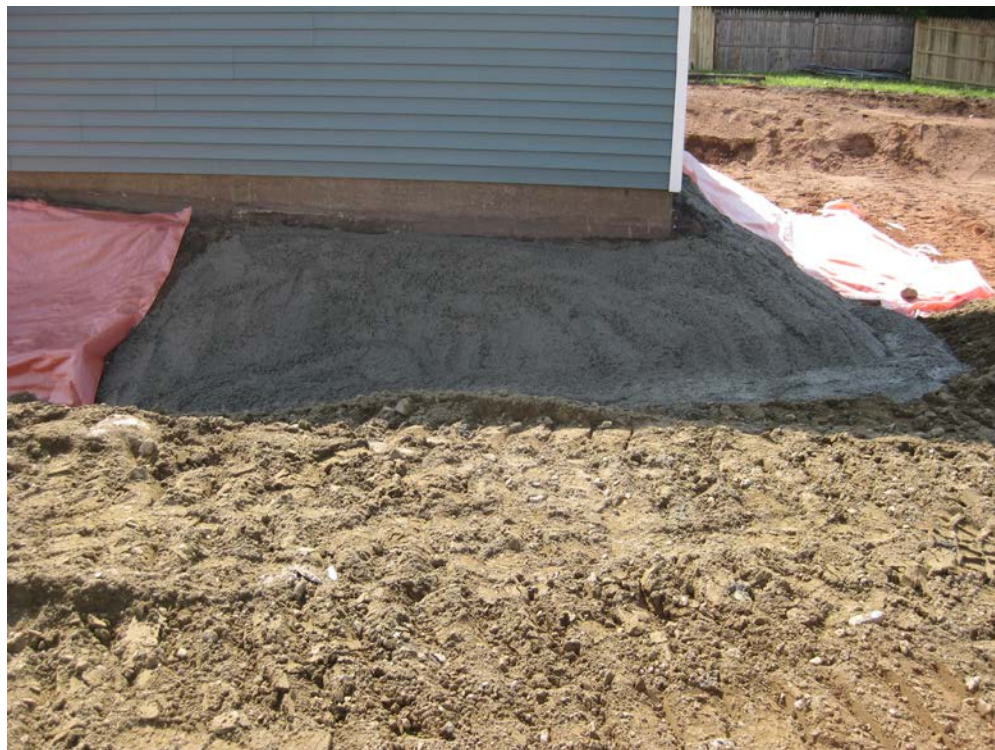
View looking West at concrete and marker barrier along garage

- In some locations, fill material was encountered at greater than 4 feet in depth below ground surface (bgs). This fill material was left in place, covered by an orange geotextile fabric, and backfilled with clean soil in accordance with the Final Design - Generic RAP. Figure 2-1 shows the approximate area of geotextile fabric identifying the presence of fill at a depth greater than 4 feet bgs.
- In some locations, it was necessary to leave fill material in place at depths less than 4 feet bgs in order to avoid jeopardizing the integrity of a structure. This fill material was left in place, covered by an orange geotextile fabric and/or shotcrete, and backfilled with clean soil in accordance with the Final Design - Generic RAP. Figure 2-1 shows the approximate area of geotextile fabric/shotcrete identifying the presence of fill at a depth less than 4 feet bgs.

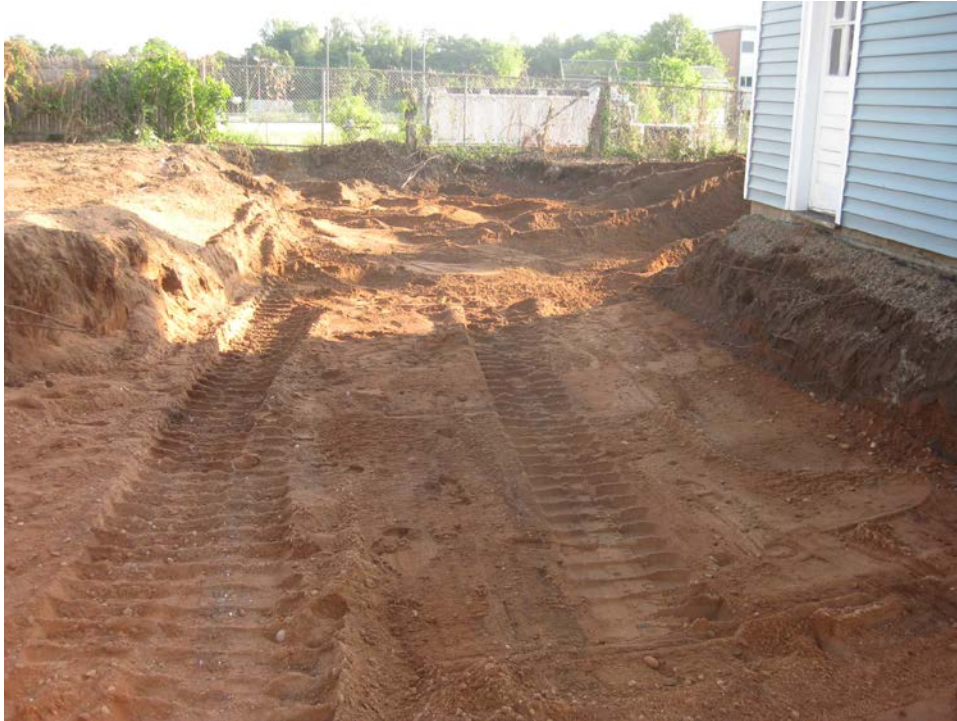
View looking North at excavated back yard

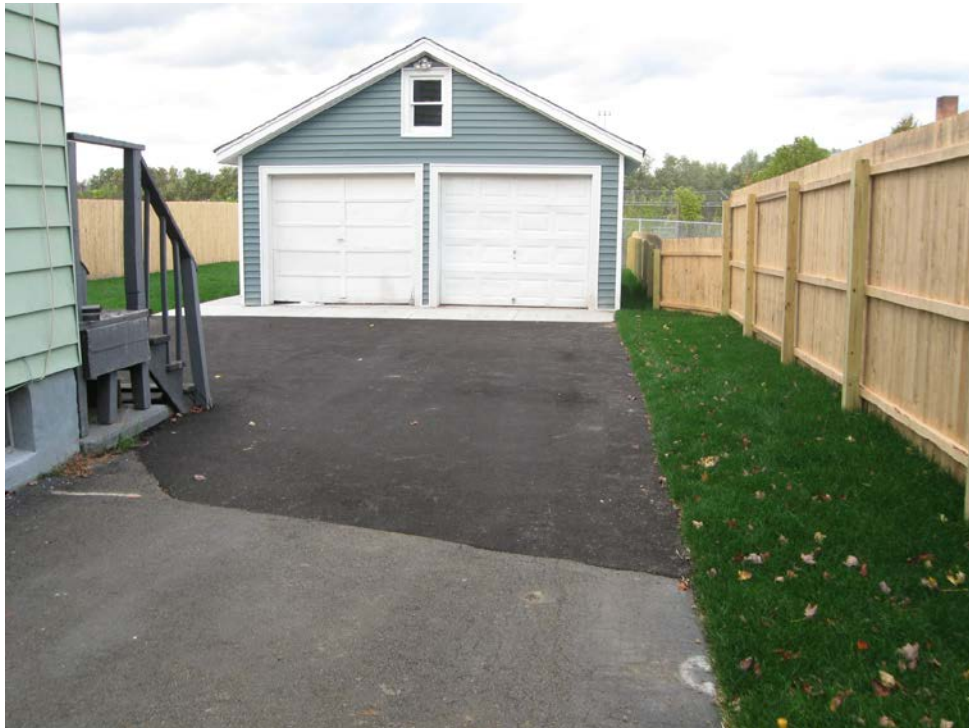
View looking North at restored driveway and fencing

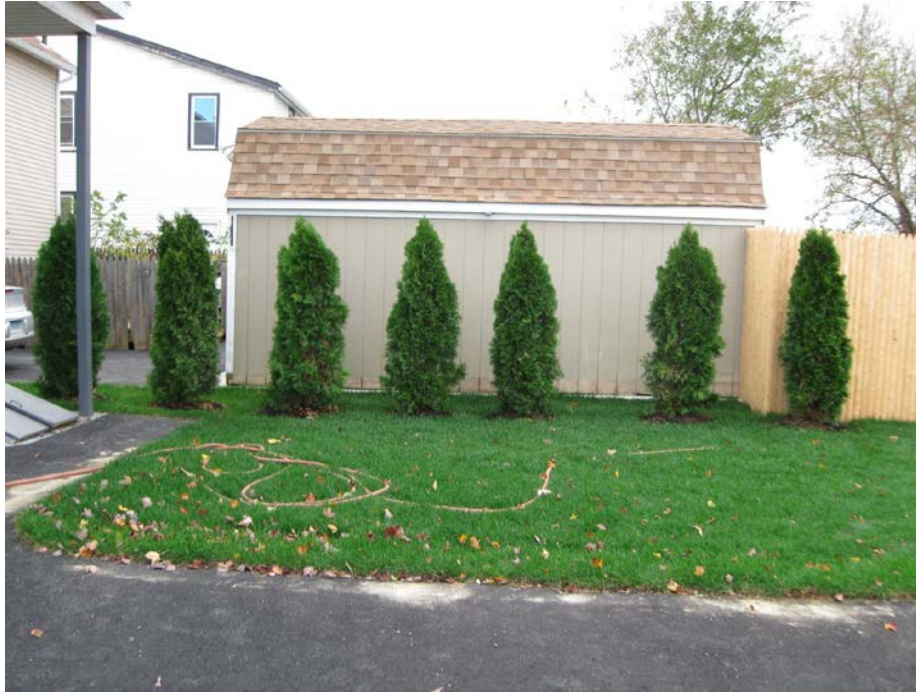
View looking West at restored lawn and bushes

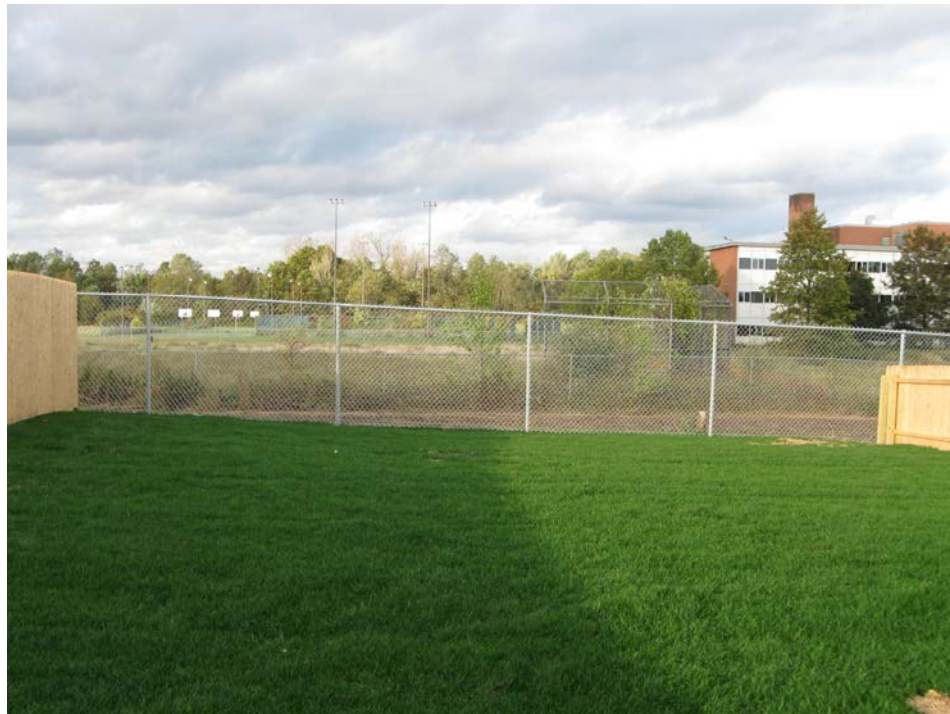
View looking North at restored back yard
