Re: Property-Specific Remedial Action Report  
Newhall Street Neighborhood  
29 Marlboro Street, Block P  
Hamden, Connecticut 06517

**PROPERTY-SPECIFIC REMEDIAL ACTION REPORT  
29 MARLBORO STREET**

**NON-PUBLIC PROPERTIES  
NEWHALL STREET NEIGHBORHOOD  
HAMDEN, CONNECTICUT**

**AMEC Project Number: 6107120004.155**

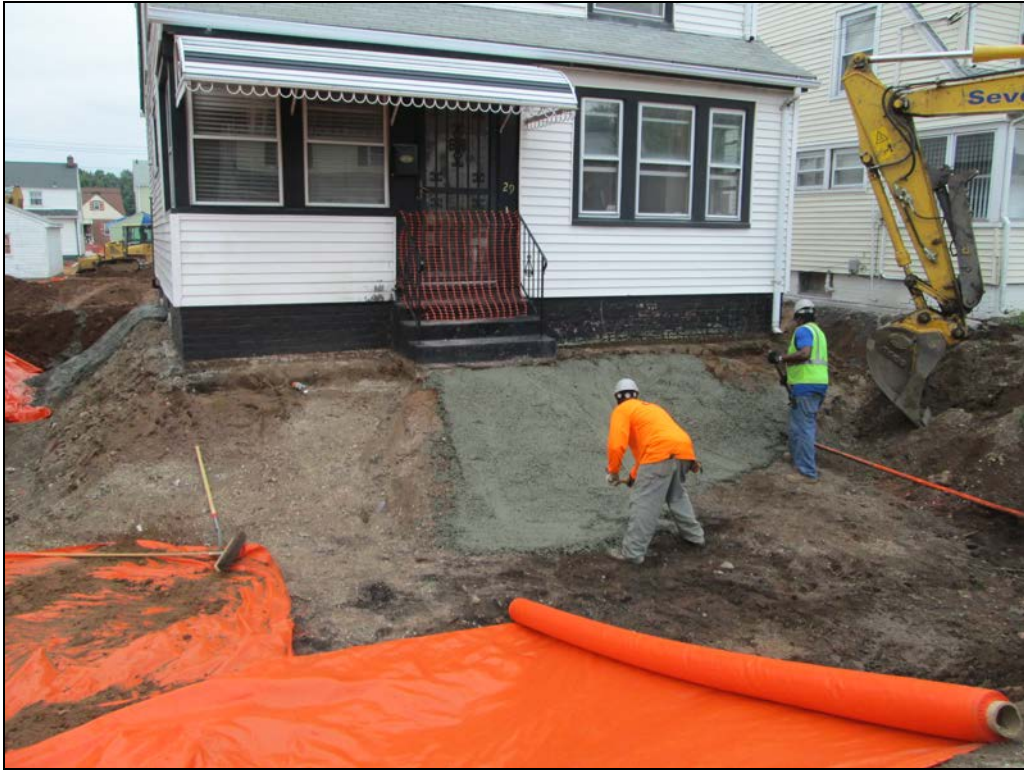
**View looking north at excavated front yard.**

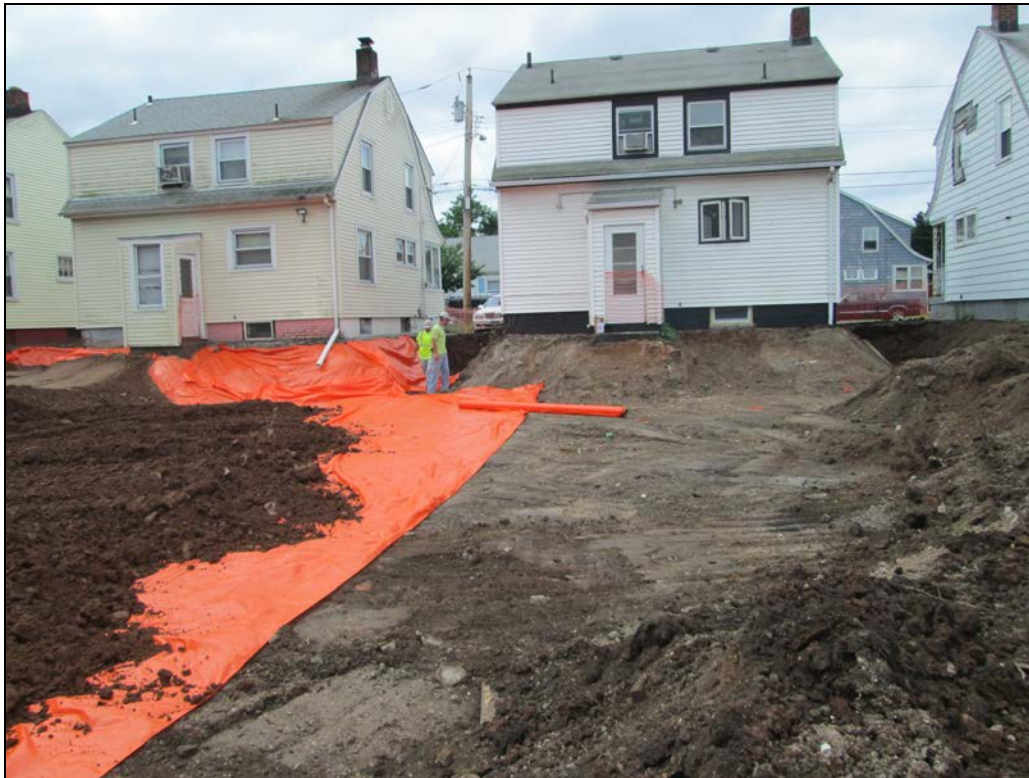
**View looking south at excavated back yard during placement of marker barrier.**

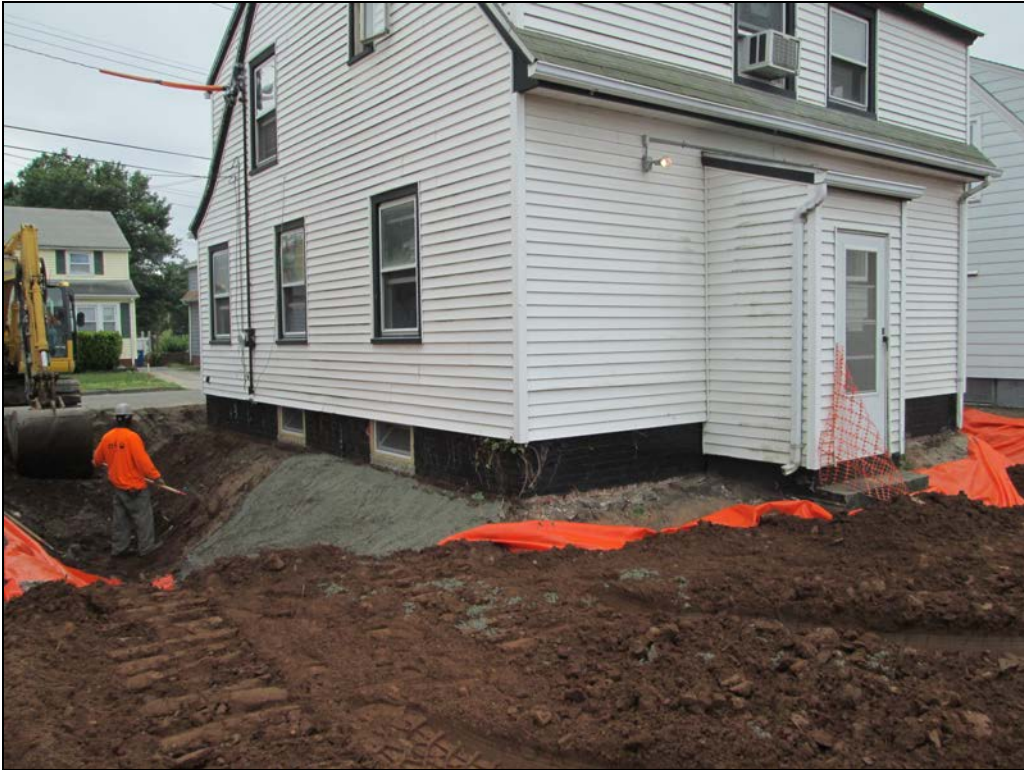
**View looking southwest at partially backfilled side yard with marker barrier.**

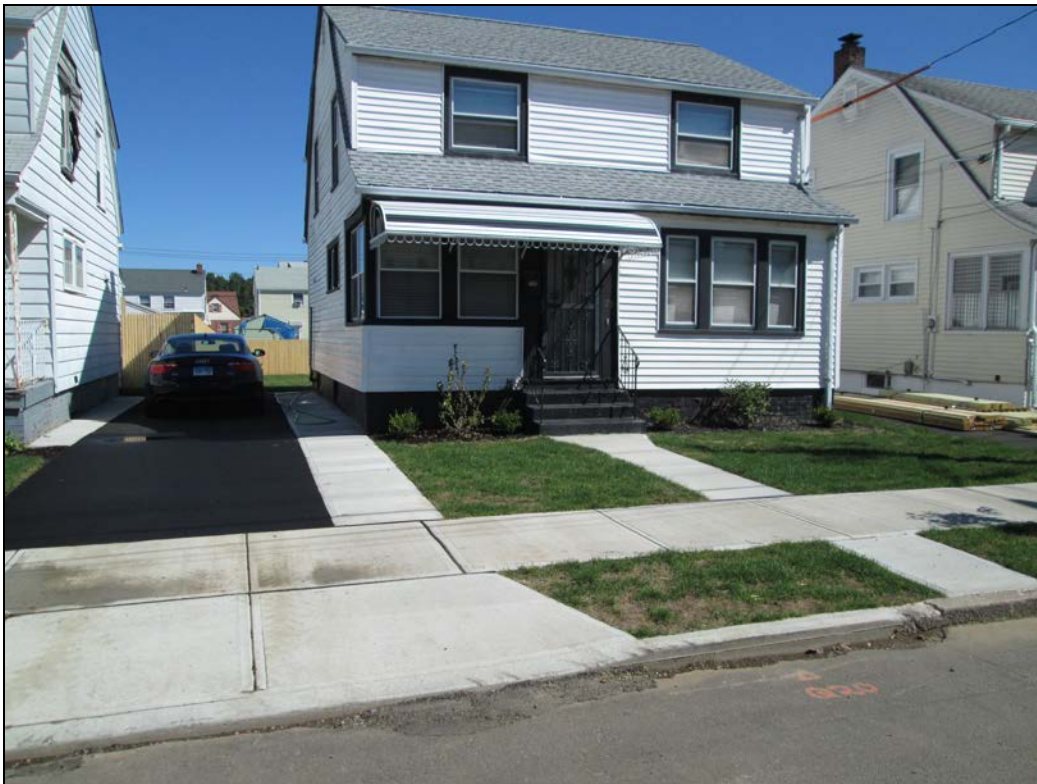
**View looking north at restored front yard.**

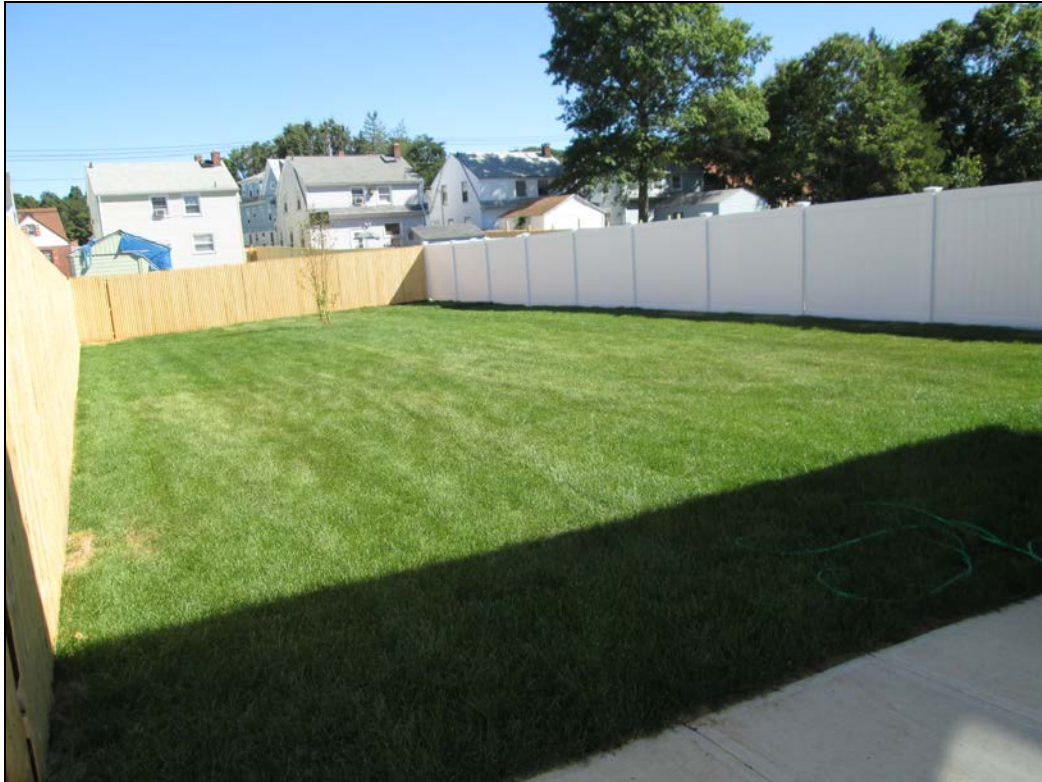
**View looking north at restored back yard.**

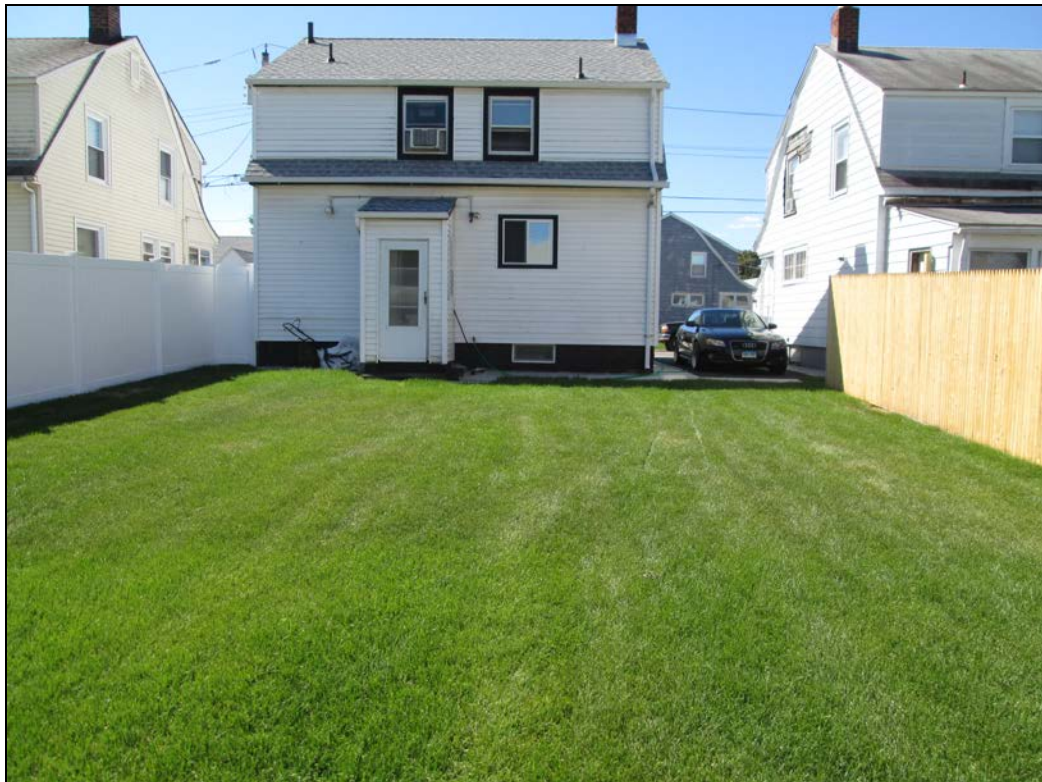
**View looking south at restored back yard.**
