Re: Property-Specific Remedial Action Report  
Newhall Street Neighborhood  
29 North Sheffield Street  
Hamden, Connecticut 06517

**PROPERTY-SPECIFIC REMEDIAL ACTION REPORT  
29 NORTH SHEFFIELD STREET**

**NON-PUBLIC PROPERTIES  
NEWHALL STREET NEIGHBORHOOD  
HAMDEN, CONNECTICUT**

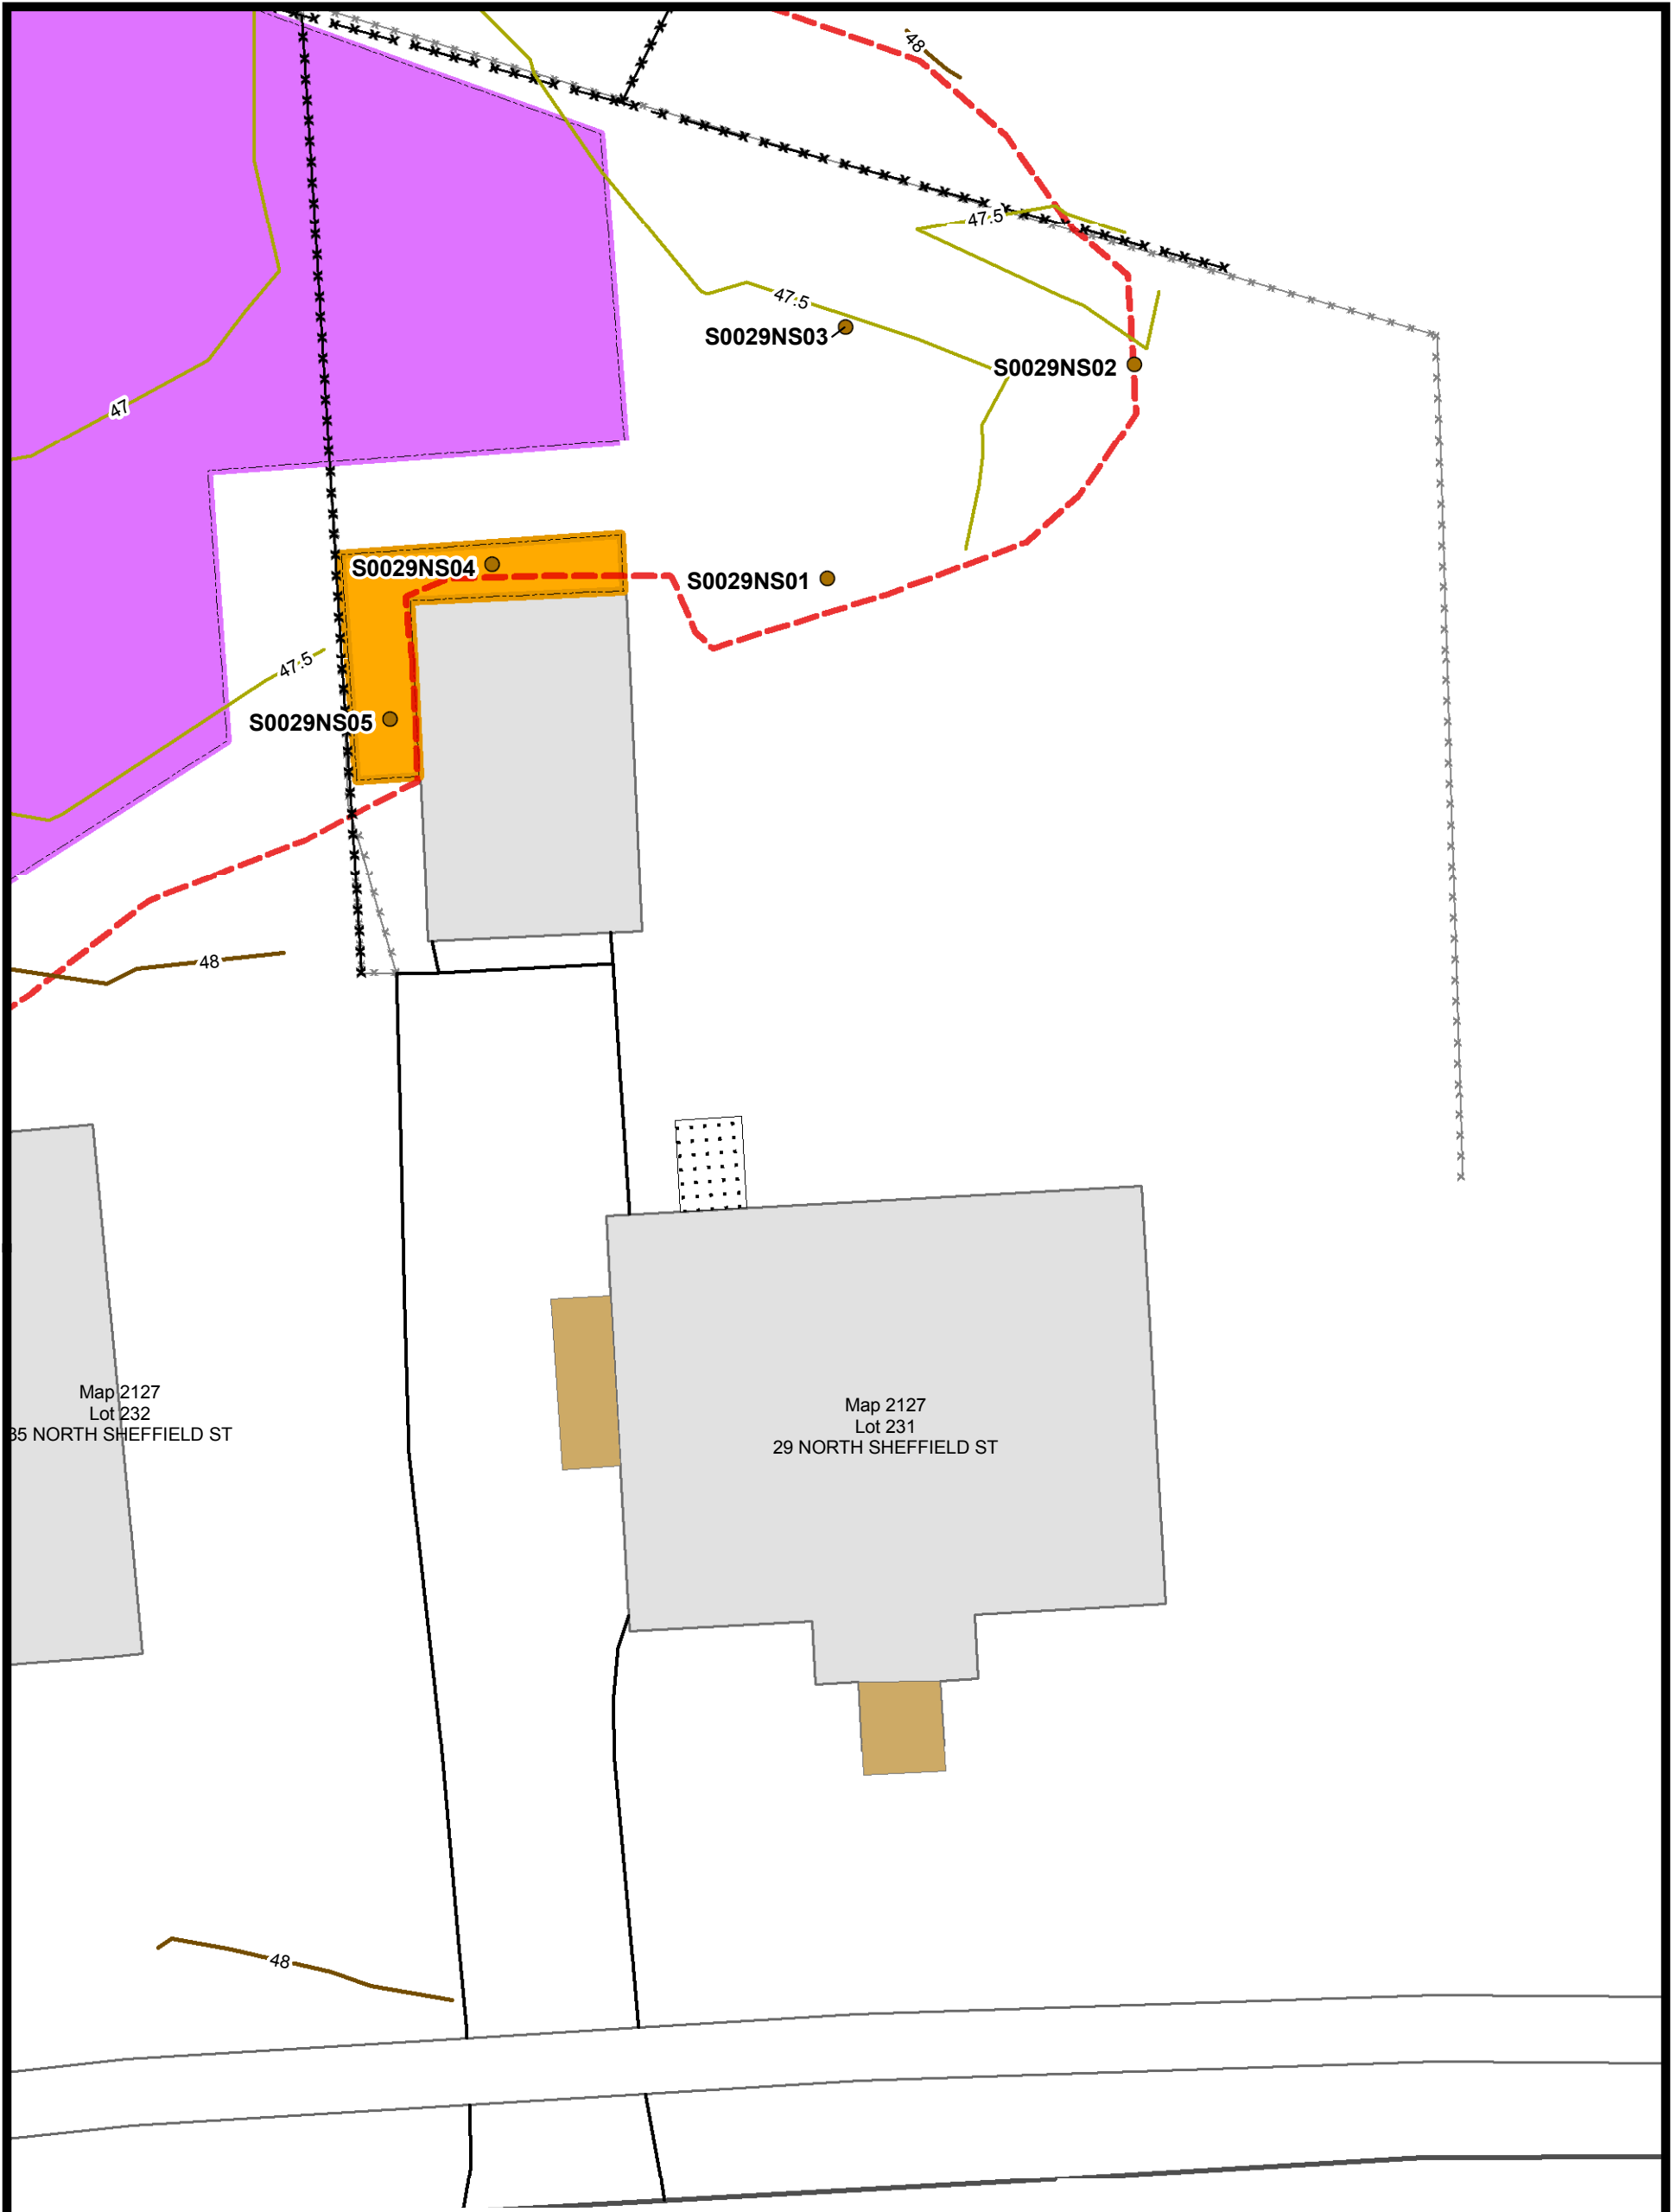
During the 2010 construction season, Olin completed the excavation of fill material to a depth of 4 feet bgs, backfill, and restoration of the property in accordance with the Final Design - Generic RAP and the Property-Specific RAP. Figure 2-1 shows the areas where excavation occurred on the property and the locations of excavation confirmation samples. Excavation confirmation samples were collected in accordance with Section 3.2.3 – Confirmatory Sampling of the Final Design - Generic RAP, including adherence to the sampling frequency requirements. X-ray fluorescence (XRF) excavation confirmation sampling results are presented in Table 2-1. As indicated in Table 2-1, all confirmation sampling results indicate total lead concentrations less than the criteria of 400 mg/kg approved by CTDEP in the Final Design - Generic RAP.

- All fill material within 4 feet of ground surface was removed in accordance with the Property-Specific RAP and the Final Design - Generic RAP, with the exception of an area at the back of the garage where removal of the fill material would have resulted in undermining the garage. The fill material left in place was covered with an orange geotextile marker barrier prior to backfilling with clean soil, in accordance with the Final Design - Generic RAP. The approximate limits of the orange geotextile marker barrier are presented on Figure 2-1.

- In some locations, fill material was encountered at a depth greater than 4 feet bgs. This fill material was left in place, covered by an orange geotextile fabric, and backfilled with clean soil in accordance with the Final Design - Generic RAP. Figure 2-1 shows the approximate area of geotextile fabric identifying the presence of fill at a depth greater than 4 feet bgs. This area extends from behind the garage to the back property boundary.

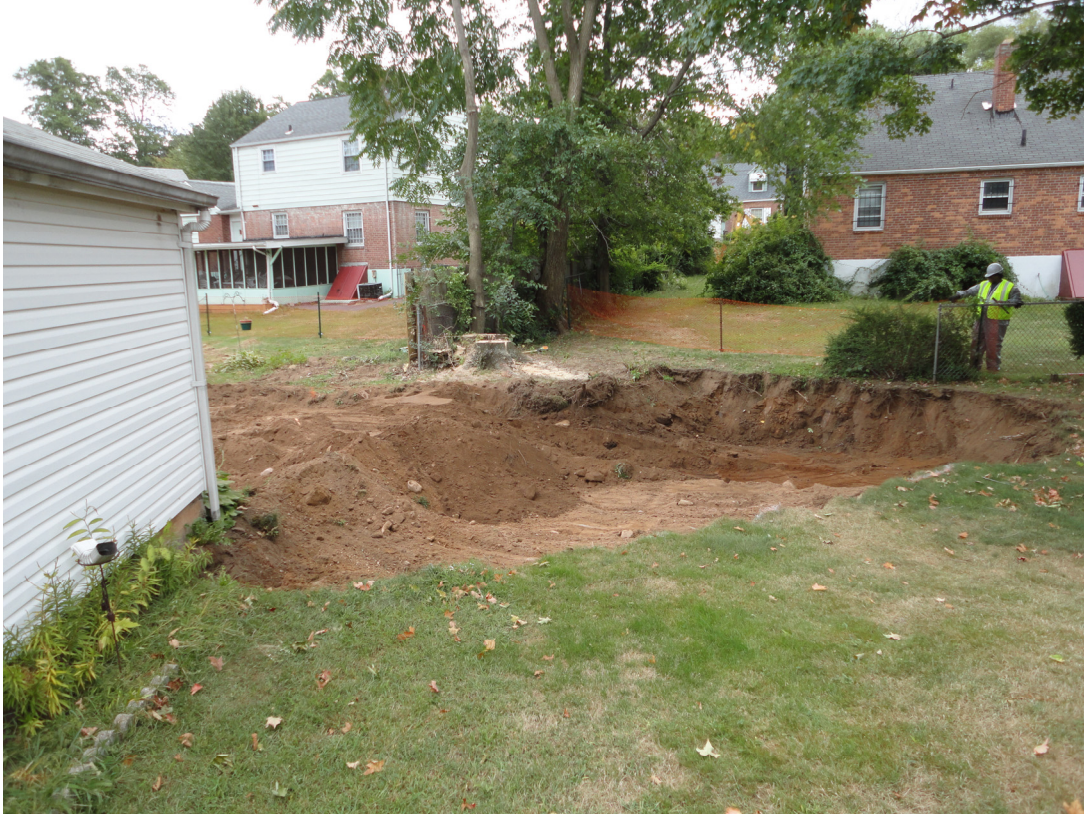
View looking east from back yard as excavation activities begin.

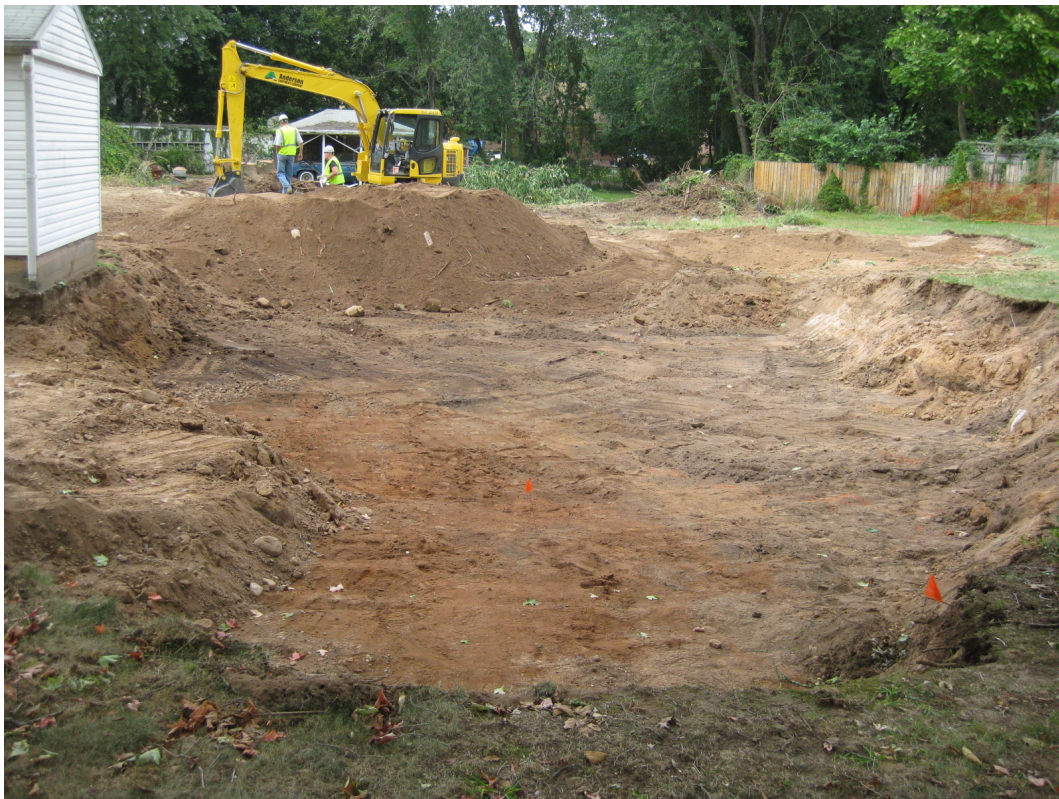
Looking west from backyard, view of excavation immediately prior to placement of marker barrier.

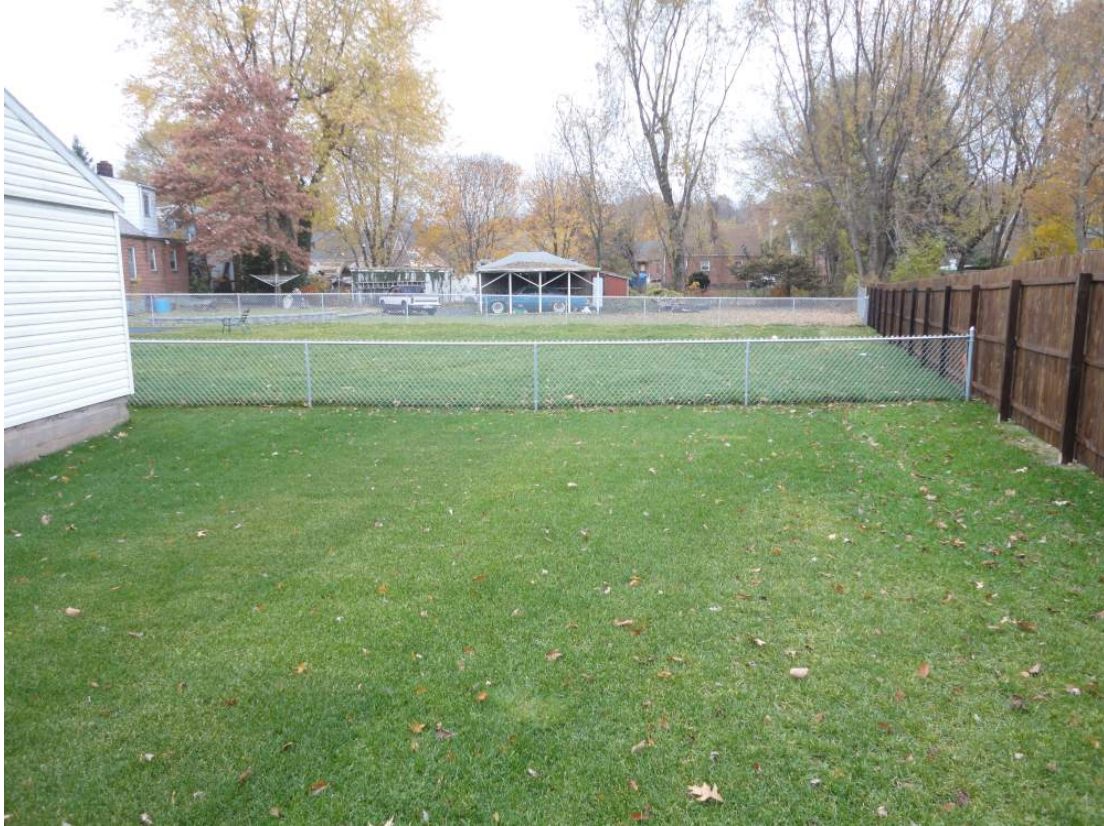
**View looking north from back yard showing restored property.**

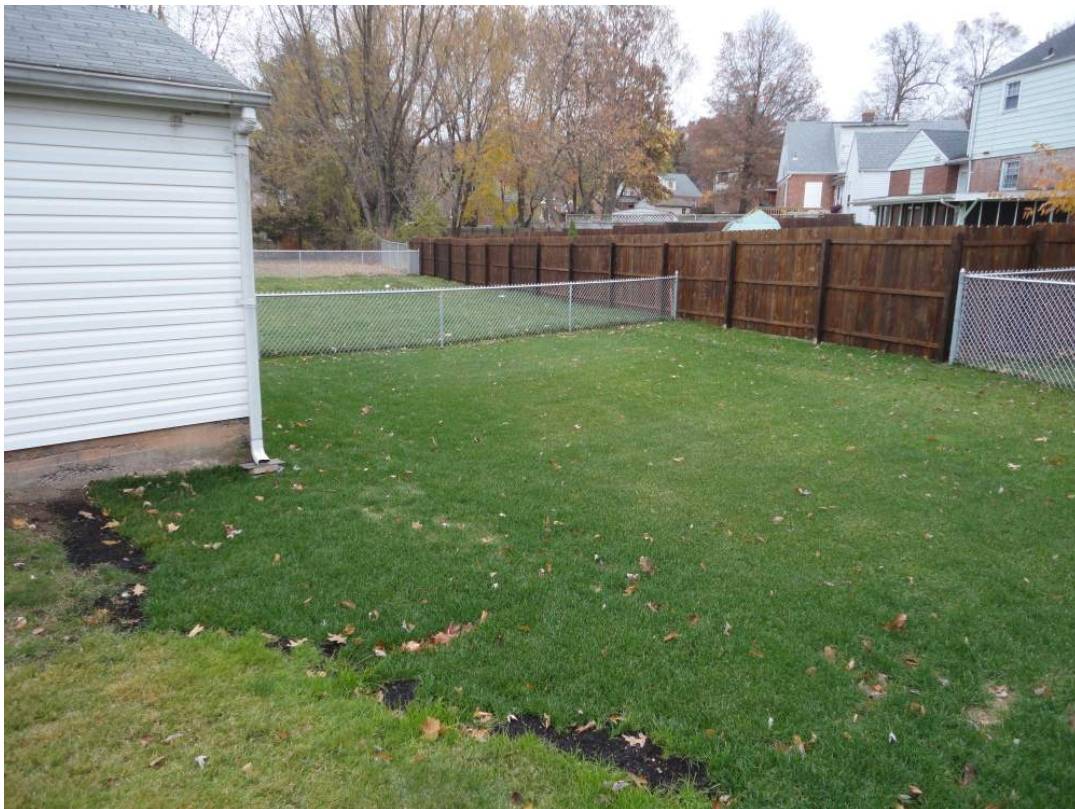
**View looking northeast from back yard showing restored property.**
