Re: Property-Specific Remedial Action Report
Newhall Street Neighborhood
311 Morse Street, Block A
Hamden, Connecticut 06517

**PROPERTY-SPECIFIC REMEDIAL ACTION REPORT
311 MORSE STREET**

**NON-PUBLIC PROPERTIES
NEWHALL STREET NEIGHBORHOOD
HAMDEN, CONNECTICUT**

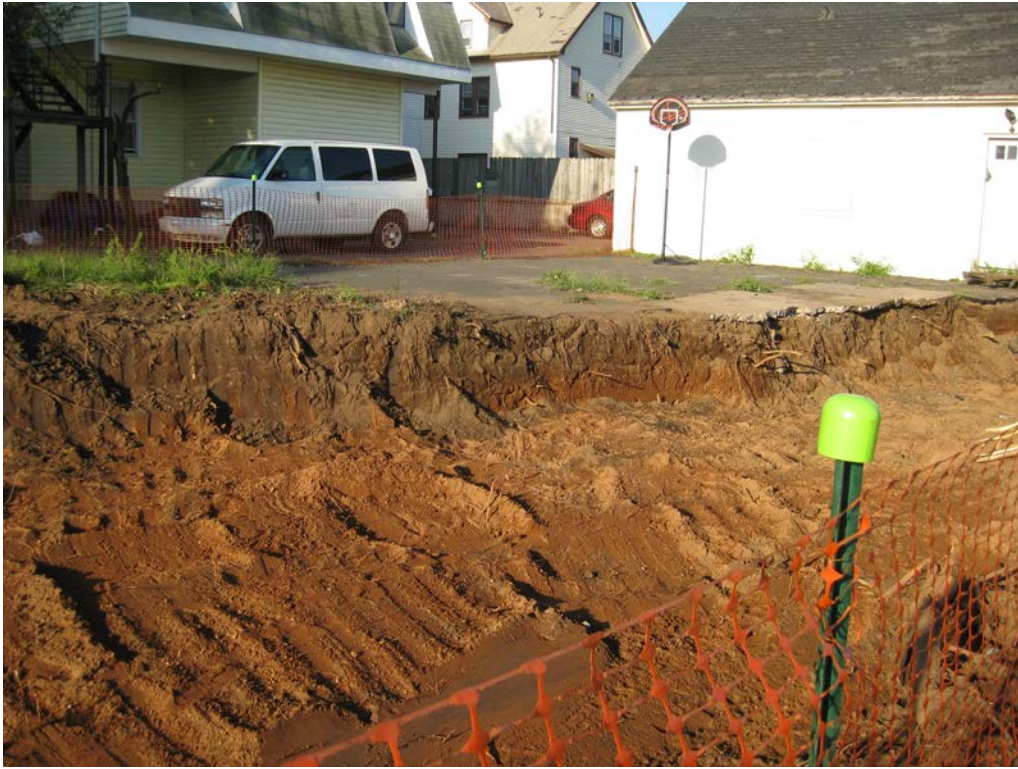
View looking Southwest at excavation of back yard

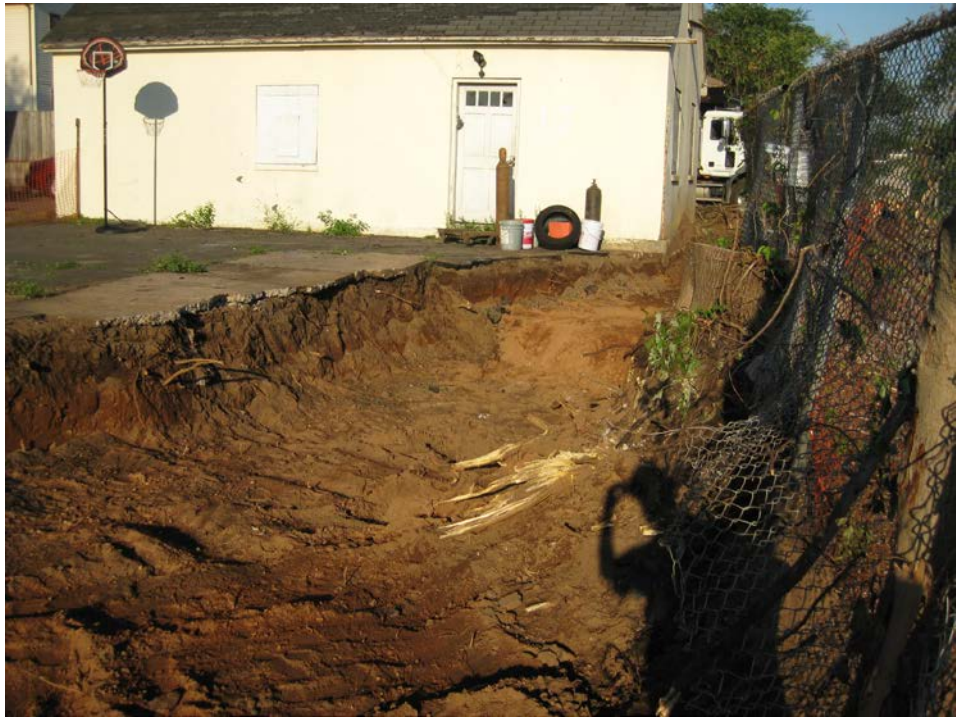
View looking West at excavation of back yard

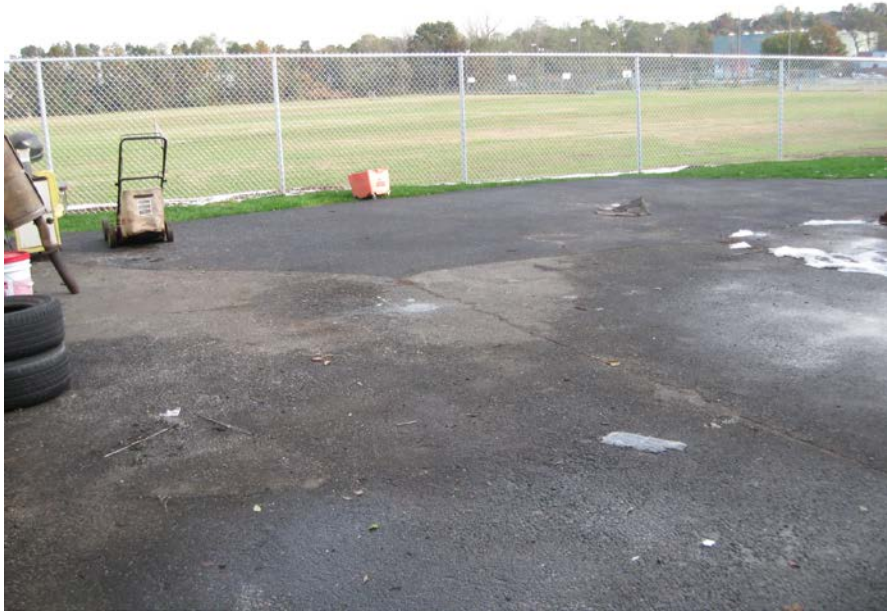
View looking North at partially restored driveway

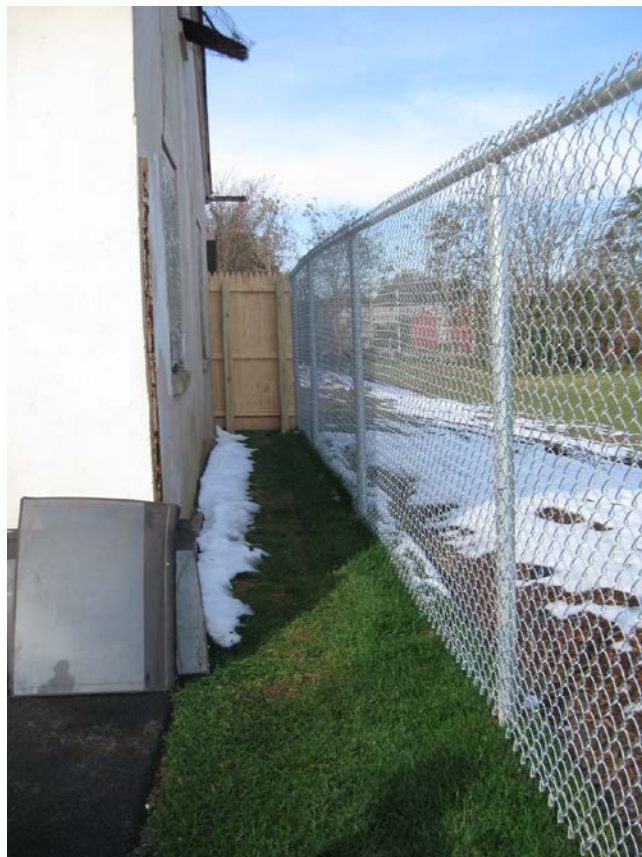
View looking West at area behind garage

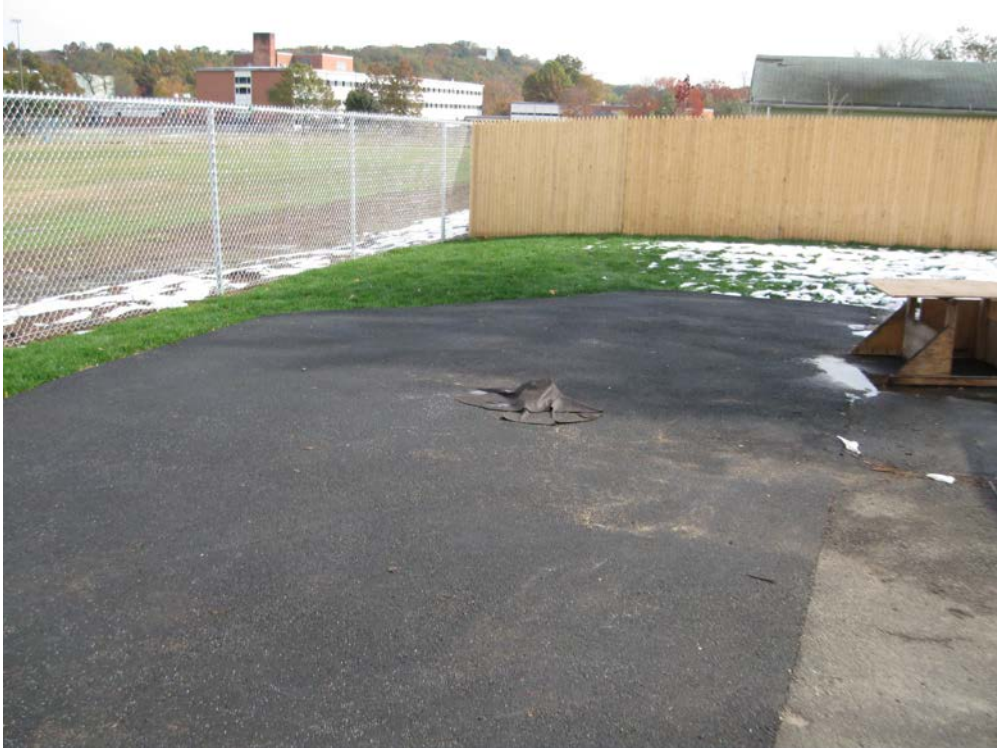
View looking East at restored back yard and parking area
