Re: Property-Specific Remedial Action Report
Newhall Street Neighborhood
323 Augur Street, Block T
Hamden, Connecticut 06517

**PROPERTY-SPECIFIC REMEDIAL ACTION REPORT
323 AUGUR STREET**

**NON-PUBLIC PROPERTIES
NEWHALL STREET NEIGHBORHOOD
HAMDEN, CONNECTICUT**

October 23, 2012

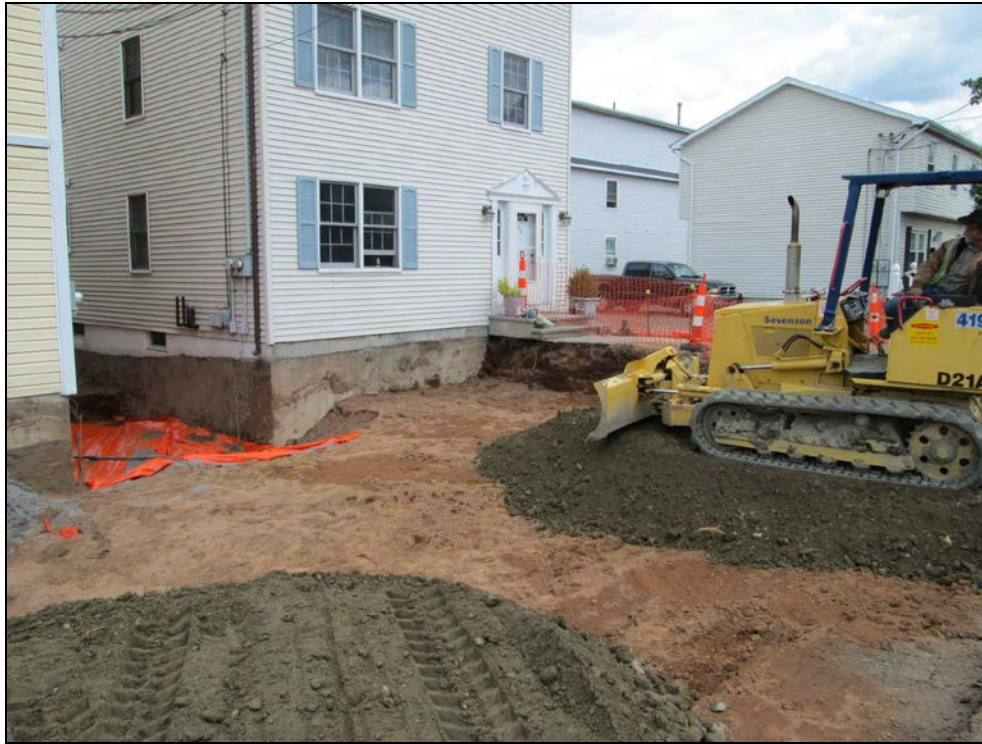
View looking northeast at partially backfilled front yard.

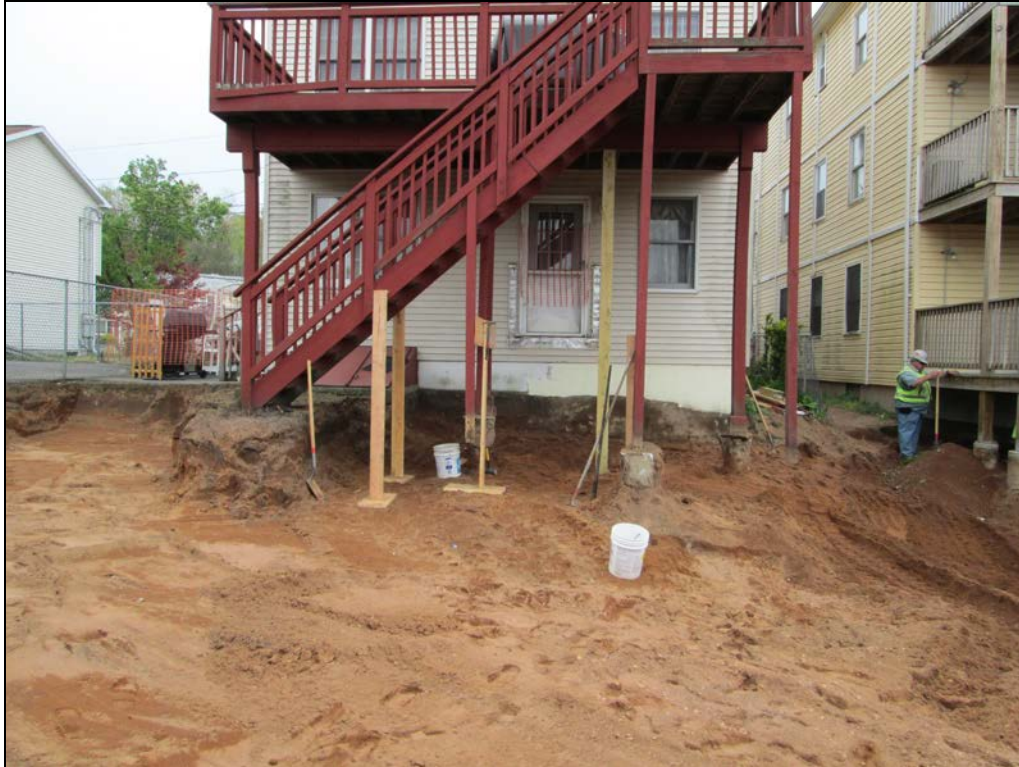
View looking south at excavated back yard. Deck was braced to allow excavation of fill beneath the footprint of the two-story deck.

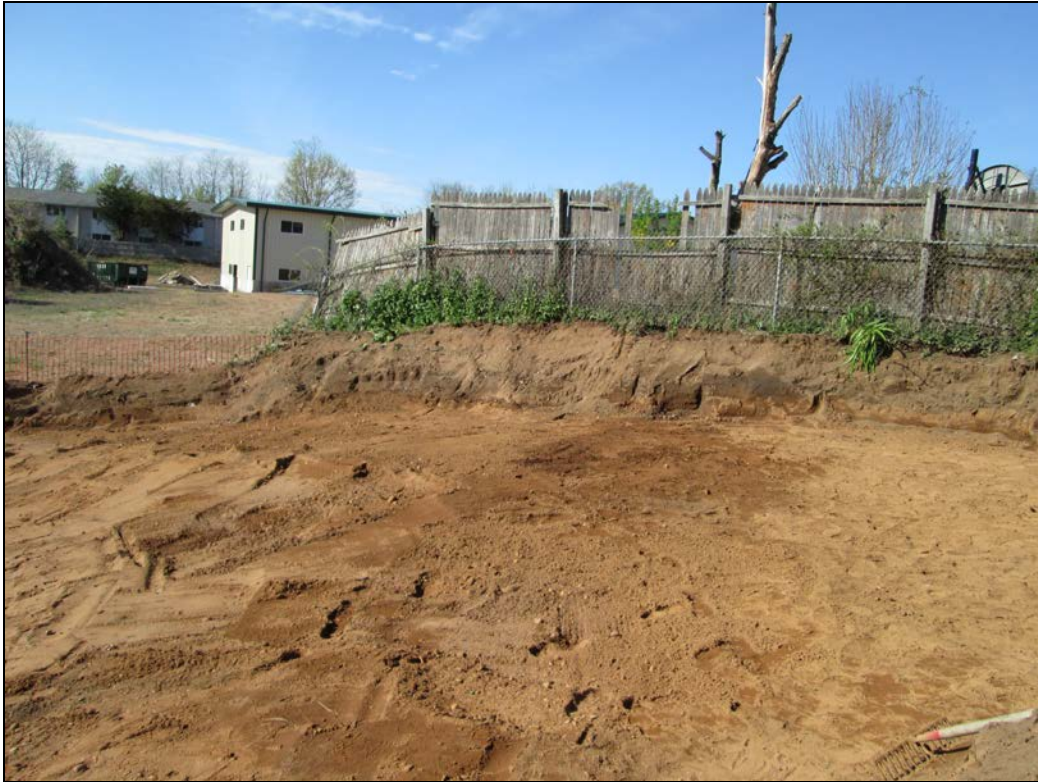
View looking northeast at excavated back yard.

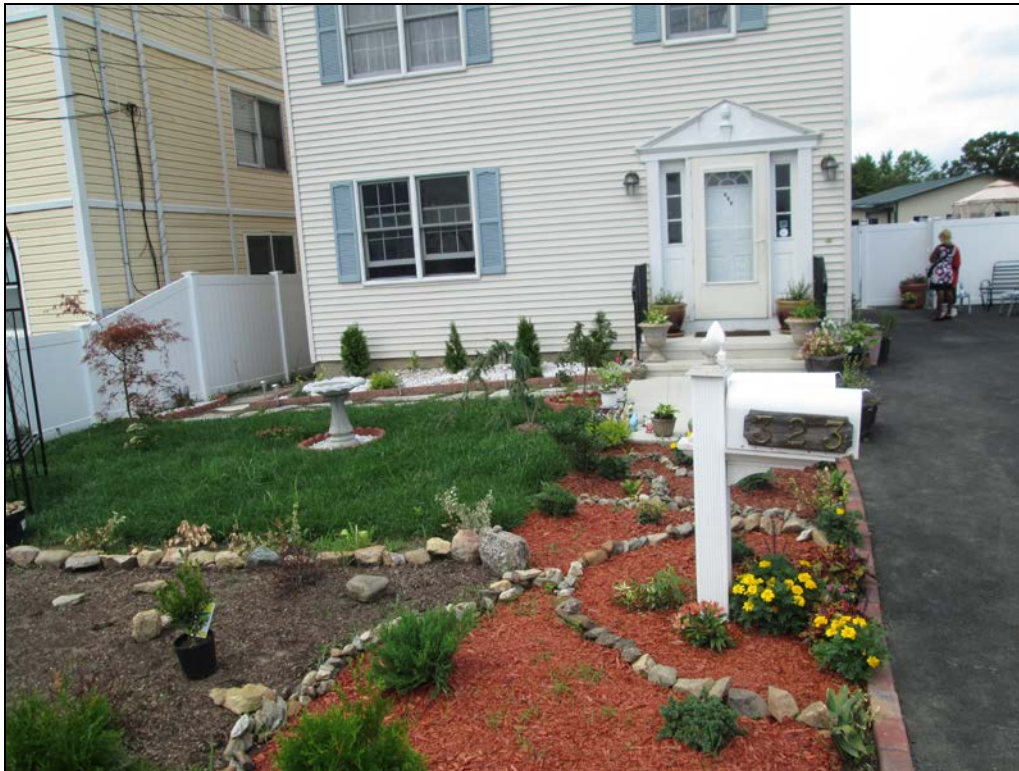
View looking north at restored front yard.

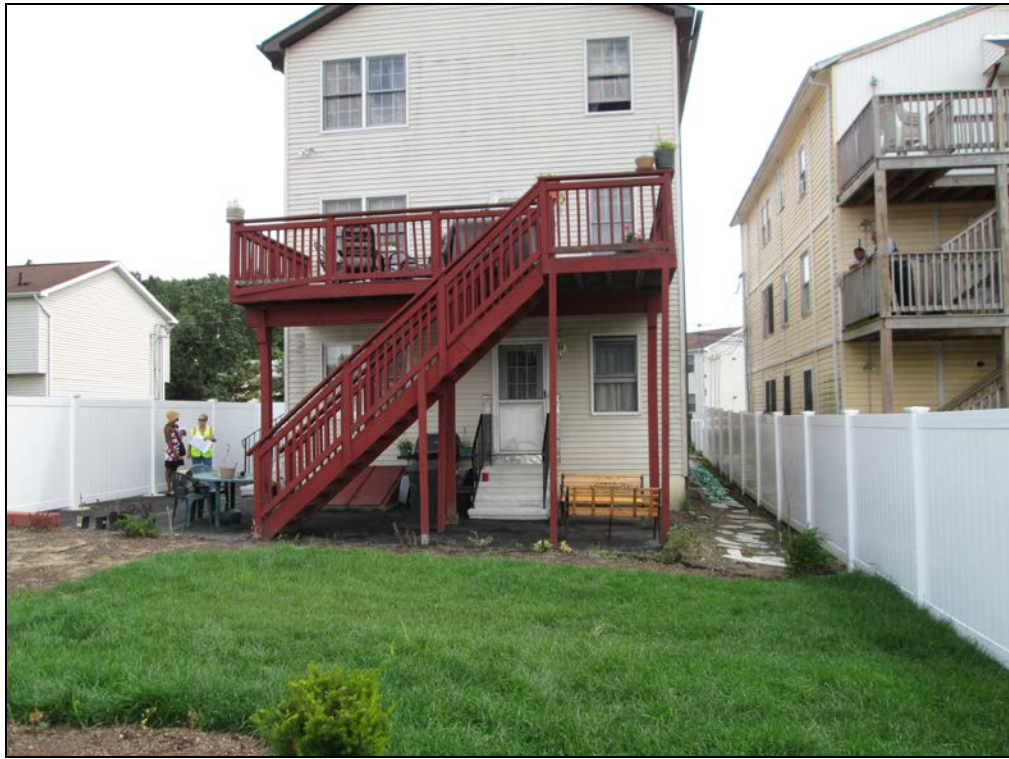
View looking south at partially restored back of house.
