Re: Property-Specific Remedial Action Report
Newhall Street Neighborhood
342 Augur Street, Block T
Hamden, Connecticut 06517

**PROPERTY-SPECIFIC REMEDIAL ACTION REPORT
342 AUGUR STREET**

**NON-PUBLIC PROPERTIES
NEWHALL STREET NEIGHBORHOOD
HAMDEN, CONNECTICUT**

AMEC Project Number: 6107120004.175

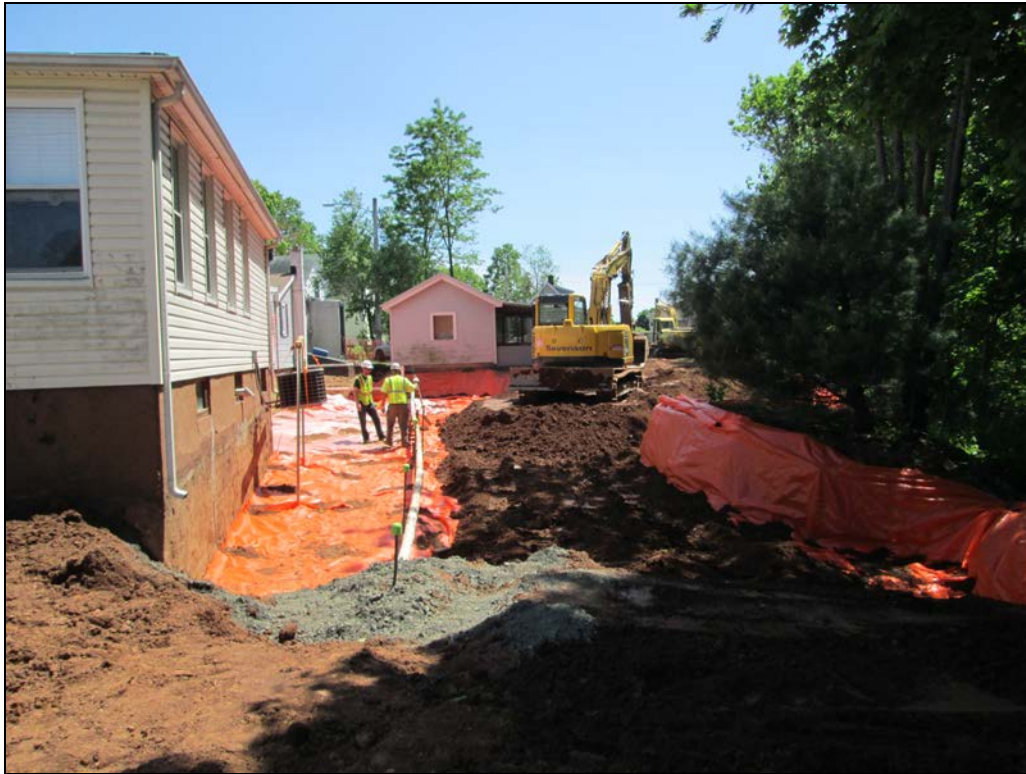
View looking south at excavated driveway area.

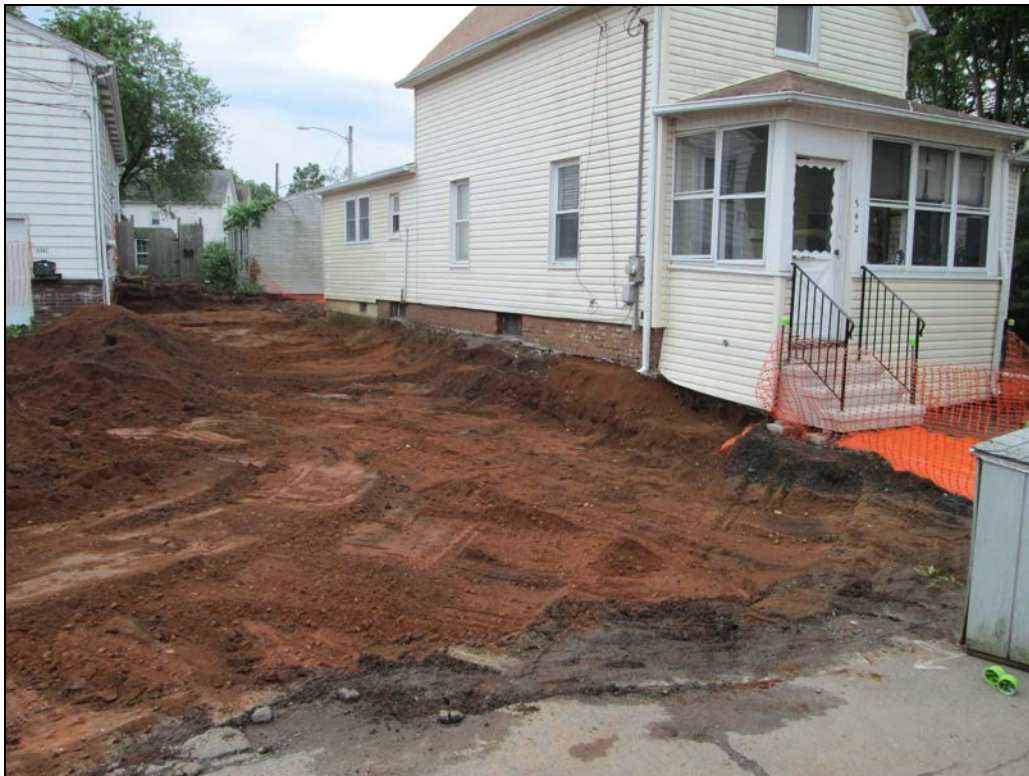
View looking southwest at excavated side yard.

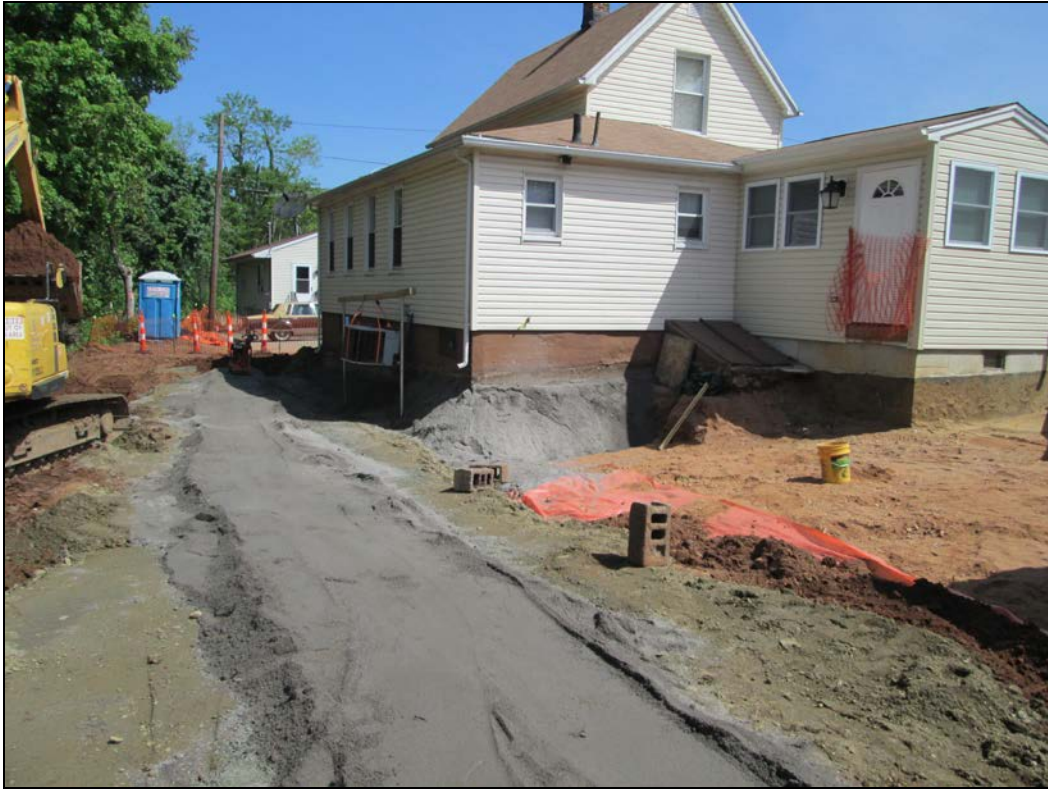
View looking north at excavated back yard.

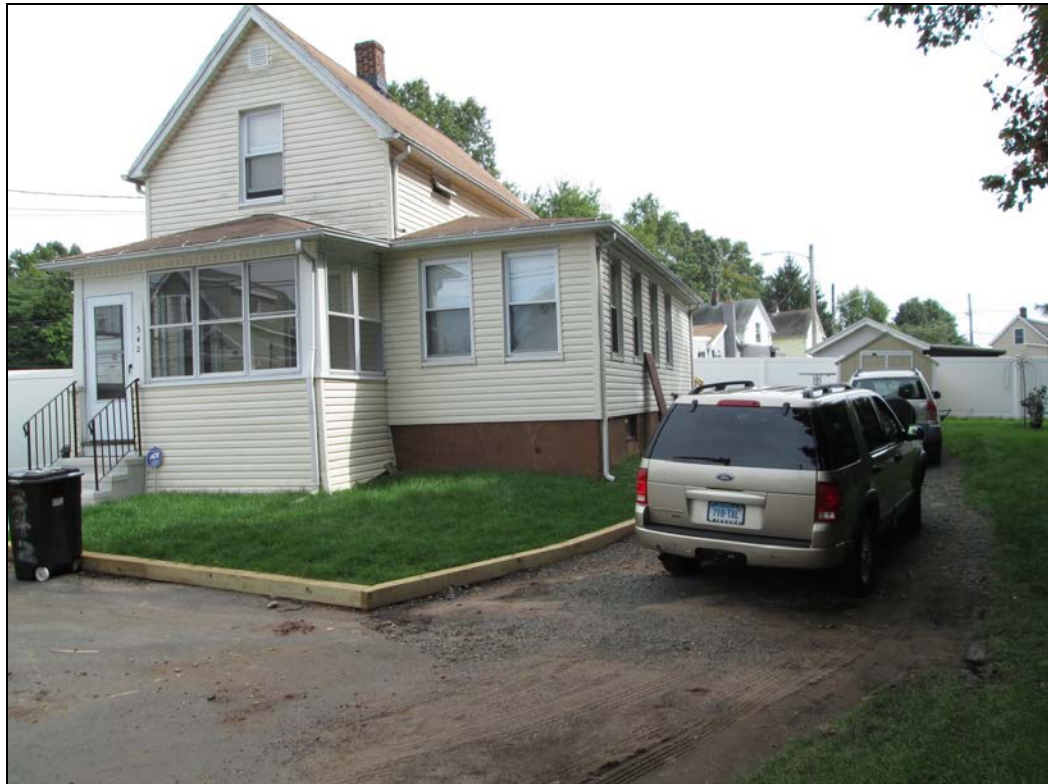
View looking south at restored front yard.

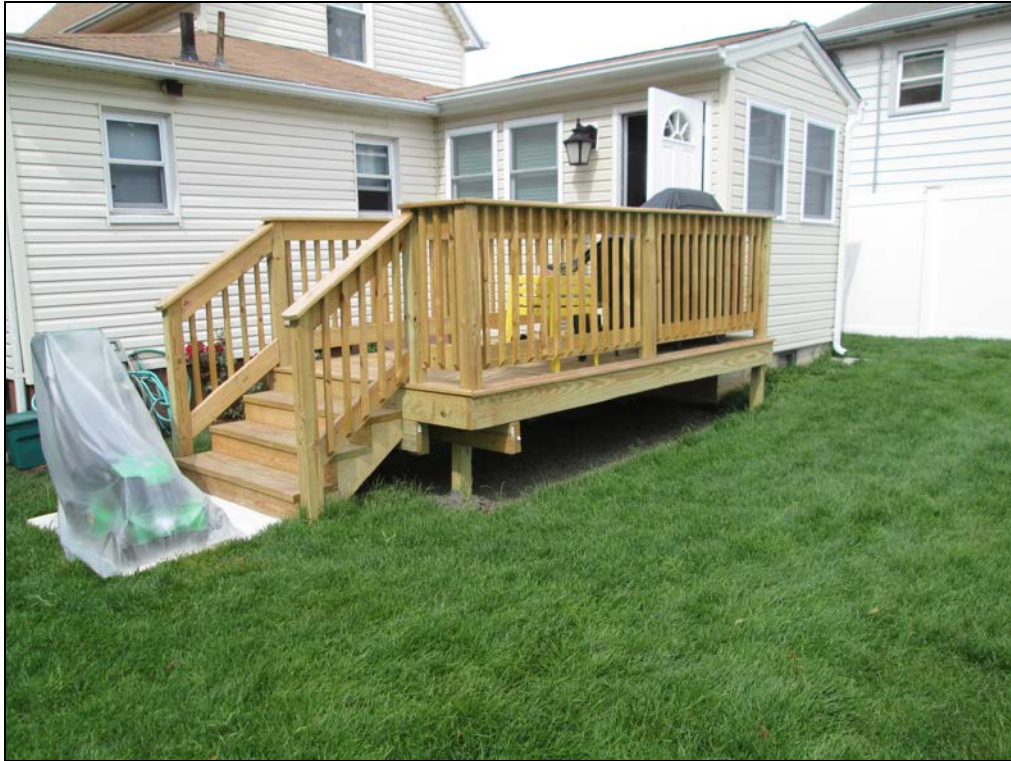
View looking northeast at restored back yard.

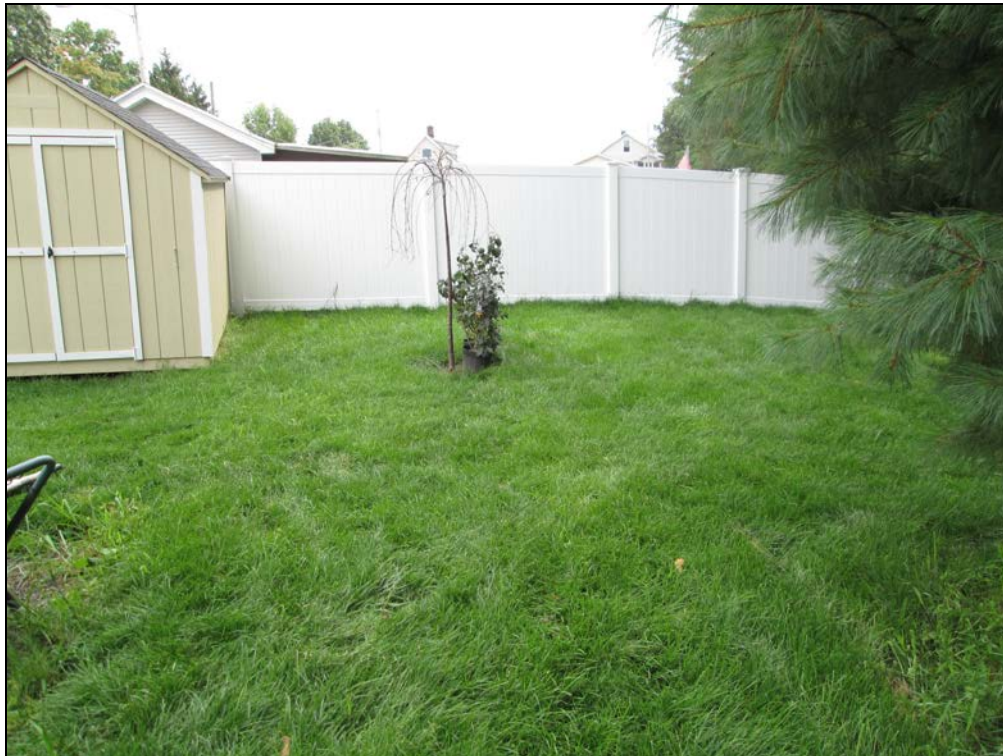
View looking south at restored back yard.
