Re: Property-Specific Remedial Action Report
Newhall Street Neighborhood
34 Marlboro Street, Block Q
Hamden, Connecticut 06517

**PROPERTY-SPECIFIC REMEDIAL ACTION REPORT
34 MARLBORO STREET**

**NON-PUBLIC PROPERTIES
NEWHALL STREET NEIGHBORHOOD
HAMDEN, CONNECTICUT**

AMEC Project Number: 6107120004.165

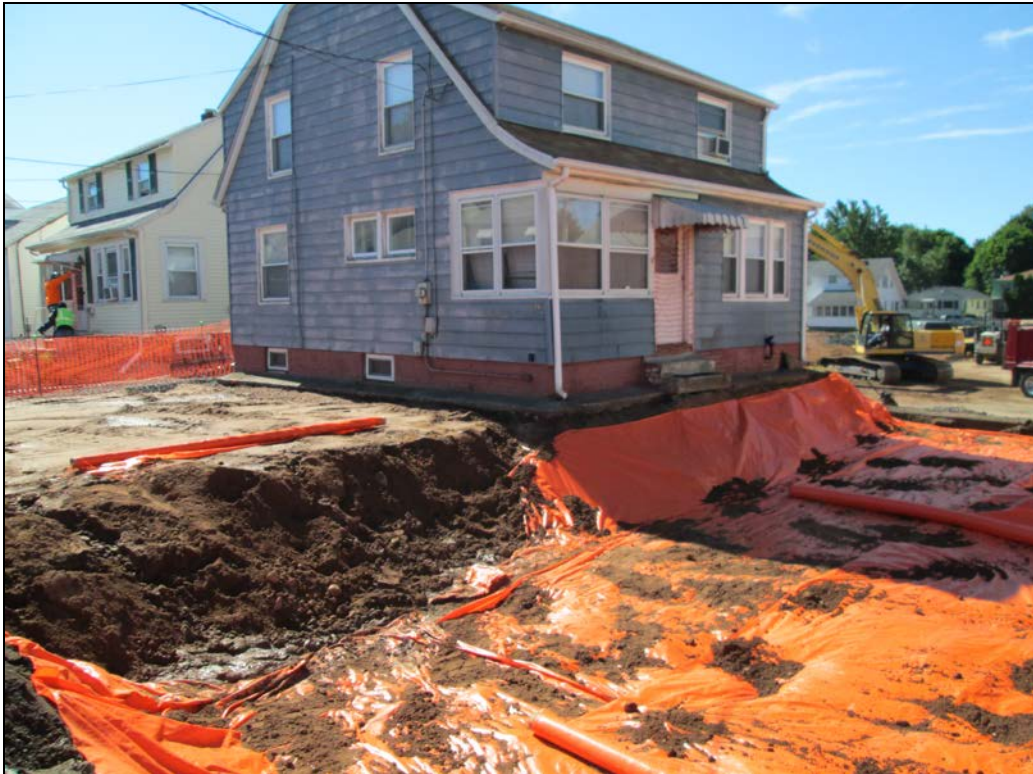
View looking southeast at excavated front yard and driveway area.

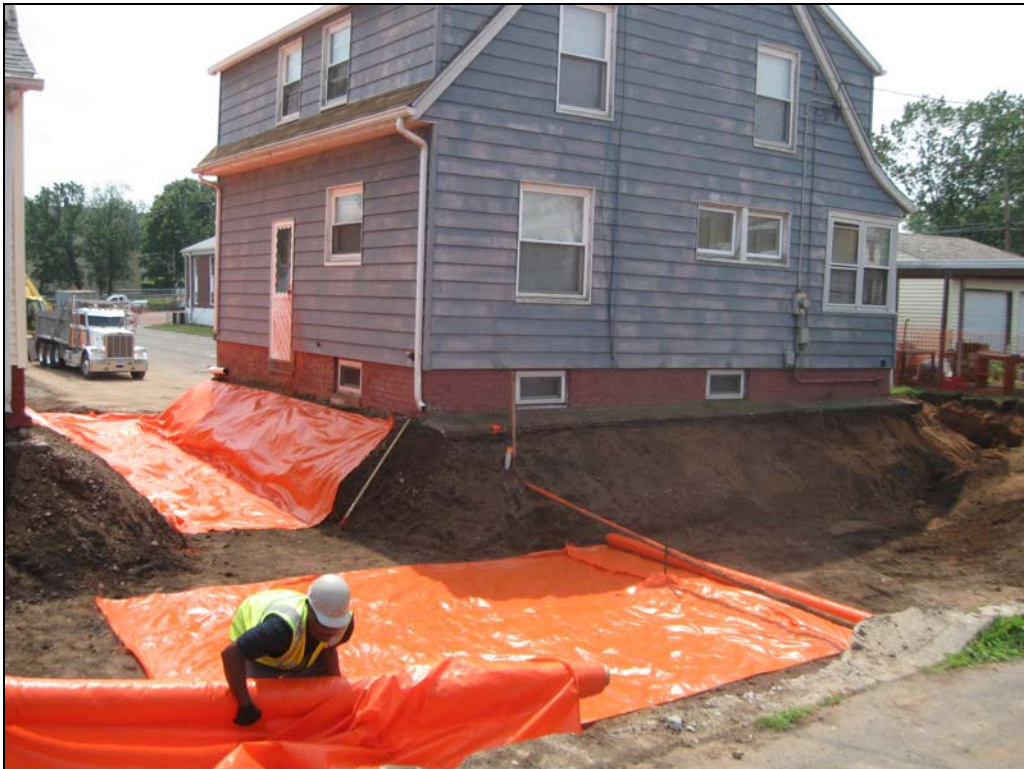
View looking southwest during installation of marker barrier.

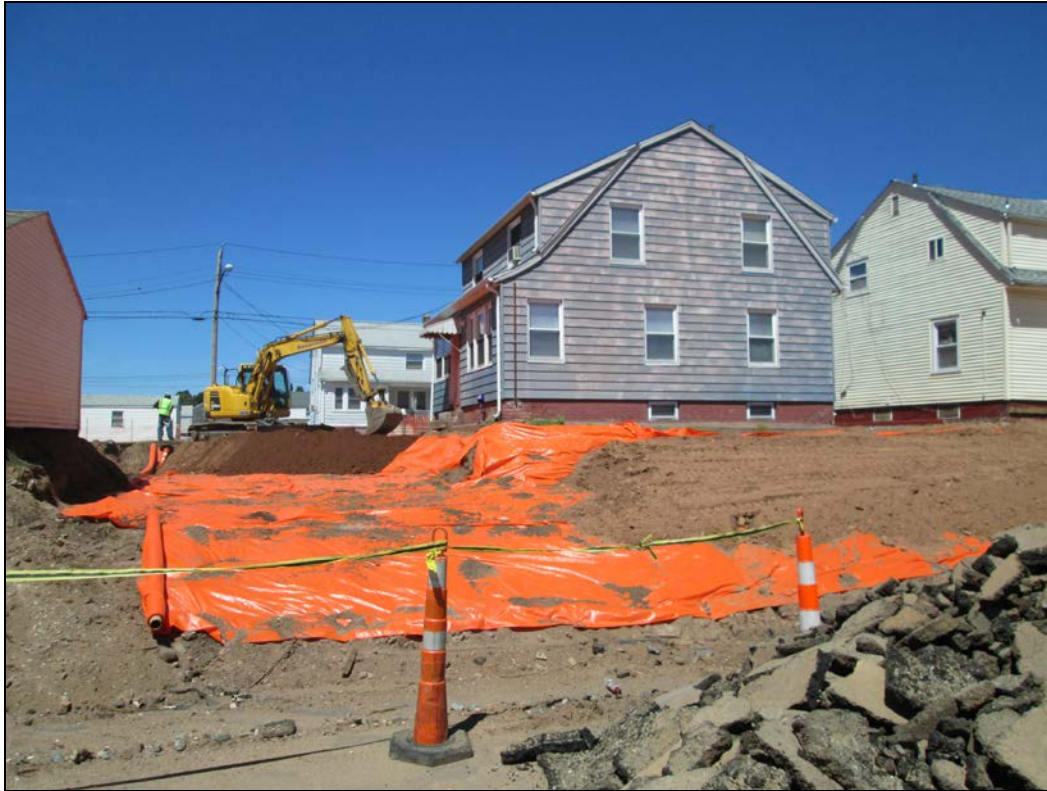
View looking north at excavated back yard.

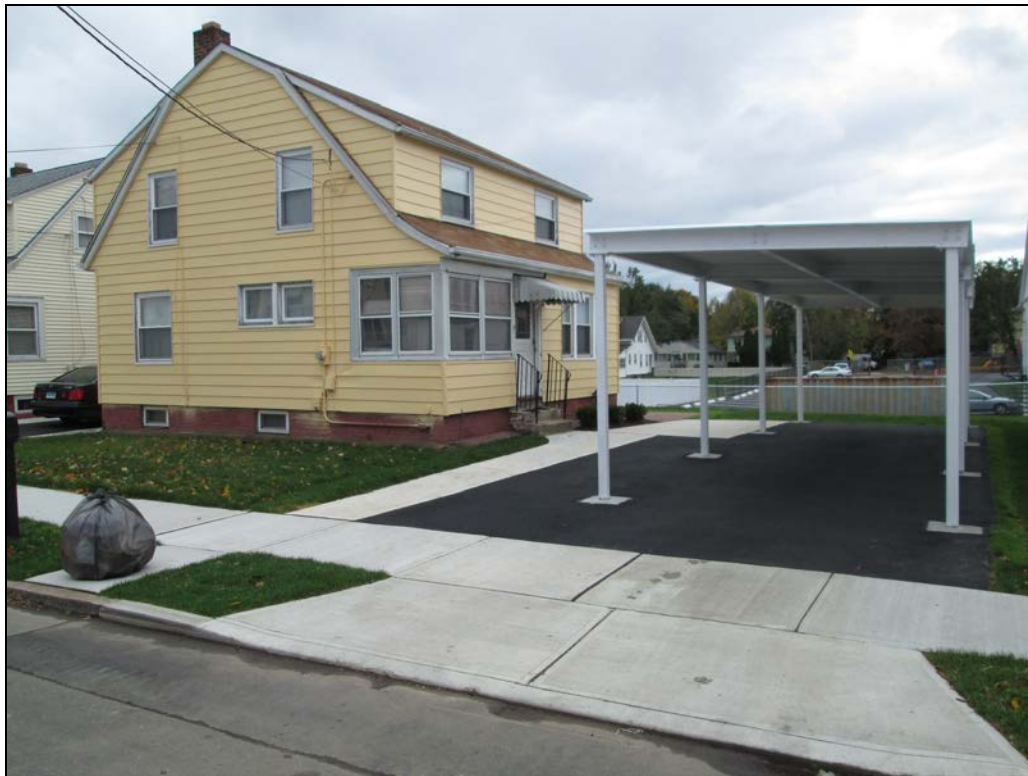
View looking south at restored front yard.

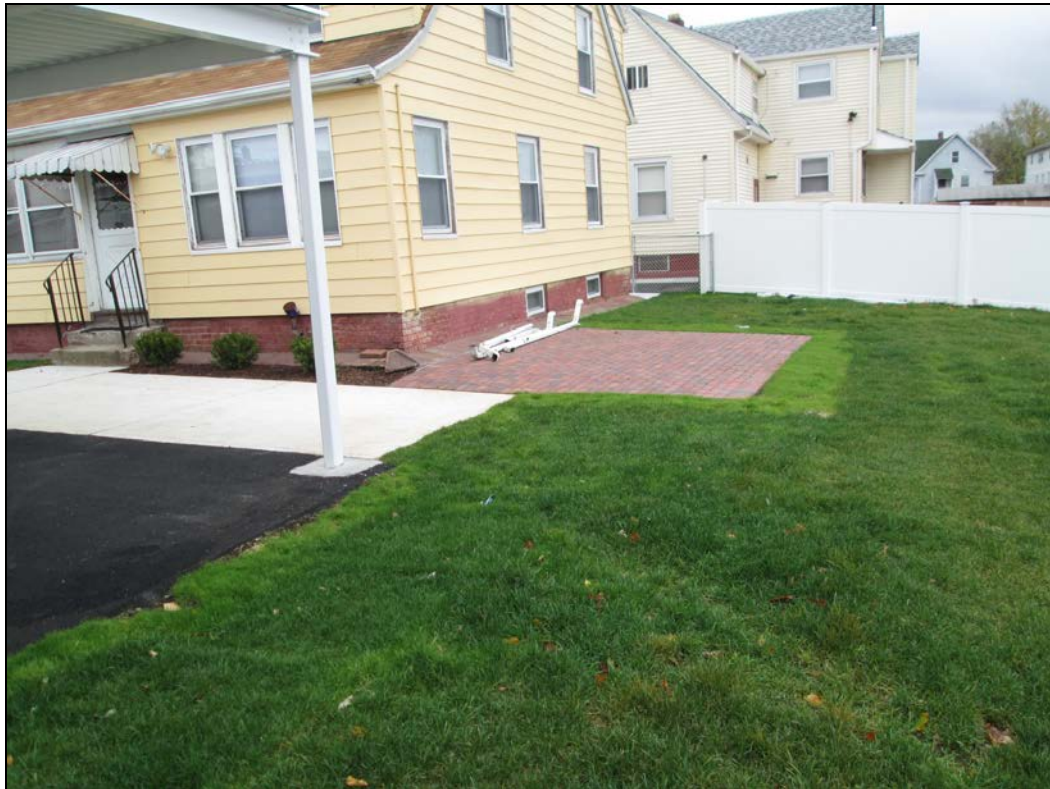
View looking east at restored back yard.
