Re: Property-Specific Remedial Action Report
Newhall Street Neighborhood
35 North Sheffield Street
Hamden, Connecticut 06517

**PROPERTY-SPECIFIC REMEDIAL ACTION REPORT
35 NORTH SHEFFIELD STREET**

**NON-PUBLIC PROPERTIES
NEWHALL STREET NEIGHBORHOOD
HAMDEN, CONNECTICUT**

March 22, 2011

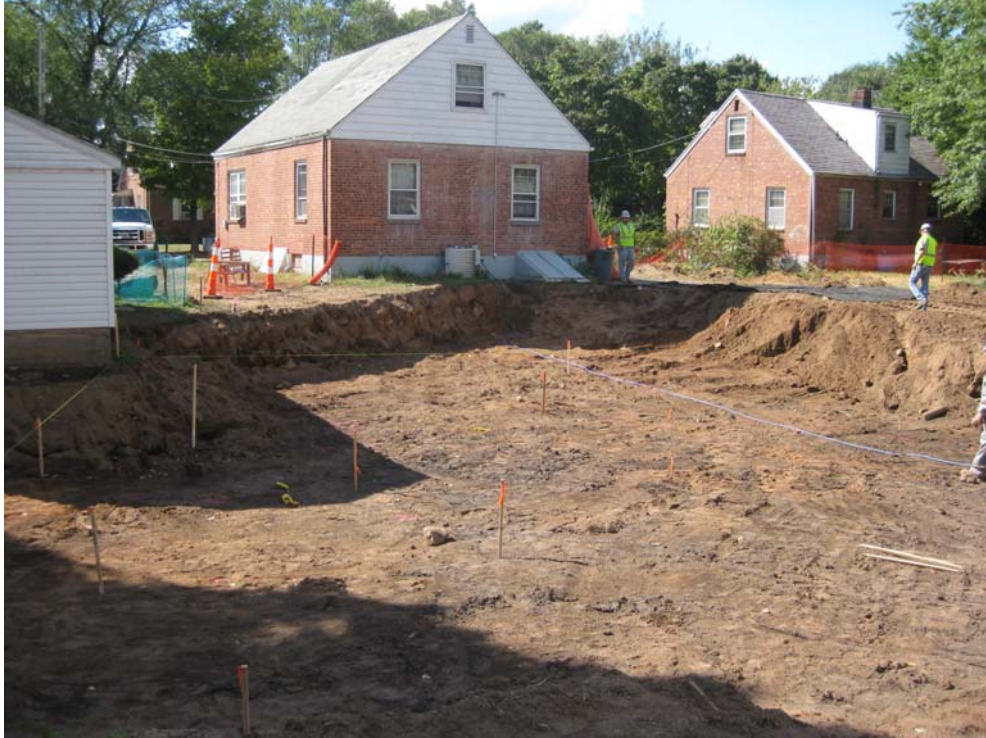
Looking west from adjacent property, view of excavation in back yard.

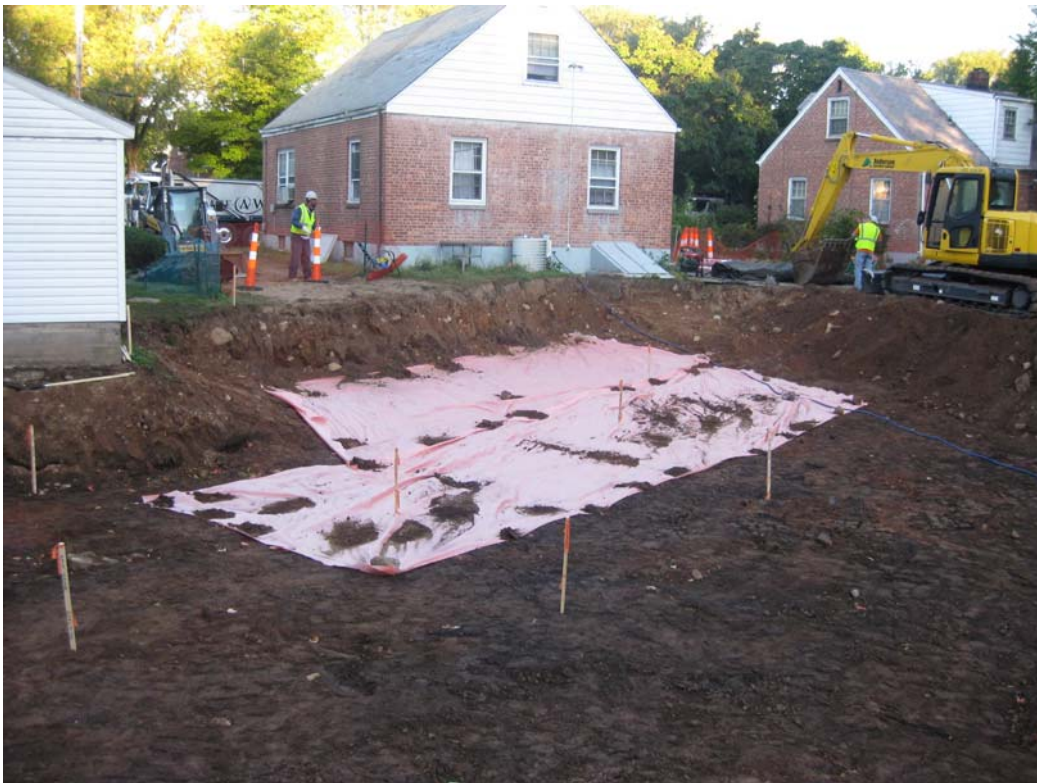
Looking west from adjacent property, view of excavation following placement of marker barrier.

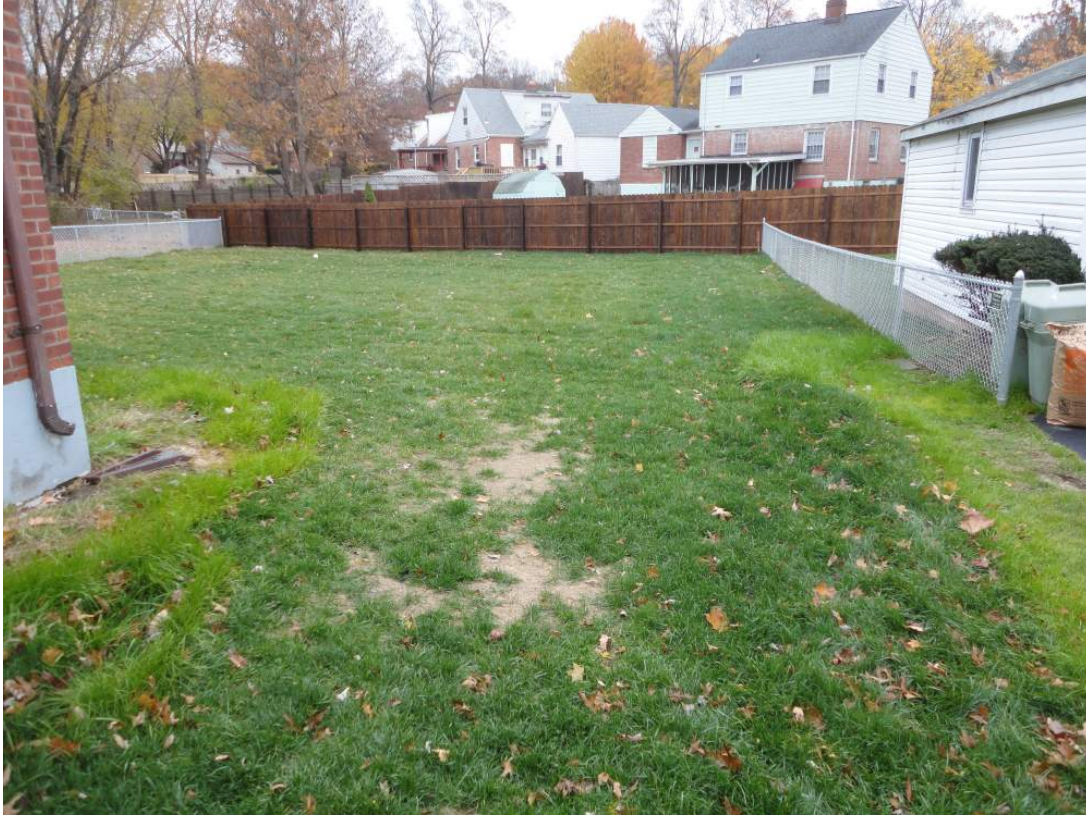
Looking northeast from south side of house, view of restored property and newly-installed sod.

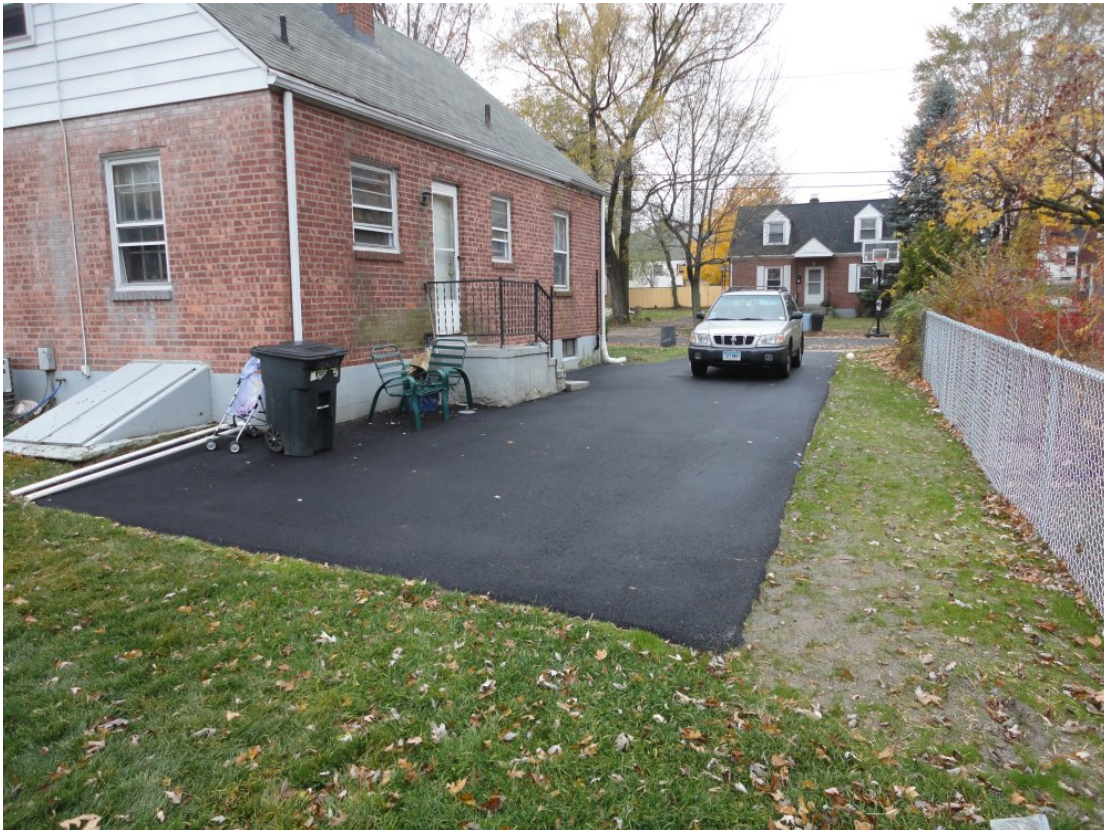
Looking west from back yard, view of restored driveway area.
