Re: Property-Specific Remedial Action Report
Newhall Street Neighborhood
449 Newhall Street, Block Q
Hamden, Connecticut 06517

**PROPERTY-SPECIFIC REMEDIAL ACTION REPORT
421, 425-431, 449 NEWHALL STREET**

**NON-PUBLIC PROPERTIES
NEWHALL STREET NEIGHBORHOOD
HAMDEN, CONNECTICUT**

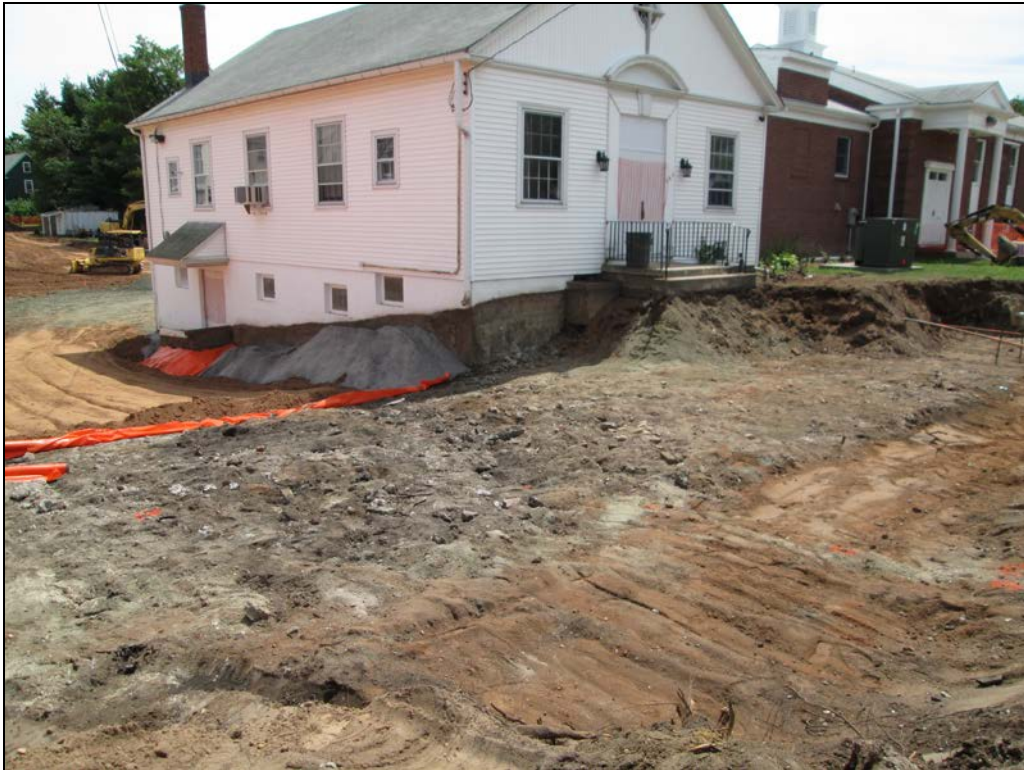
View looking southeast at excavated front yard and driveway area.

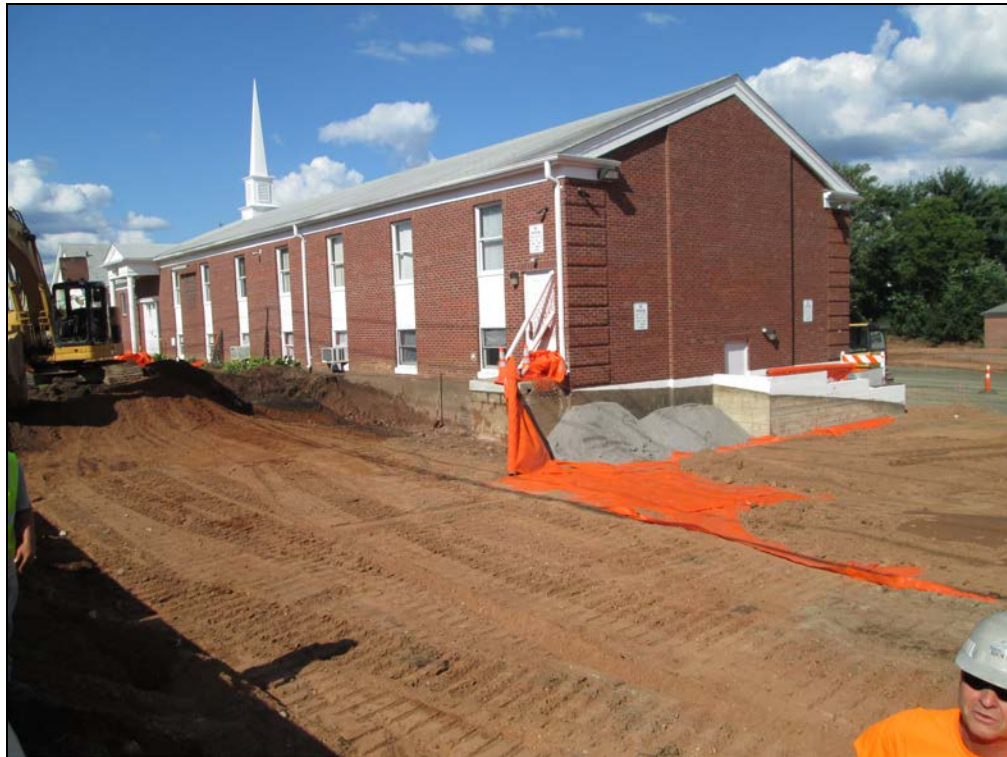
View looking northeast at excavation in front yard and parking area.

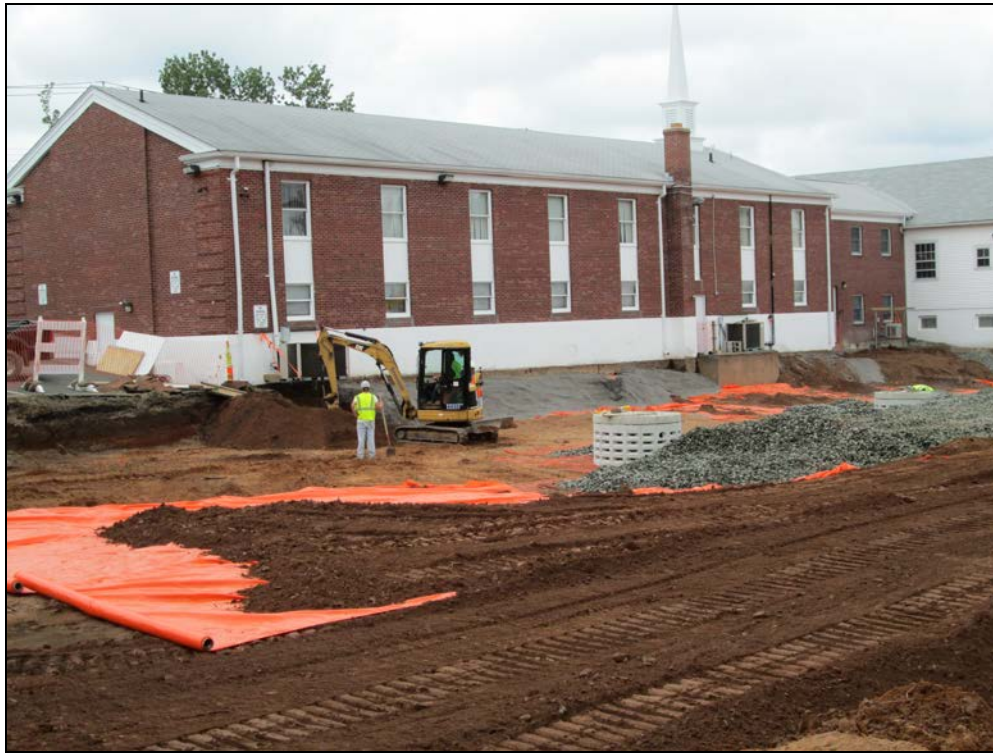
View looking northwest at back parking area during installation of drainage features and marker barrier.

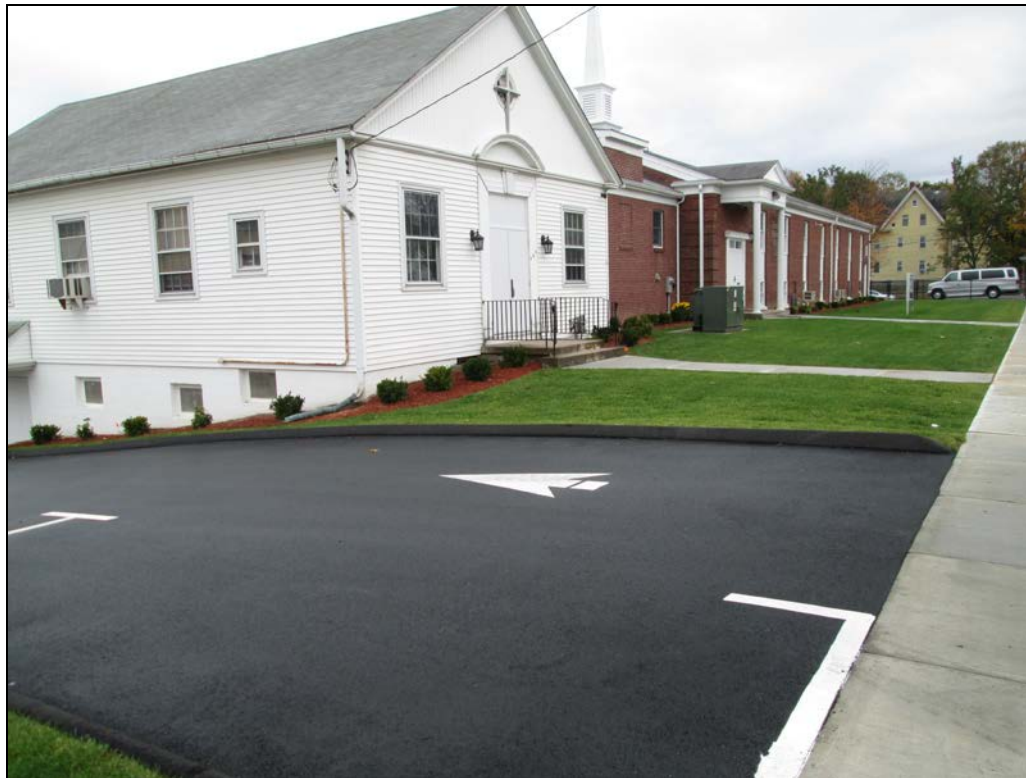
View looking southeast at restored front yard and driveway area.

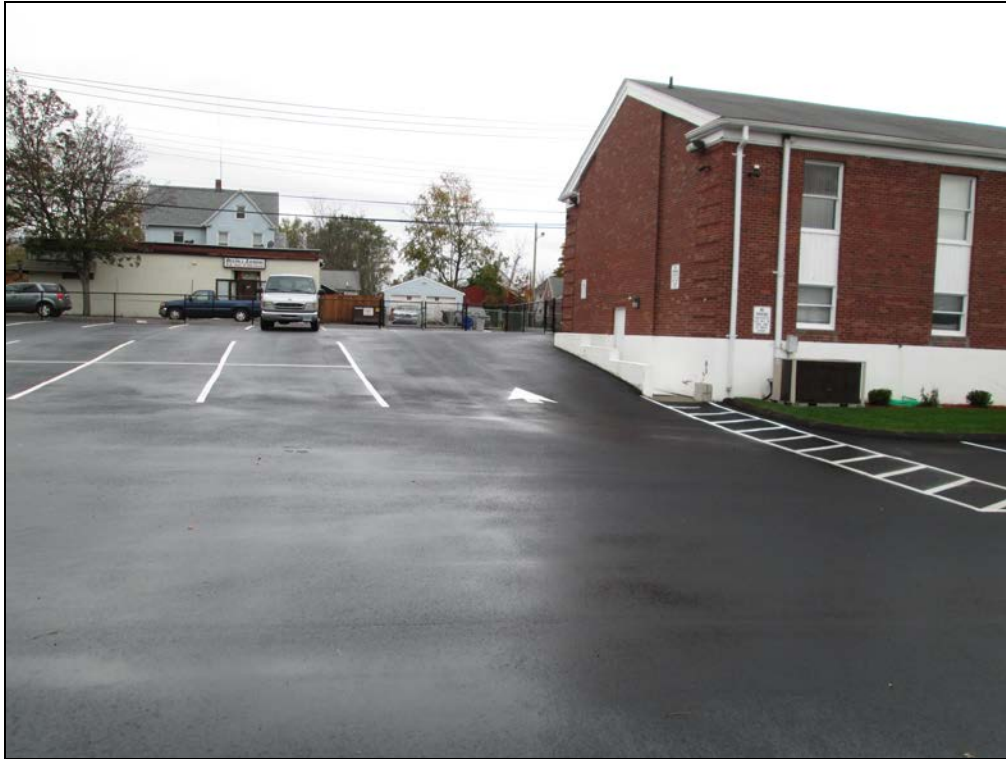
View looking west at parking area.

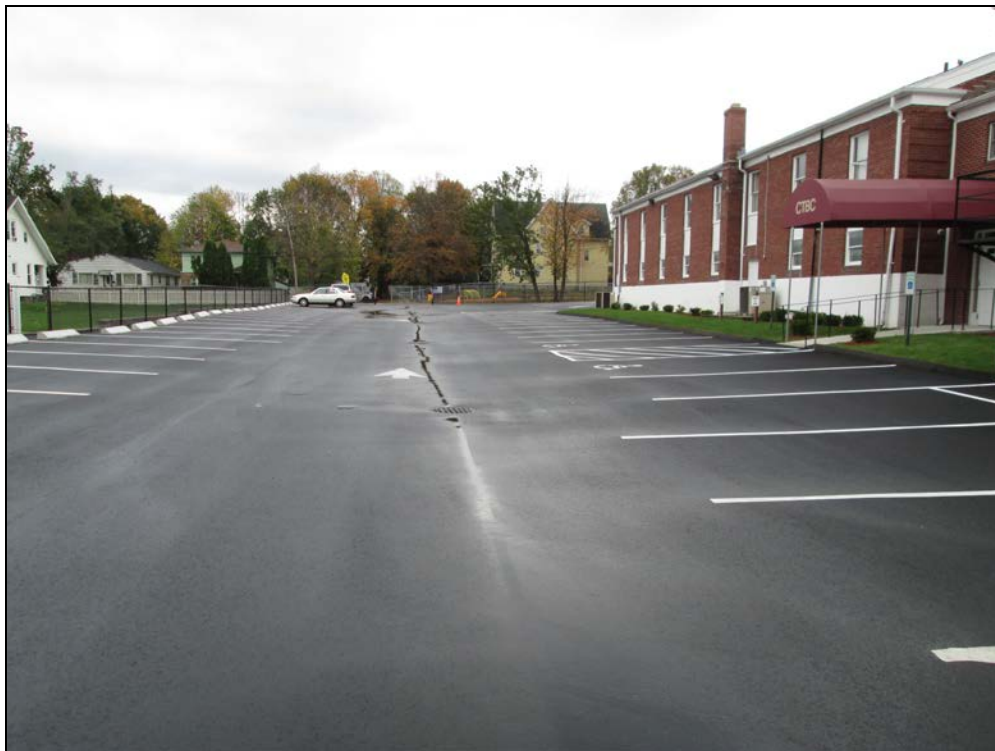
View looking south at restored back parking area.
