Re: Property-Specific Remedial Action Report  
Newhall Street Neighborhood  
457 Shelton Avenue, Block L  
Hamden, Connecticut 06517

**PROPERTY-SPECIFIC REMEDIAL ACTION REPORT  
457 SHELTON AVENUE**

**NON-PUBLIC PROPERTIES  
NEWHALL STREET NEIGHBORHOOD  
HAMDEN, CONNECTICUT**

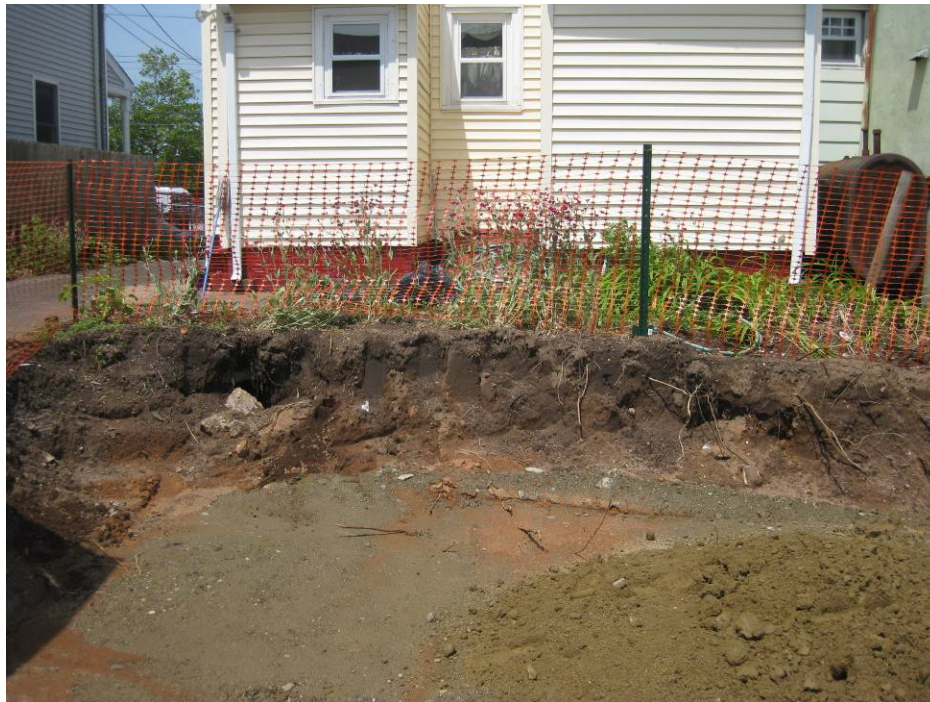
**View looking West at excavation area behind house**

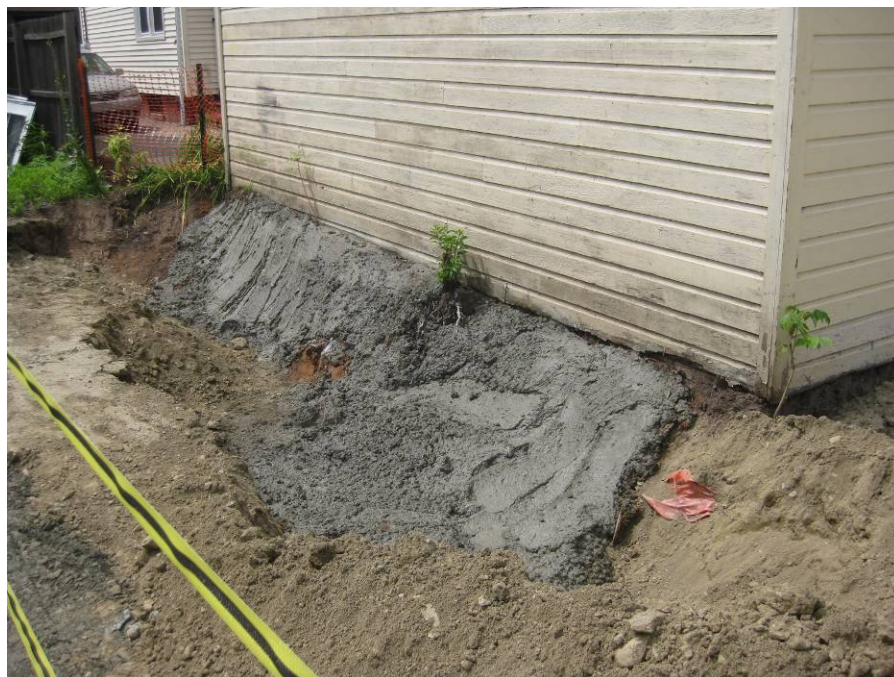
**View looking Northwest excavation along south side of garage following placement of marker barrier**

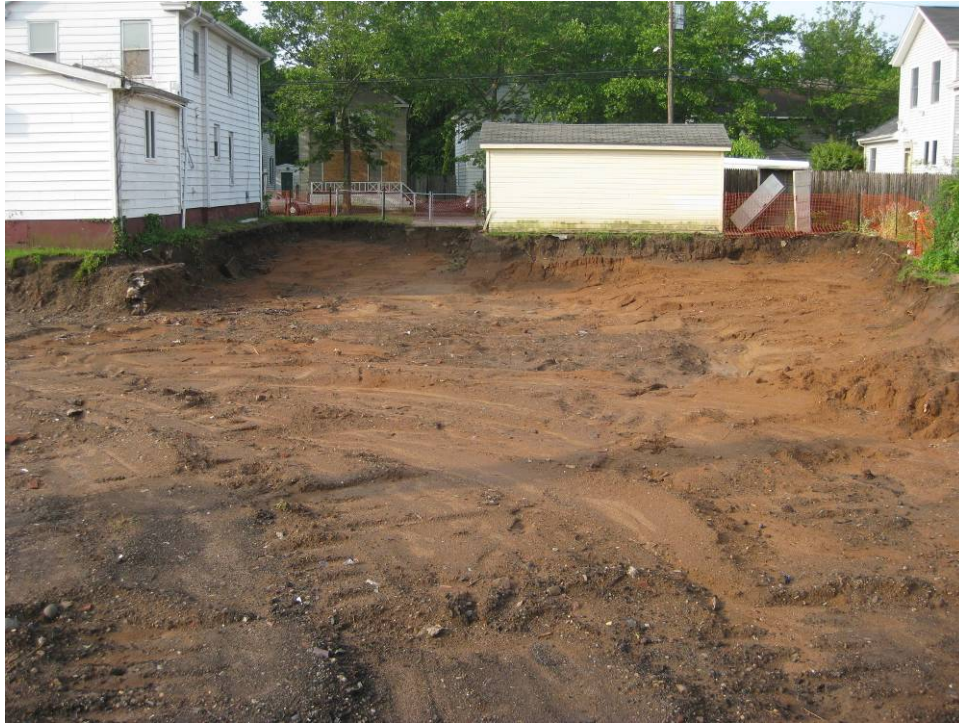
**View looking South at back yard excavation area from the adjacent property**

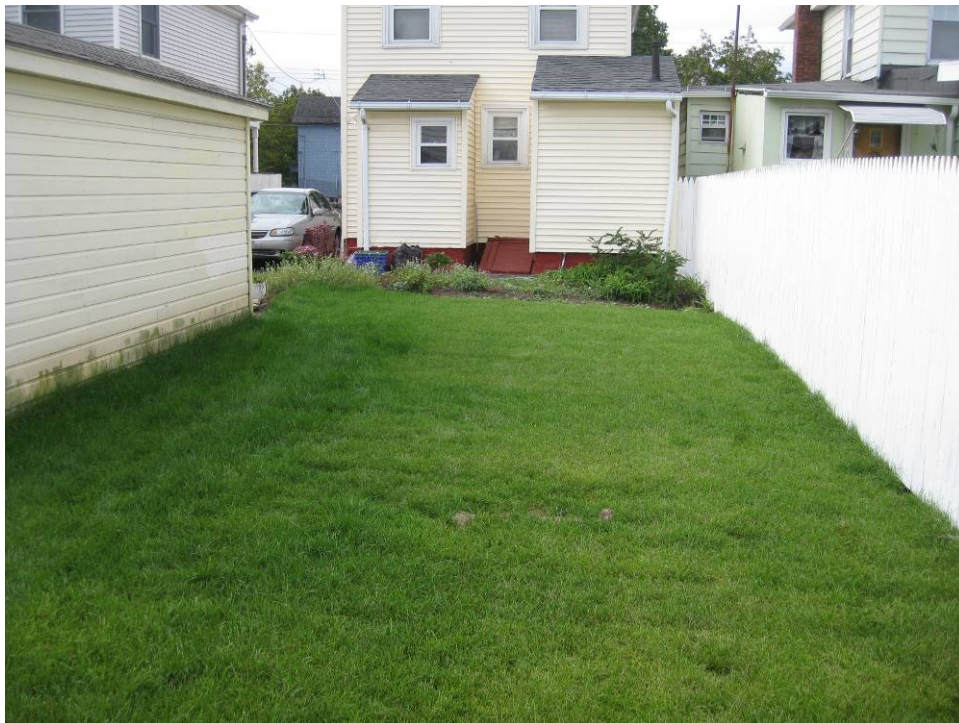
**View looking West at partially restored back yard**

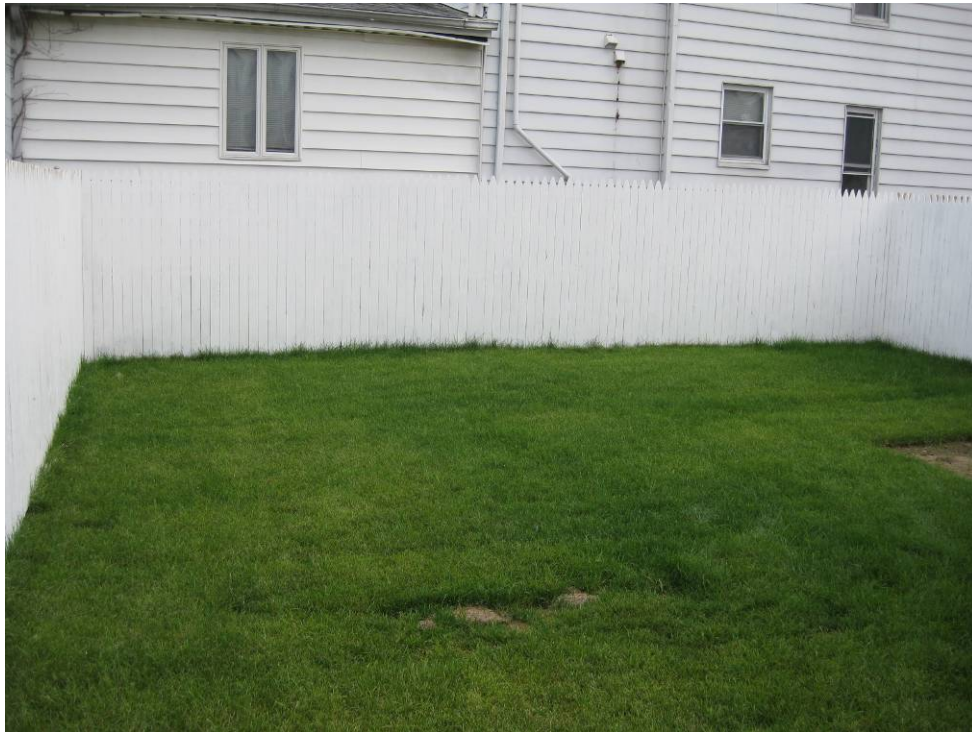
**View looking East at partially restored lawn and fencing**
