Re: Property-Specific Remedial Action Report  
Newhall Street Neighborhood  
466 Shelton Ave, Block J  
Hamden, Connecticut 06517

**PROPERTY-SPECIFIC REMEDIAL ACTION REPORT  
466 SHELTON AVENUE**

**NON-PUBLIC PROPERTIES  
NEWHALL STREET NEIGHBORHOOD  
HAMDEN, CONNECTICUT**

**AMEC Project Number: 6107110004/65**

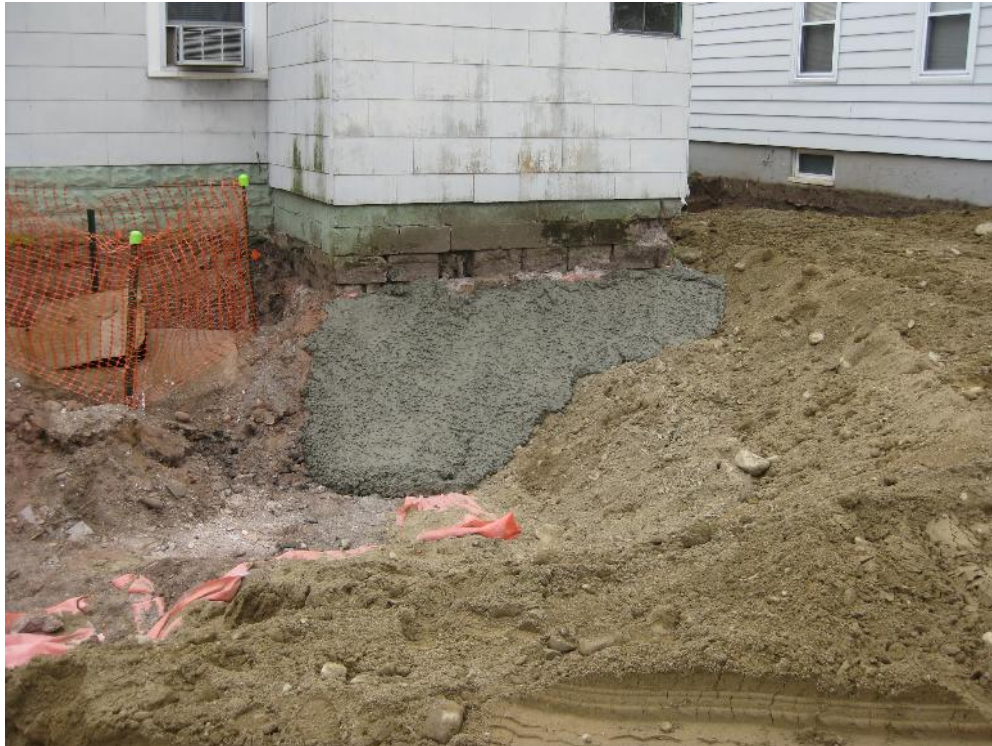
**View looking East at excavated back yard following placement of marker barrier. In this photo, the area of the excavated UST is surrounded by orange construction fencing.**

- An active fuel oil underground storage tank (UST) was located in the excavation area. The property owner and the DEEP were informed and the UST was removed in accordance with the proper protocols and local approvals, and was replaced with an above-ground fuel oil storage tank.

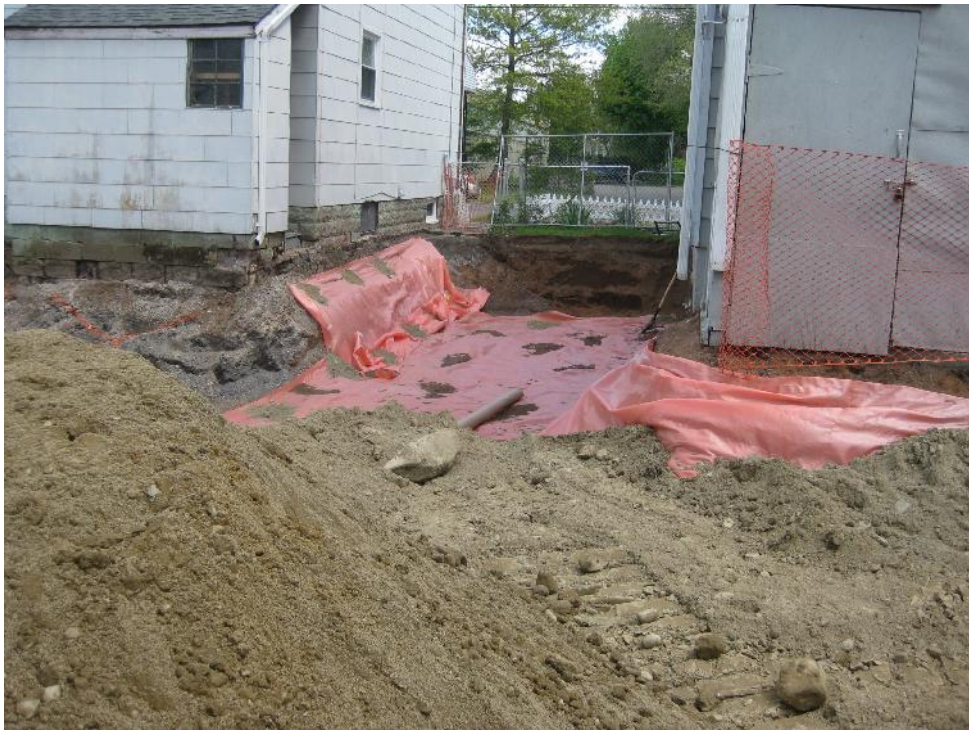
**View looking East at excavated side yard to the South of the house following placement of marker barrier**

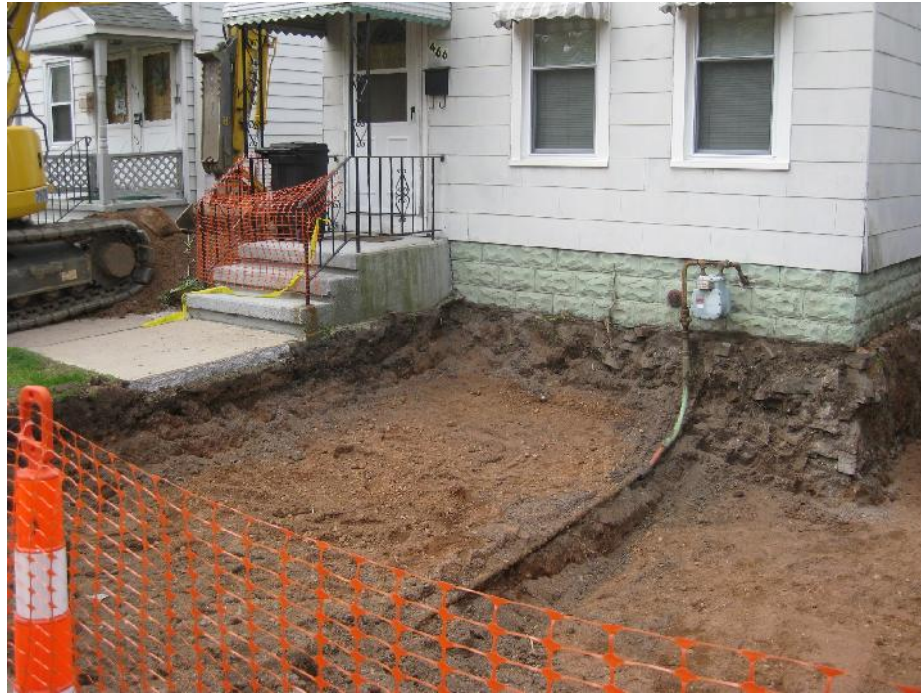
**View looking Southwest at excavated front yard with utility line exposed**

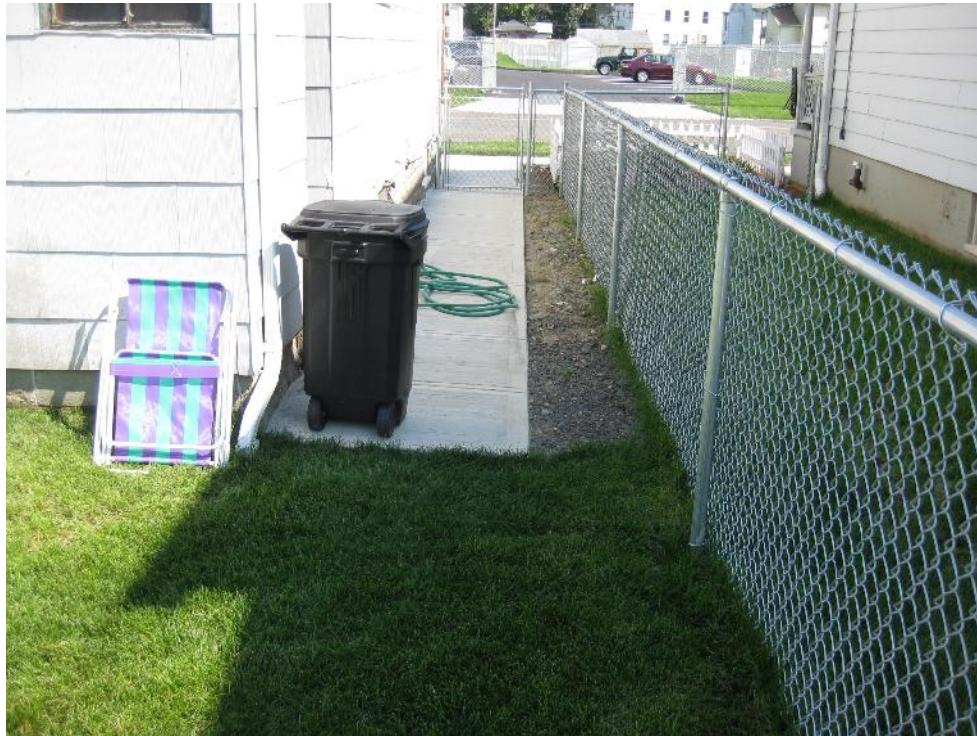
**View looking East at restored side yard**

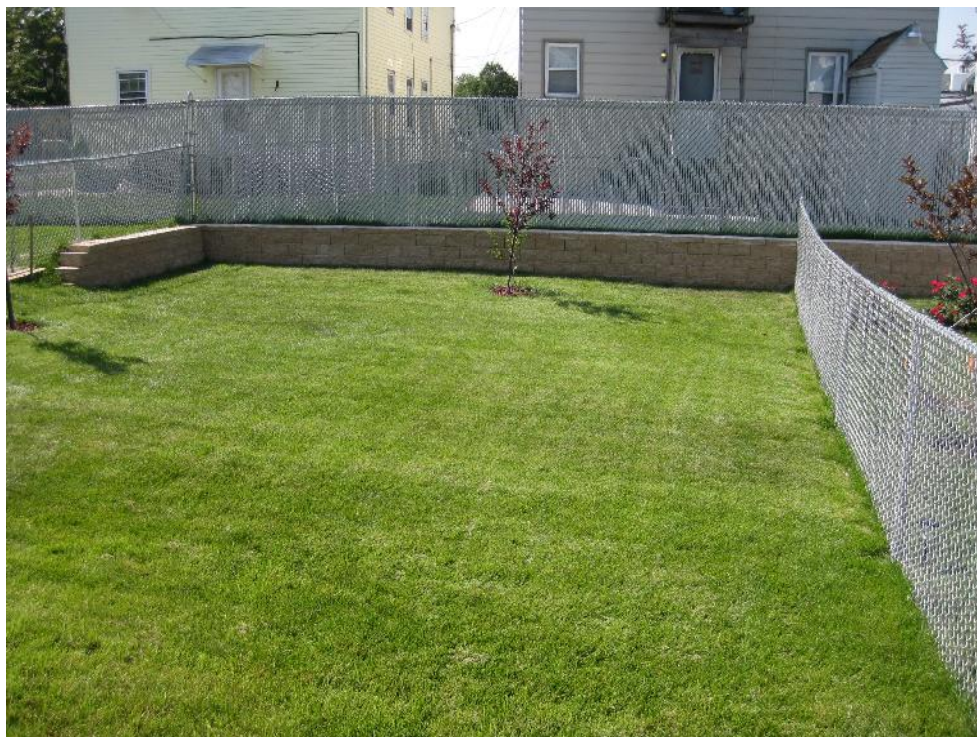
**View looking West at partially restored back yard**

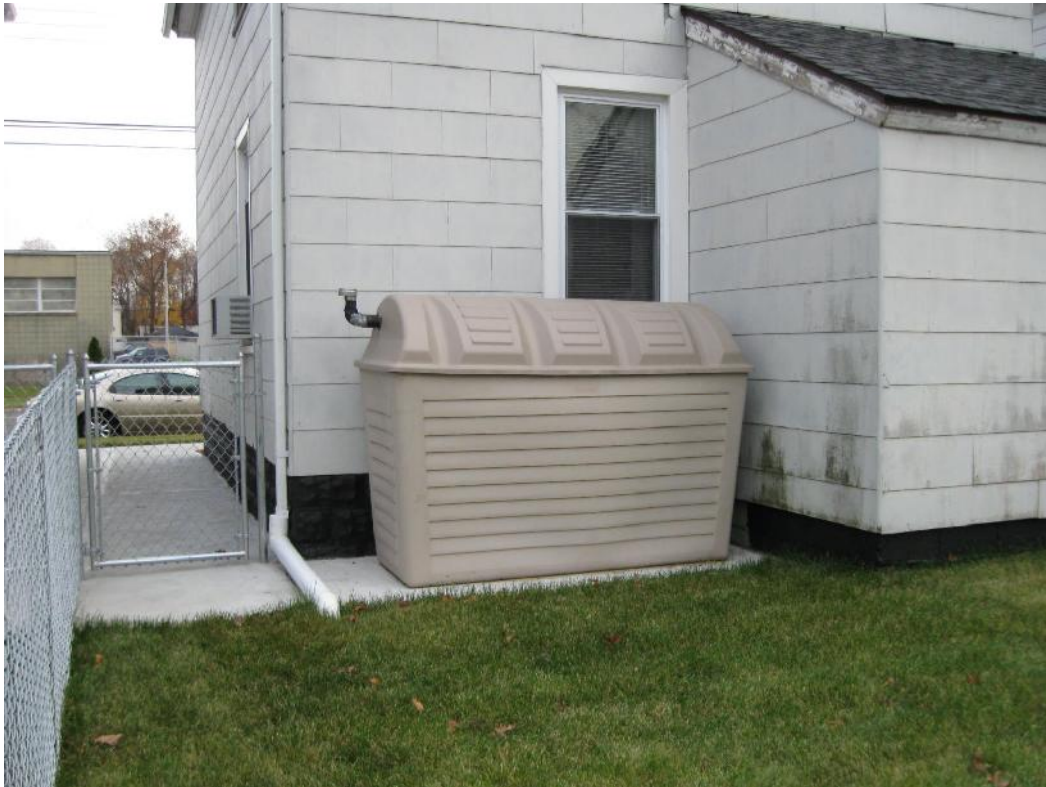
**View looking east at newly installed aboveground fuel oil storage tank**
