Re: Property-Specific Remedial Action Report
Newhall Street Neighborhood
476 Shelton Ave, Block J
Hamden, Connecticut 06517

**PROPERTY-SPECIFIC REMEDIAL ACTION REPORT
476 SHELTON AVENUE**

**NON-PUBLIC PROPERTIES
NEWHALL STREET NEIGHBORHOOD
HAMDEN, CONNECTICUT**

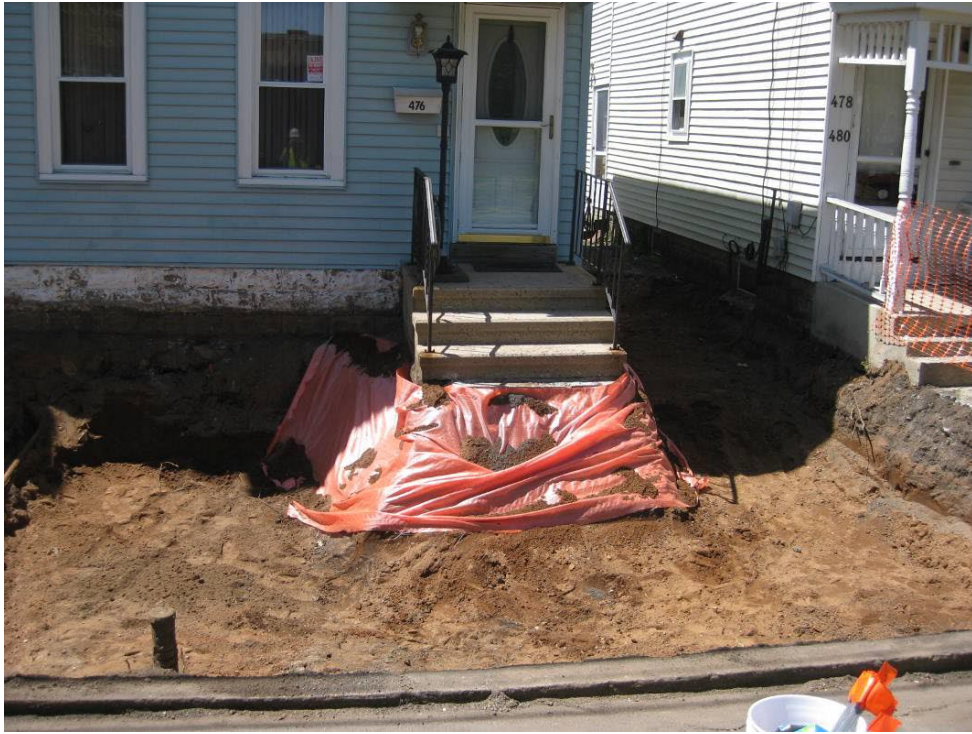
View looking West at excavated front yard following placement of marker barrier around front steps

- In some locations, it was necessary to leave fill material in place at depths less than 4 feet bgs in order to avoid jeopardizing the integrity of a structure. This fill material was left in place, covered by an orange geotextile fabric and/or shotcrete, and backfilled with clean soil in accordance with the Final Design - Generic RAP. Figure 2-1 shows the approximate area of geotextile fabric/shotcrete identifying the presence of fill at a depth less than 4 feet bgs.

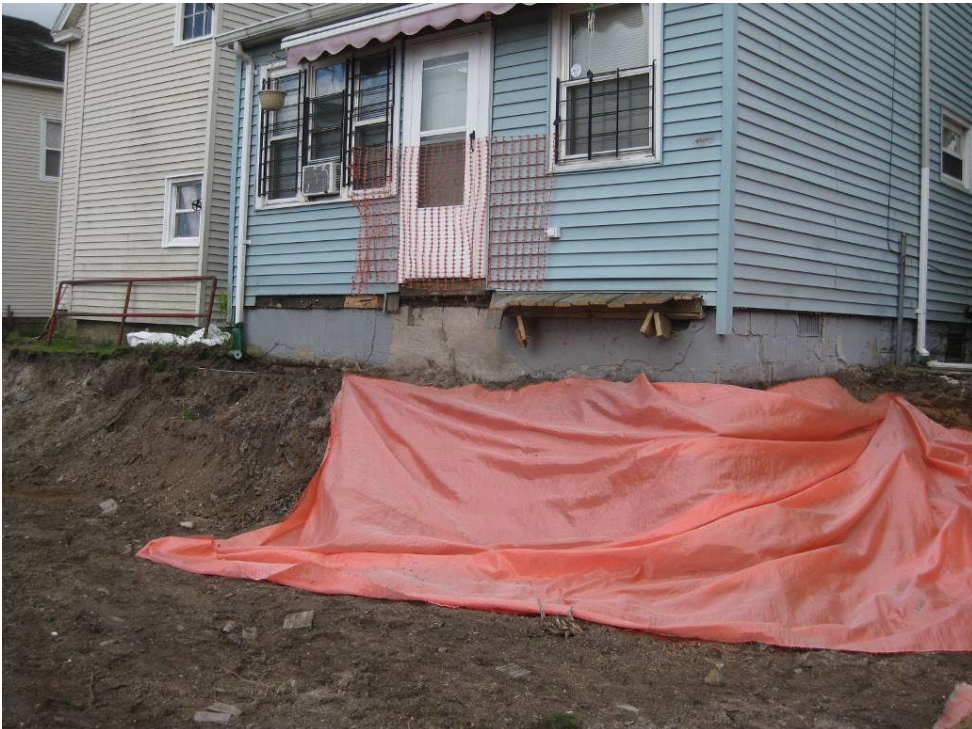
View looking East at excavated back yard following placement of marker barrier under former deck

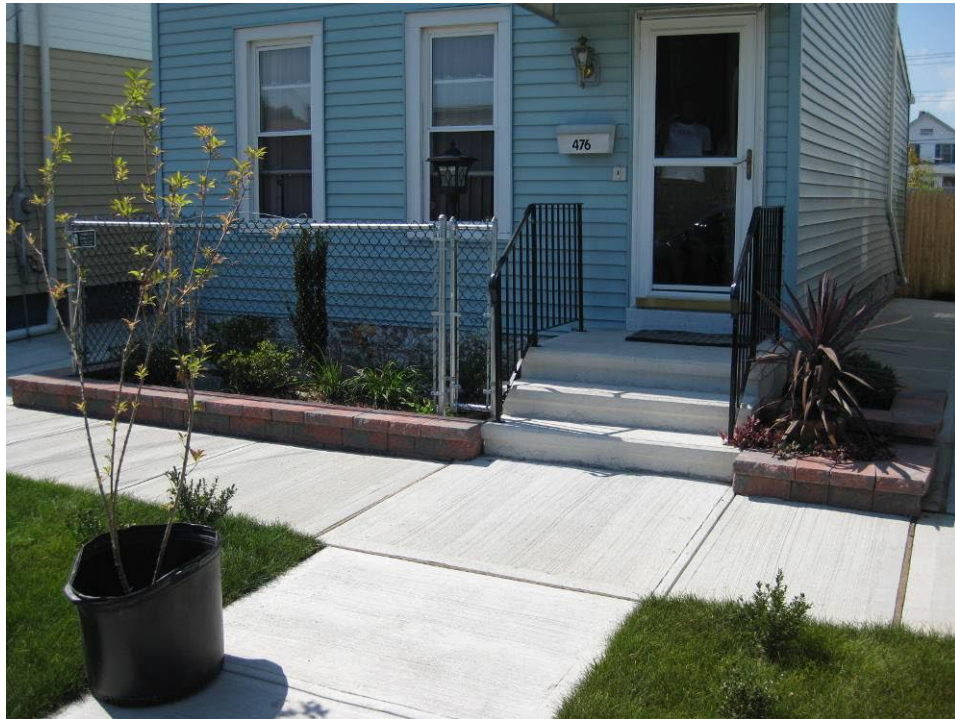
View looking West at partially restored front yard

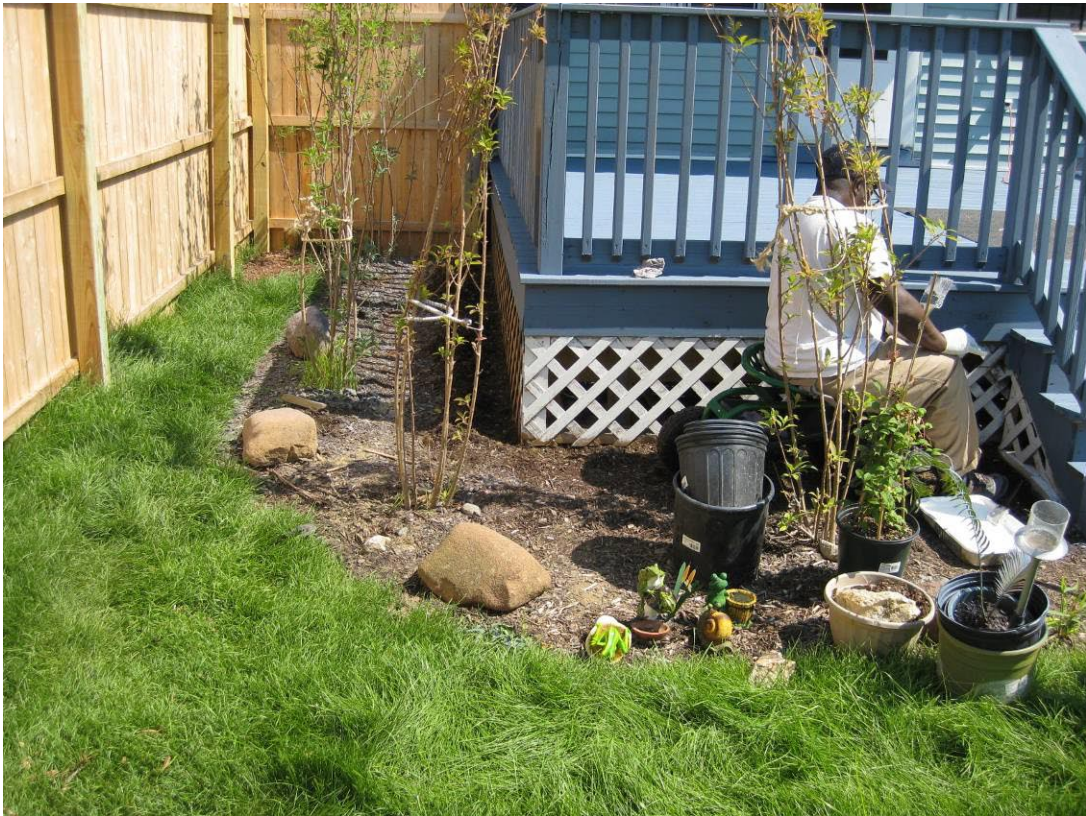
View looking East at restored rear of house
