Re: Property-Specific Remedial Action Report
Newhall Street Neighborhood
478-480 Shelton Ave, Block J
Hamden, Connecticut 06517

**PROPERTY-SPECIFIC REMEDIAL ACTION REPORT
478 - 480 SHELTON AVENUE**

**NON-PUBLIC PROPERTIES
NEWHALL STREET NEIGHBORHOOD
HAMDEN, CONNECTICUT**

AMEC Project Number: 6107110004/65

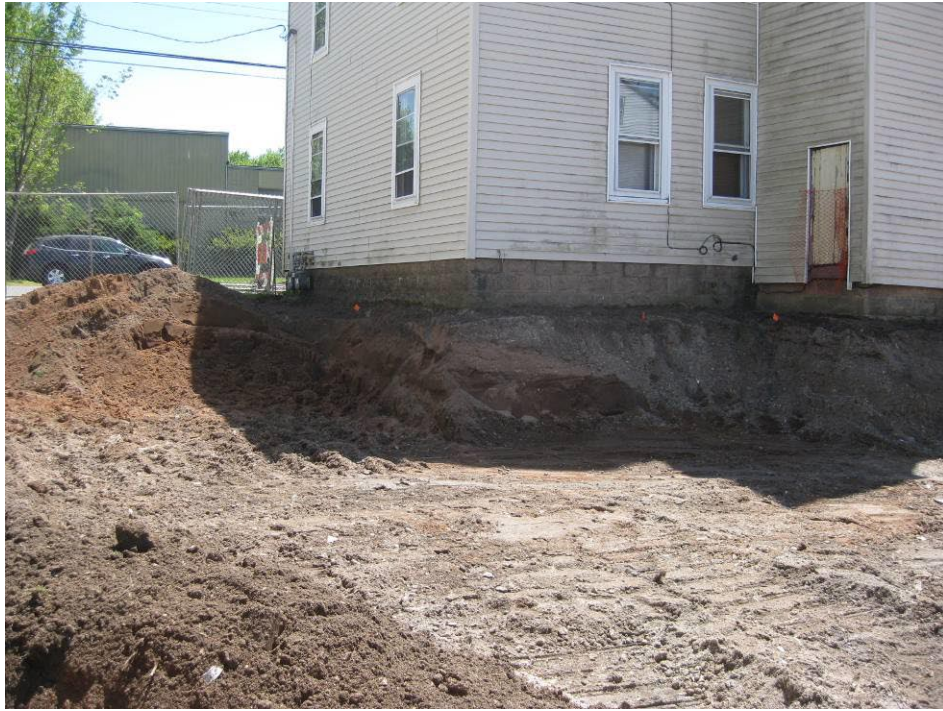
View looking Southeast at excavated back yard of house

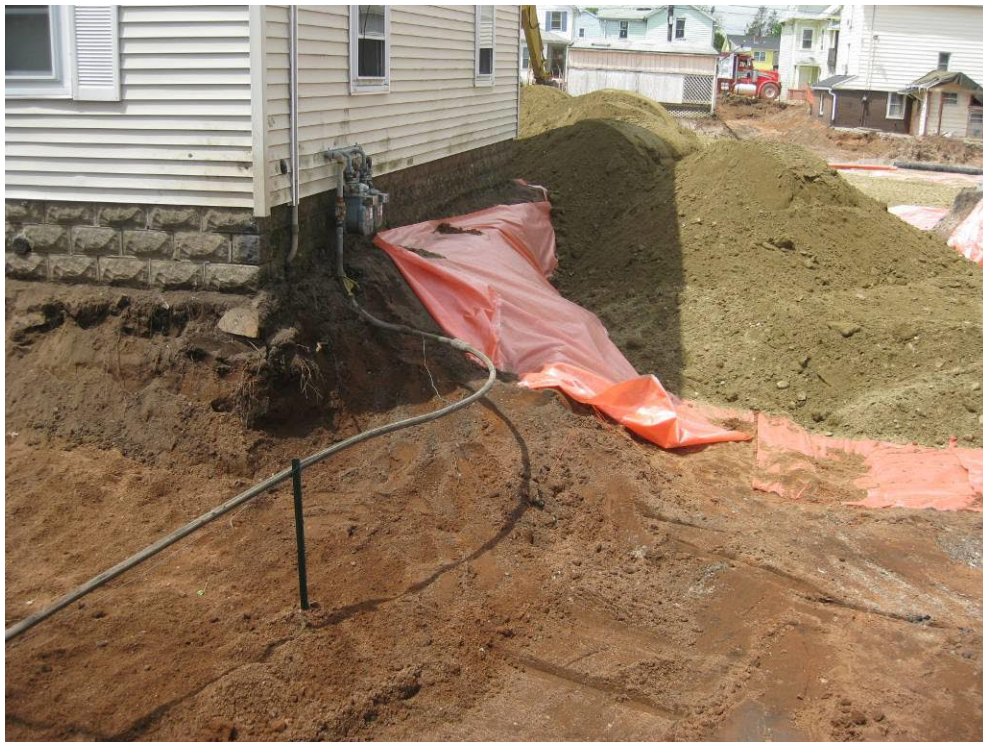
View looking Northeast at excavated side yard during placement of marker barrier

- In some locations, fill material was encountered at greater than 4 feet in depth below ground surface (bgs). This fill material was left in place, covered by an orange geotextile fabric, and backfilled with clean soil in accordance with the Final Design - Generic RAP. Figure 2-1 shows the approximate area of geotextile fabric identifying the presence of fill at a depth greater than 4 feet bgs.
- In some locations, it was necessary to leave fill material in place at depths less than 4 feet bgs in order to avoid jeopardizing the integrity of a structure. This fill material was left in place, covered by an orange geotextile fabric and/or shotcrete, and backfilled with clean soil in accordance with the Final Design - Generic RAP. Figure 2-1 shows the approximate area of geotextile fabric/shotcrete identifying the presence of fill at a depth less than 4 feet bgs.

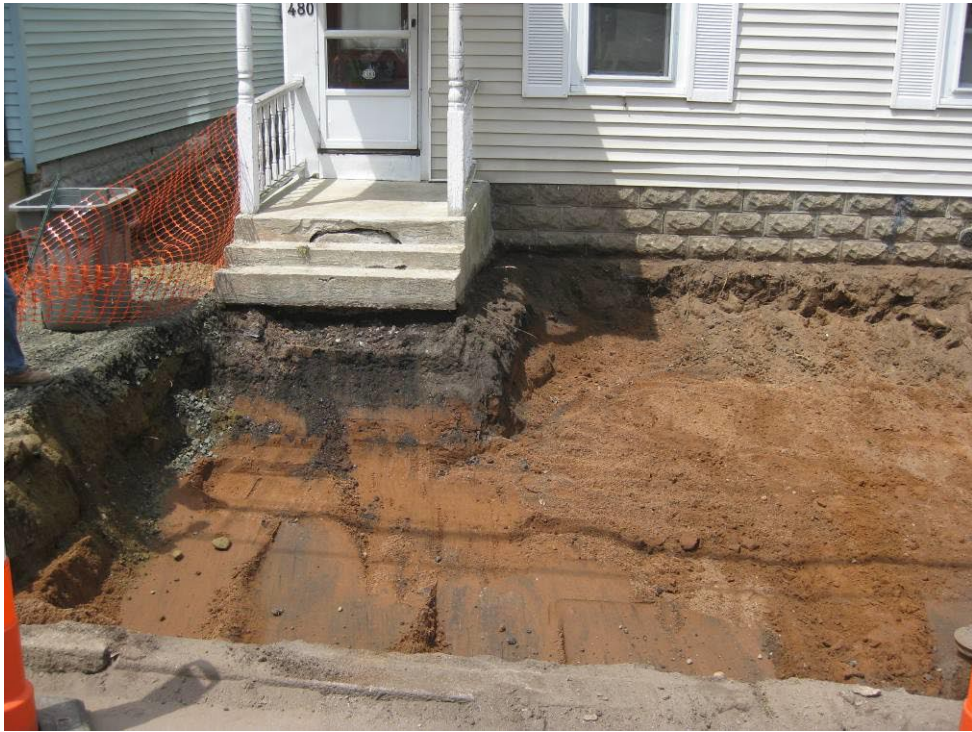
View looking West at excavated front yard

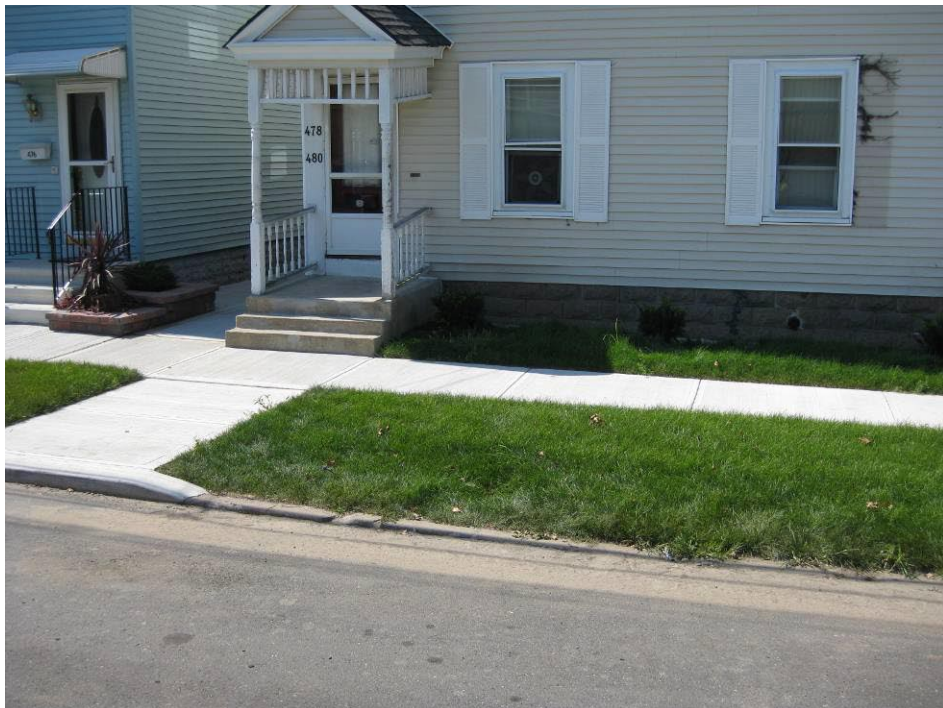
View looking West at restored front yard

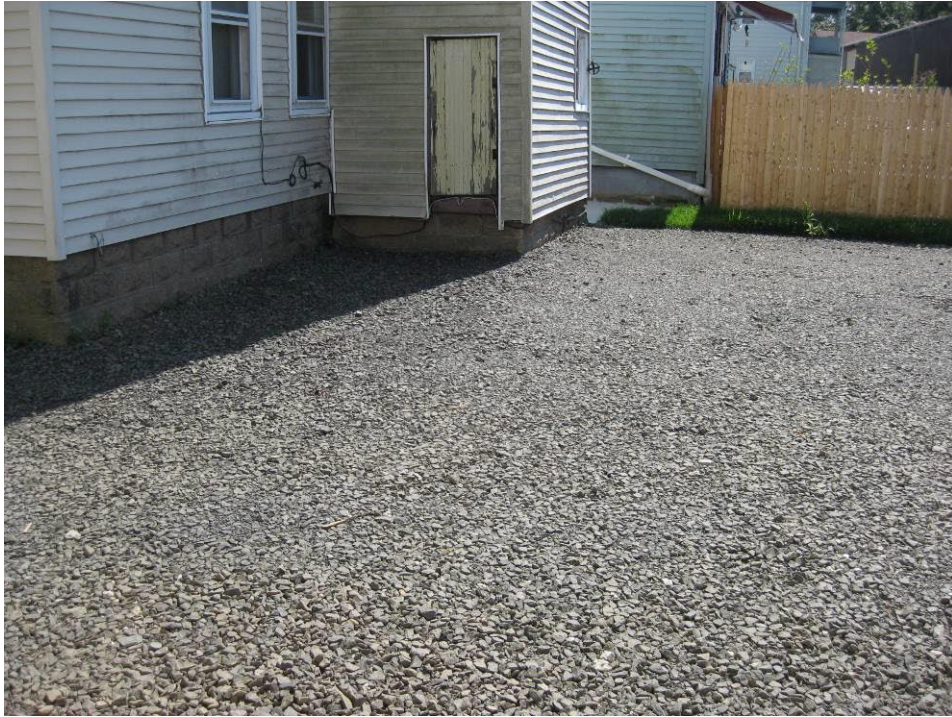
View looking South at restored parking area behind house

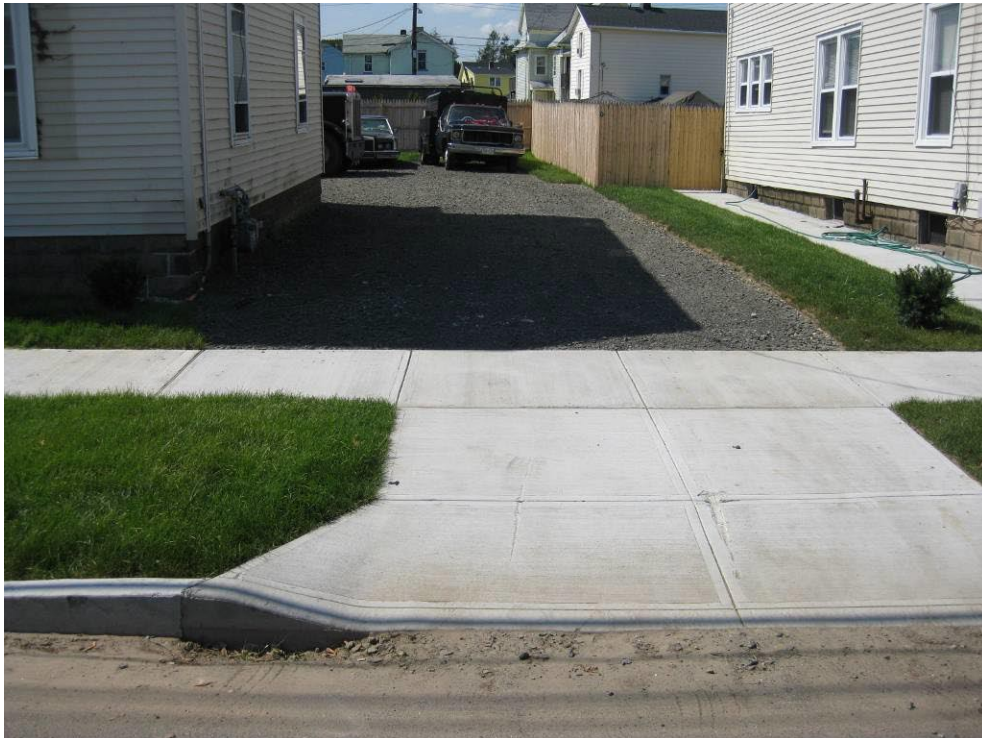
View looking West at restored driveway
