Re: Property-Specific Remedial Action Report
Newhall Street Neighborhood
478 Newhall Street, Block K
Hamden, Connecticut 06517

**PROPERTY-SPECIFIC REMEDIAL ACTION REPORT
478 NEWHALL STREET**

**NON-PUBLIC PROPERTIES
NEWHALL STREET NEIGHBORHOOD
HAMDEN, CONNECTICUT**

AMEC Project Number: 6107110004/95

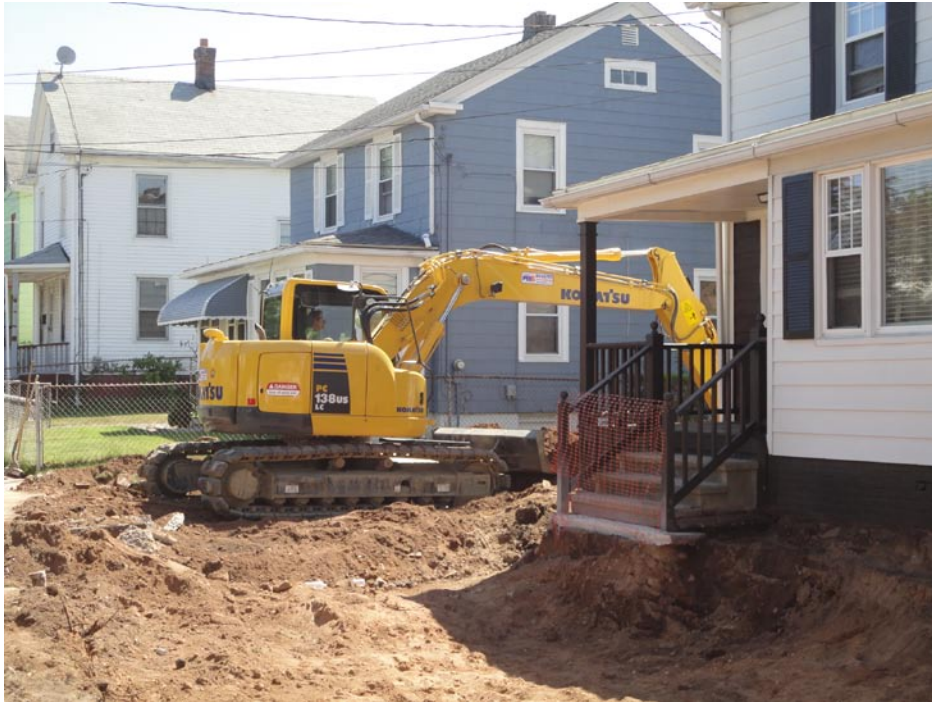
View looking Southwest at excavation in front and side yards

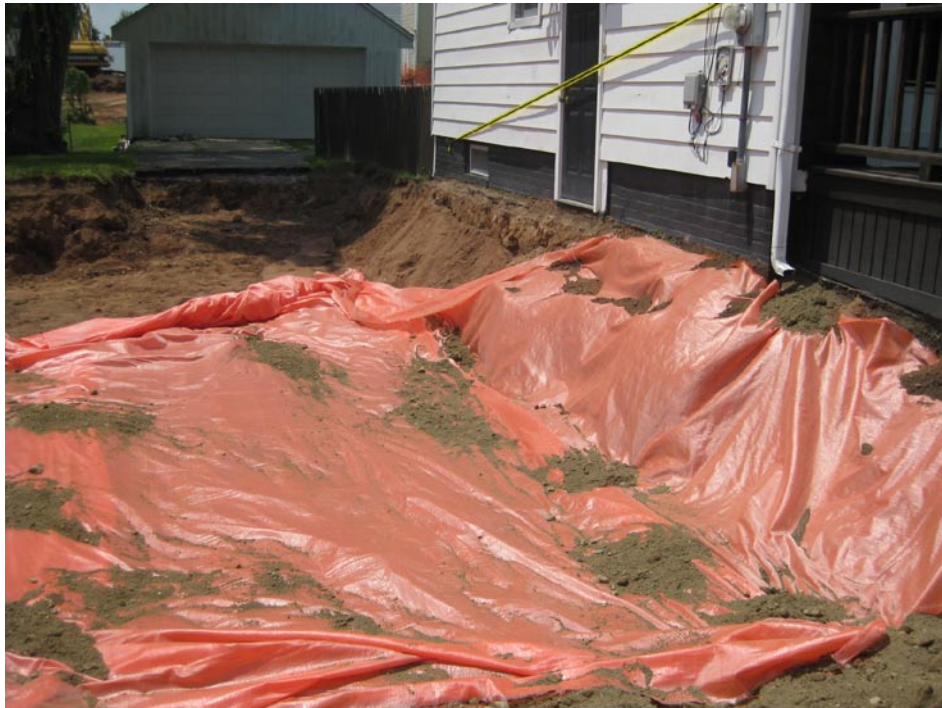
View looking West at excavation in driveway area following placement of marker barrier

- In some locations, fill material was encountered at greater than 4 feet in depth below ground surface (bgs). This fill material was left in place, covered by an orange geotextile fabric, and backfilled with clean soil in accordance with the Final Design - Generic RAP. Figure 2-1 shows the approximate area of geotextile fabric identifying the presence of fill at a depth greater than 4 feet bgs.
- In some locations, it was necessary to leave fill material in place at depths less than 4 feet bgs in order to avoid jeopardizing the integrity of a structure. This fill material was left in place, covered by a marker barrier (orange geotextile fabric and/or shotcrete), and backfilled with clean soil in accordance with the Final Design - Generic RAP. Figure 2-1 shows the approximate area of geotextile fabric/shotcrete identifying the presence of fill at a depth less than 4 feet bgs.

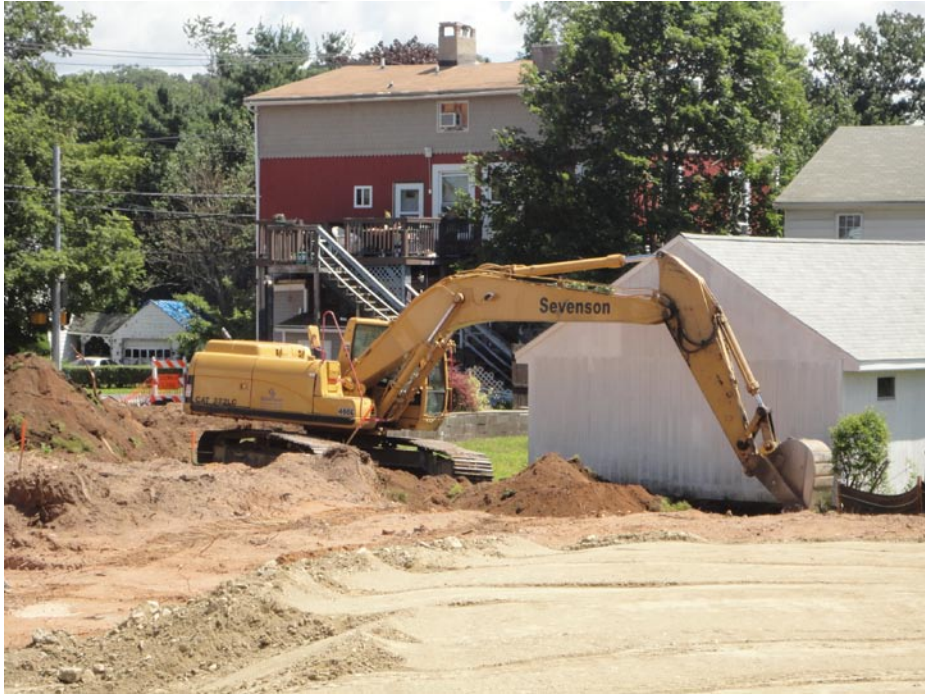
View looking east at excavation in side yard with view of 484-486 Newhall in background

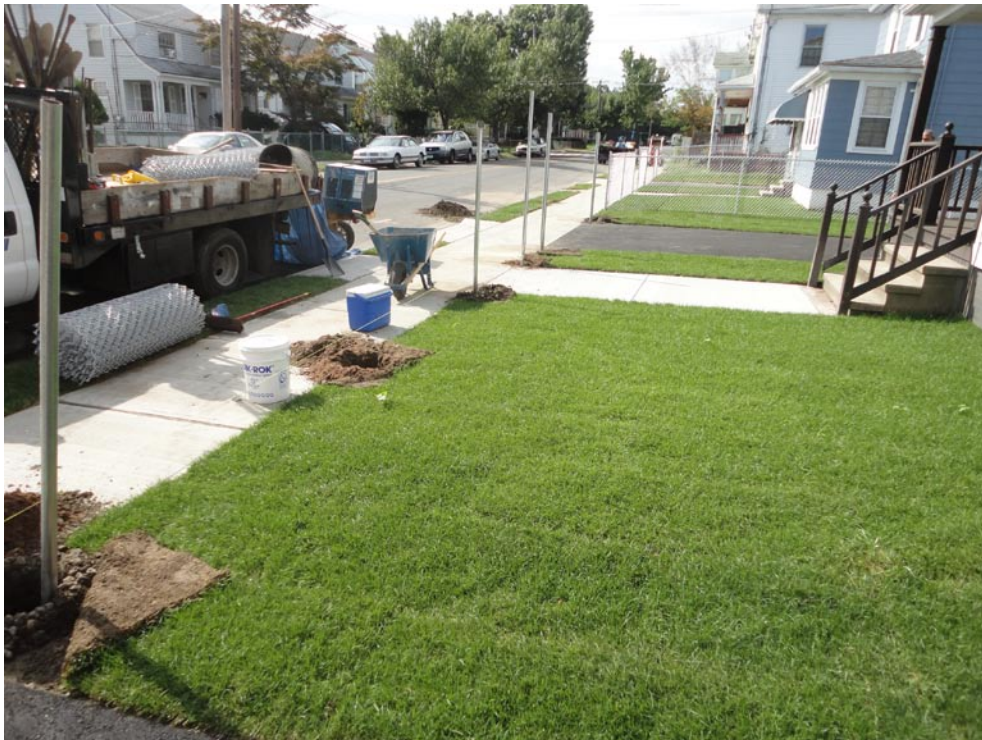
View looking South at front yard during restoration and installation of new fencing
