Re: Property-Specific Remedial Action Report
Newhall Street Neighborhood
496 Shelton Ave, Block J
Hamden, Connecticut 06517

**PROPERTY-SPECIFIC REMEDIAL ACTION REPORT
496 SHELTON AVENUE**

**NON-PUBLIC PROPERTIES
NEWHALL STREET NEIGHBORHOOD
HAMDEN, CONNECTICUT**

AMEC Project Number: 6107110004/65

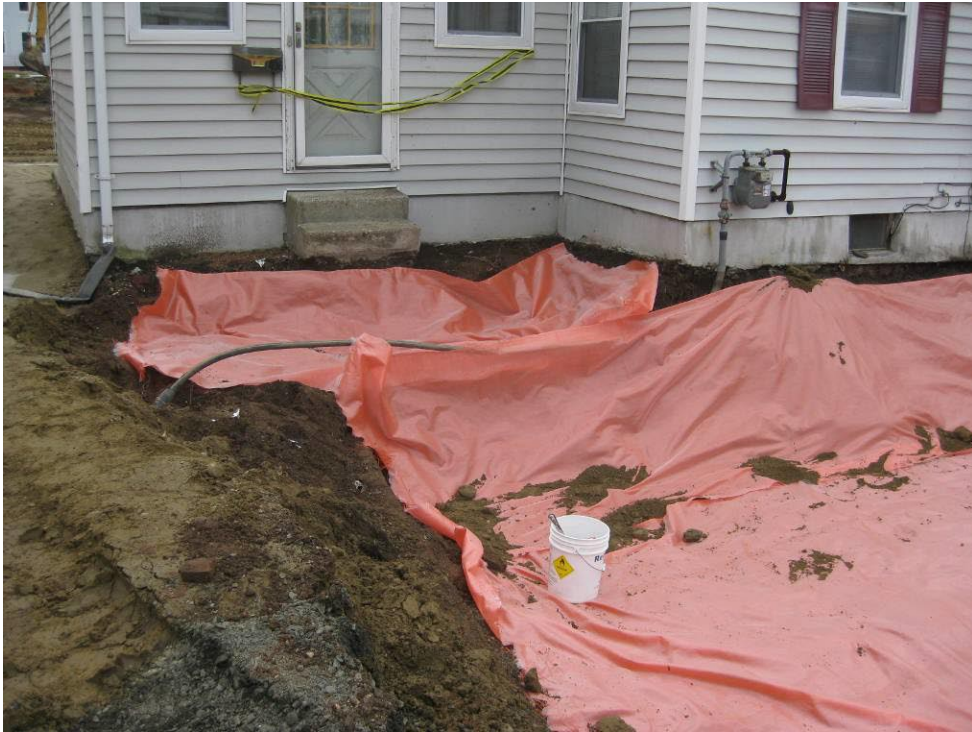
View looking West at excavated front yard during placement of marker barrier

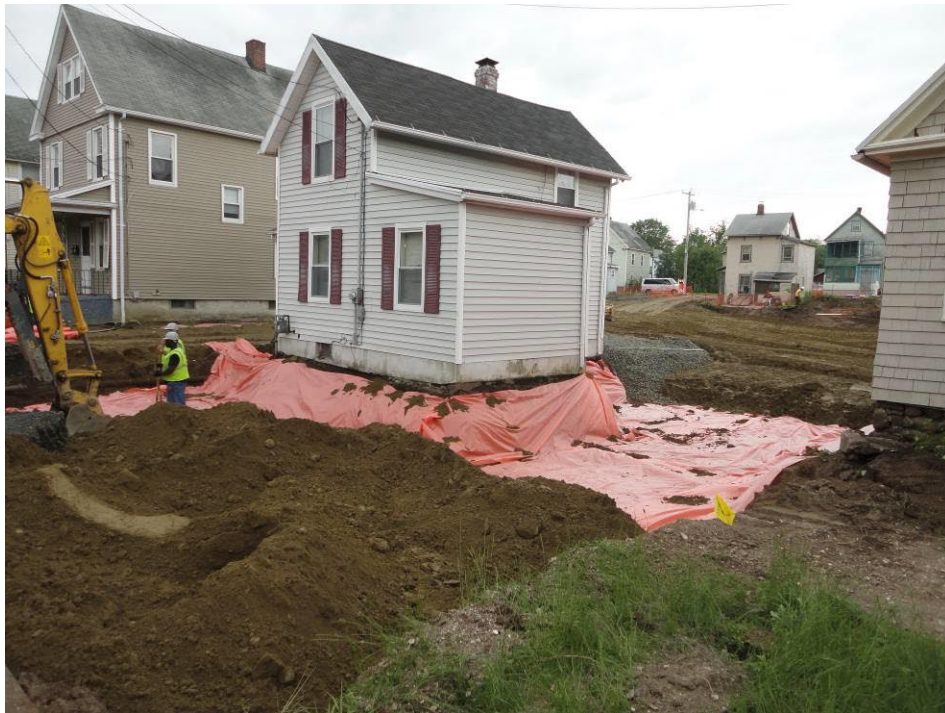
View looking Southwest at excavated back and side yards

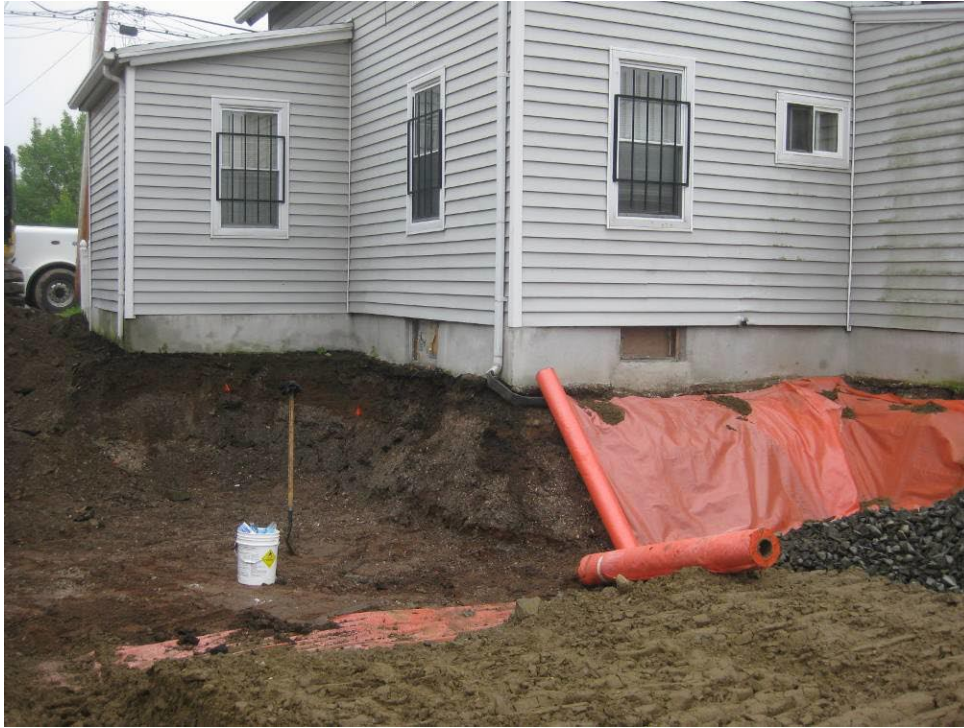
View looking East at excavated back yard

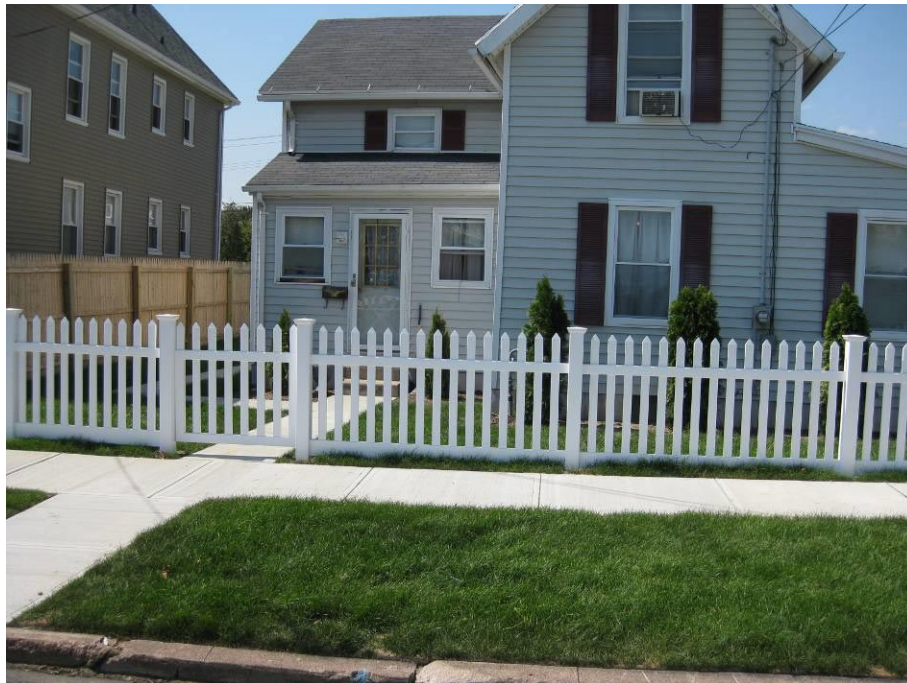
View looking West at restored front yard

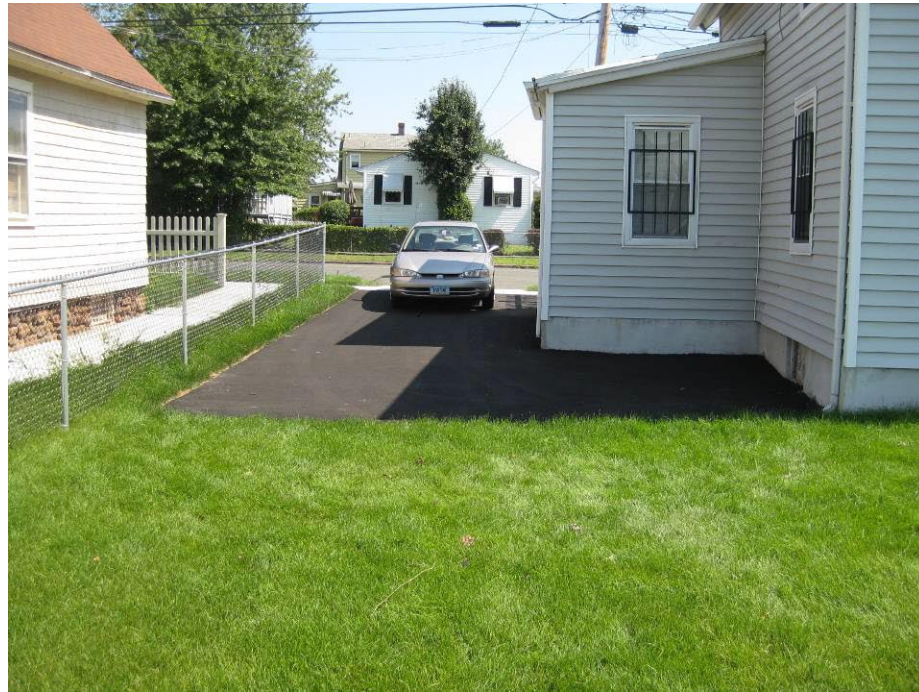
View looking East at restored back yard and driveway
