Re: Property-Specific Remedial Action Report  
Newhall Street Neighborhood  
499 Newhall Street, Block E  
Hamden, Connecticut 06517

**PROPERTY-SPECIFIC REMEDIAL ACTION REPORT  
499 NEWHALL STREET**

**NON-PUBLIC PROPERTIES  
NEWHALL STREET NEIGHBORHOOD  
HAMDEN, CONNECTICUT**

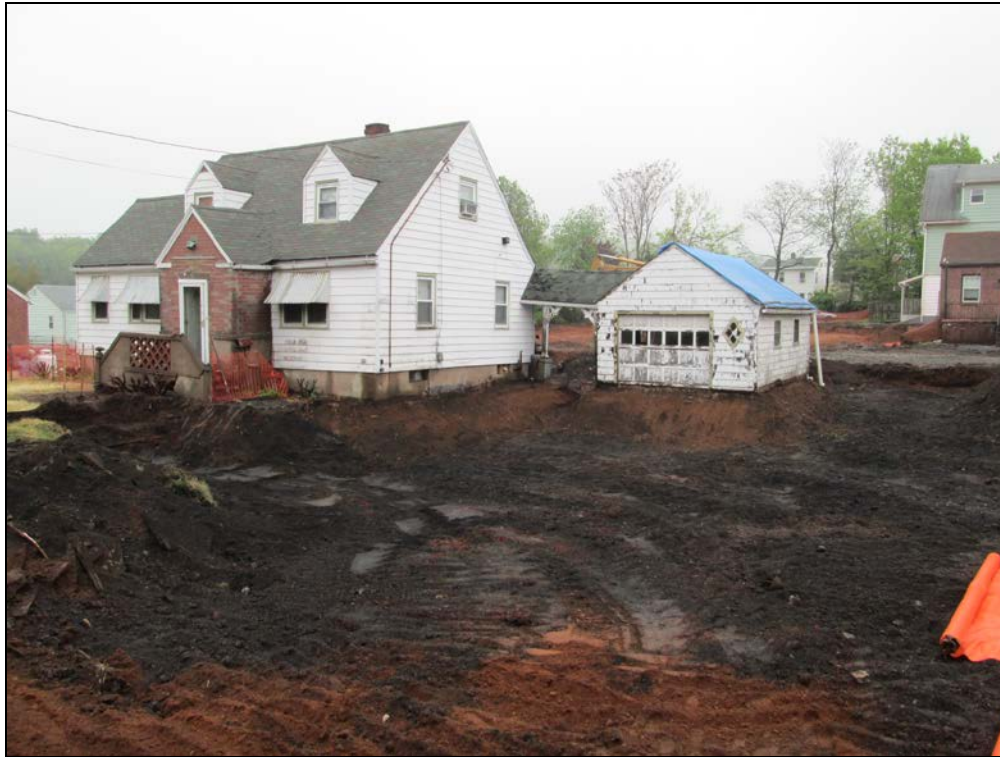
**View looking northeast at excavated front yard.**

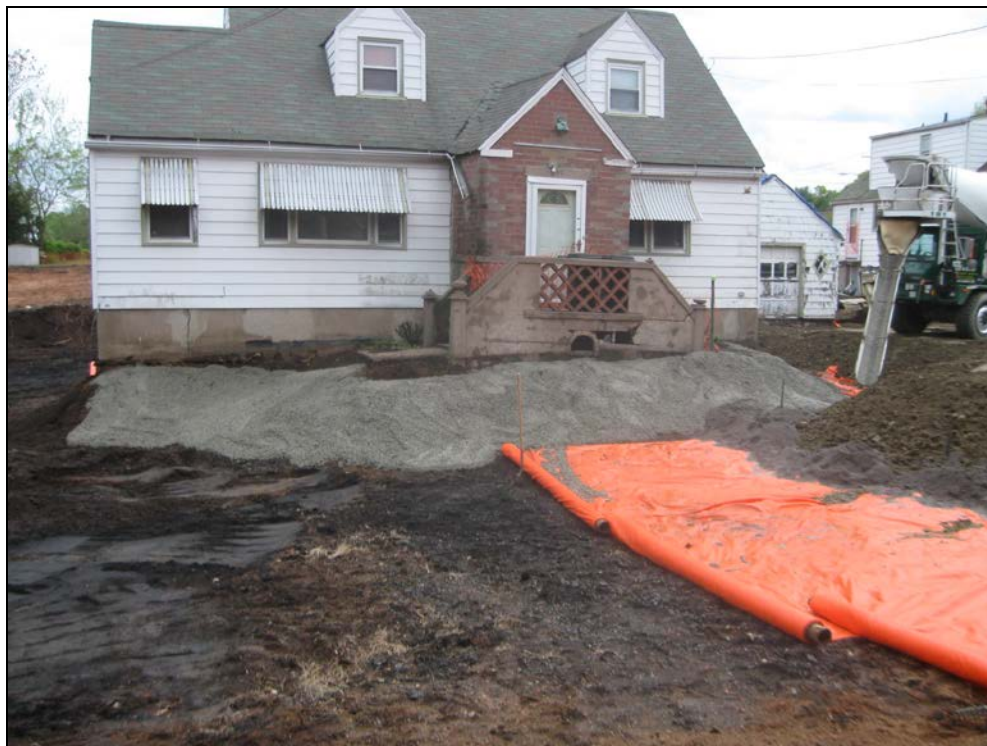
**View looking east at marker barrier being placed over fill material left in place.**

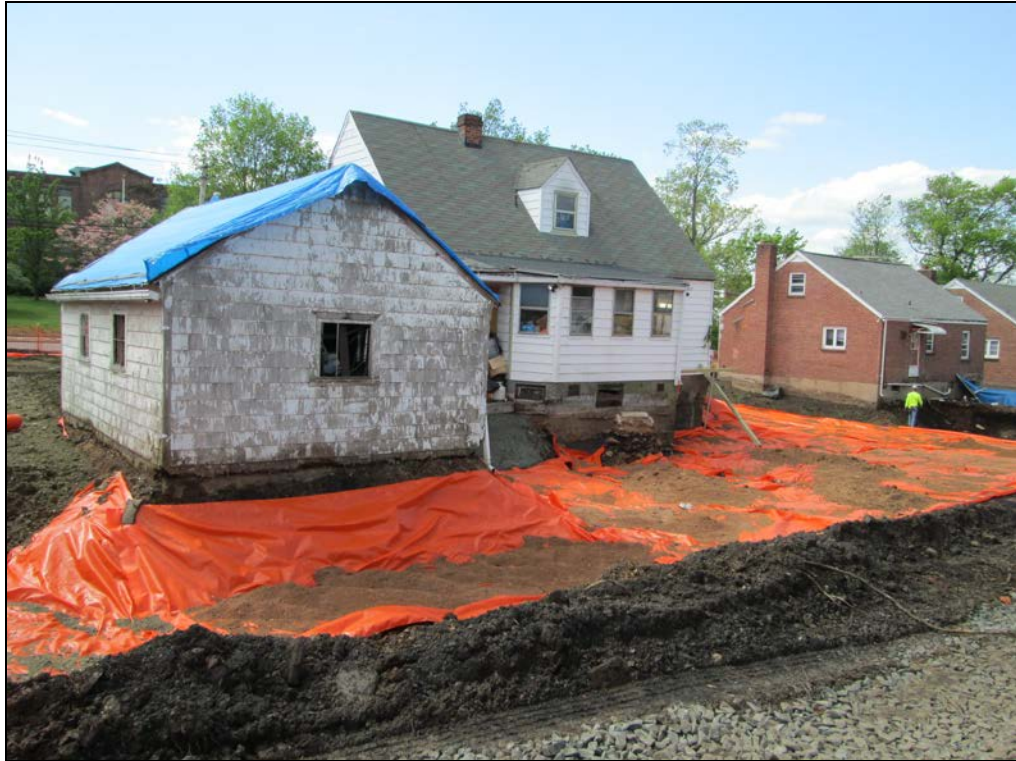
**View looking northwest at excavated back yard.**

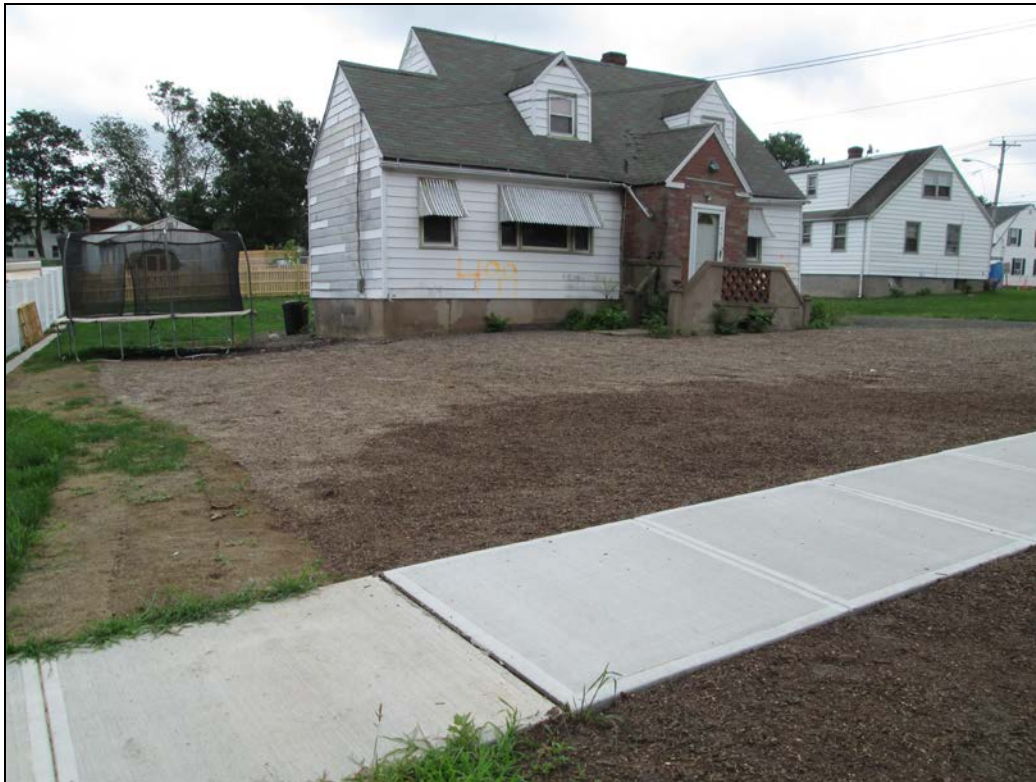
**View looking southeast at restored front yard prior to application of hydroseed.**

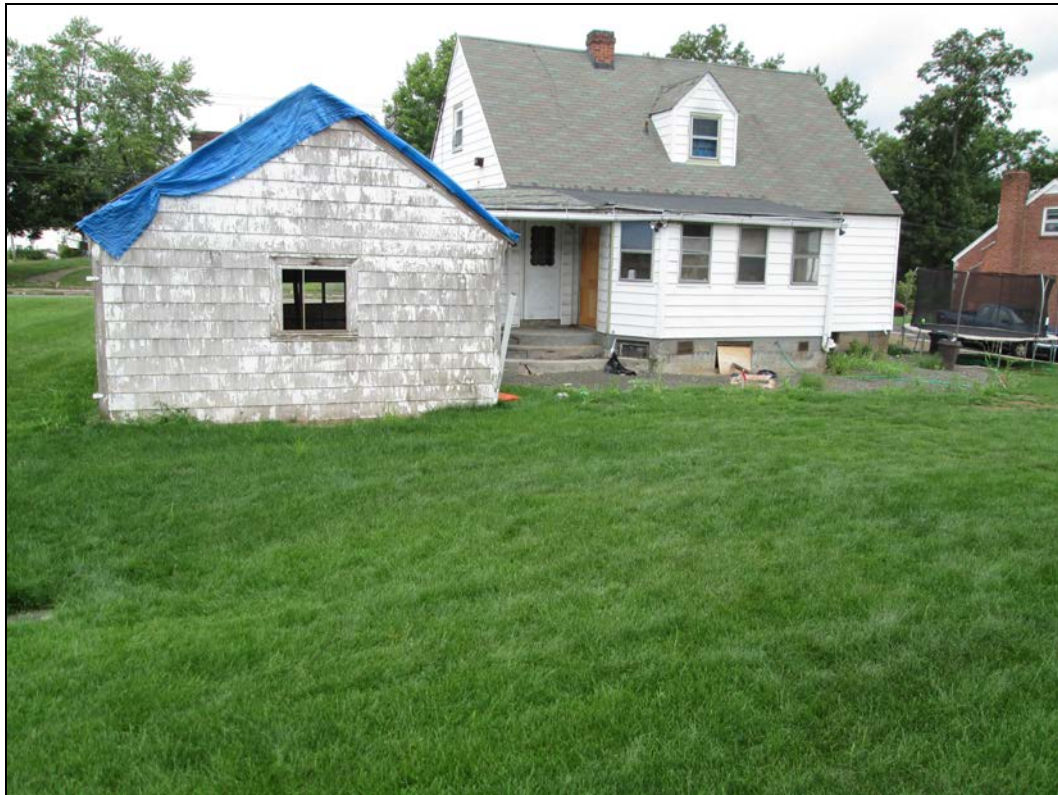
**View looking west at restored back yard.**
