Re: Property-Specific Remedial Action Report
Newhall Street Neighborhood
79 Marlboro Street, Block K
Hamden, Connecticut 06517

**PROPERTY-SPECIFIC REMEDIAL ACTION REPORT
79 MARLBORO STREET**

**NON-PUBLIC PROPERTIES
NEWHALL STREET NEIGHBORHOOD
HAMDEN, CONNECTICUT**

AMEC Project Number: 6107110004/95

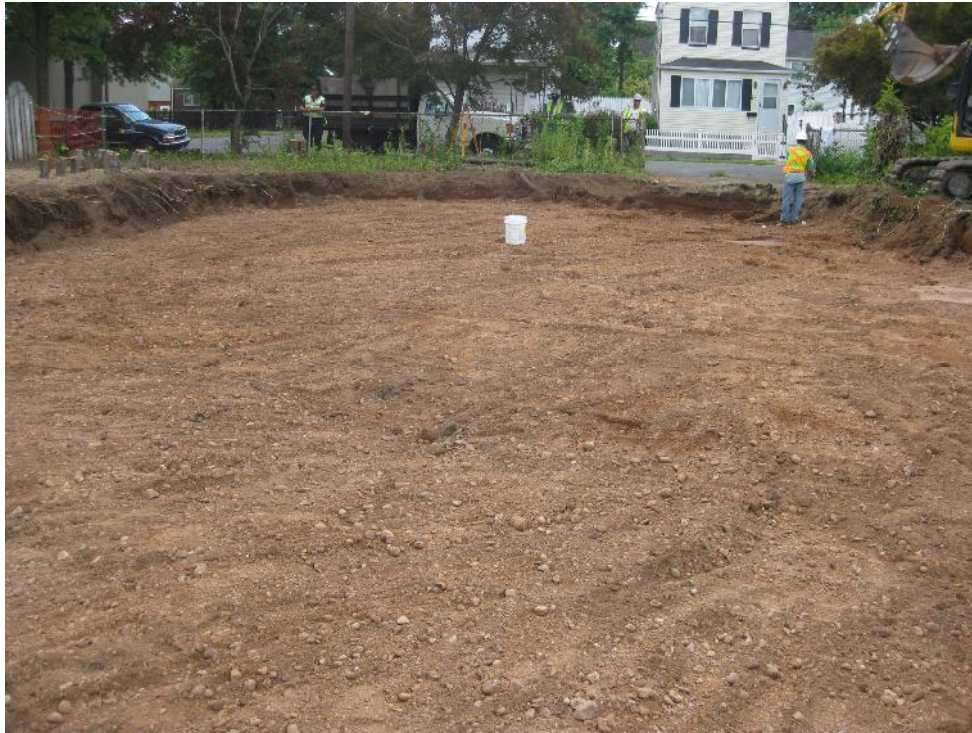
View looking South at excavation area

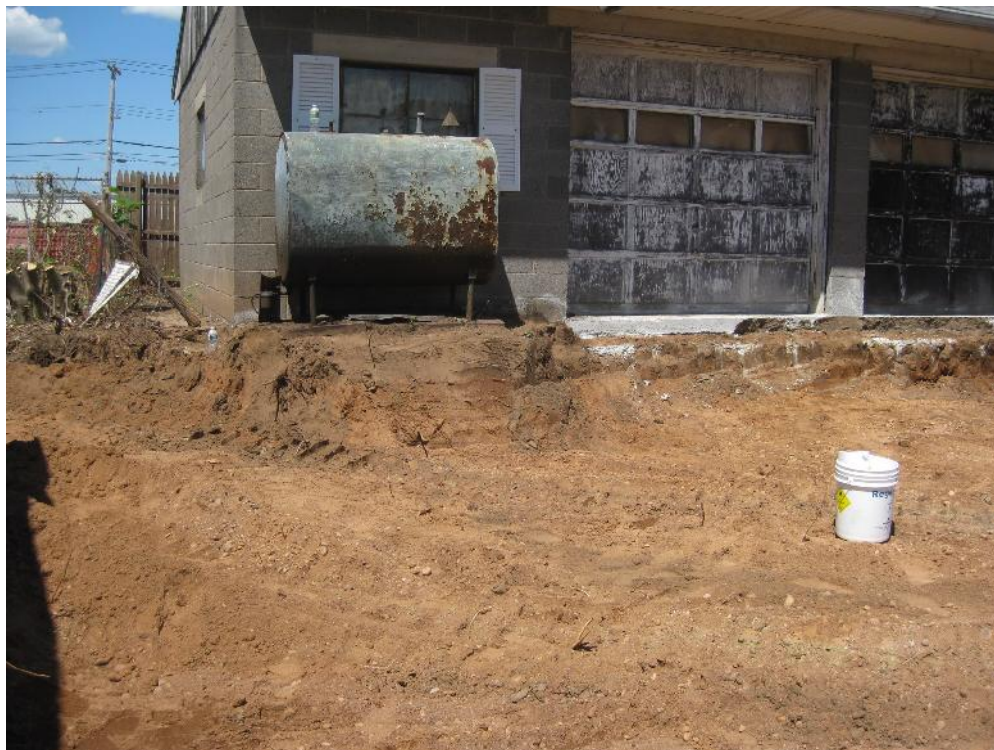
View looking North at excavation along garage

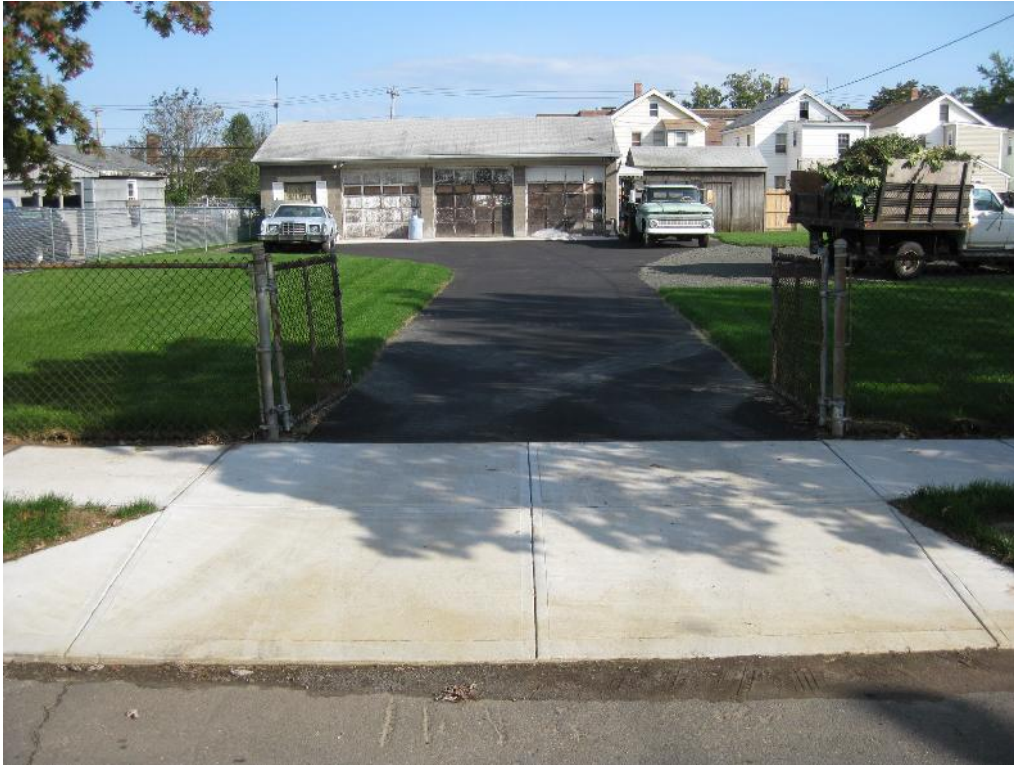
View looking North at restored driveway

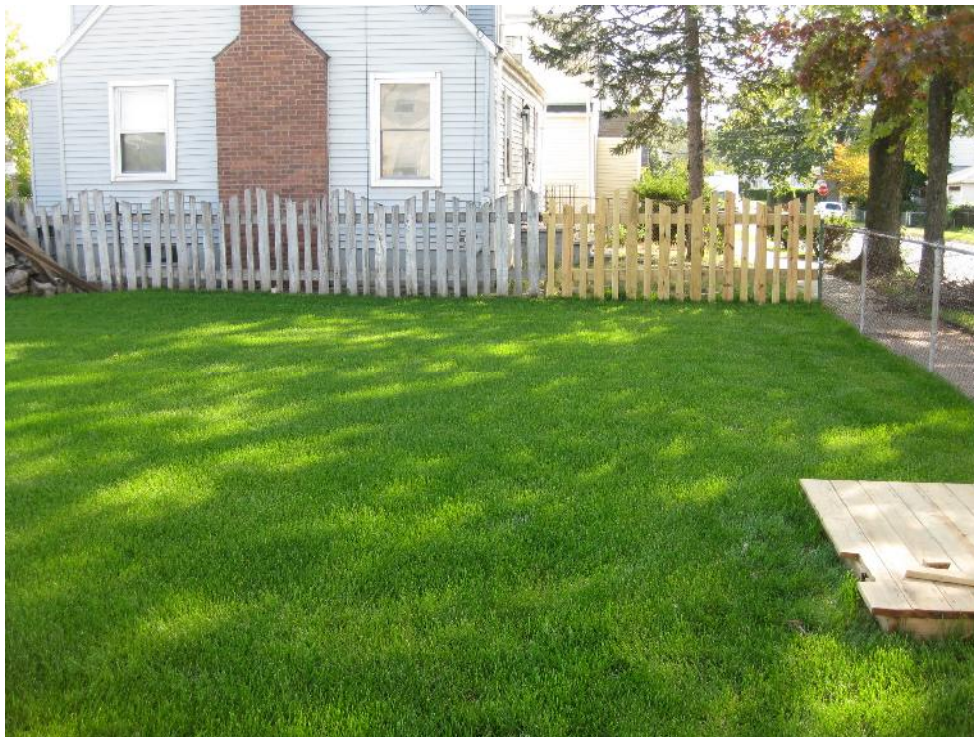
View looking East at restored side yard
