Re: Property-Specific Remedial Action Report
Newhall Street Neighborhood
968-970 Winchester Avenue, Block Q
Hamden, Connecticut 06517

**PROPERTY-SPECIFIC REMEDIAL ACTION REPORT
968-970 WINCHESTER AVENUE**

**NON-PUBLIC PROPERTIES
NEWHALL STREET NEIGHBORHOOD
HAMDEN, CONNECTICUT**

AMEC Project Number: 6107120004.165

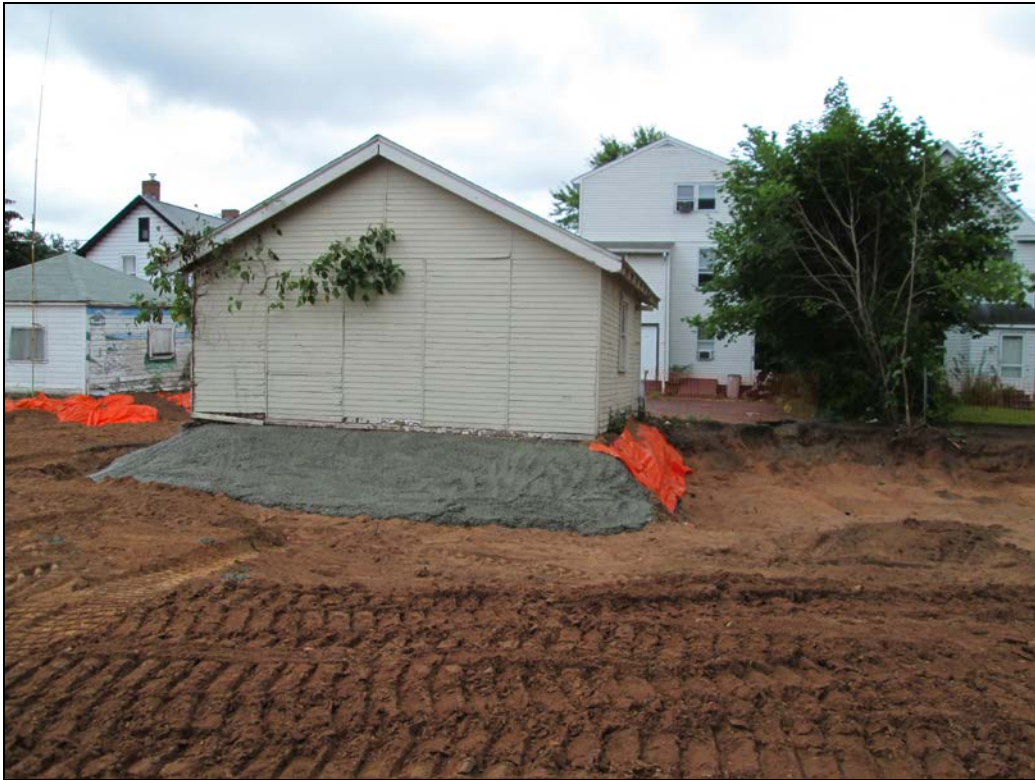
View looking east at excavated back yard during placement of marker barrier around garage.

- In some locations, it was necessary to leave fill material in place at depths less than 4 feet bgs in order to avoid jeopardizing the integrity of a structure or feature that was to be left in place. This fill material was left in place, covered by an orange geotextile fabric and/or concrete, and backfilled with clean soil in accordance with the Final Design - Generic RAP. Figure 2-1 shows the approximate area of geotextile fabric/concrete identifying the presence of fill at a depth less than 4 feet bgs.

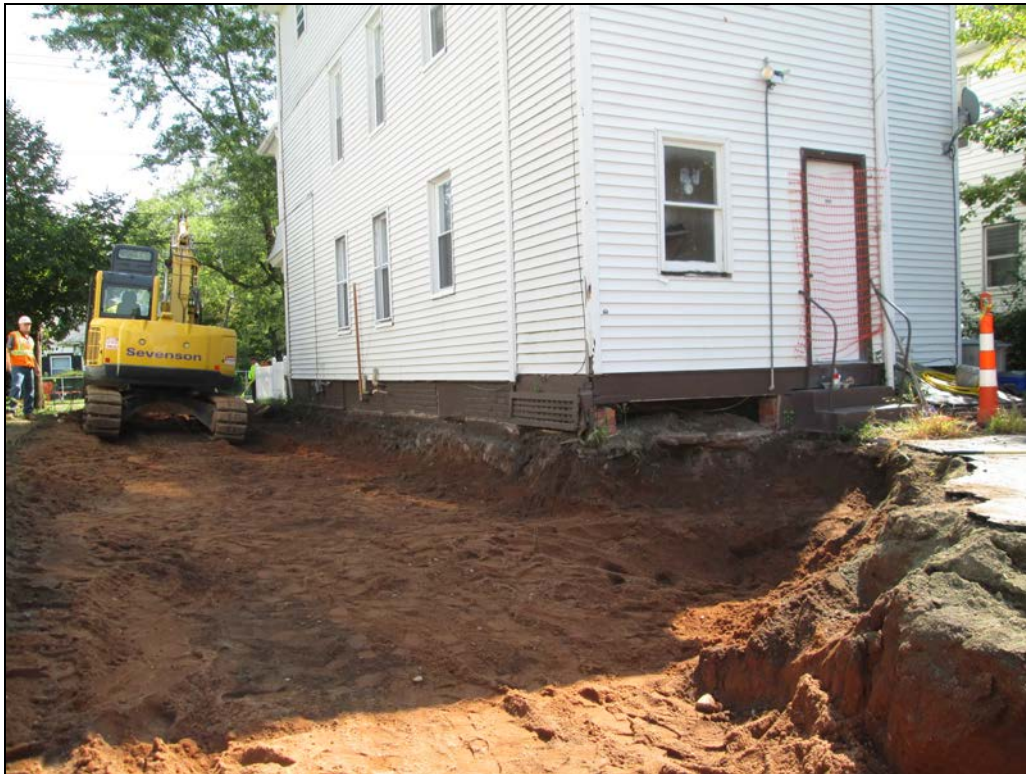
View looking east at excavated driveway area.

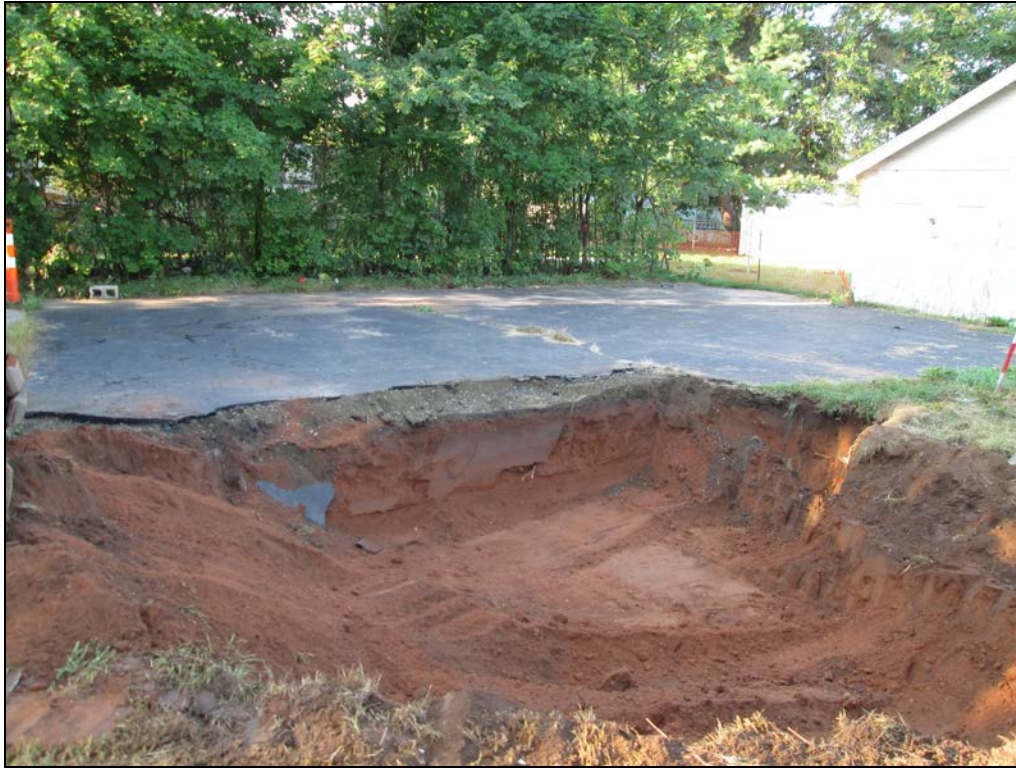
View looking south at extent of excavation in parking area.

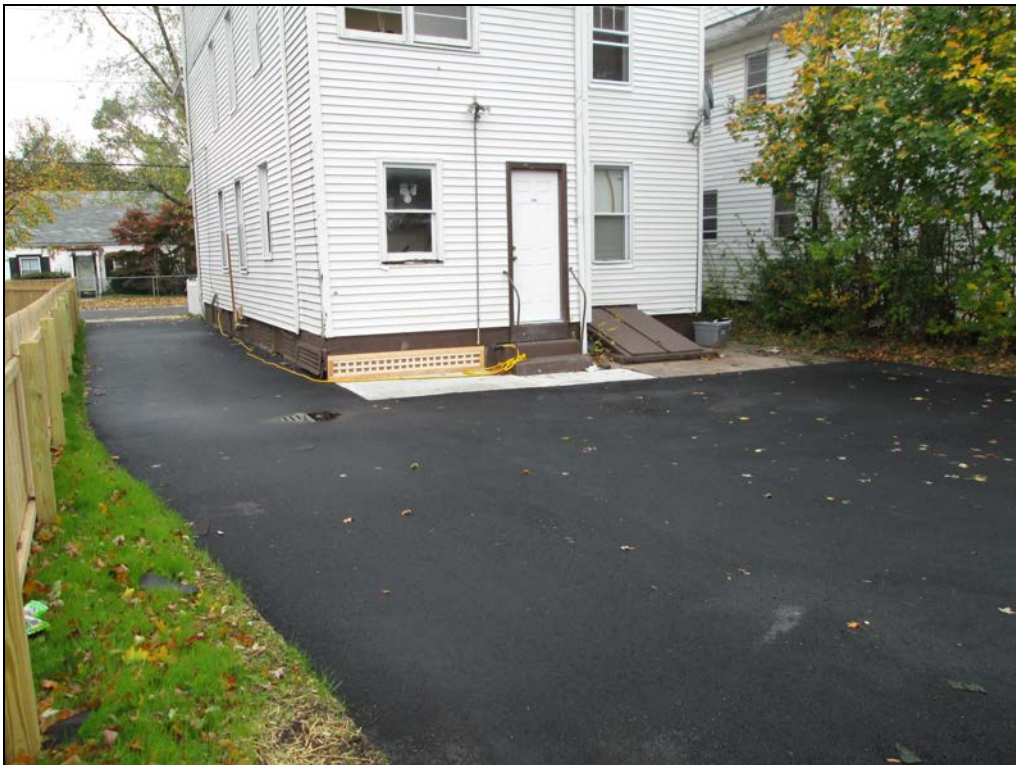
View looking east at restored parking area.

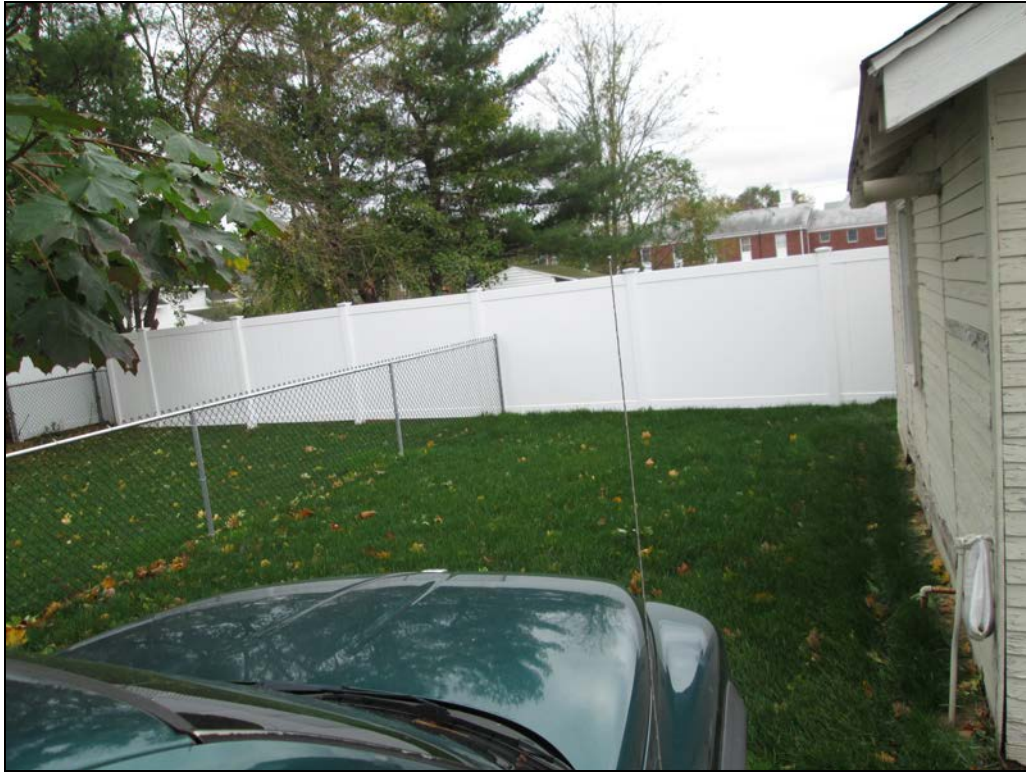
View looking west at restored back yard.
